# Inspection Photos

Operator: CAERUS PICEANCE LLC # 10456

Location ID: 335856

Garfield County, CO

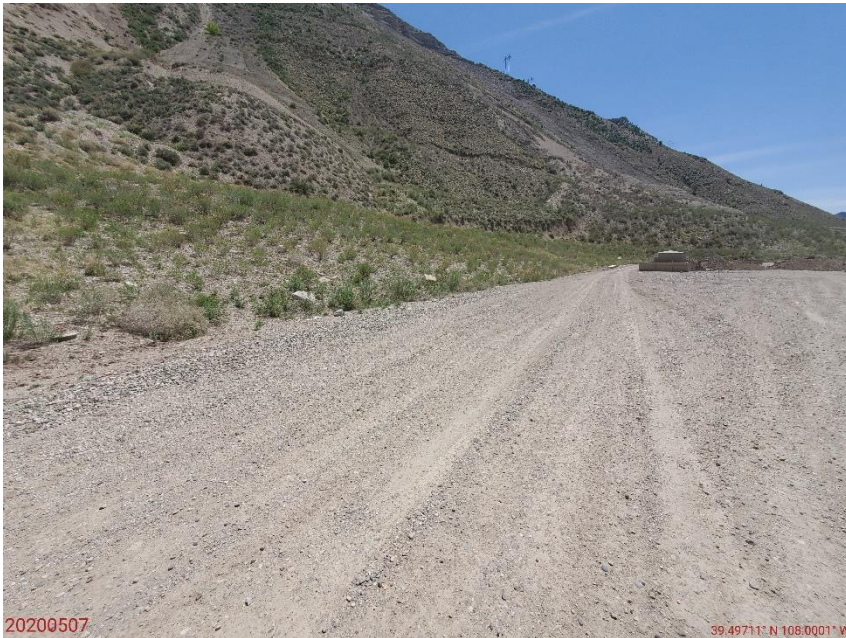
**Photo 1:** Photo taken from the north end of the Location, facing southeast. Photo shows Location remains flat, and has not been contoured in accordance with Rule 1004.a. Records indicate this is due to safety concerns regarding the stability of the adjacent landslide area.

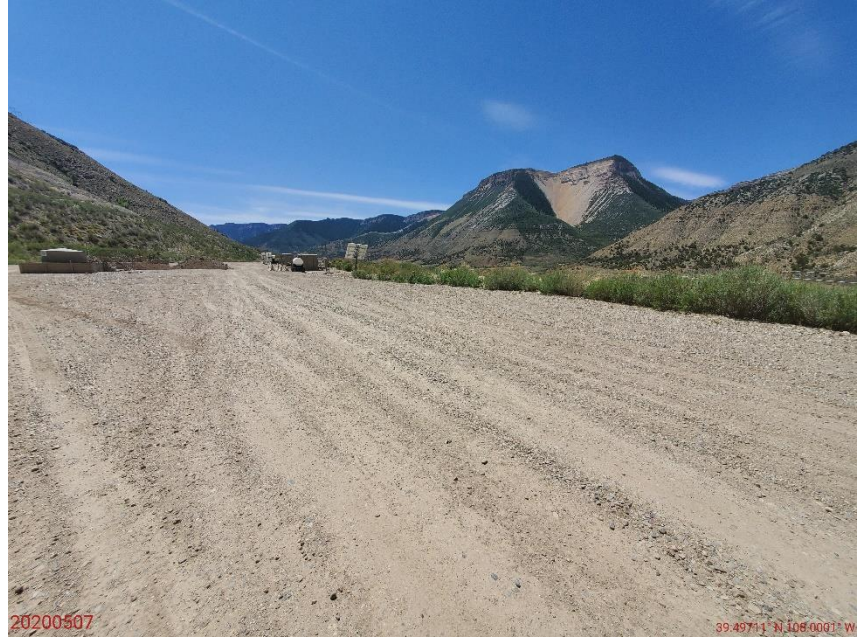
**Photo 2:** Photo taken from the north end of the Location, facing southwest. See comments under photo 1.

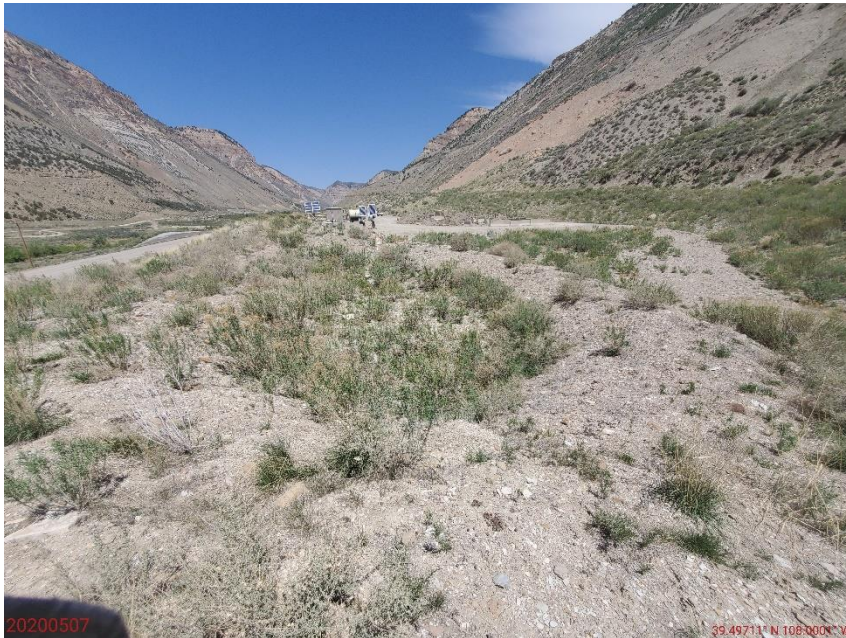
**Photo 3:** Photo taken from south end of the Location, facing north. Photo shows what appears to be a sediment trap/pond or pit. BMP does not appear to be in proper functioning condition, or constructed in such a manner to collect runoff from the pad. Feature will either need to be repaired in accordance with good engineering practices, or removed/reclaimed if no longer in use or needed.

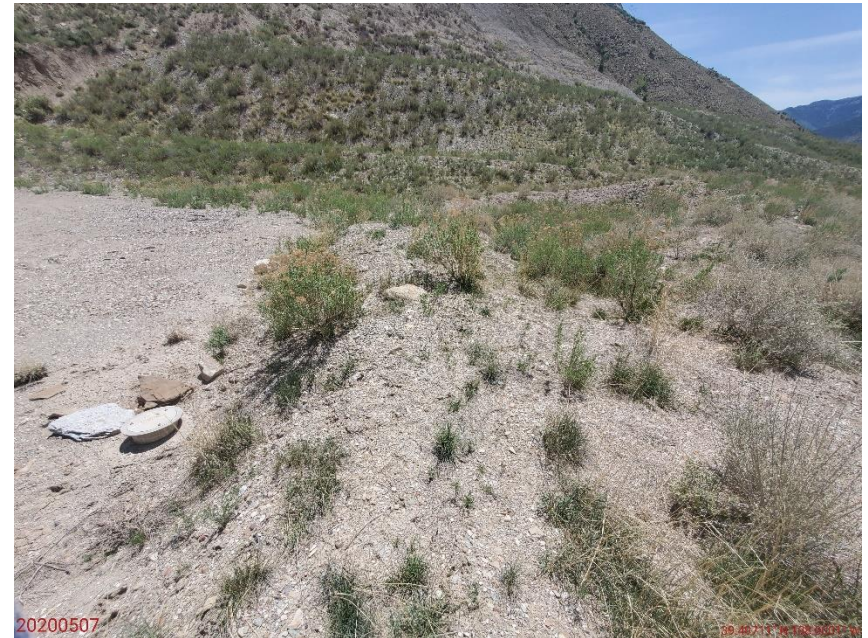
**Photo 4:** Photo taken from the north end of the trap/pond/pit observed in photo 3, facing southeast. Photo shows no inlet at BMP to catch runoff from the pad, or outlet for proper discharge.

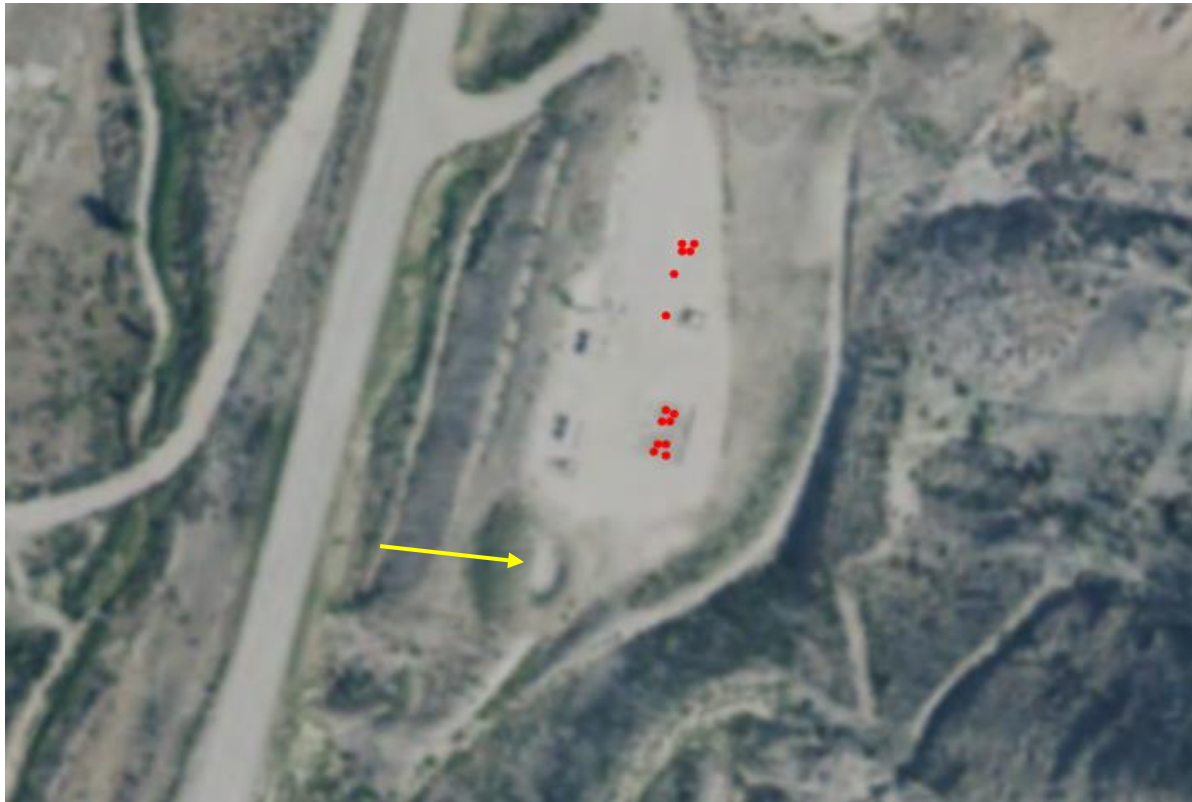
**Photo 5:** 2017 COGIS aerial imagery. Photo shows location of trap/pond/pit observed on the south end of the Location.

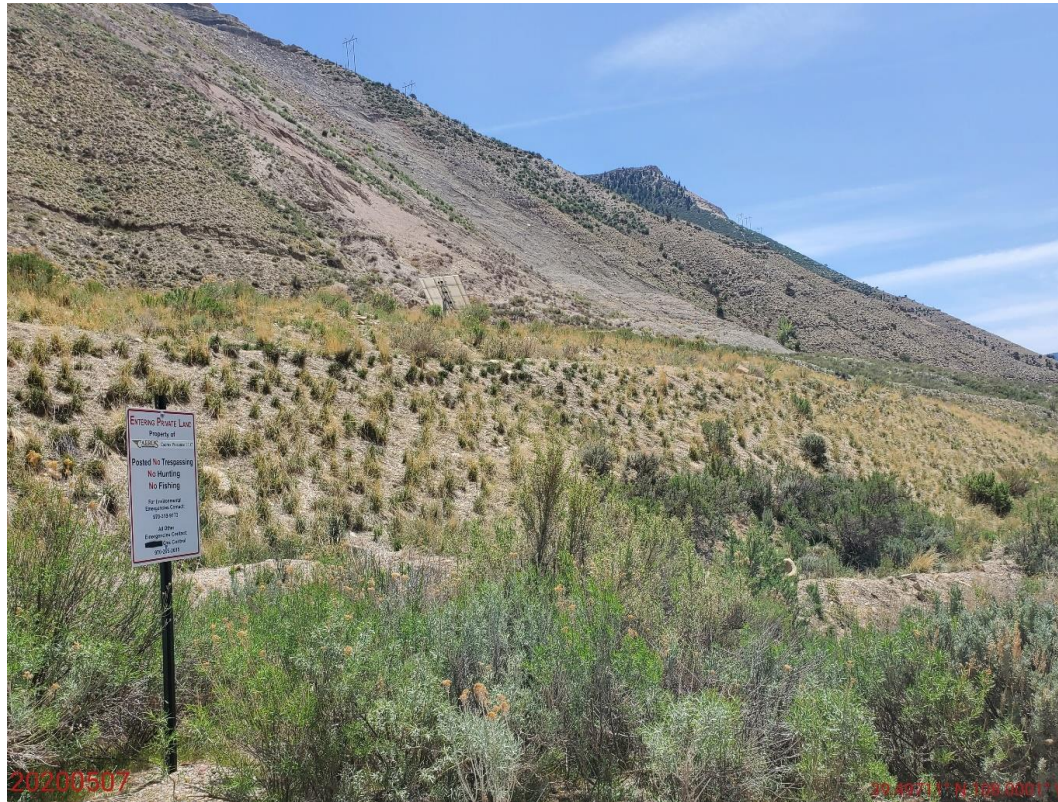
**Photo 6:** Photo taken from access road, northwest of the pad, facing southeast. Photo shows vegetative establishment on the fill slope of the Location.
