Inspection Photos

Operator: EAGLE OPERATING INC - 26155

Location ID: 397838

Rio Blanco County, CO

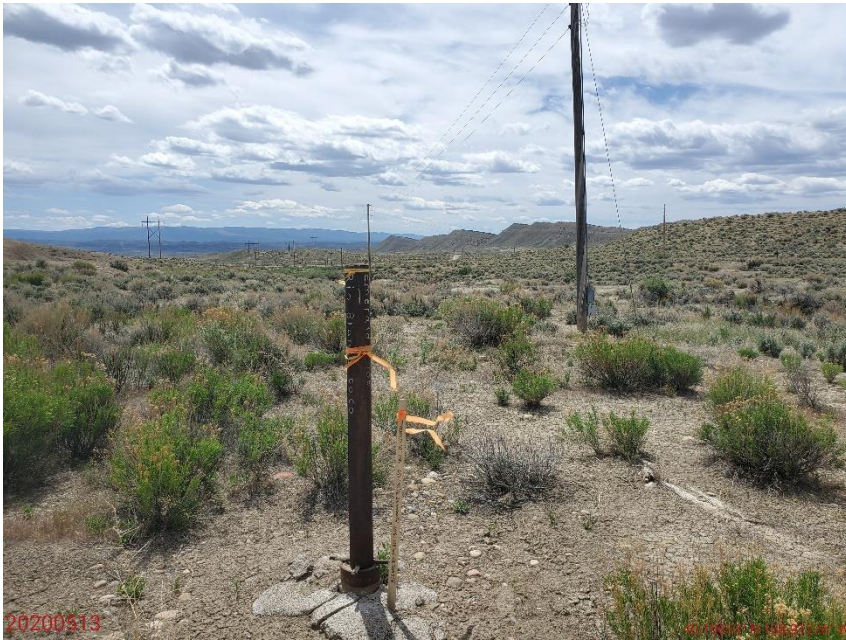
Photo 1: Photo taken from the well facing southeast. Photo shows oil and gas associated utility equipment remaining on the Location.

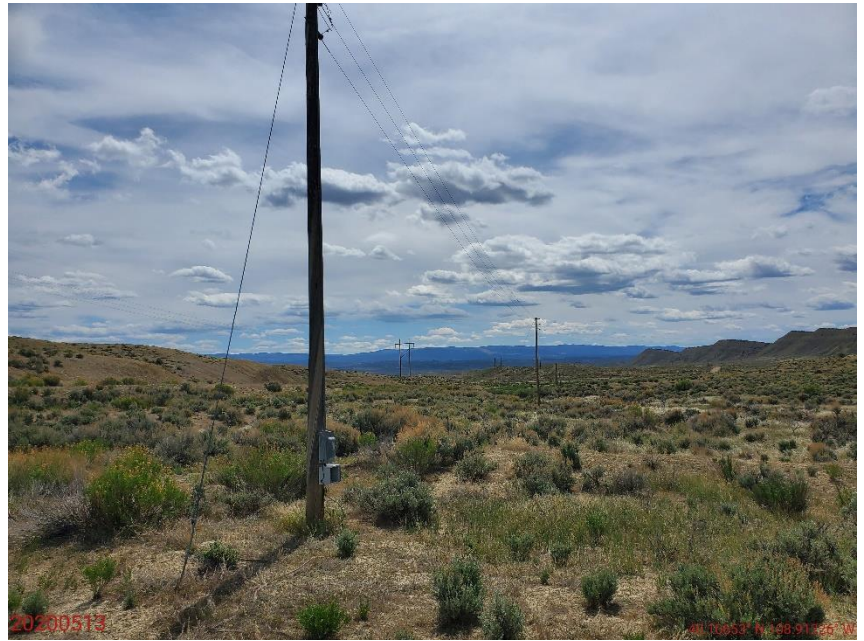
Photo 2: Photo taken from the south end of the Location, facing southeast. Photo shows oil and gas associated utility equipment on, and leading to, the Location. Equipment requires removal in accordance with 1004 rules.

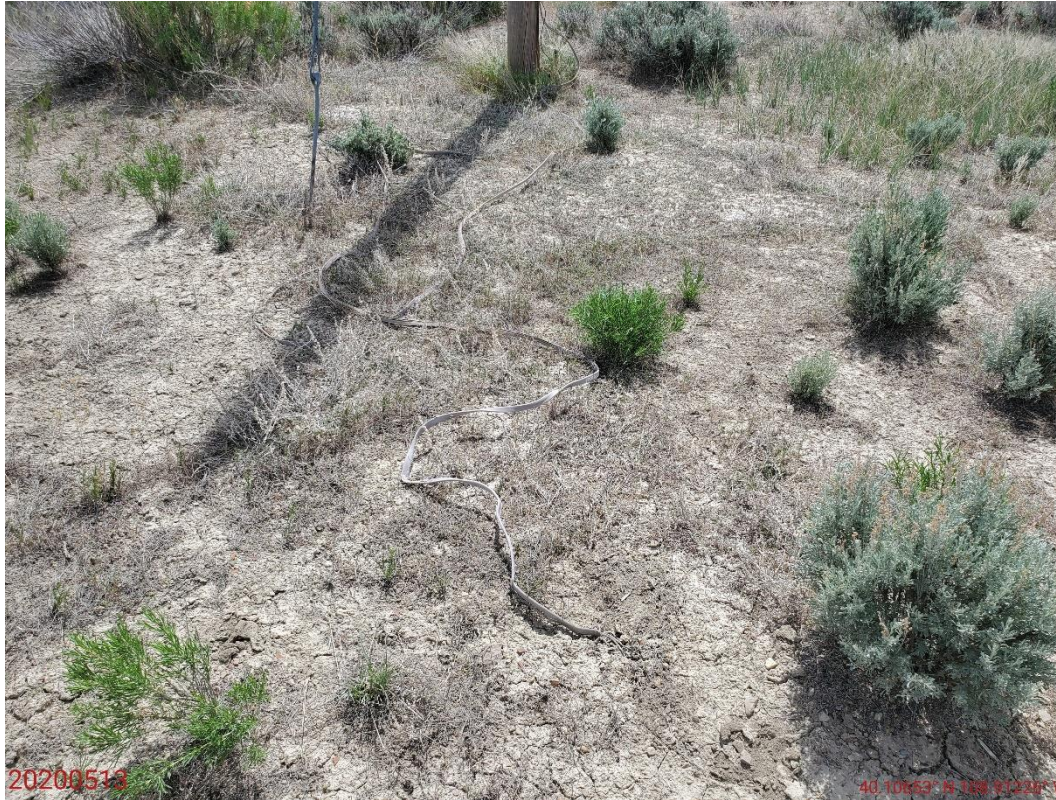
Photo 3: Photo shows exposed wire that had cut at the utility pole.
