Inspection Photos

5/13/2020

Operator: EAGLE OPERATING INC - 26155

Location ID: 316697

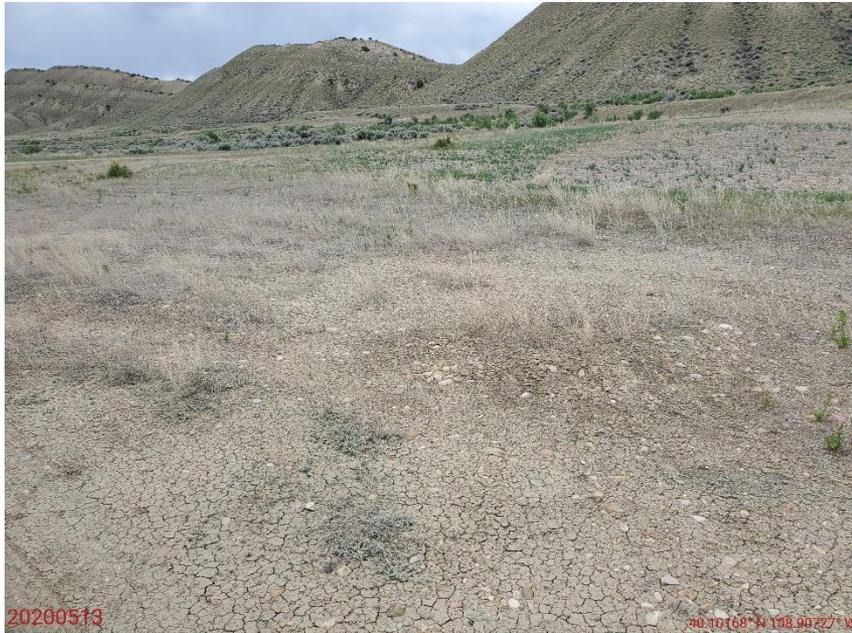
Photo 1: Photo taken from the north end of the Location, facing southeast. Photos 1-3 provide an overview of the Location from southeast, south, to southwest.

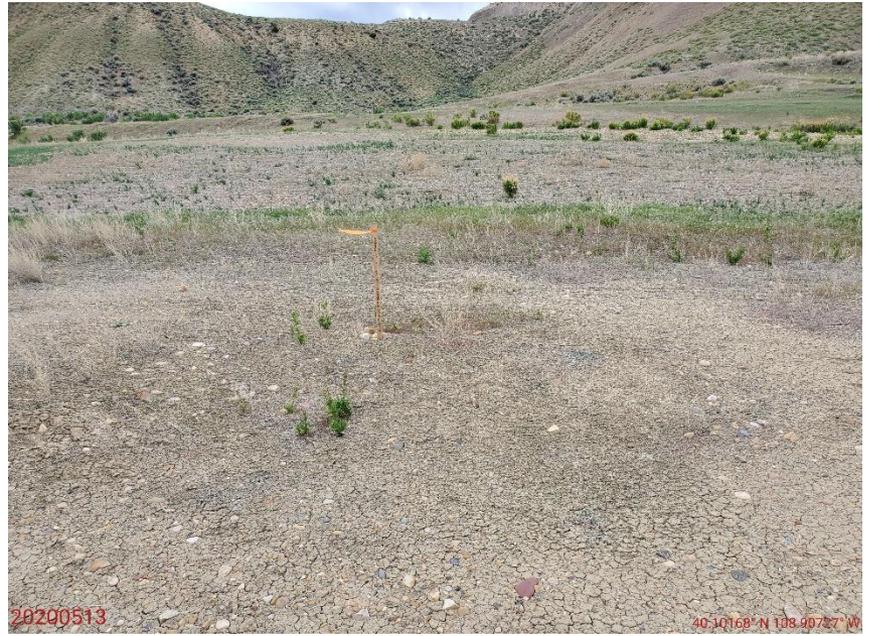
Photo 2: See comments under photo 1.

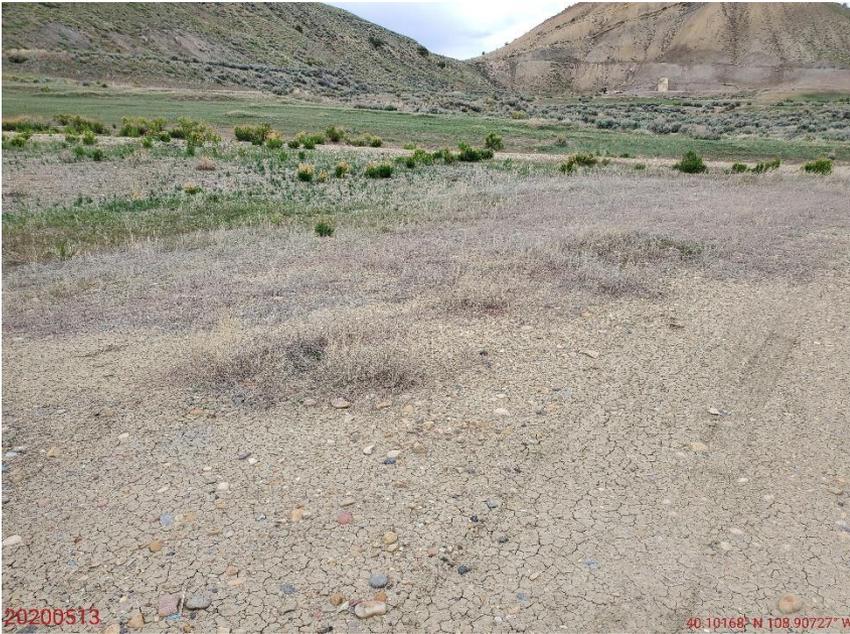
Photo 3: See comments under photo 1.

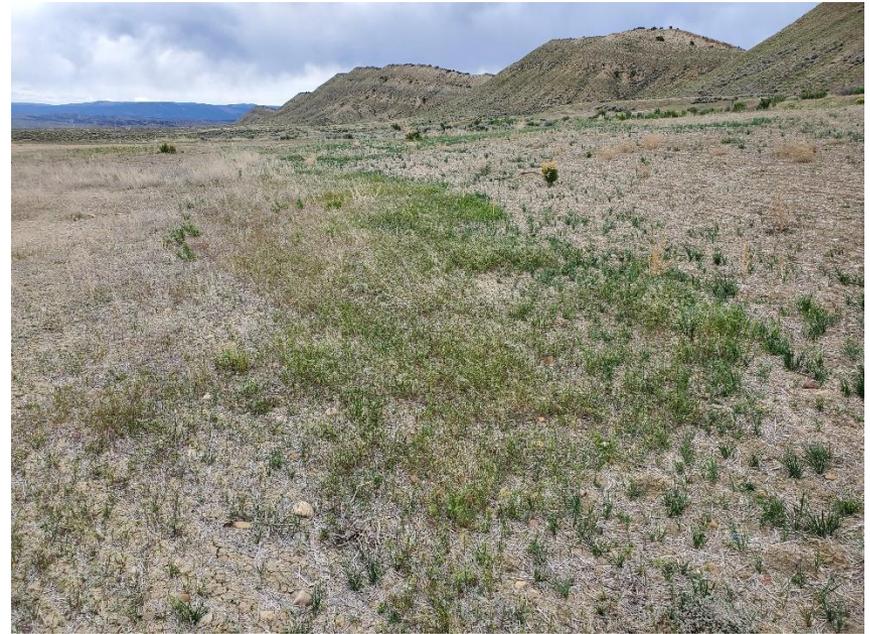
Photo 4: Photo taken from the toe of the slope, facing east. Photo shows vegetation observed is predominantly Cheatgrass. Management required.

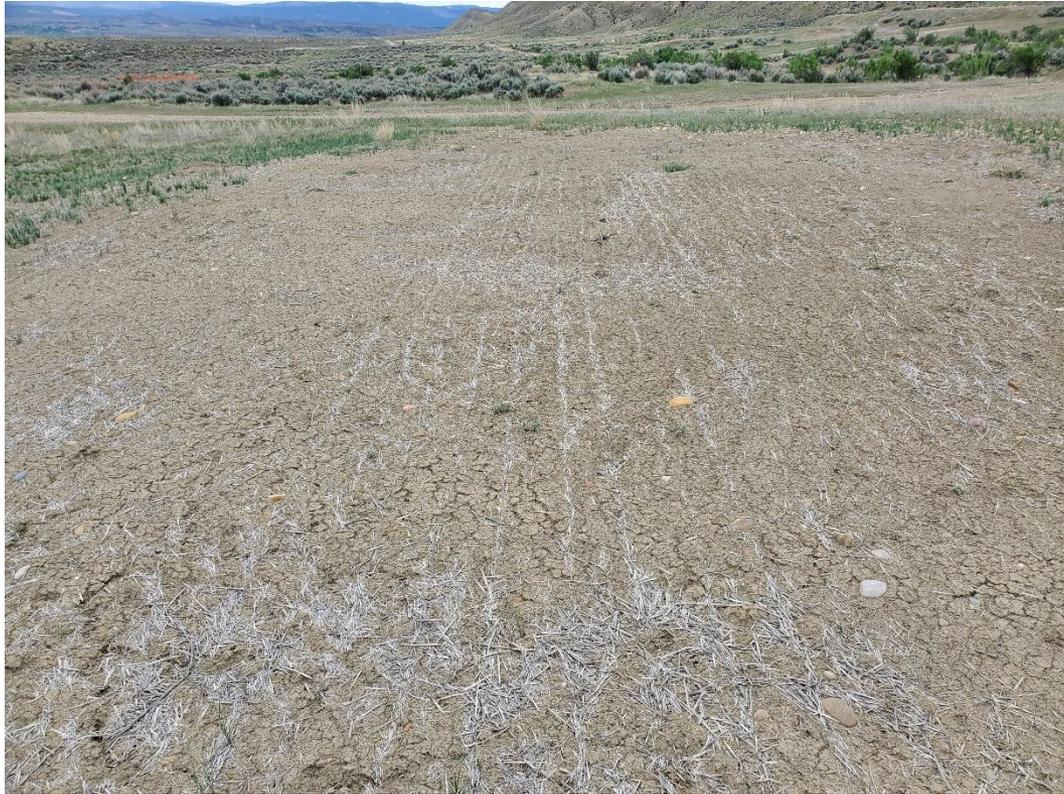
Photo 5 Photo taken from the south end of the Location, facing east. Photo shows large section of the location where germination was not evident.
