# Final Reclamation Inspection

Operator: FOUNDATION ENERGY MANAGEMENT LLC- #10112

Location ID: 417783

Inspection Photos  
Location Name: Hillman /9-1  
Location ID: 417783

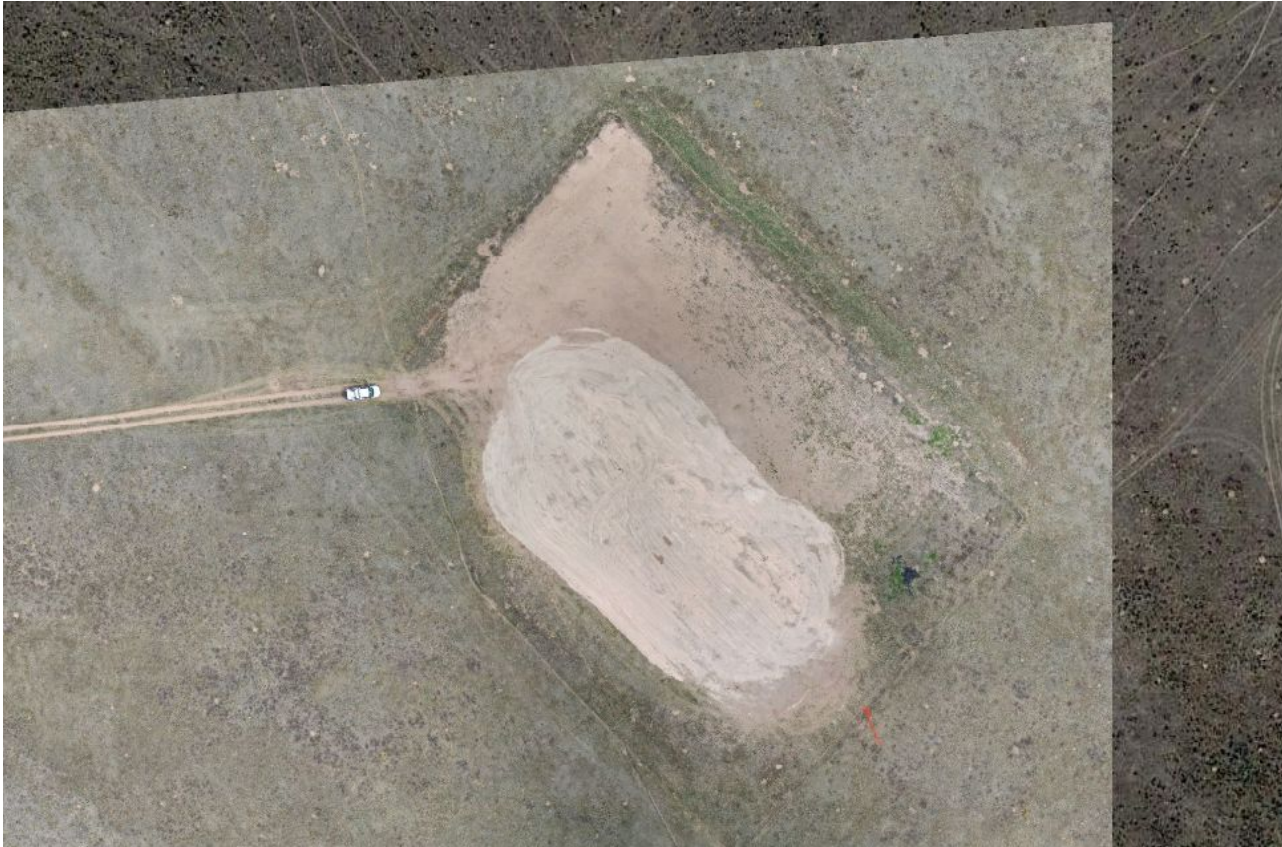
**Photo 1.** Drone aerial imagery taken May 18, 2020. Aerial imagery illustrates a total well location disturbance of 1.7 acres, a well location access road of ~600' and a stockpile totalling ~250 cy.

Operator has removed the 2 tanks and in-process of cleaning up the spill.

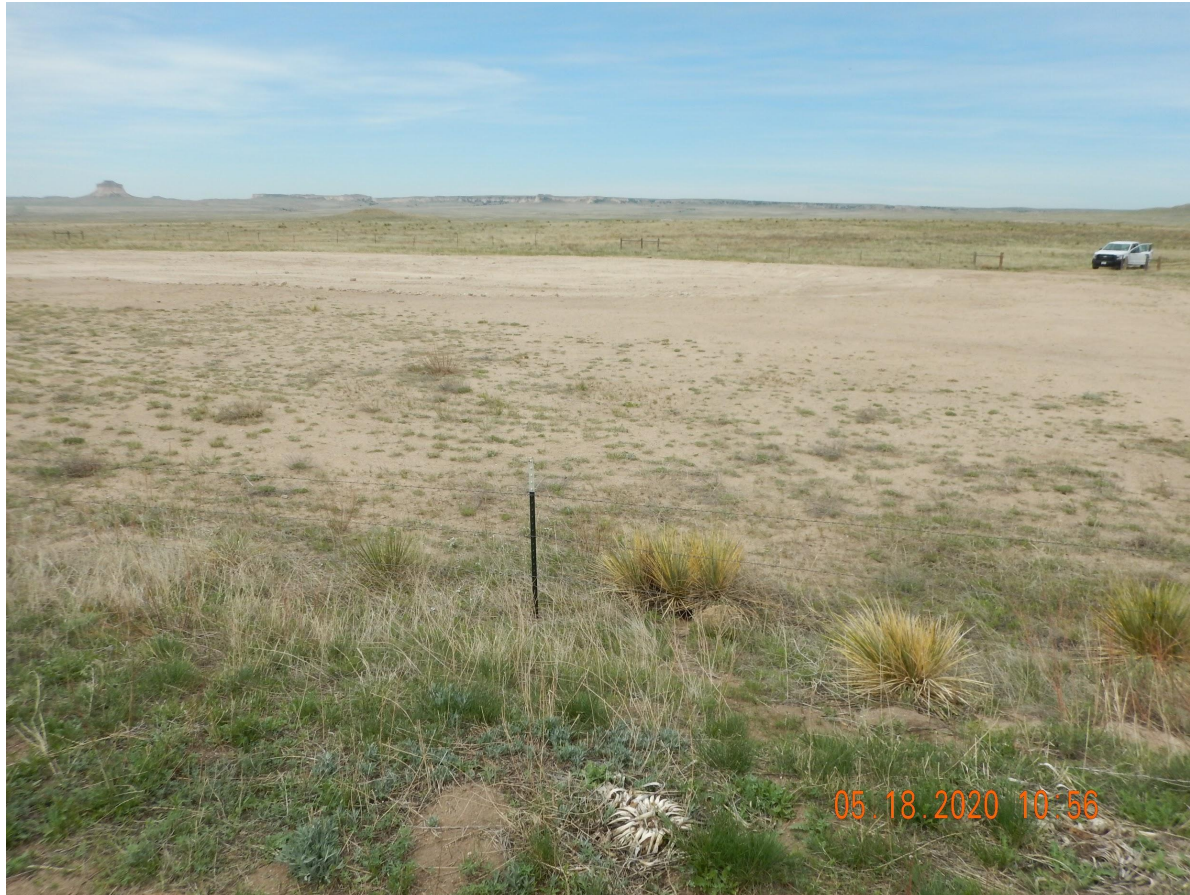
**Photo 2.** Photo taken from the northeastern perimeter of location, facing Southwest. Photo illustrates Operator has removed the tanks and in-process of cleaning up the spill.

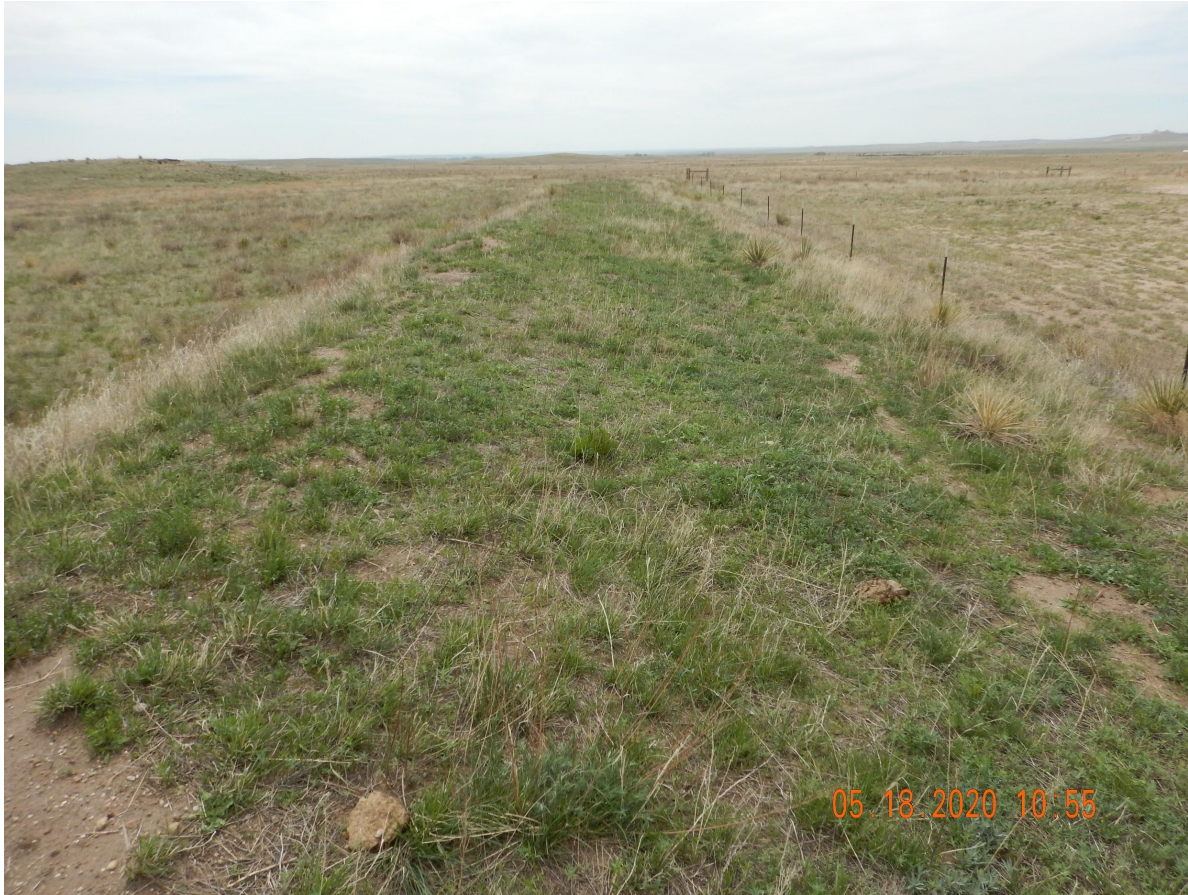
**Photo 3.** Photo taken from the northeastern perimeter of location, facing South. Photo illustrates a stockpile that is likely topsoil that should be incorporated to facilitate final reclamation activities.

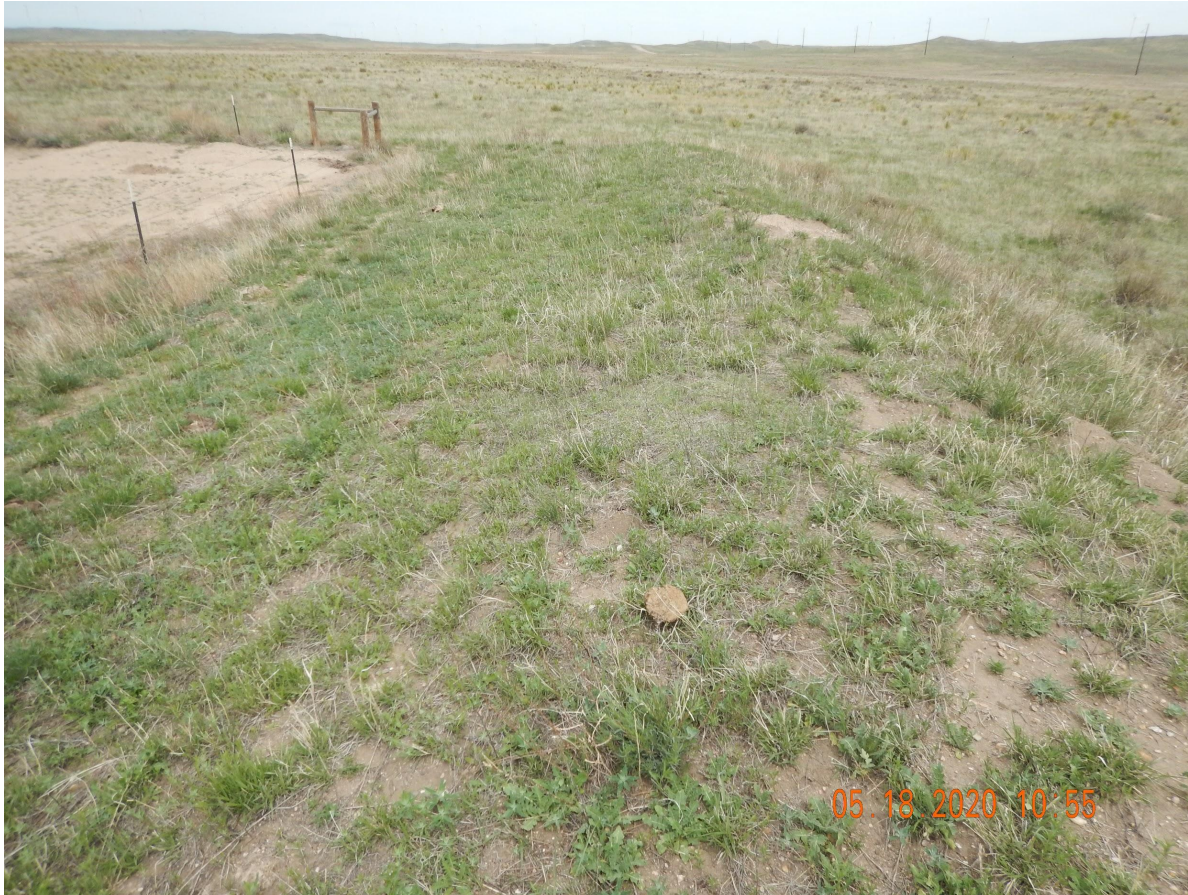
**Photo 4.** Photo taken from the northeastern perimeter of location, facing North.  
See comments under Photo 3.

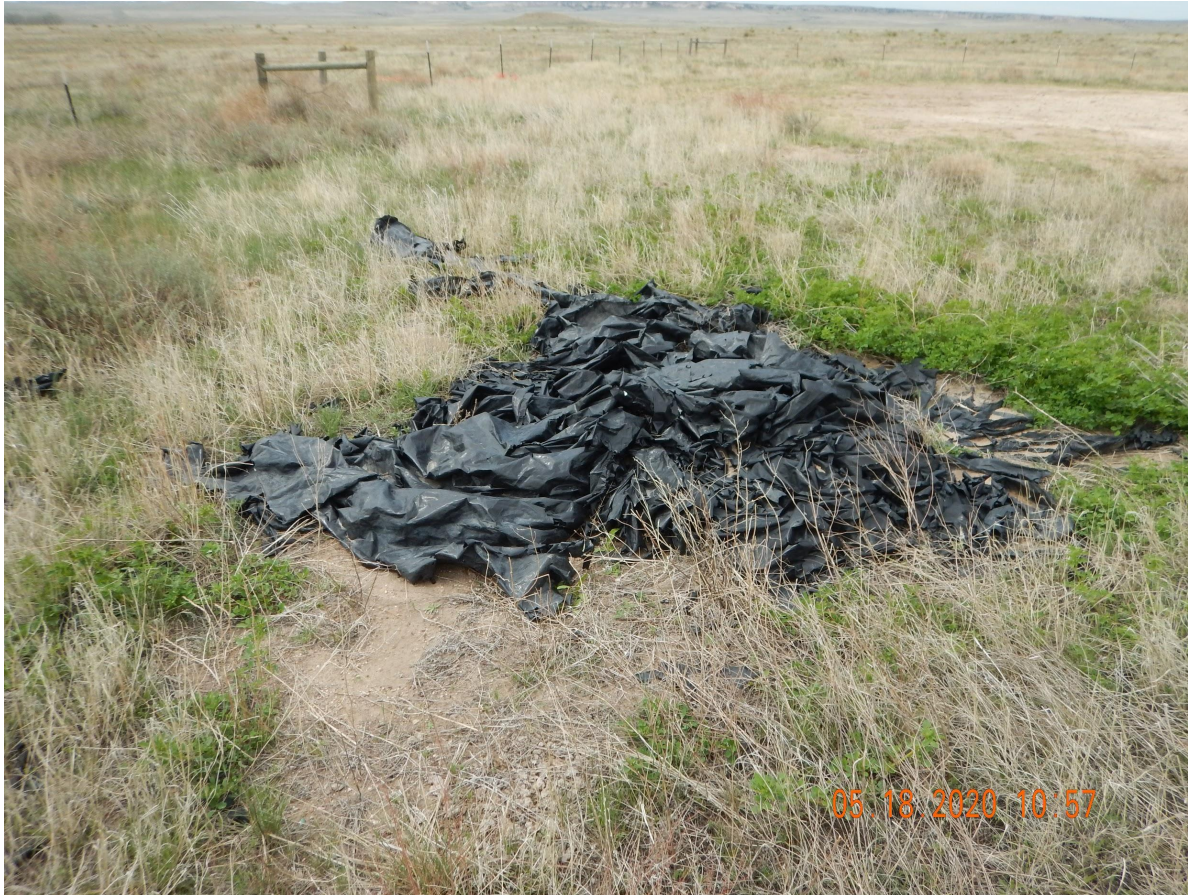
**Photo 5.** Photo taken from the southern location, facing West. Photo illustrates trash left behind.

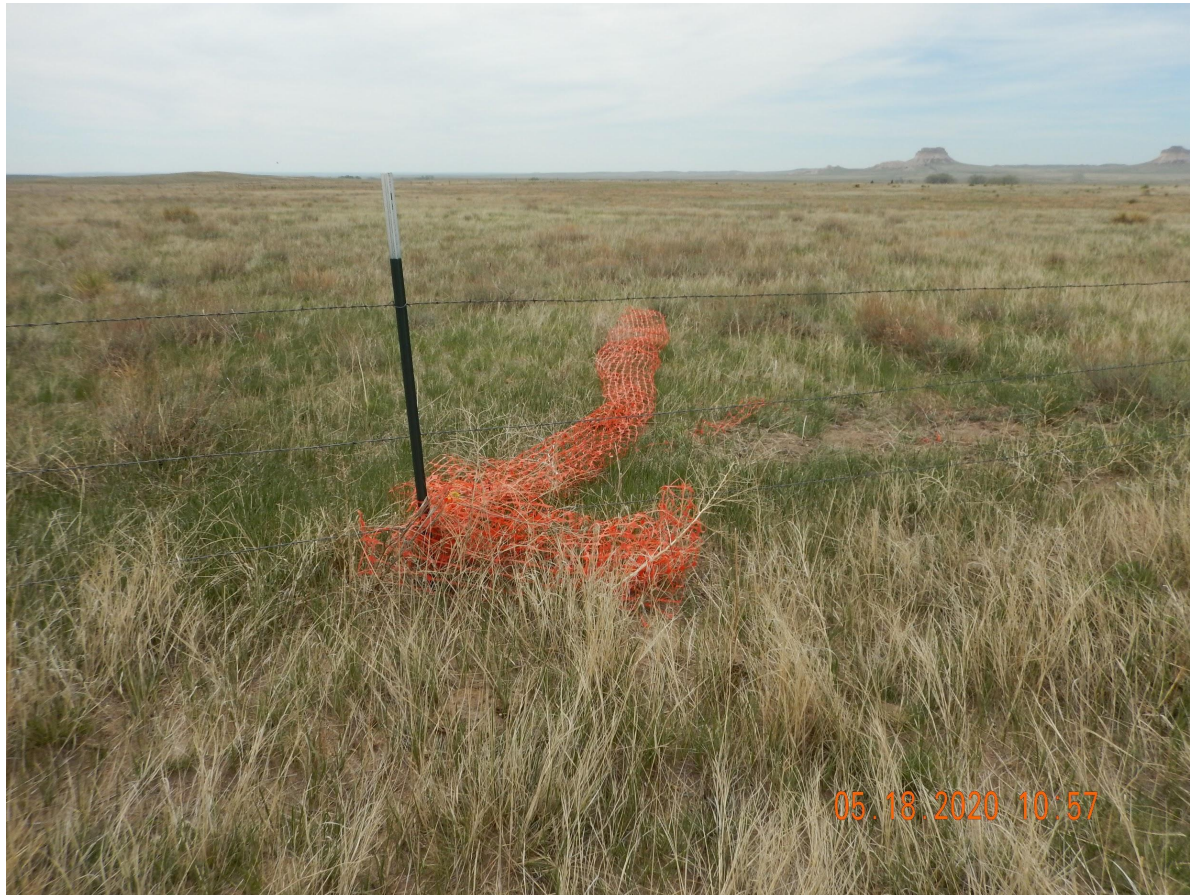
**Photo 6.** Photo taken from the southern location, facing South. Photo illustrates trash/debris left behind.

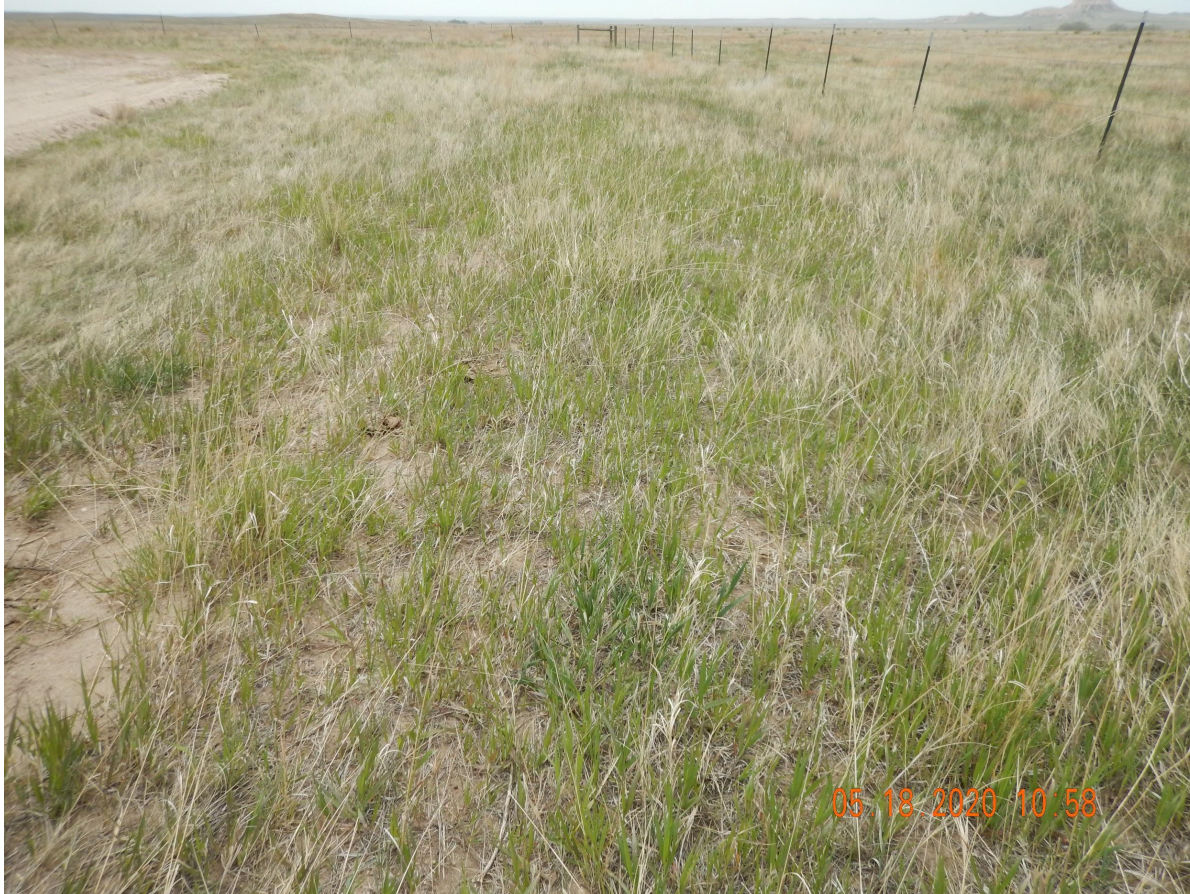
**Photo 7.** Photo taken from the western interim area, facing South. Photo illustrates an introduced grass species, Smooth brome, has been planted.

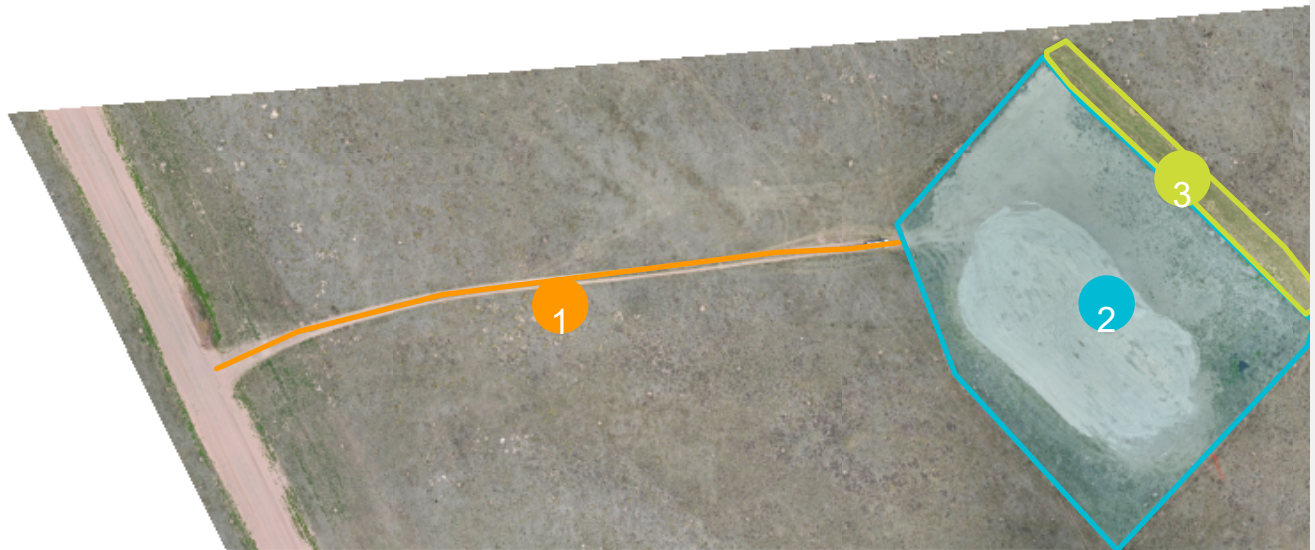
# Foundation: HILLMAN #9-1

| Label | Title | Horizontal Length | Surface Length | Slope |
|---|---|---|---|---|
| 1 | Access road | 591 ft | 75.64 ft | 1.77°, 3.1% |

| Label | Title | Area | Surface Area |
|---|---|---|---|
| 2 | Well pad | 1.74 acres | 1.746 acres |

| Label | Title | Area | Volume | Cut | Fill |
|---|---|---|---|---|---|
| 3 | Stockpile | 7698 ft <sup>2</sup> | 257.8 y <sup>3</sup> | 262 y <sup>3</sup> | -4.3 y <sup>3</sup> |
