Inspection Photos
Operator: BP America
API#: 067-06362
Date: 5/20/2020

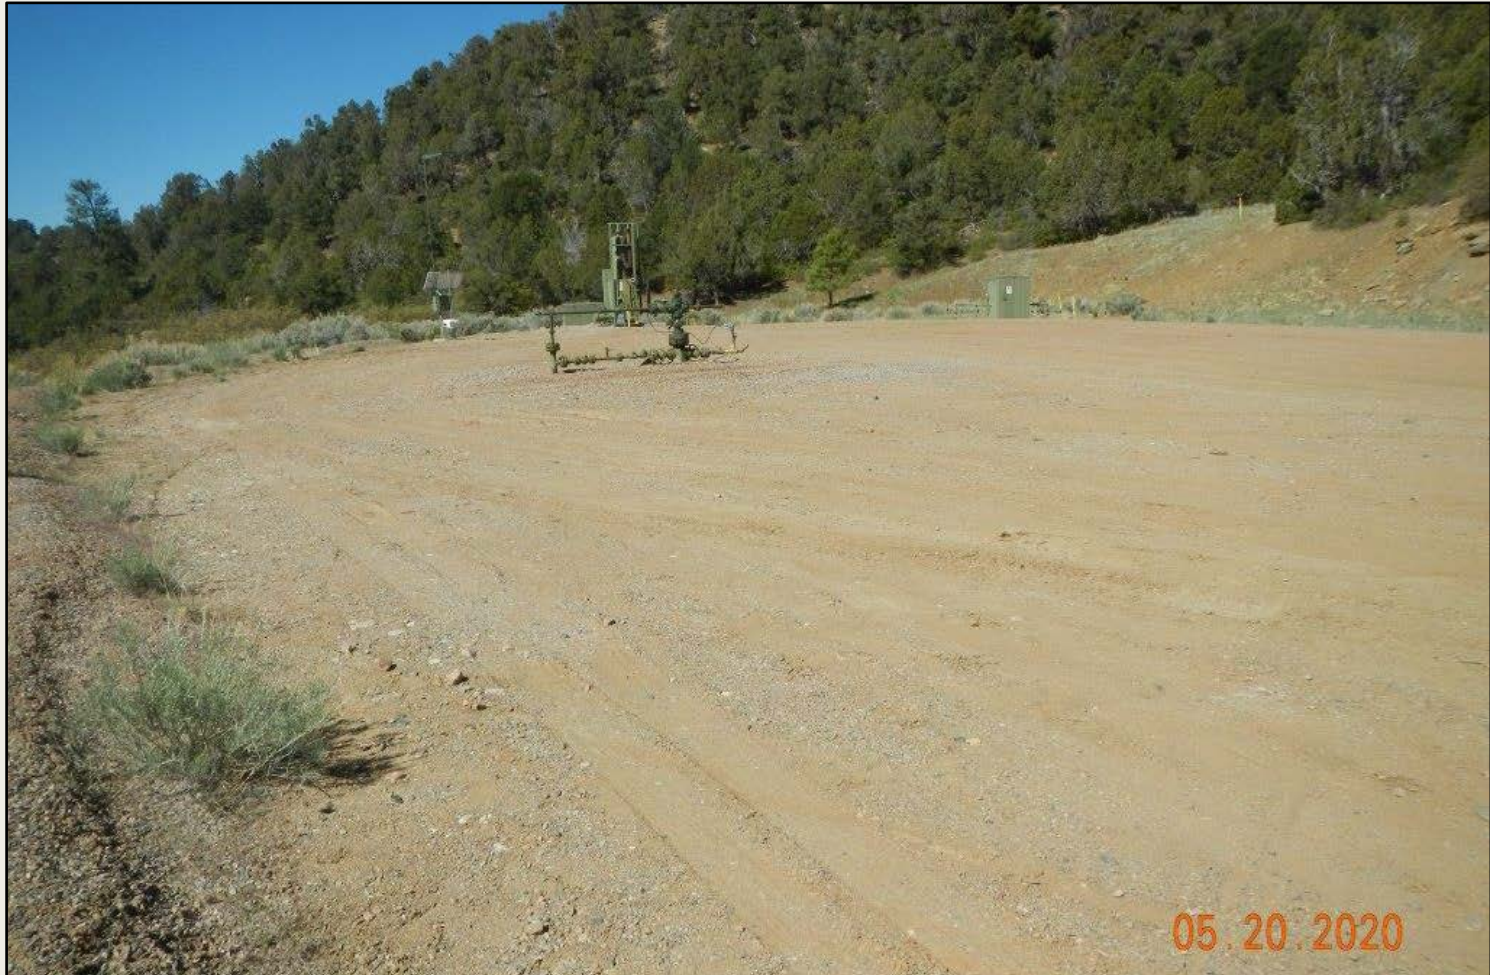
Photo 1. View of the project area from the well pad entrance facing center.

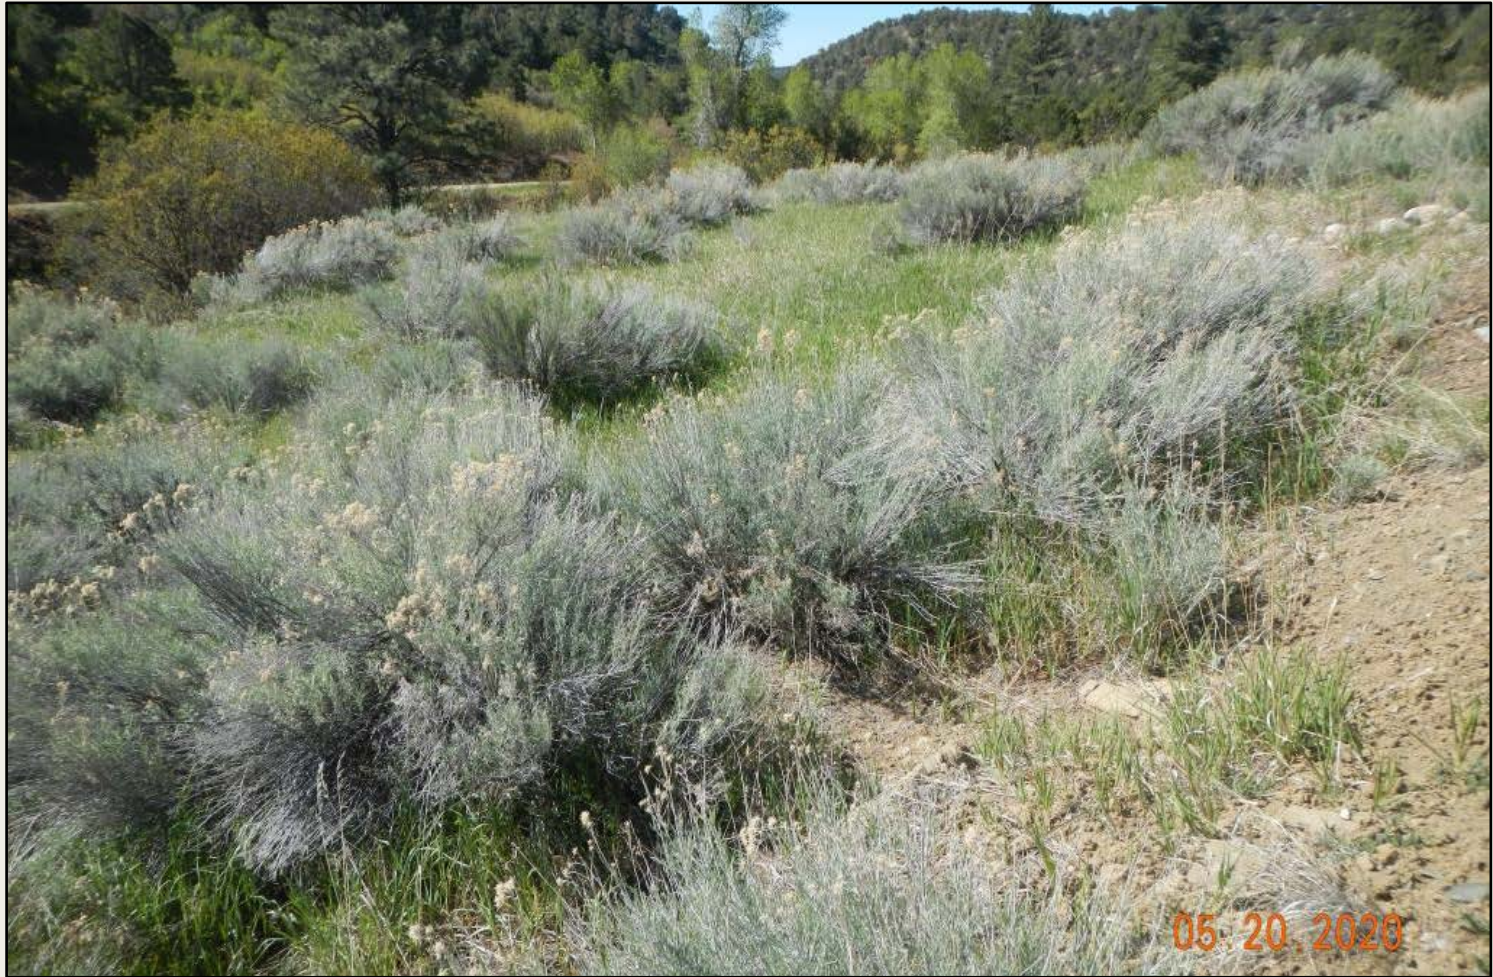
Photo 2. View of the eastern fill slope from the southeastern corner facing westward. Revegetation is progressing with grasses such as western wheatgrass, sand dropseed, and smooth brome.

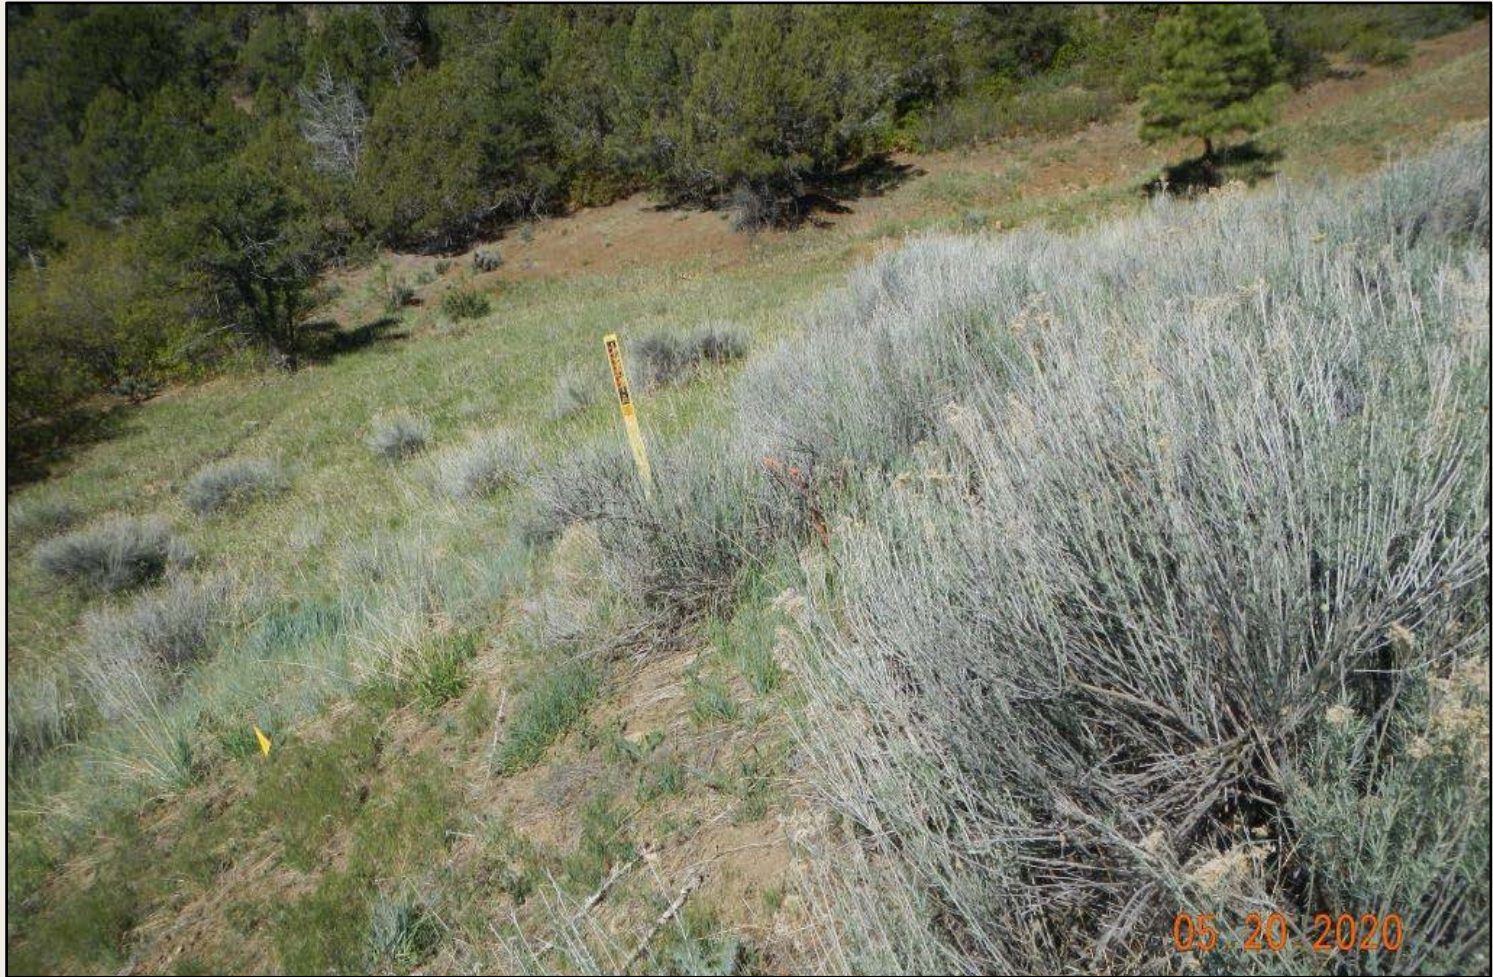
Photo 3. View of the southern project area from the southeastern corner facing westward.

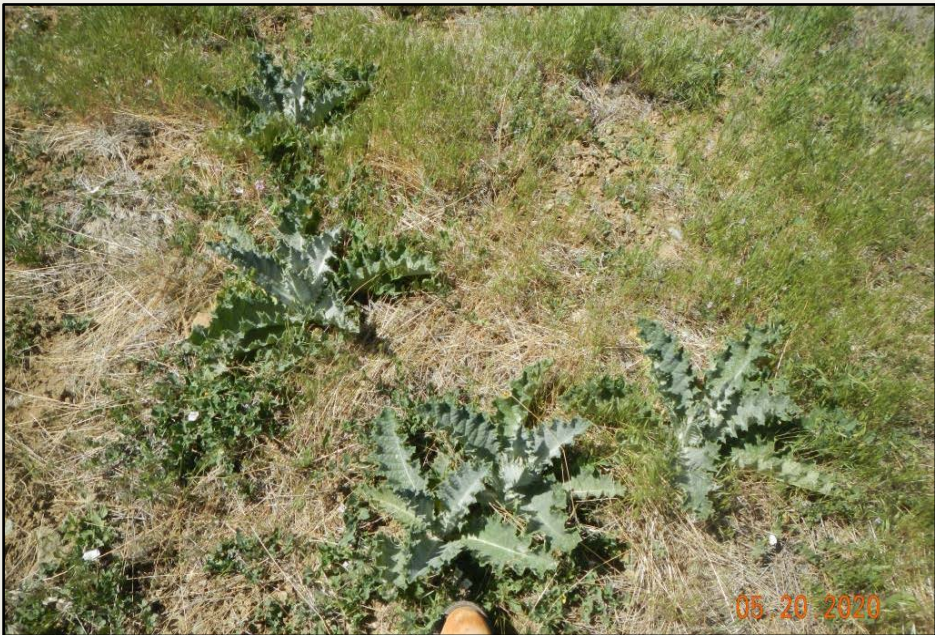
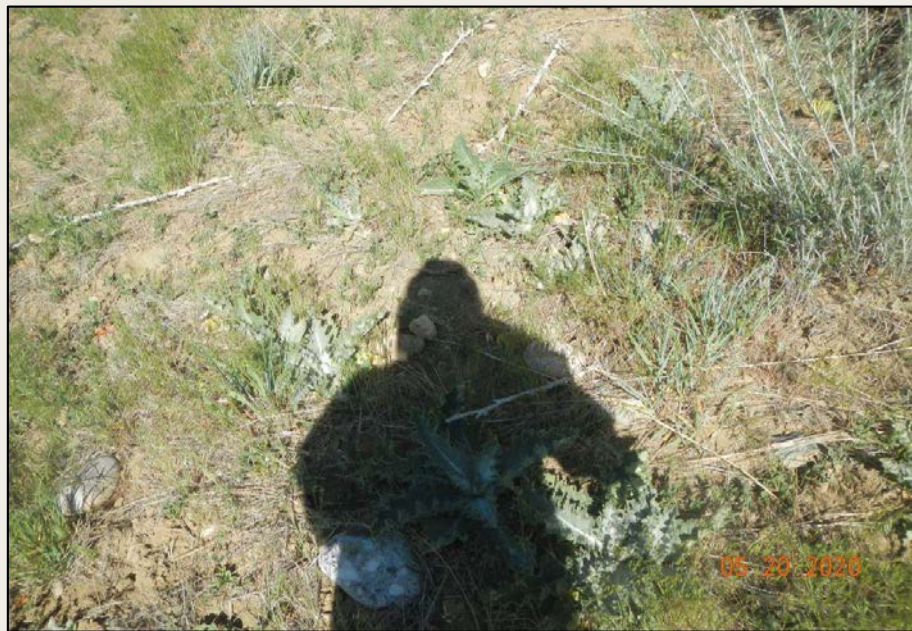
Photo 4/5. View of dense Scotch thistles within the southeastern project area. Thistles were observed scattered throughout the interim reclamation area. Approximately 200 individuals observed.
