Inspection Photos

Operator: Highpoint Operating
API#: 033-06144
Date: 5/27/2020

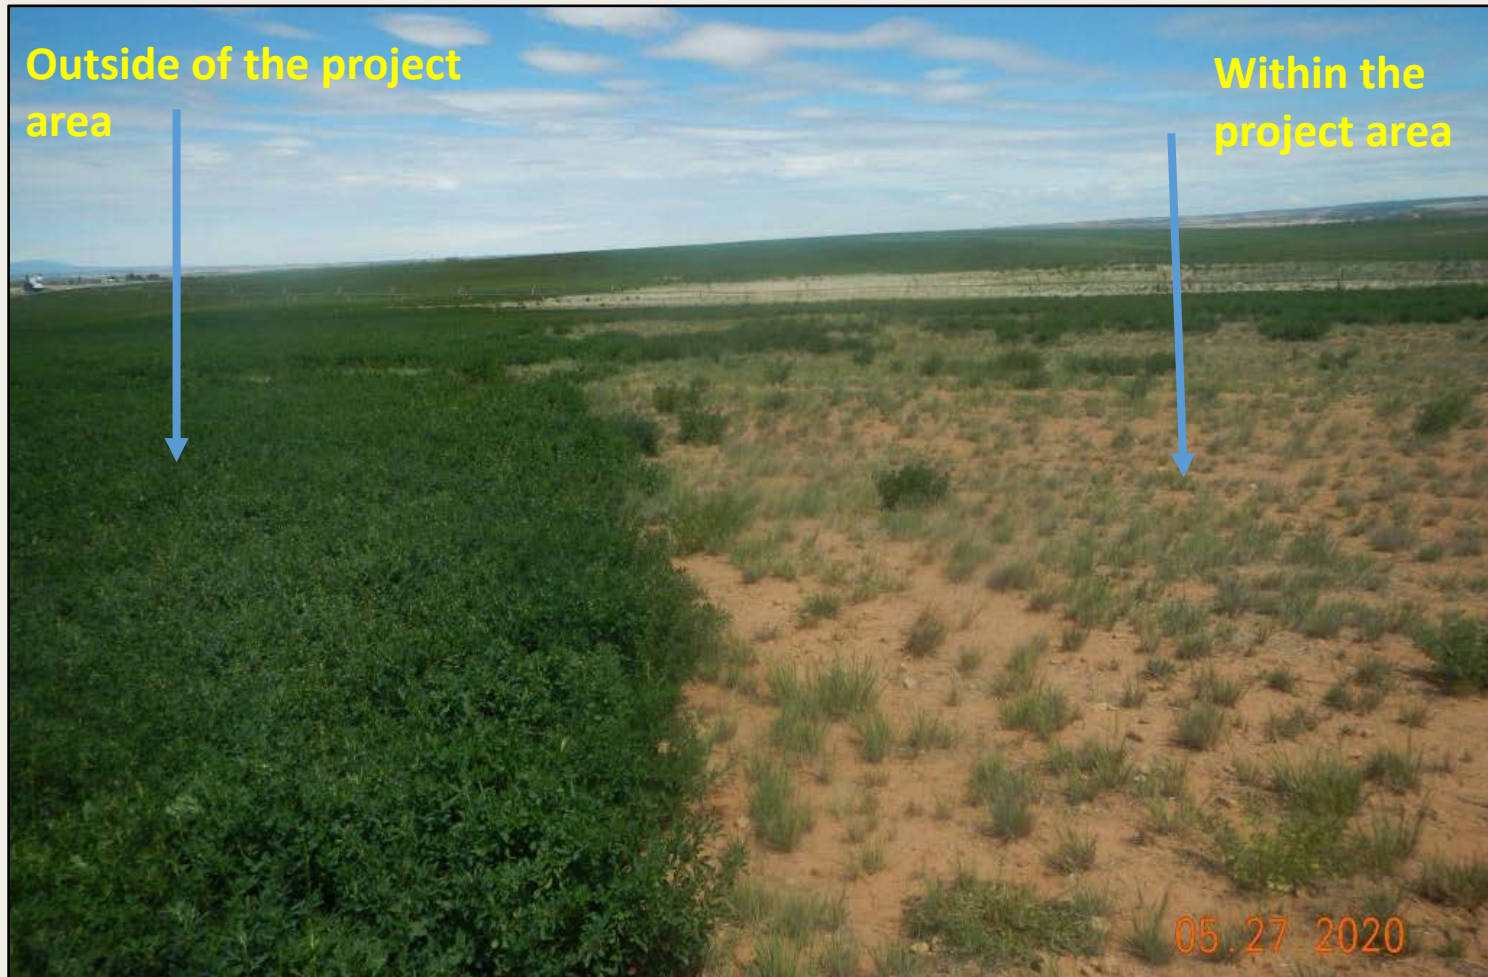
Photo 1. View of the western edge of the well pad facing northward. Vegetation (alfalfa) in left portion of the photo is outside of the project area. Vegetation (largely foxtail grasses) in the right of the photo is within the project area. Vegetation within the project area does not match reference area. Significant areas of bare soil remain. Additional soil remediation is needed for successful revegetation.

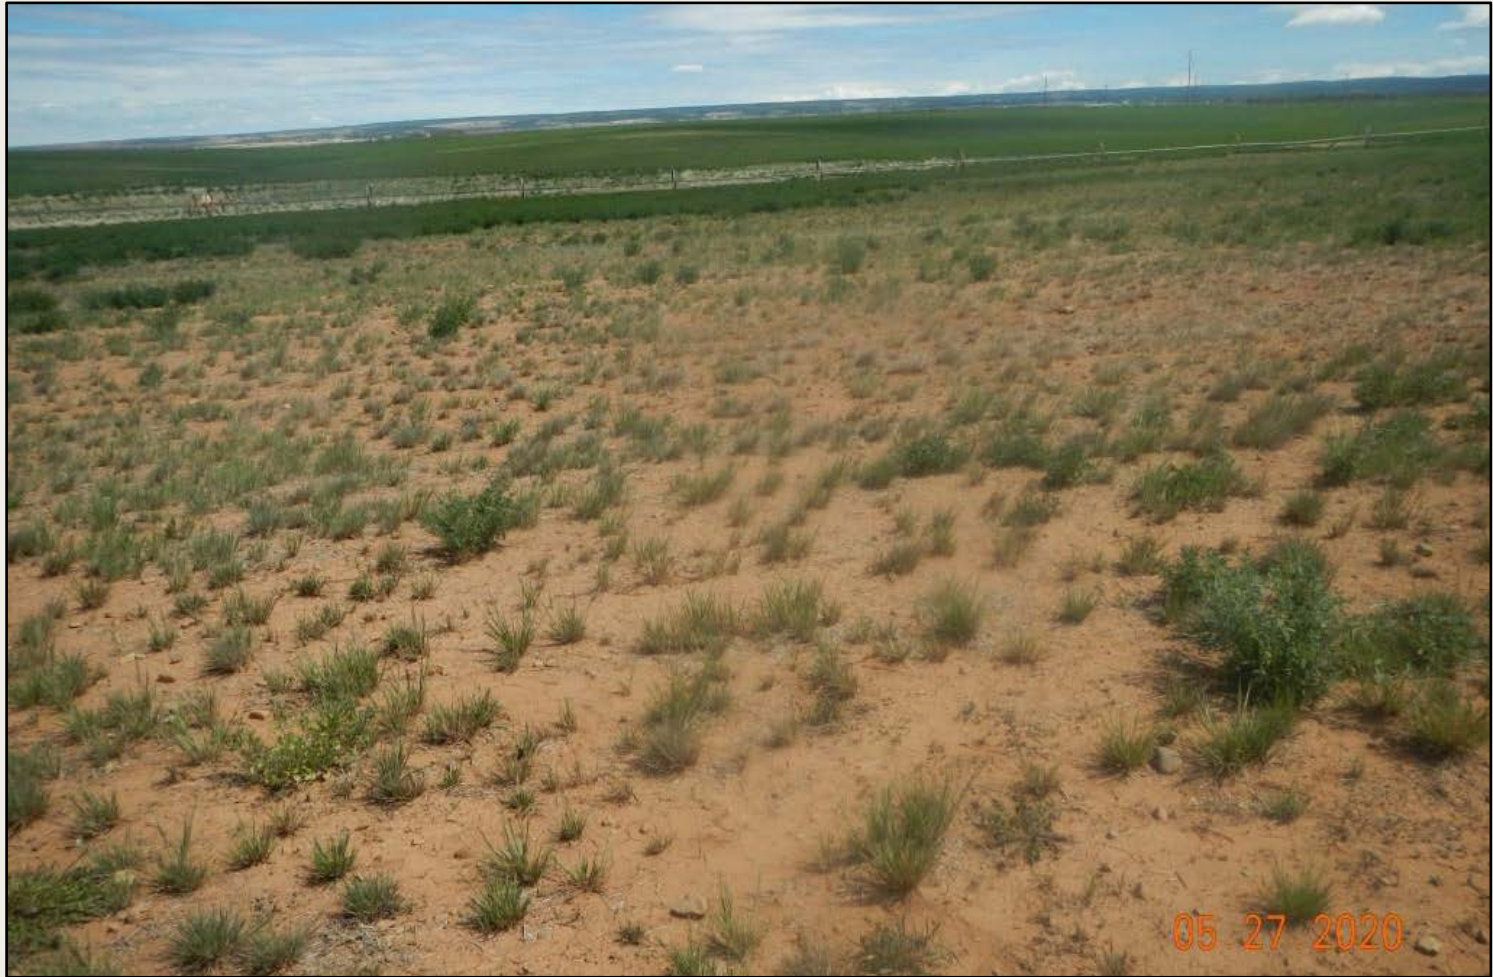
Photo 2. View of the project area facing northeastward. Foxtail (*Hordeum jubatum*) grasses do not match reference area comprised of alfalfa crop field.

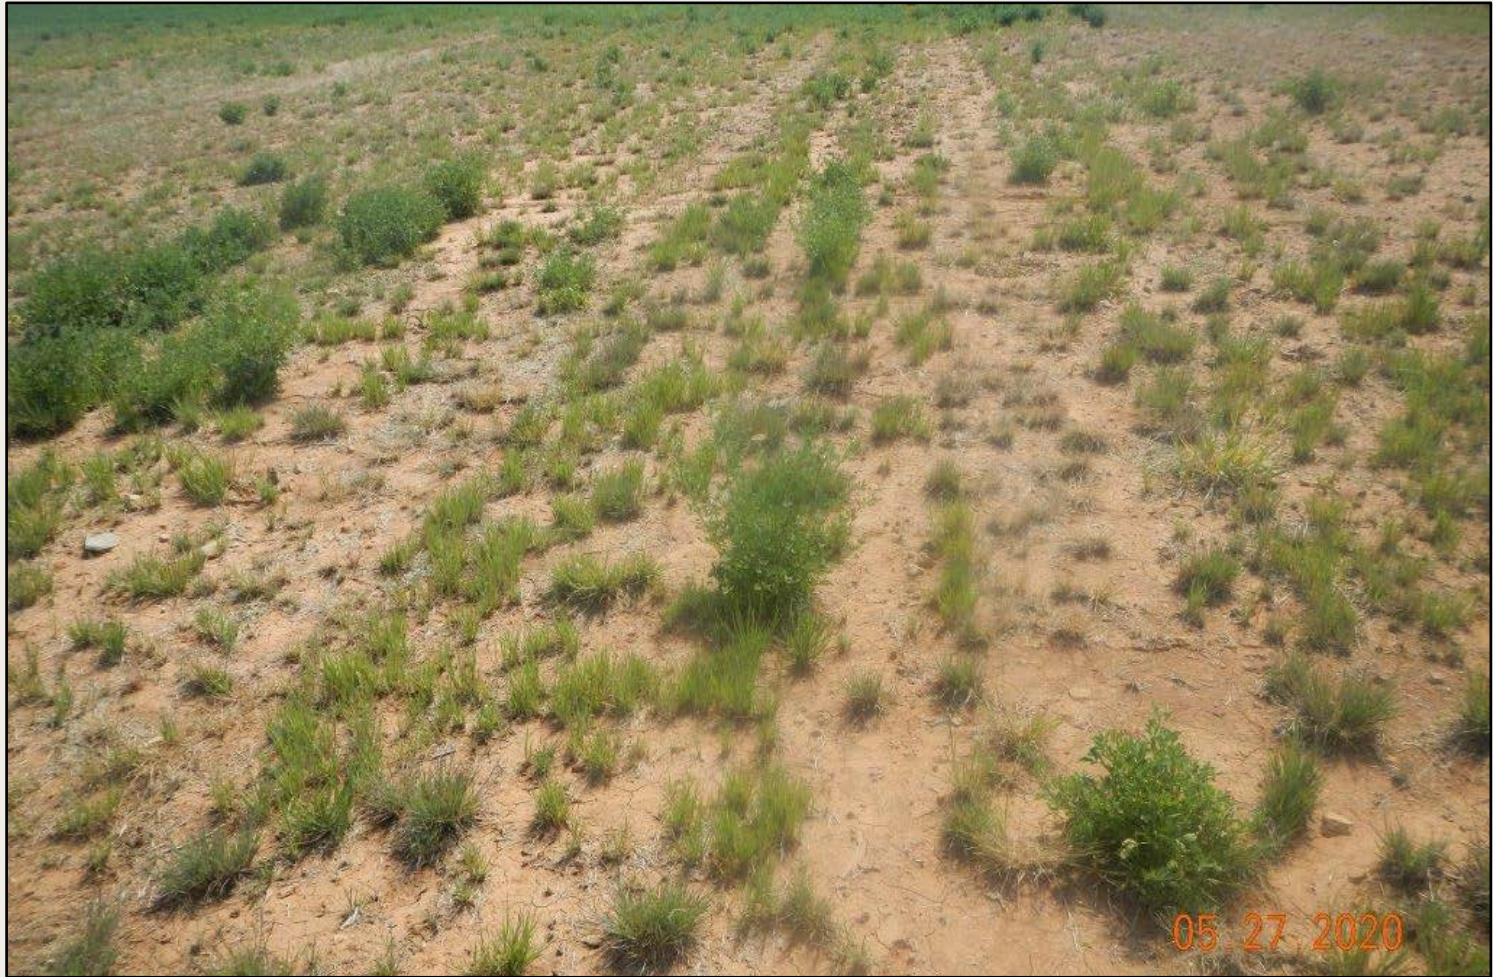
Photo 3. Another view of failed vegetation within the project area. Crop area is irrigated and only supporting sparse alfalfa that are stunted.

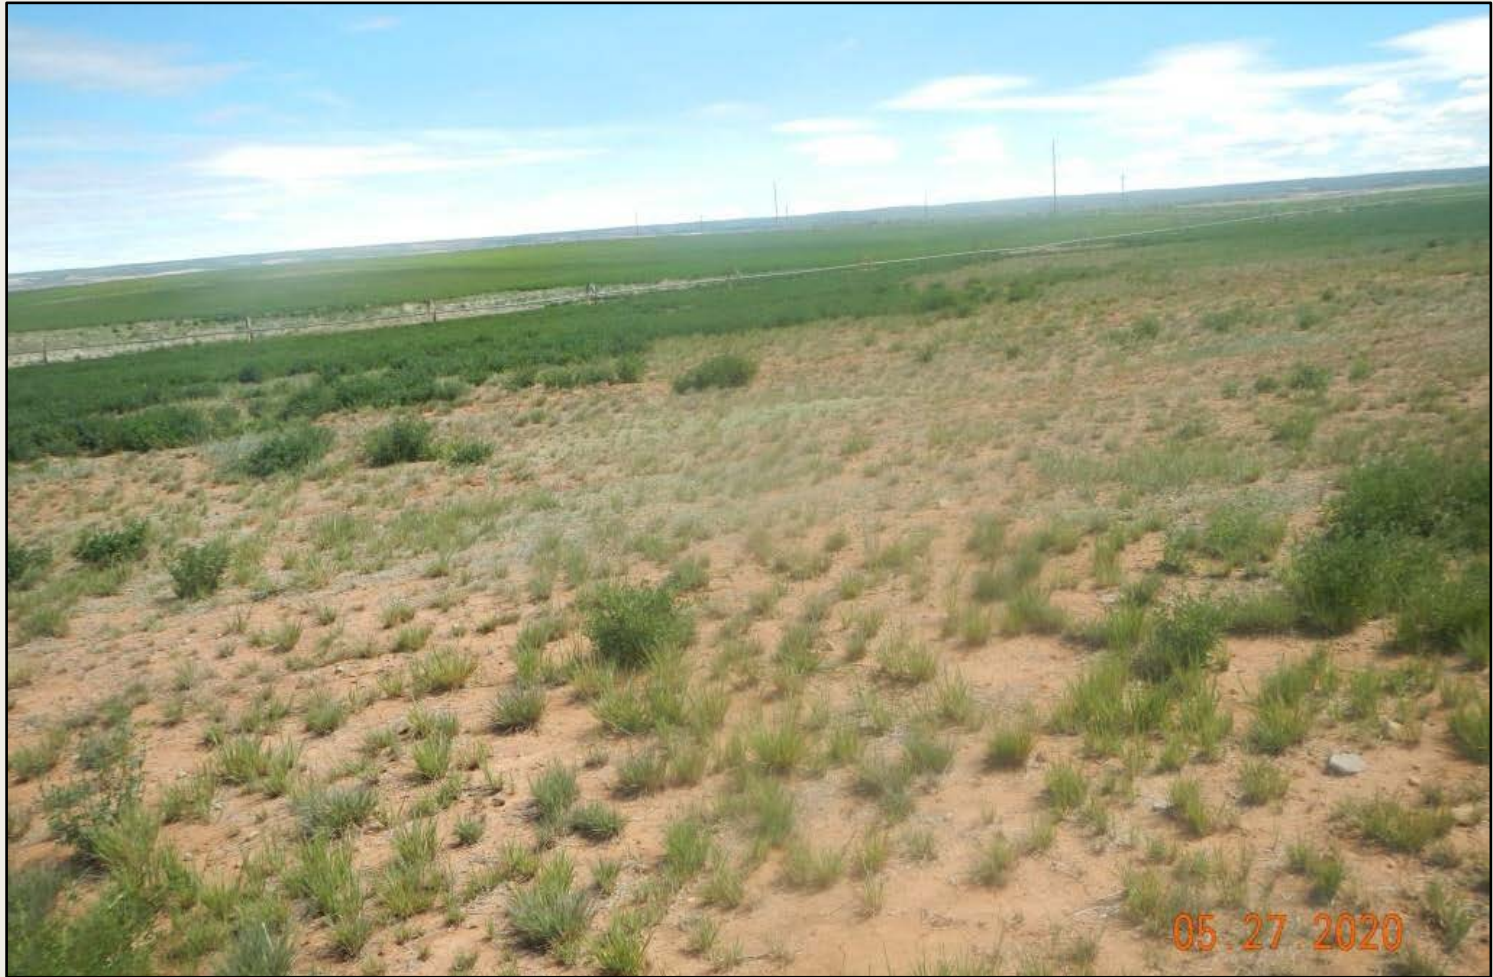
Photo 4. View of the northern project area.

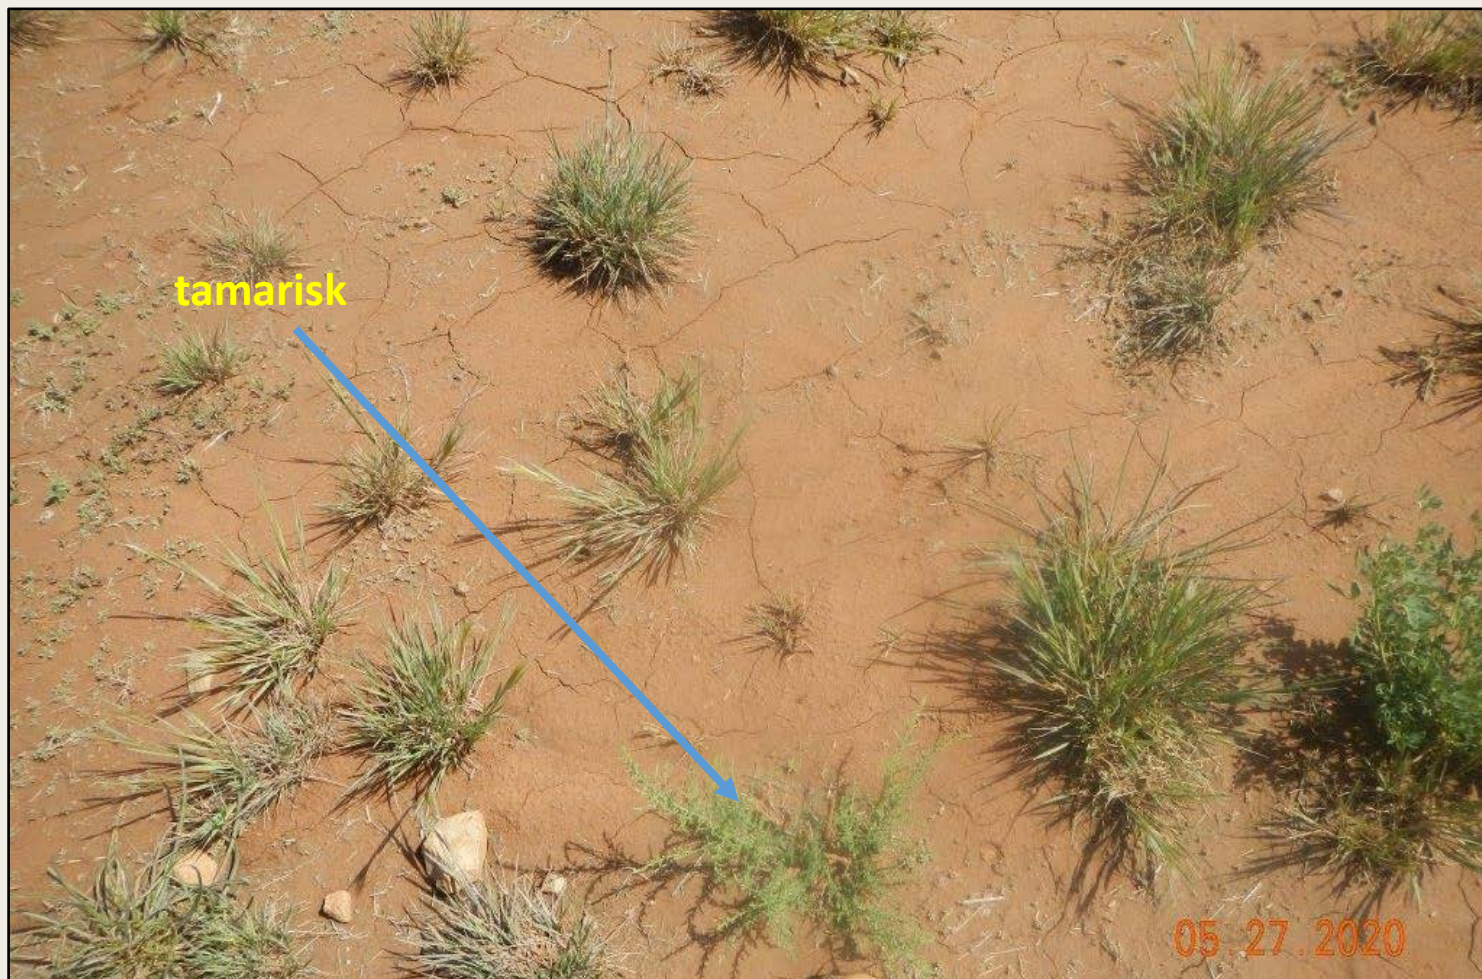
Photo 5. Birdseye view of vegetation on the well pad surface, comprised of foxtail barley (*Hordeum jubatum*), scattered alfalfa plants, and young tamarisk weed.

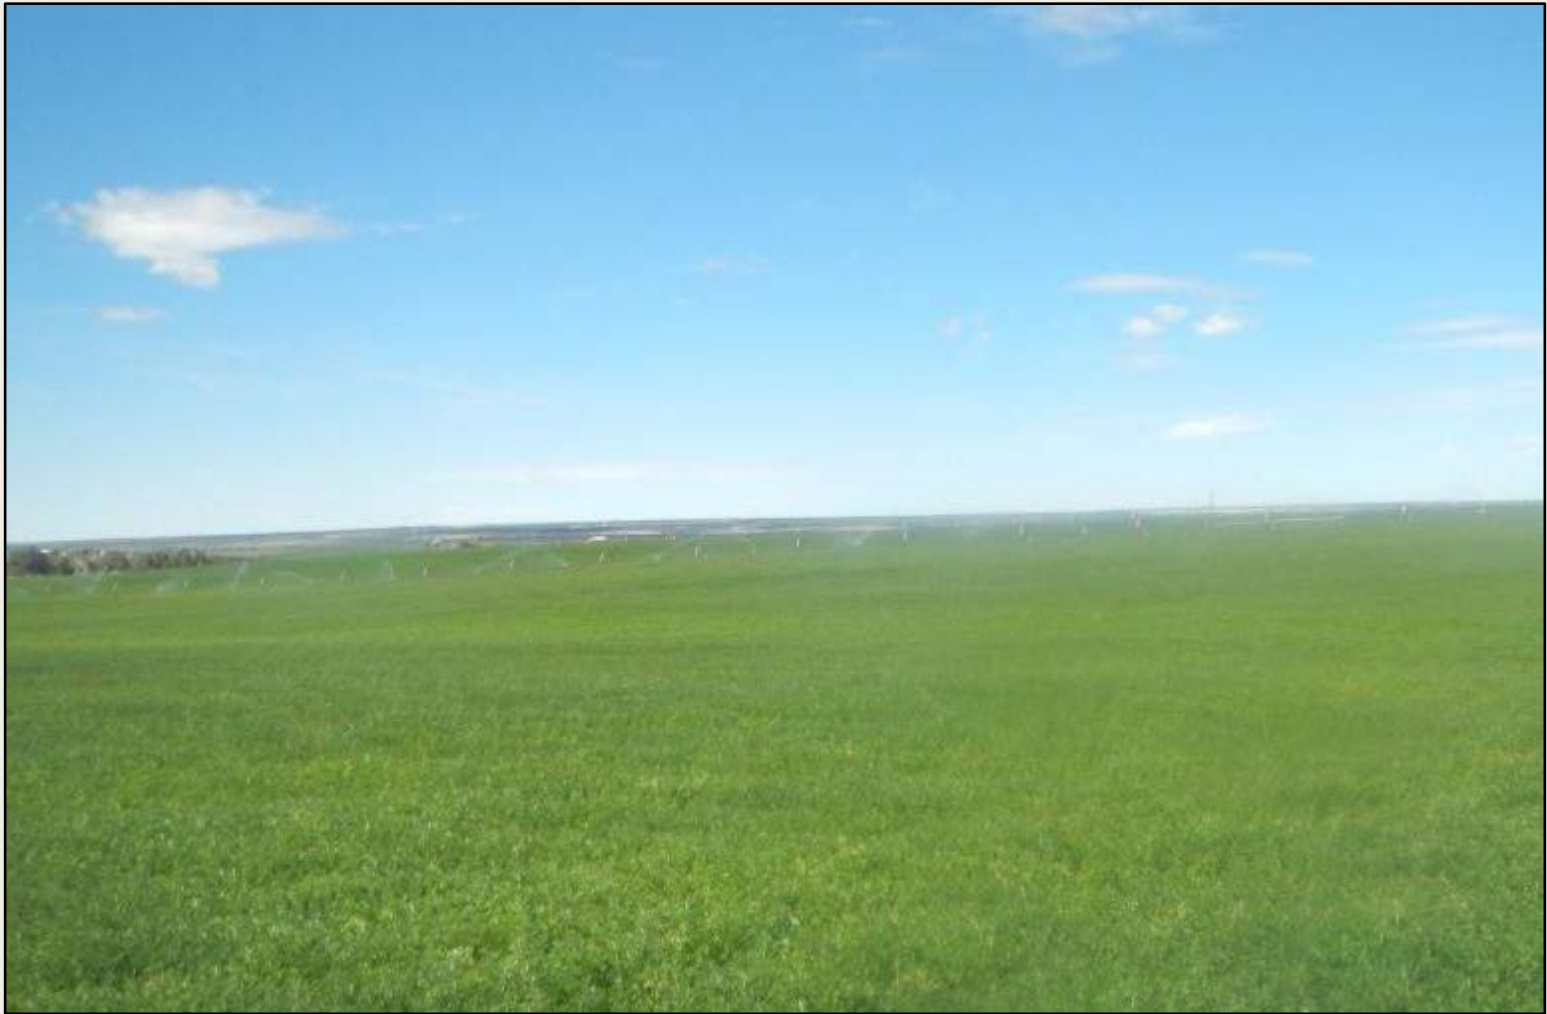
Photo 6 View of reference area vegetation comprised of irrigated alfalfa field.
