Inspection Photos

Operator: Highpoint Operating
API#: 033-06145
Date: 5/27/2020

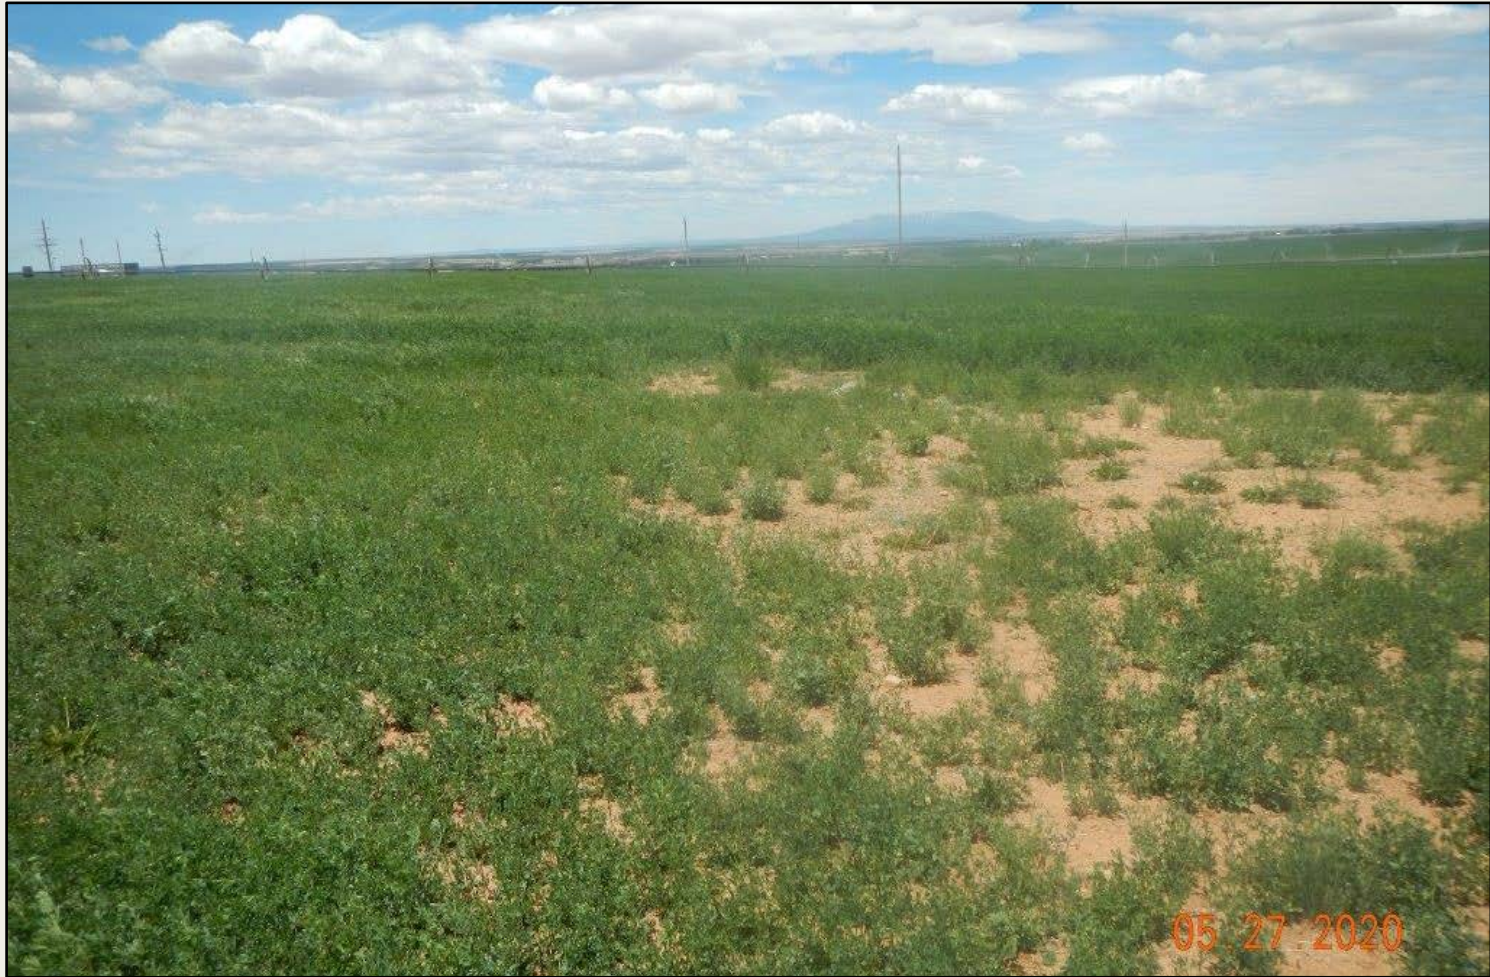
Photo 1. View of the western portion of the well pad facing northward. Alfalfa within the project area is significantly more stunted, sparse, and weedy than the alfalfa outside of the project area.

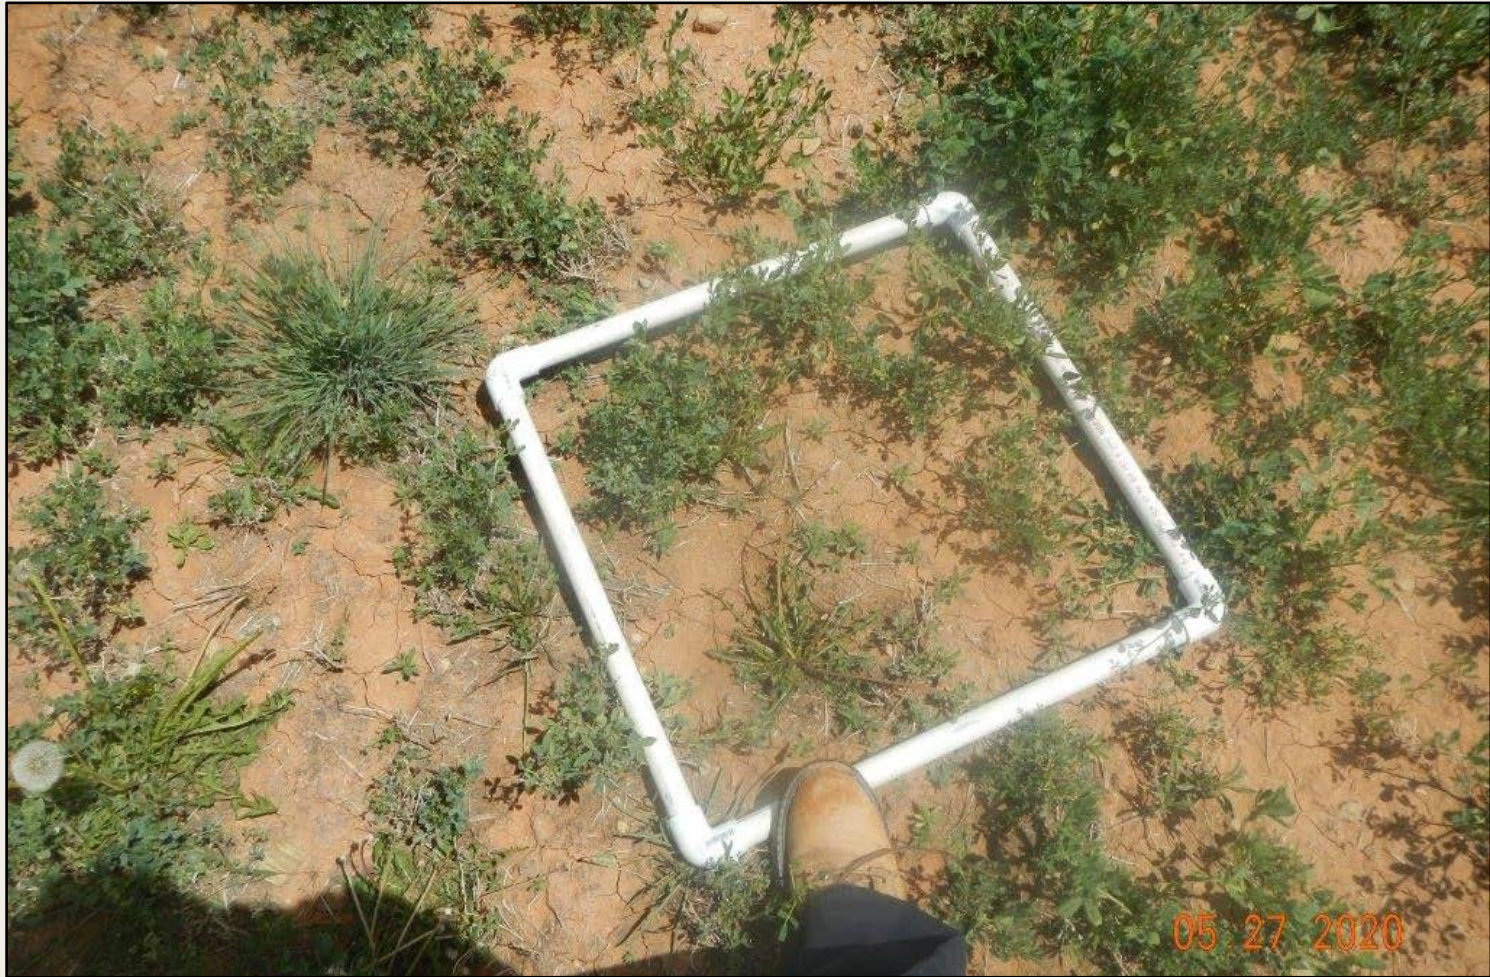
Photo 2. View of representative quadrat vegetation within the project area. Alfalfa is approximately 6 inches tall and sparse. Dandelion, foxtail, and kochia weeds present.

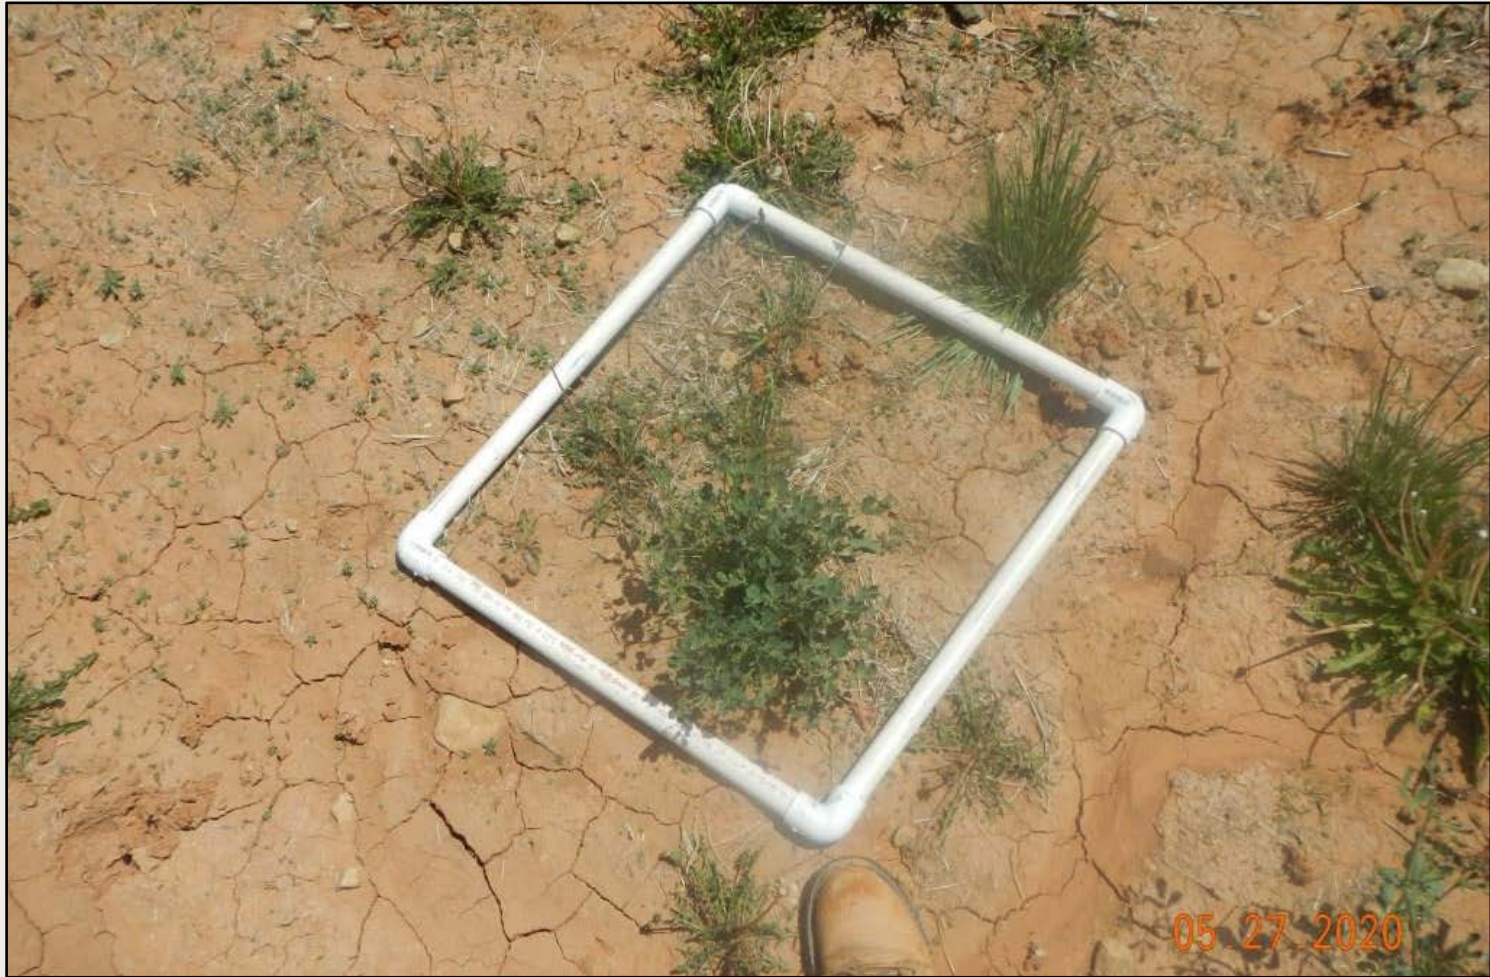
Photo 3. View of another representative quadrat within the project area. Significant areas of bare soil present.

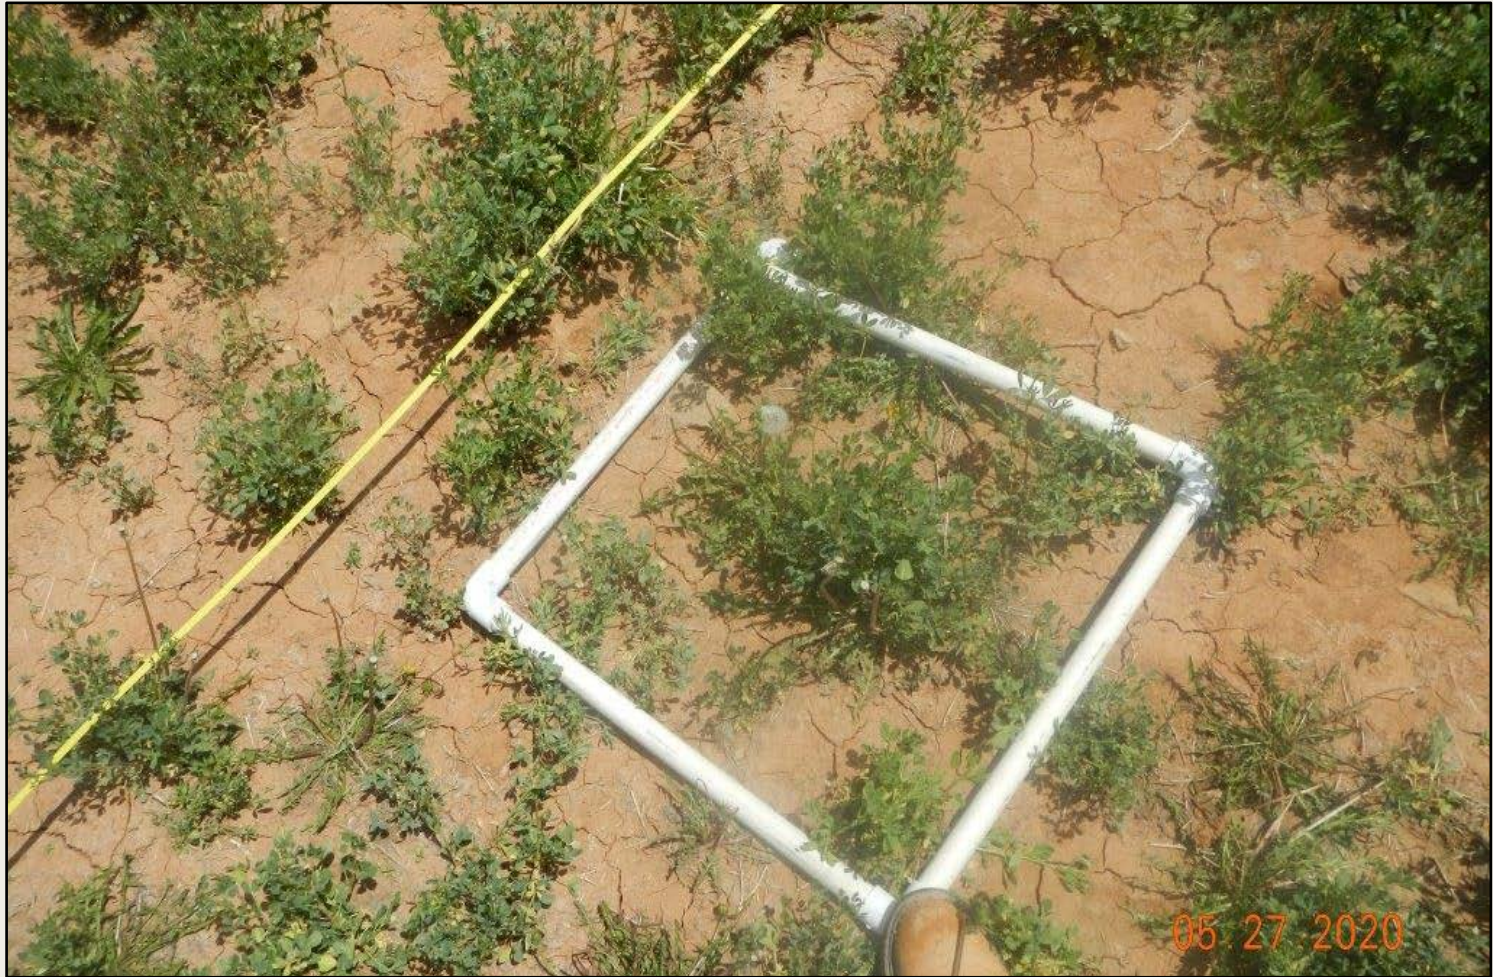
Photo 4. View of another representative quadrat within the project area. In areas where alfalfa is growing it remains sparse and stunted compared to reference area.

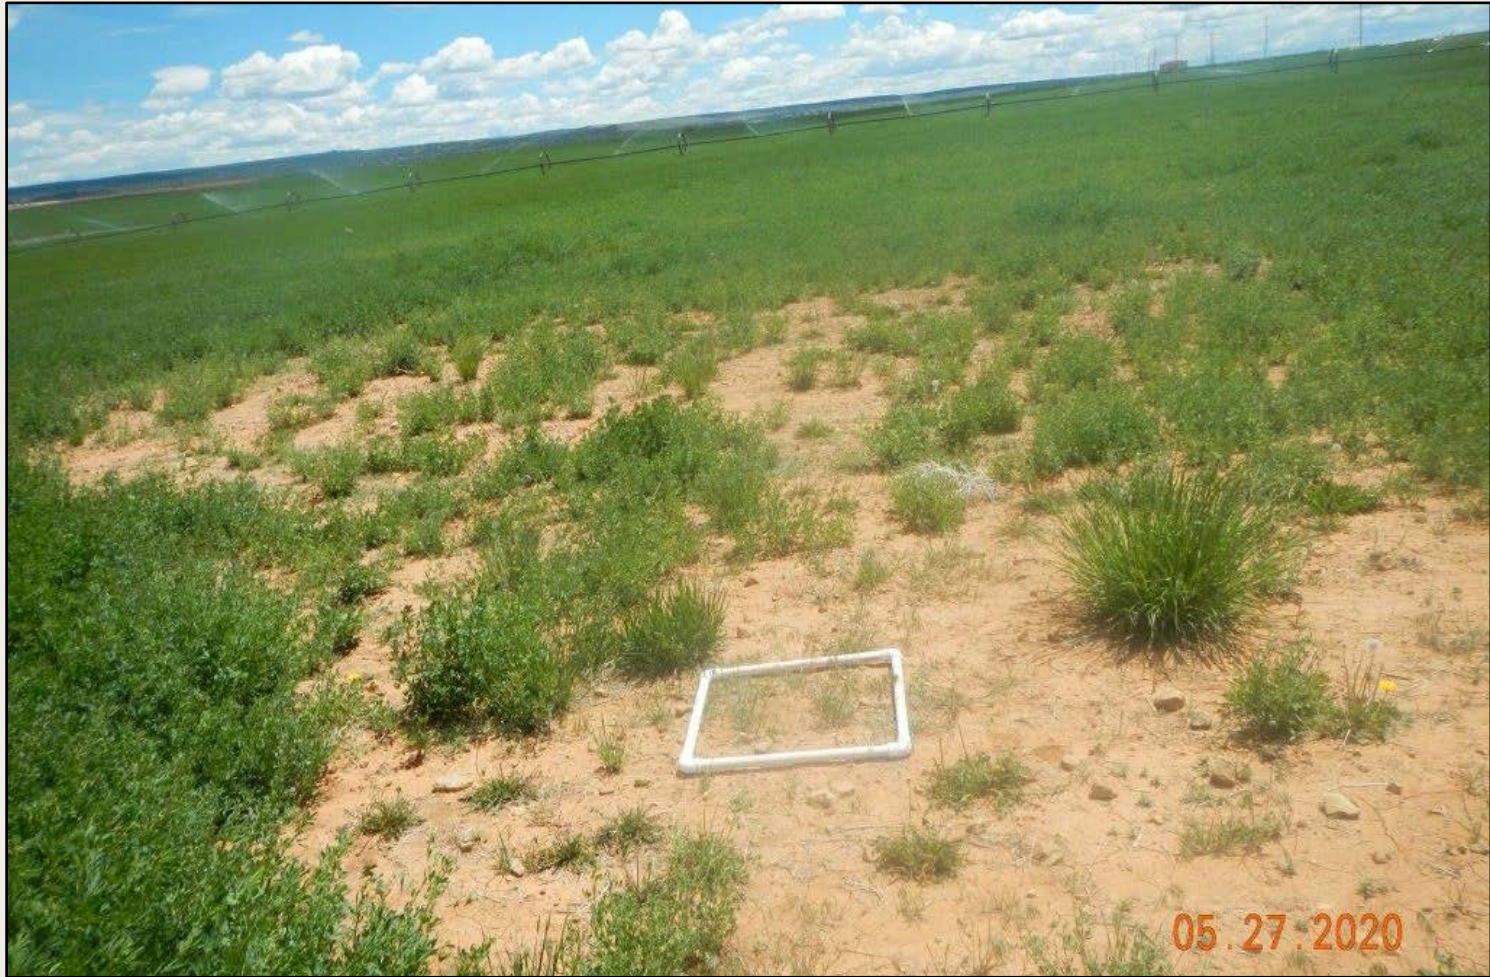
Photo 5. View of portion of the former well pad that is not revegetating, facing westward. Several of these “patches” of poor revegetation remain on the former well pad.

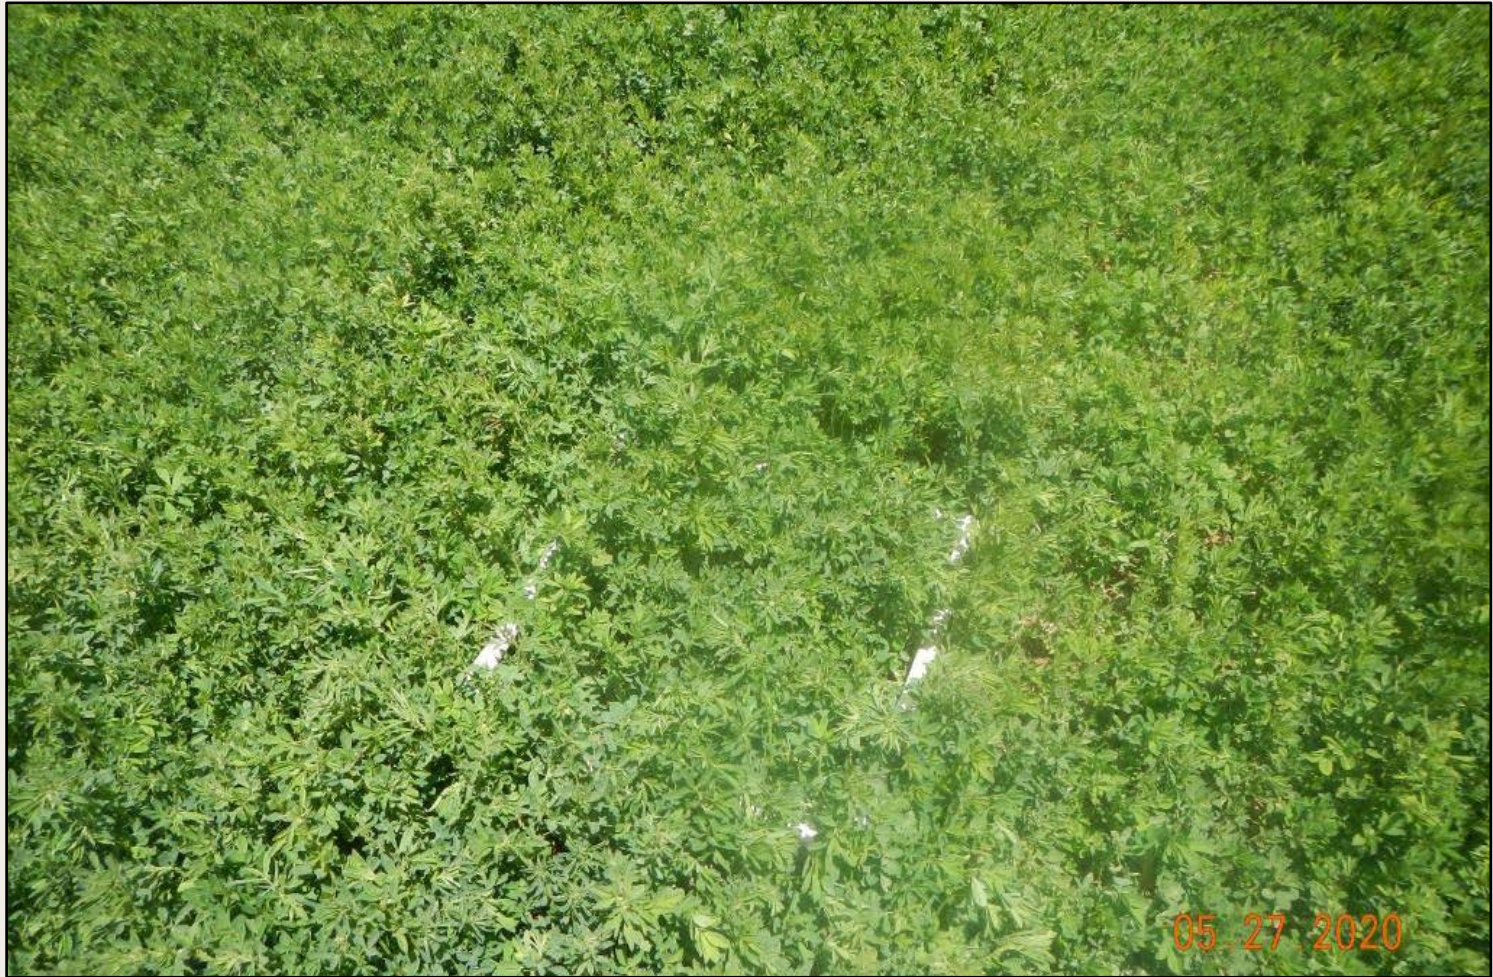
Photo 6. View of reference area vegetation comprised of irrigated alfalfa field, with dense alfalfa approximately 24-30 inches tall. Weeds were not observed.

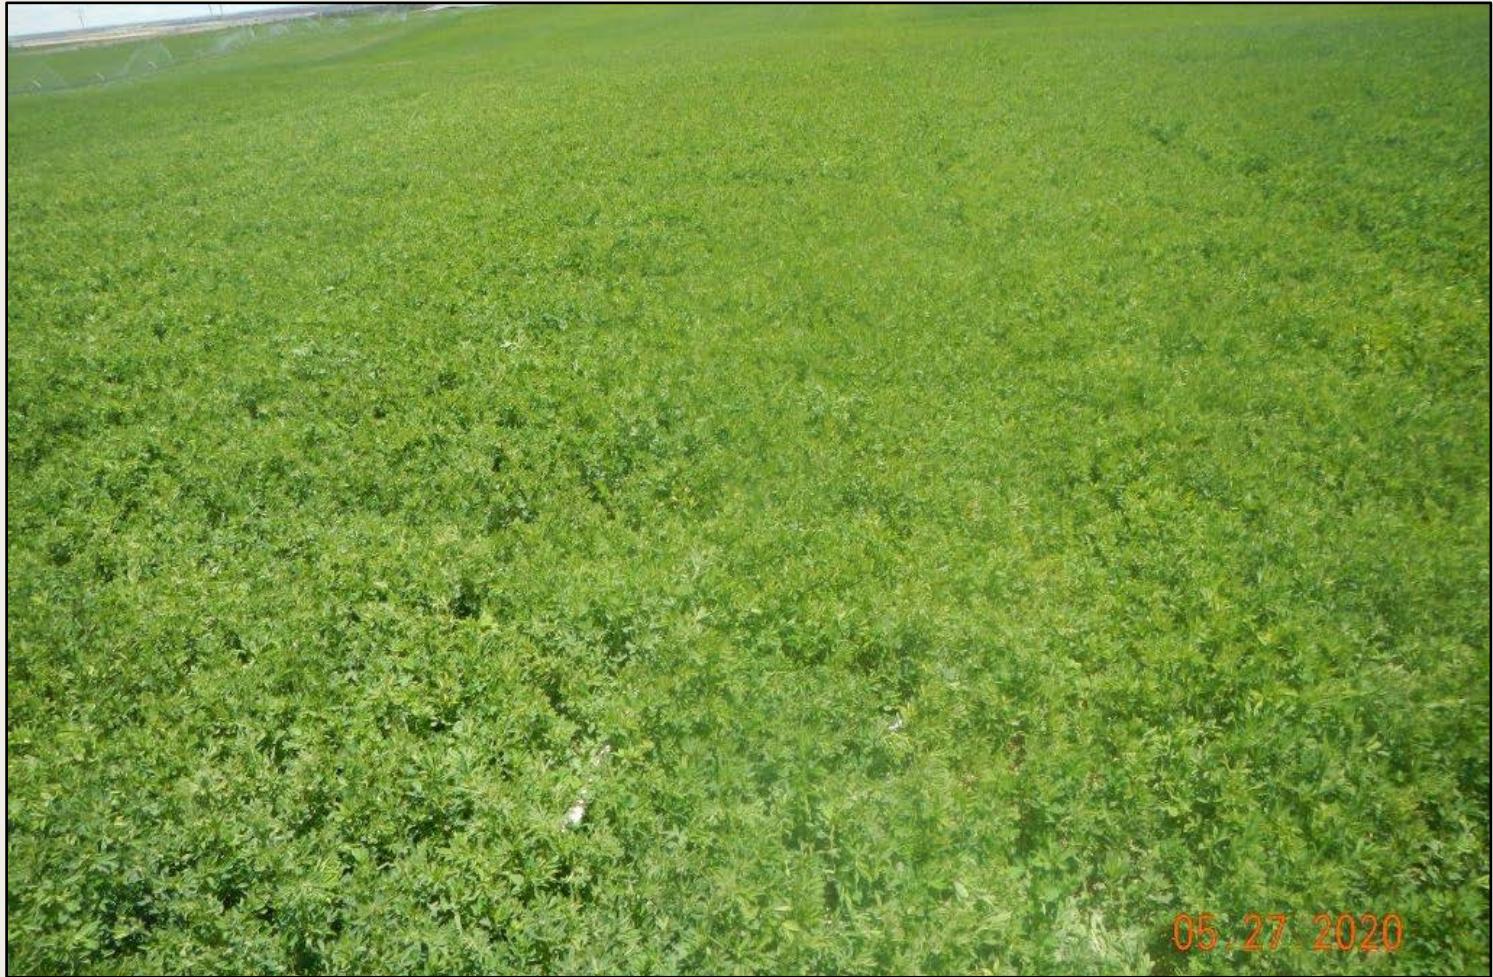
Photo 7 View of reference area vegetation comprised of irrigated alfalfa field.
