Inspection Photos

Operator: SG INTERESTS I LTD - 77330

Location ID: 324491

Gunnison County, CO

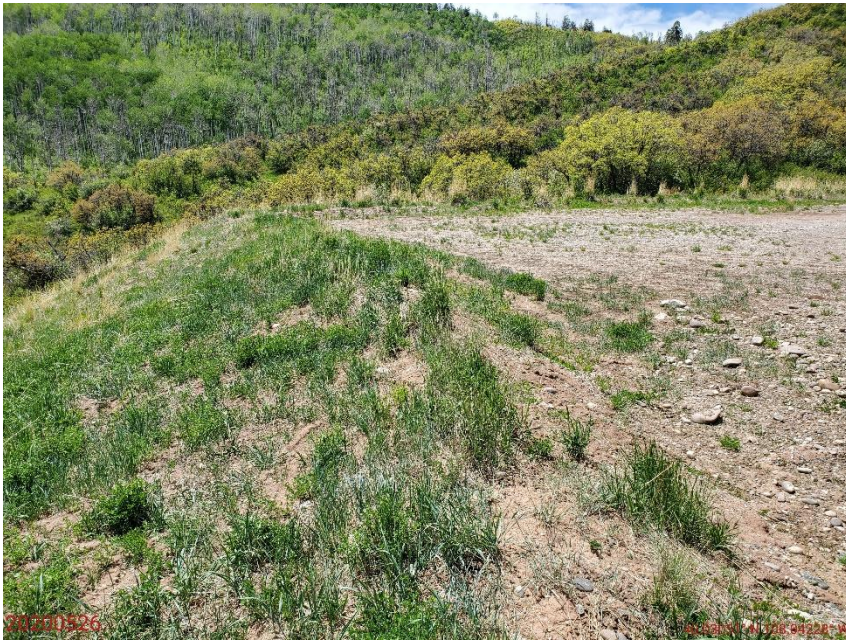
Photo 1: Photo taken from the south end of the Location, facing west. Photos 1-4 provide an overview of the Location from west, northwest, northeast to east. Photo shows areas on the west end of the Location are not needed for production and have not been reclaimed.

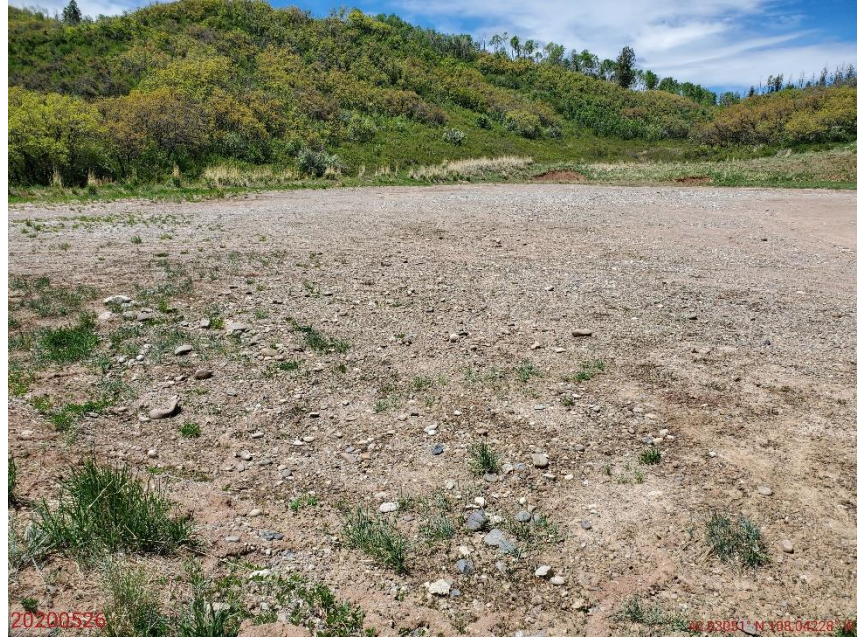
Photo 2: See comments under photo 1.

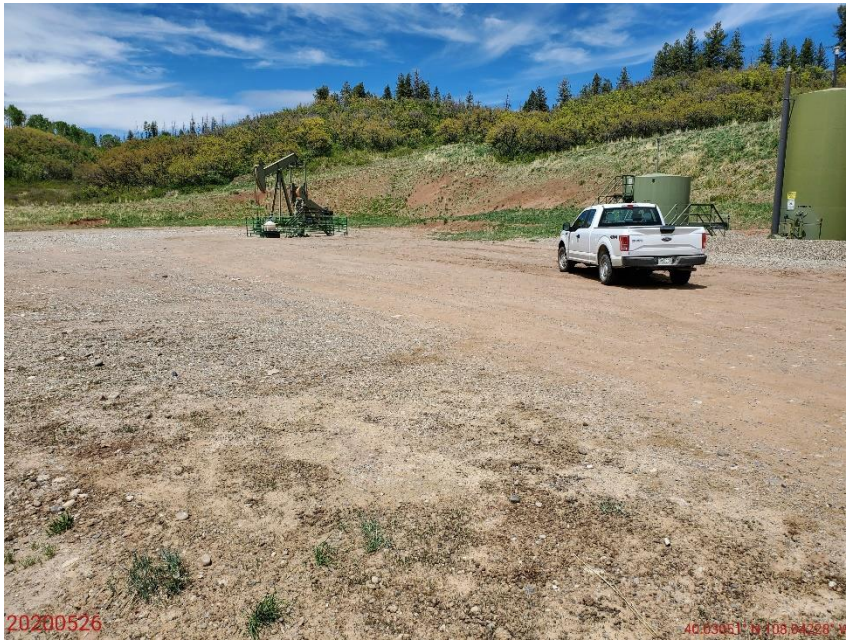
Photo 3: See comments under photo 1.

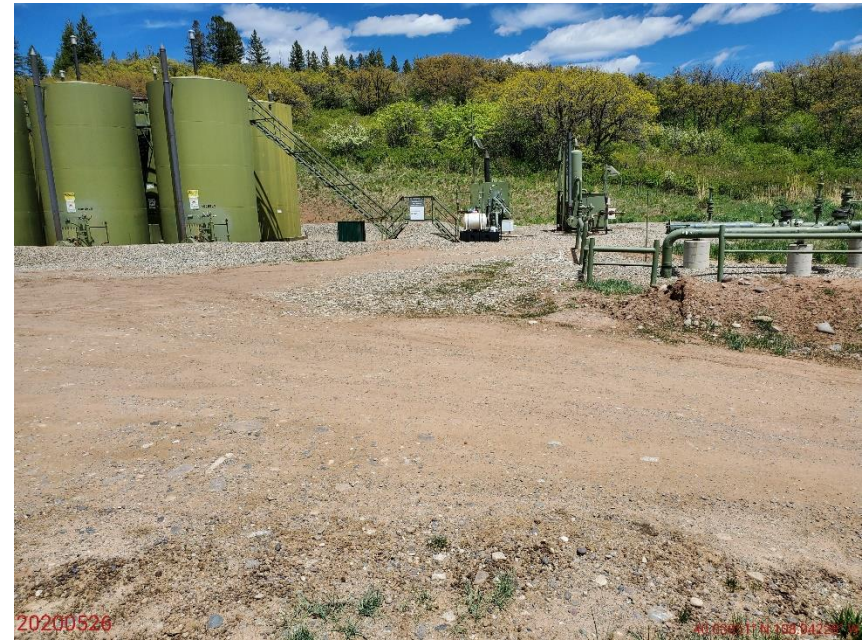
Photo 4: See comments under photo 1. Photo also shows flare equipment: Doc. #400506249 indicated that the flare was to be installed on the west end of the pad, flare appears to have been installed on the southeast corner of the Location.

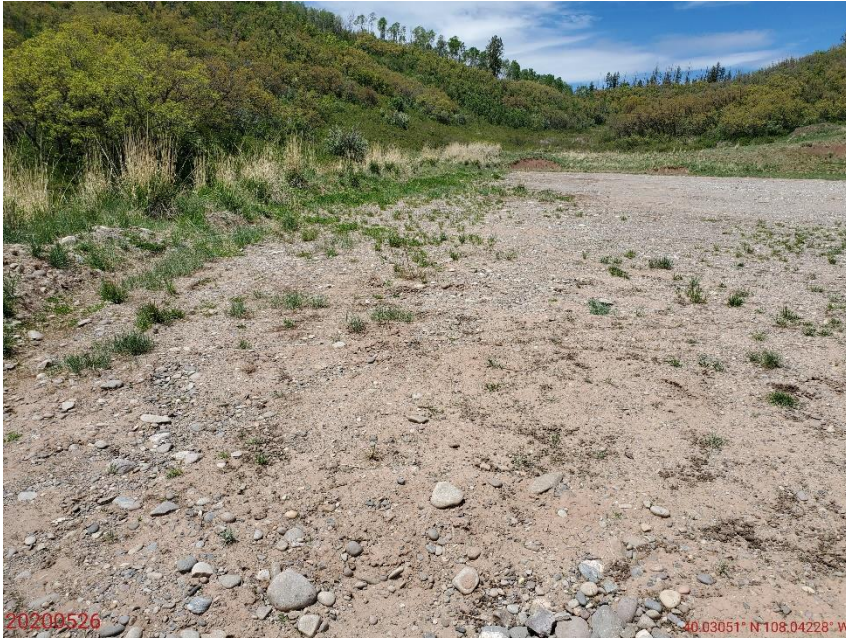
Photo 5: Photo taken from the southwest end of the Location, facing north. Photo shows areas on the west end of the Location are not needed for production and have not been reclaimed.

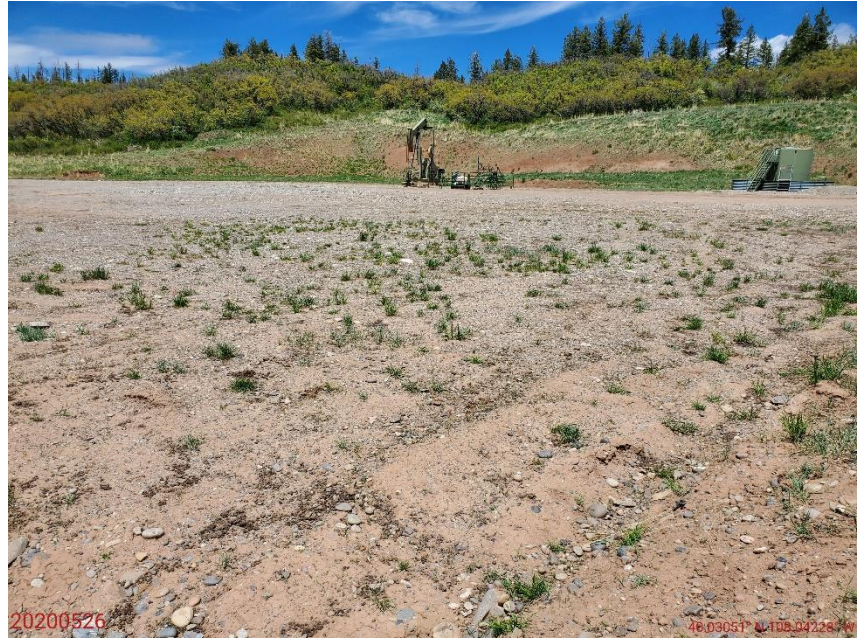
Photo 6: Photo taken from the southwest end of the Location, facing northeast. Photo shows areas on the west end of the Location are not needed for production and have not been reclaimed.

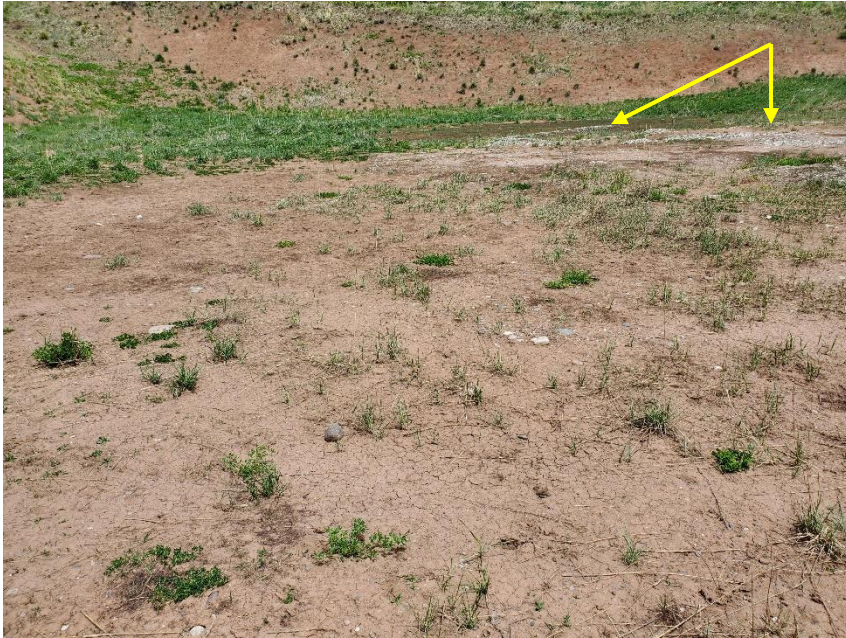
Photo 7: Photo taken from the north end of the Location, facing east. Photo shows areas where gravel has not been removed (arrow), and vegetation is not achieving uniform vegetative establishment. Vehicle disturbances also observed in these areas.

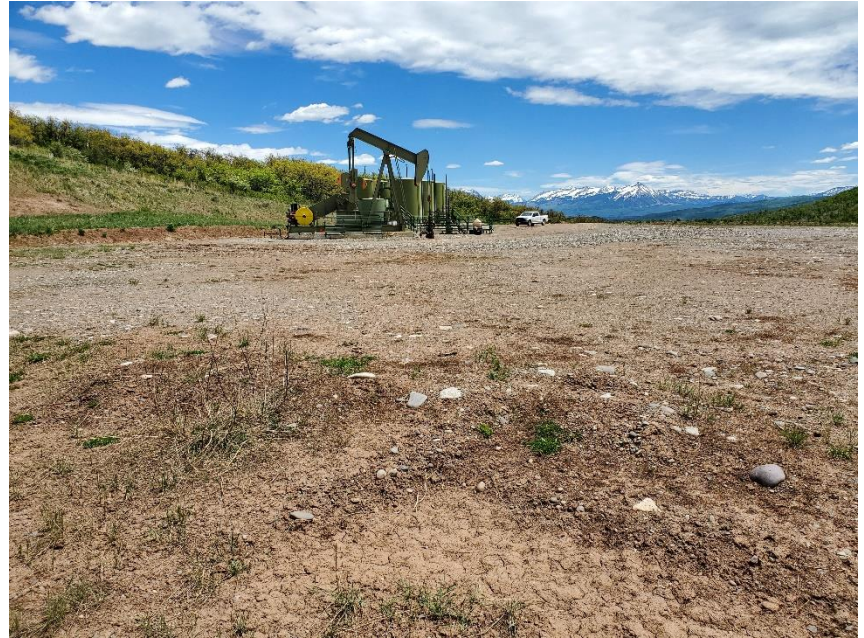
Photo 8: Photo taken from the north end of the Location, facing south. See comments under photo 1.

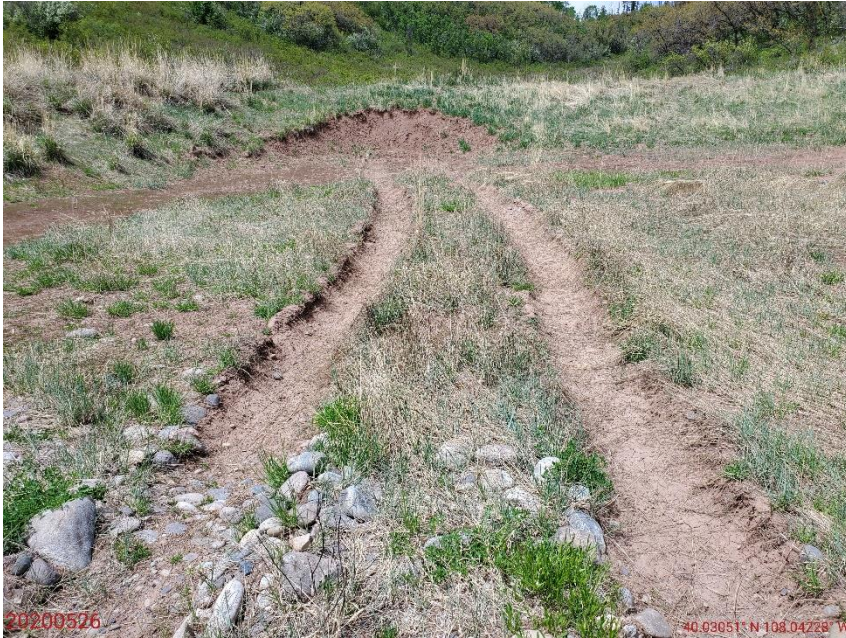
Photo 9: Photo taken from the northwest end of the Location, facing north. Photo shows areas where Operator appears to be removing soils from slopes on the north end of the Location. Photo also shows vehicle tracking/disturbances.

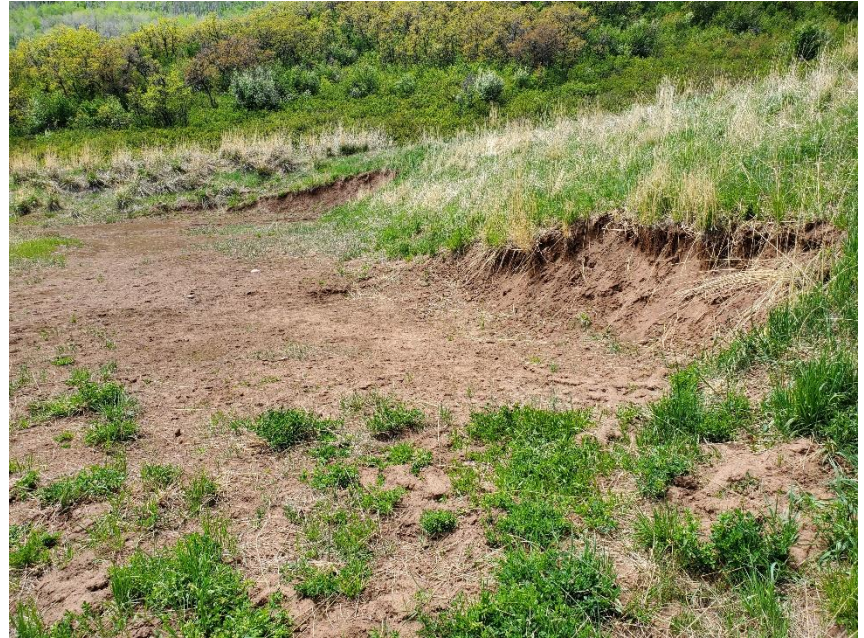
Photo 10: Photo taken from the north end of the Location, facing east. Photo shows areas where Operator appears to be removing soils from slopes on the north end of the Location.

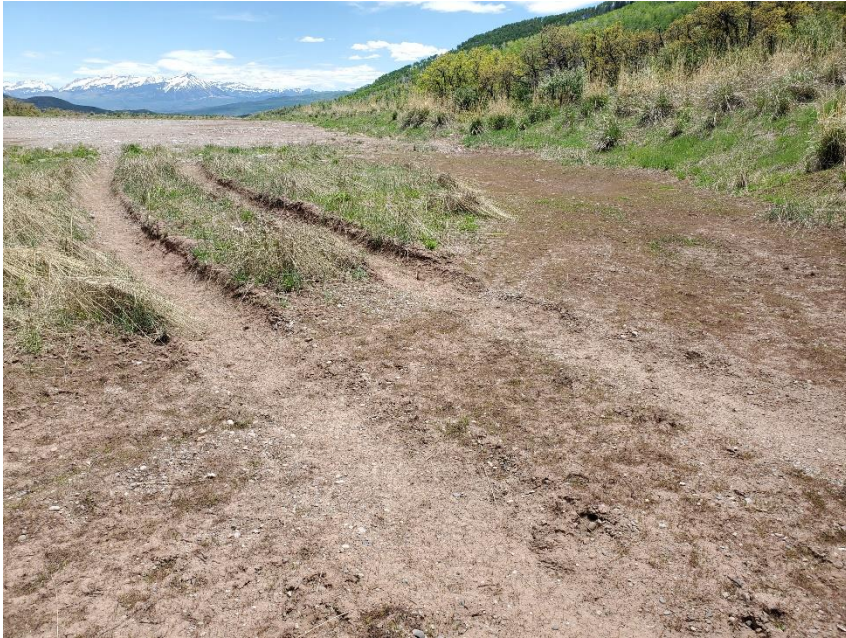
Photo 11: Photo taken from the northwest end of the Location, facing southwest. Photo shows vehicle tracking/disturbances and areas where vegetation is not progressing towards uniform establishment.

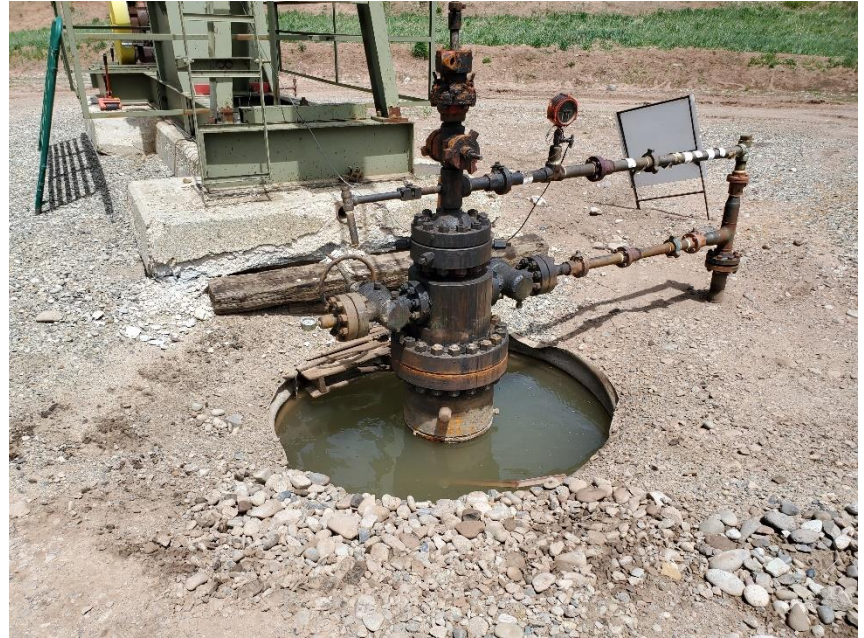
Photo 12: Photo of the 051-06129. Photo shows containment has filled with fluid and requires maintenance.
