Inspection Photos

5/26/2020

Operator: GUNNISON ENERGY LLC - 10515

Location ID: 324457

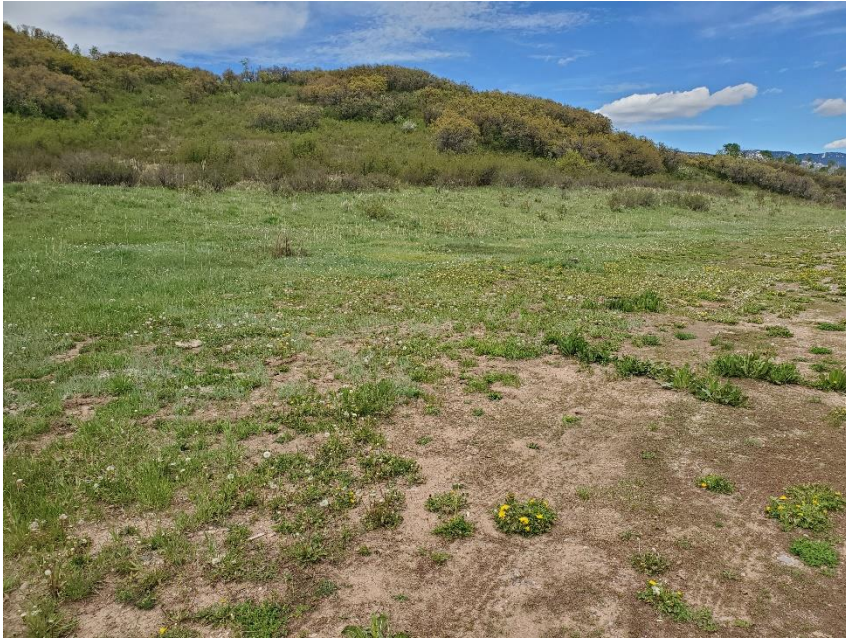
Photo 1: Photo taken from the west end of the Location, facing northeast. Photo provides an overview of the Location.

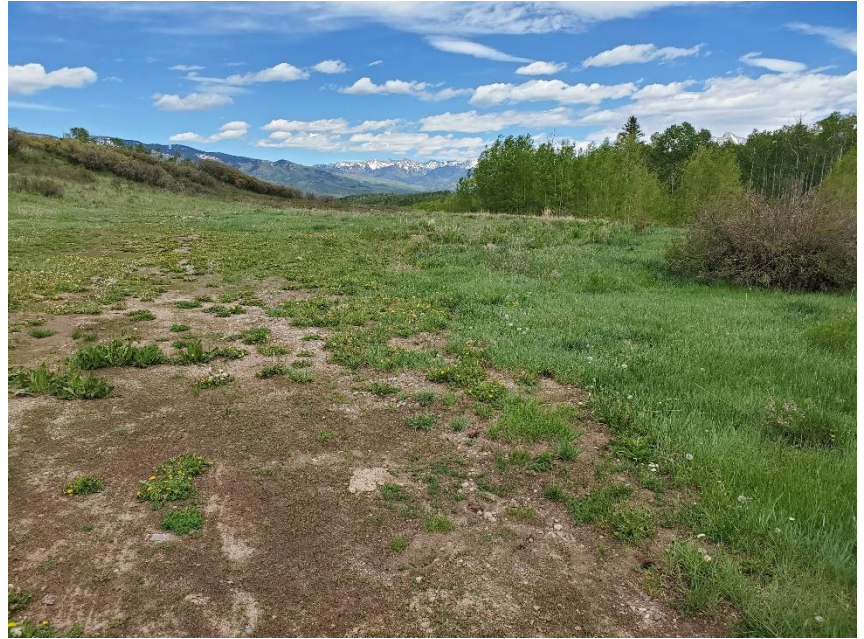
Photo 2: Photo taken from the west end of the Location, facing southeast. Photo provides an overview of the Location.

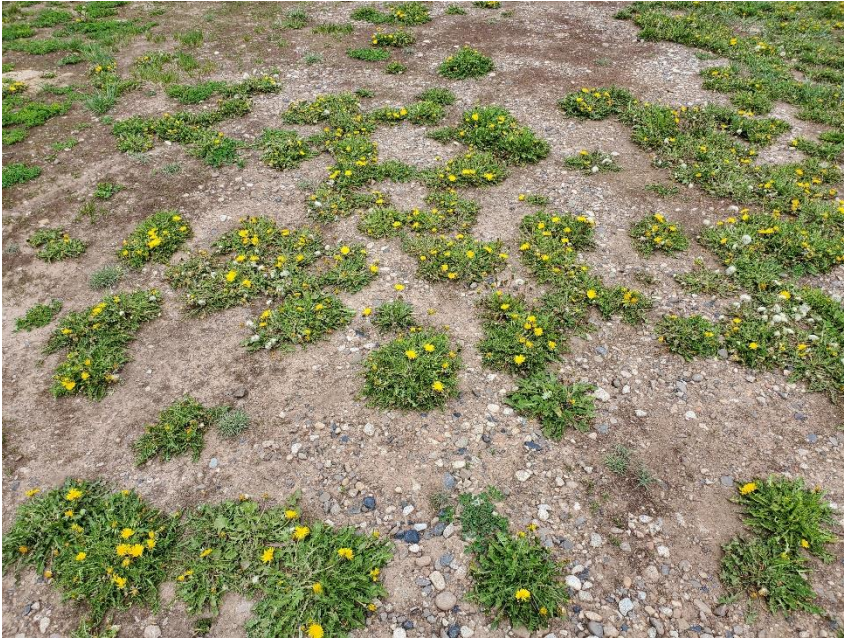
Photo 3: Photo taken from the Location. Photo shows vegetation on the Location is predominantly *Taraxacum officinale*; vegetation observed not reflective to that of the reference area, or uniform. Photo also shows gravel/base has not been removed from the Location

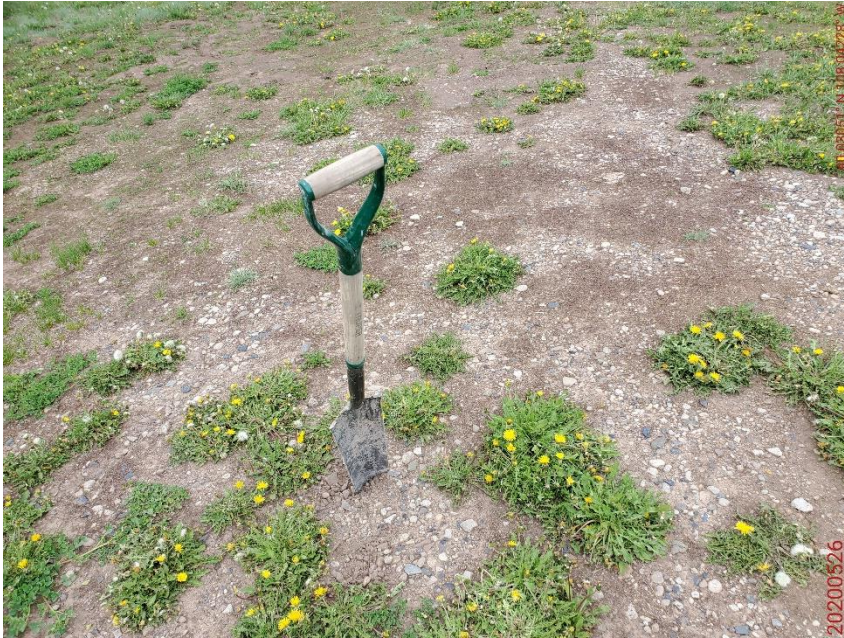
Photo 5: Photo taken from the southwest end of the Location, facing north. Photo shows Reclamation Specialist tested the pad for compaction alleviation compliance; Unable to easily penetrate the soil surface; Compaction concerns evident.

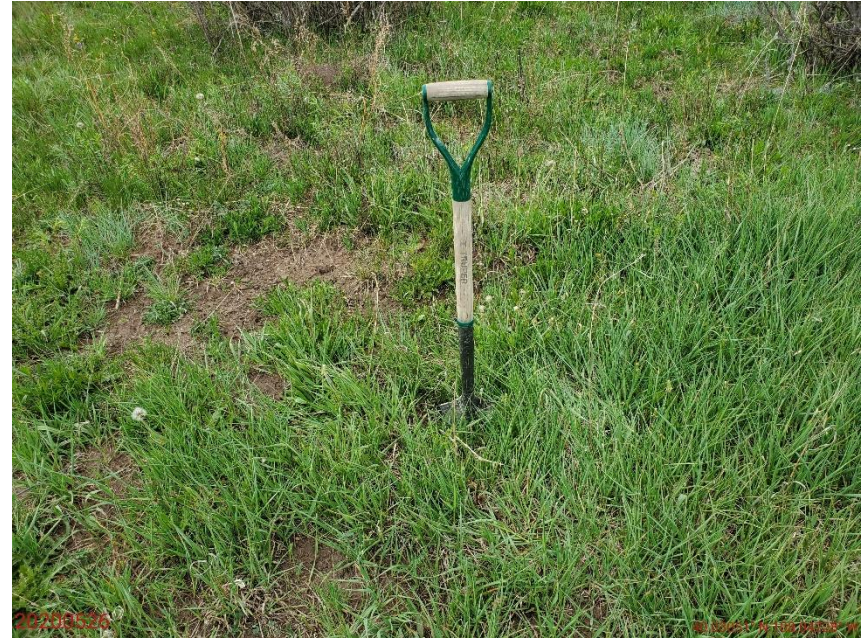
Photo 6: Photo taken from the adjacent reference area. Photo shows Reclamation Specialist tested the soils on the adjacent lands to compare to the compaction concerns observed on the pad; Photo shows Reclamation Specialist was able to soil surface for the entire length of the shovel blade (16 inches).

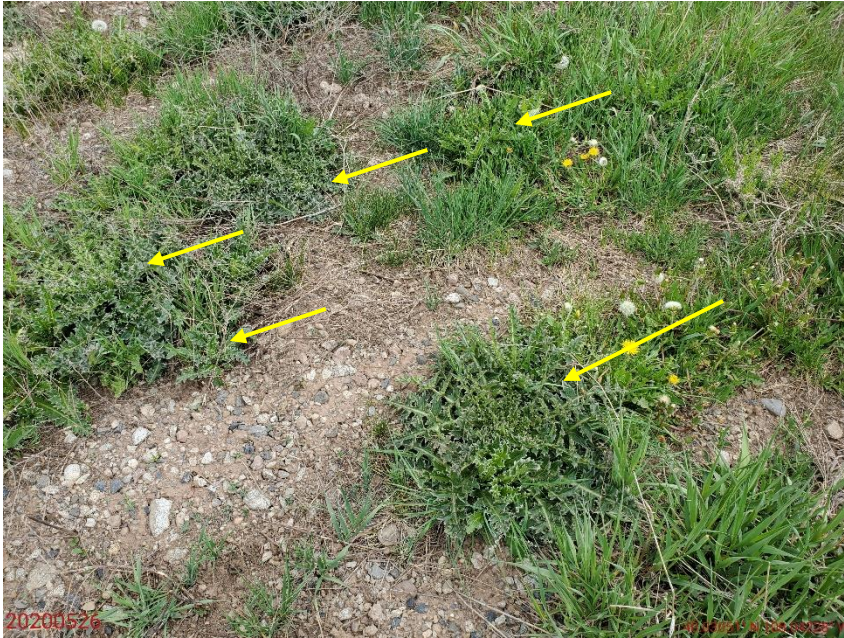
Photo 7: Photo taken from the southeast end of the pad. Photo shows Musk thistle rosettes; Noxious weed issues observed on Location since 2016. Photo also shows areas where gravel base has not been removed.

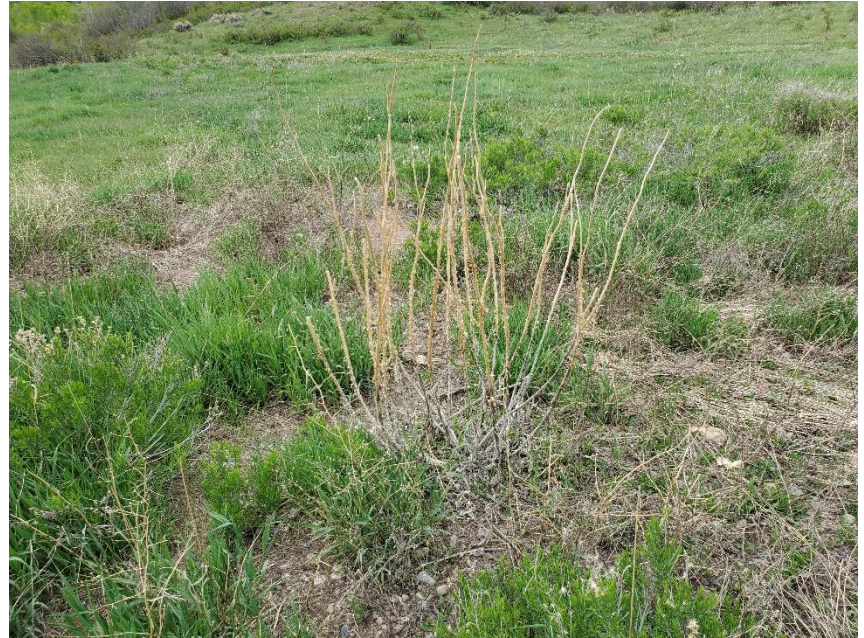
Photo 8: Continued from photo 7. Photo shows Musk thistle plant from the 2019 growing season.

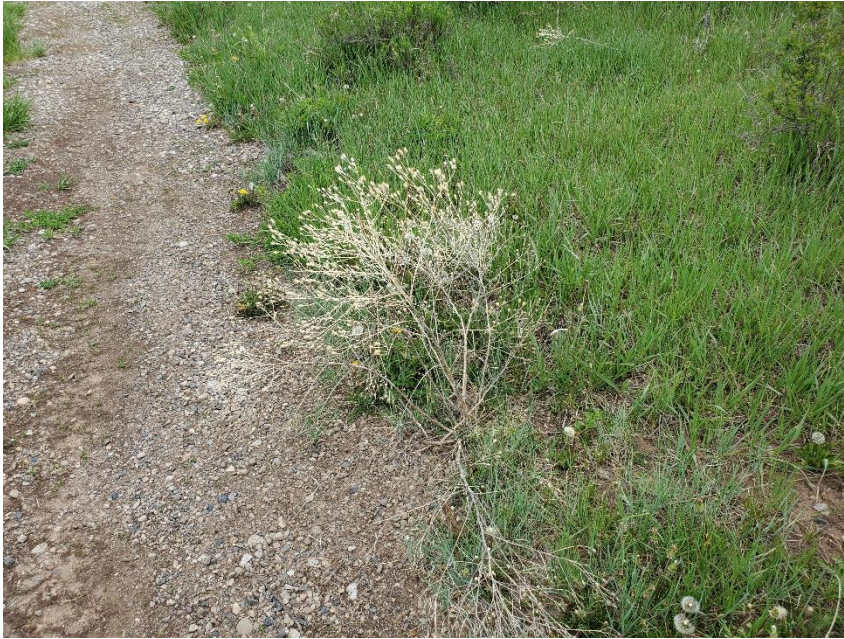
Photo 9: Photo taken from the access road. Photo shows either Diffuse or Russian Knapweed establishing on Location. Plant observed in photo from 2019 growing season. This is a Colorado State listed Noxious weed and requires management.

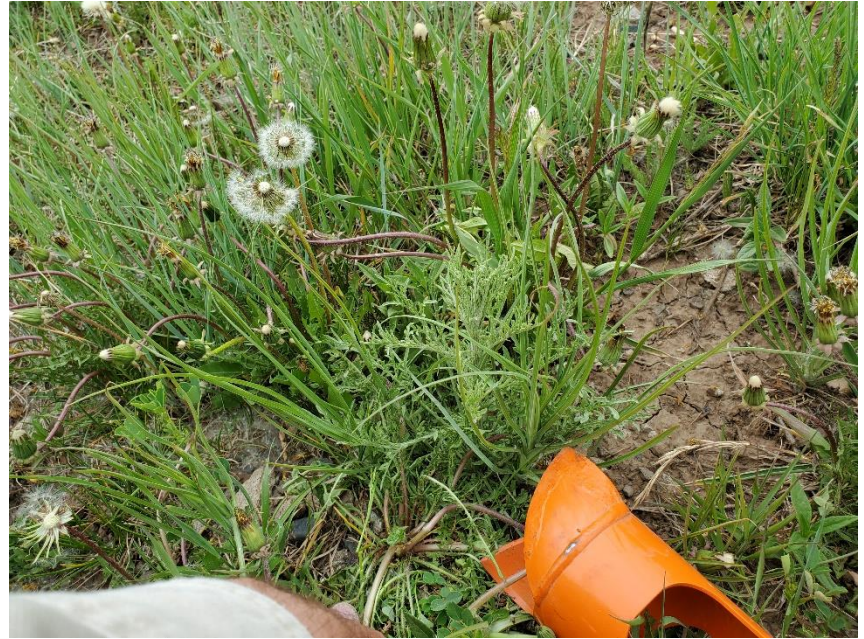
Photo 10: Continued from photo 9. Photo shows Knapweed plant growing on Location.
