Red Mesa Form 44 – 325511; 325573; 325542; 325652

Herrera OWP #5 – 325652 – 067-06776
Operator: RED MESA HOLDINGS/O&G LLC - 10254

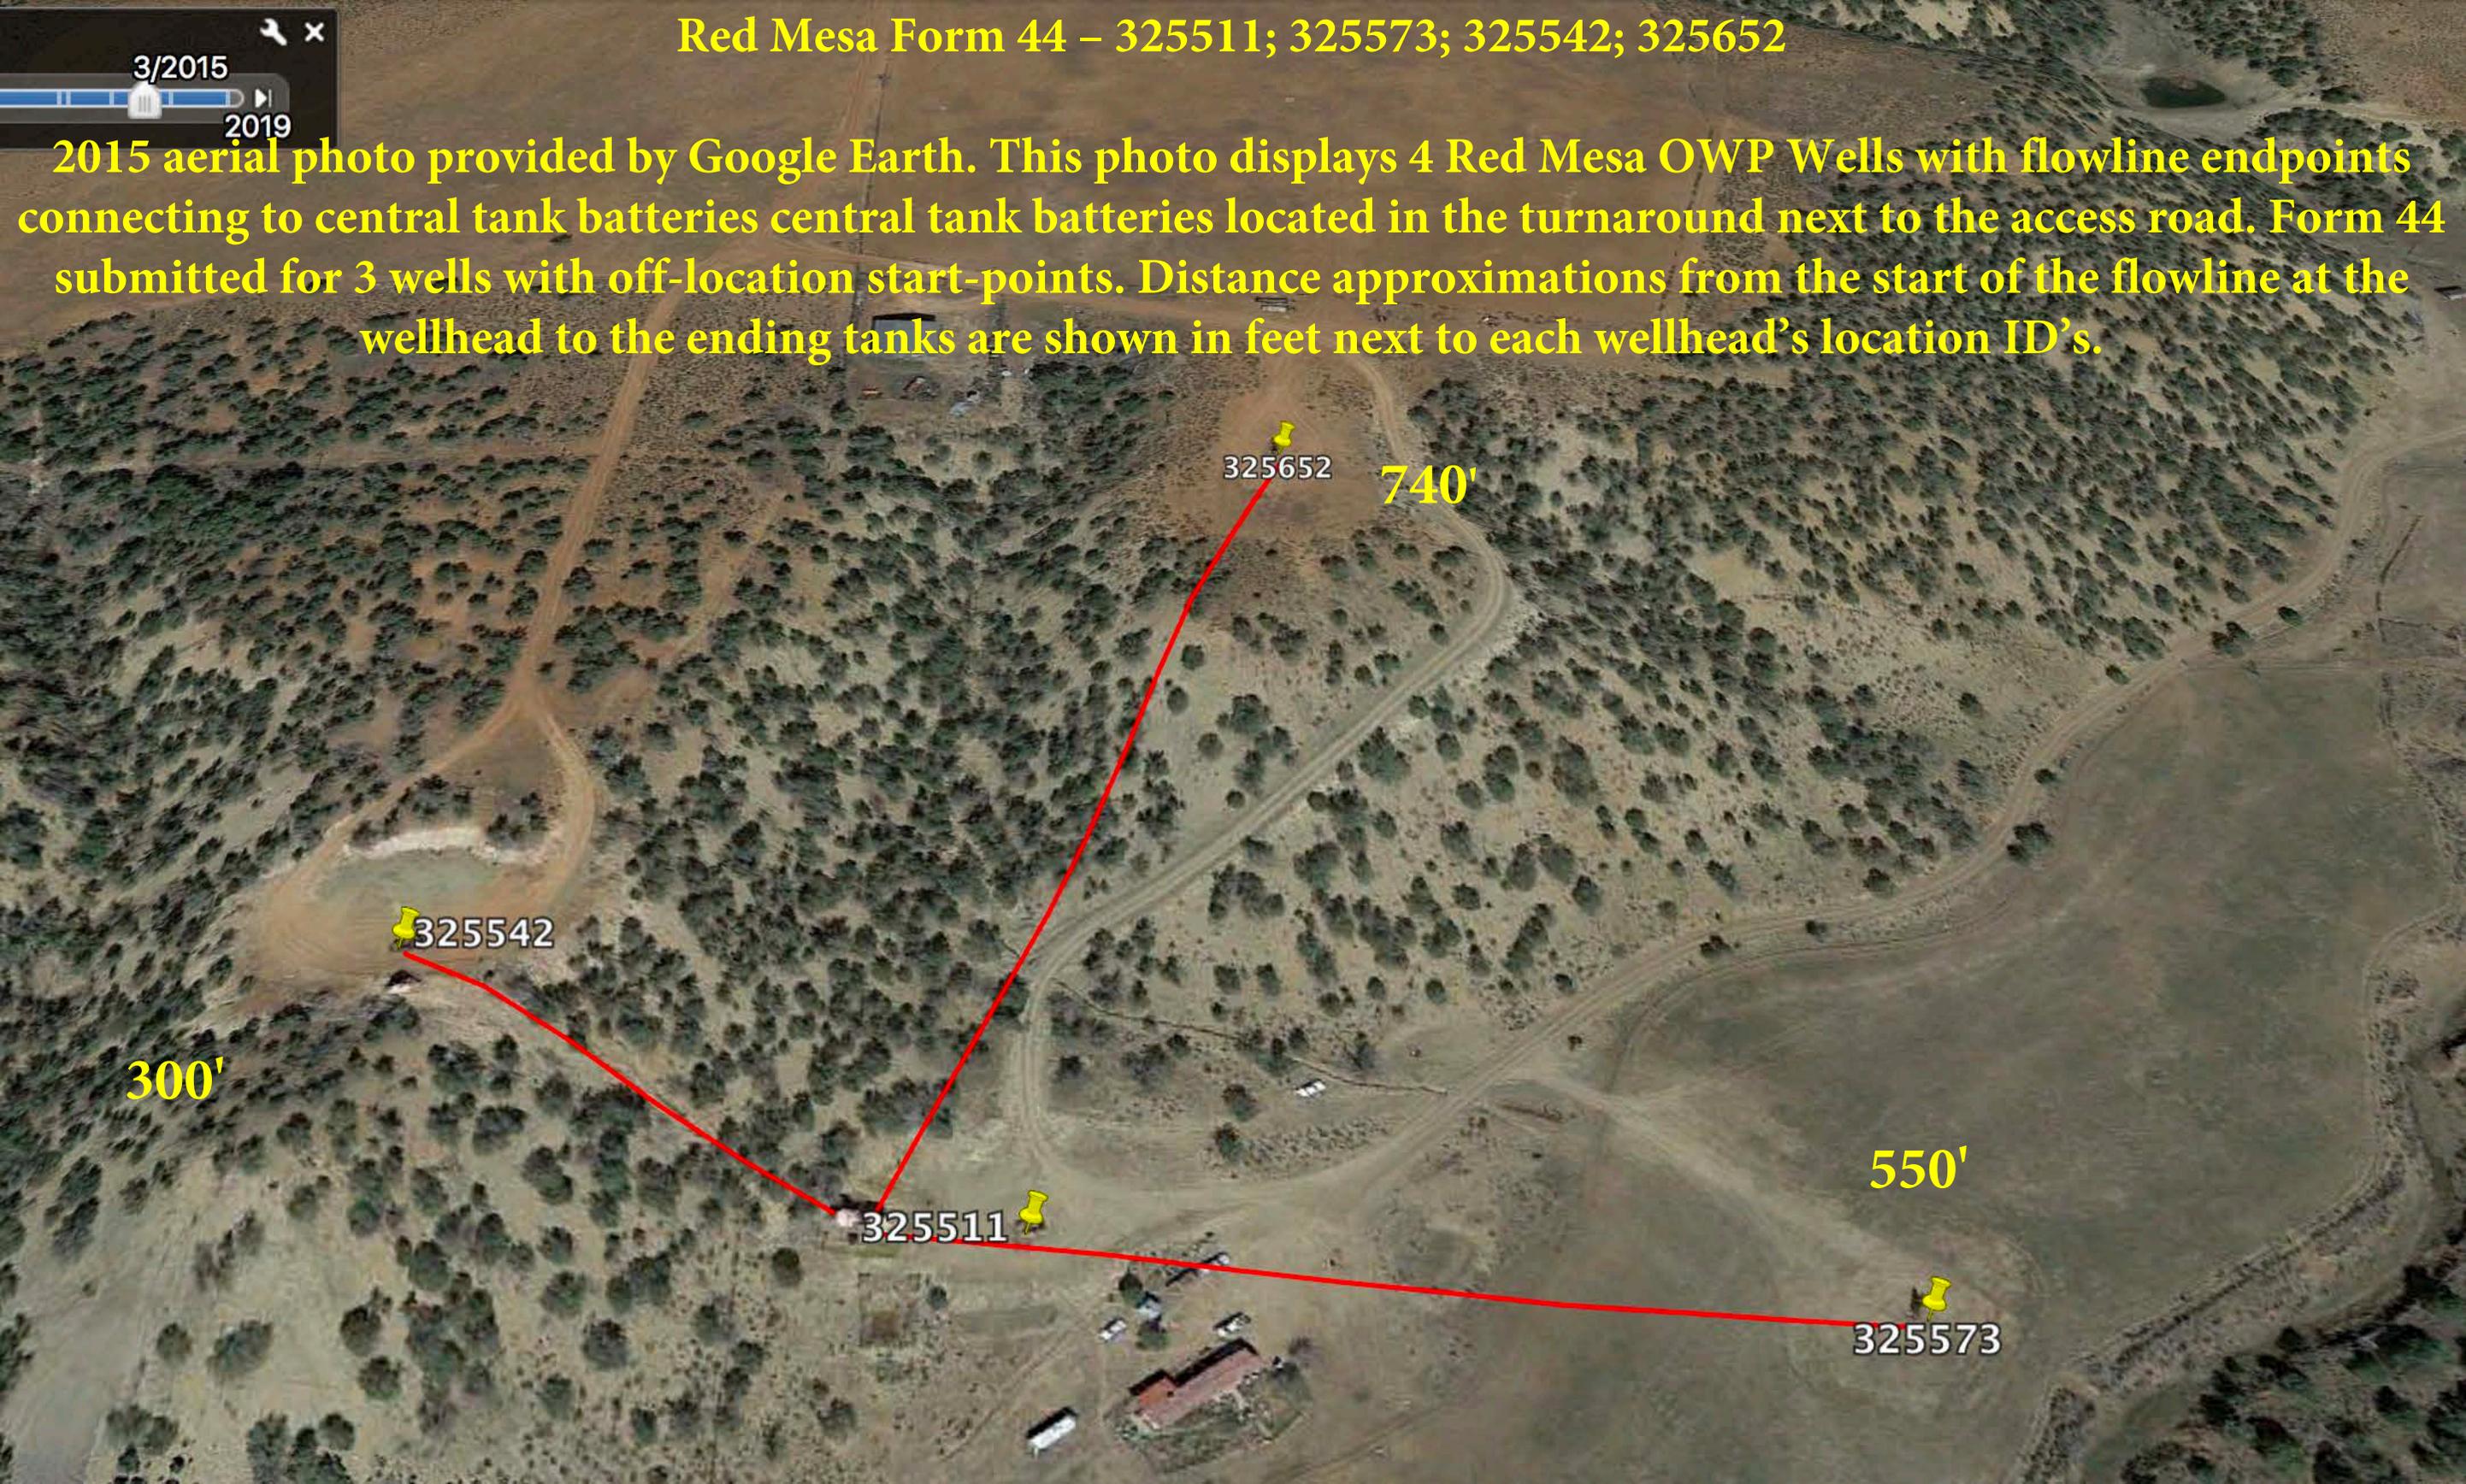
2015 aerial photo provided by Google Earth. This photo displays 4 Red Mesa OWP Wells with flowline endpoints connecting to central tank batteries central tank batteries located in the turnaround next to the access road. Form 44 submitted for 3 wells with off-location start-points. Distance approximations from the start of the flowline at the wellhead to the ending tanks are shown in feet next to each wellhead's location ID's.

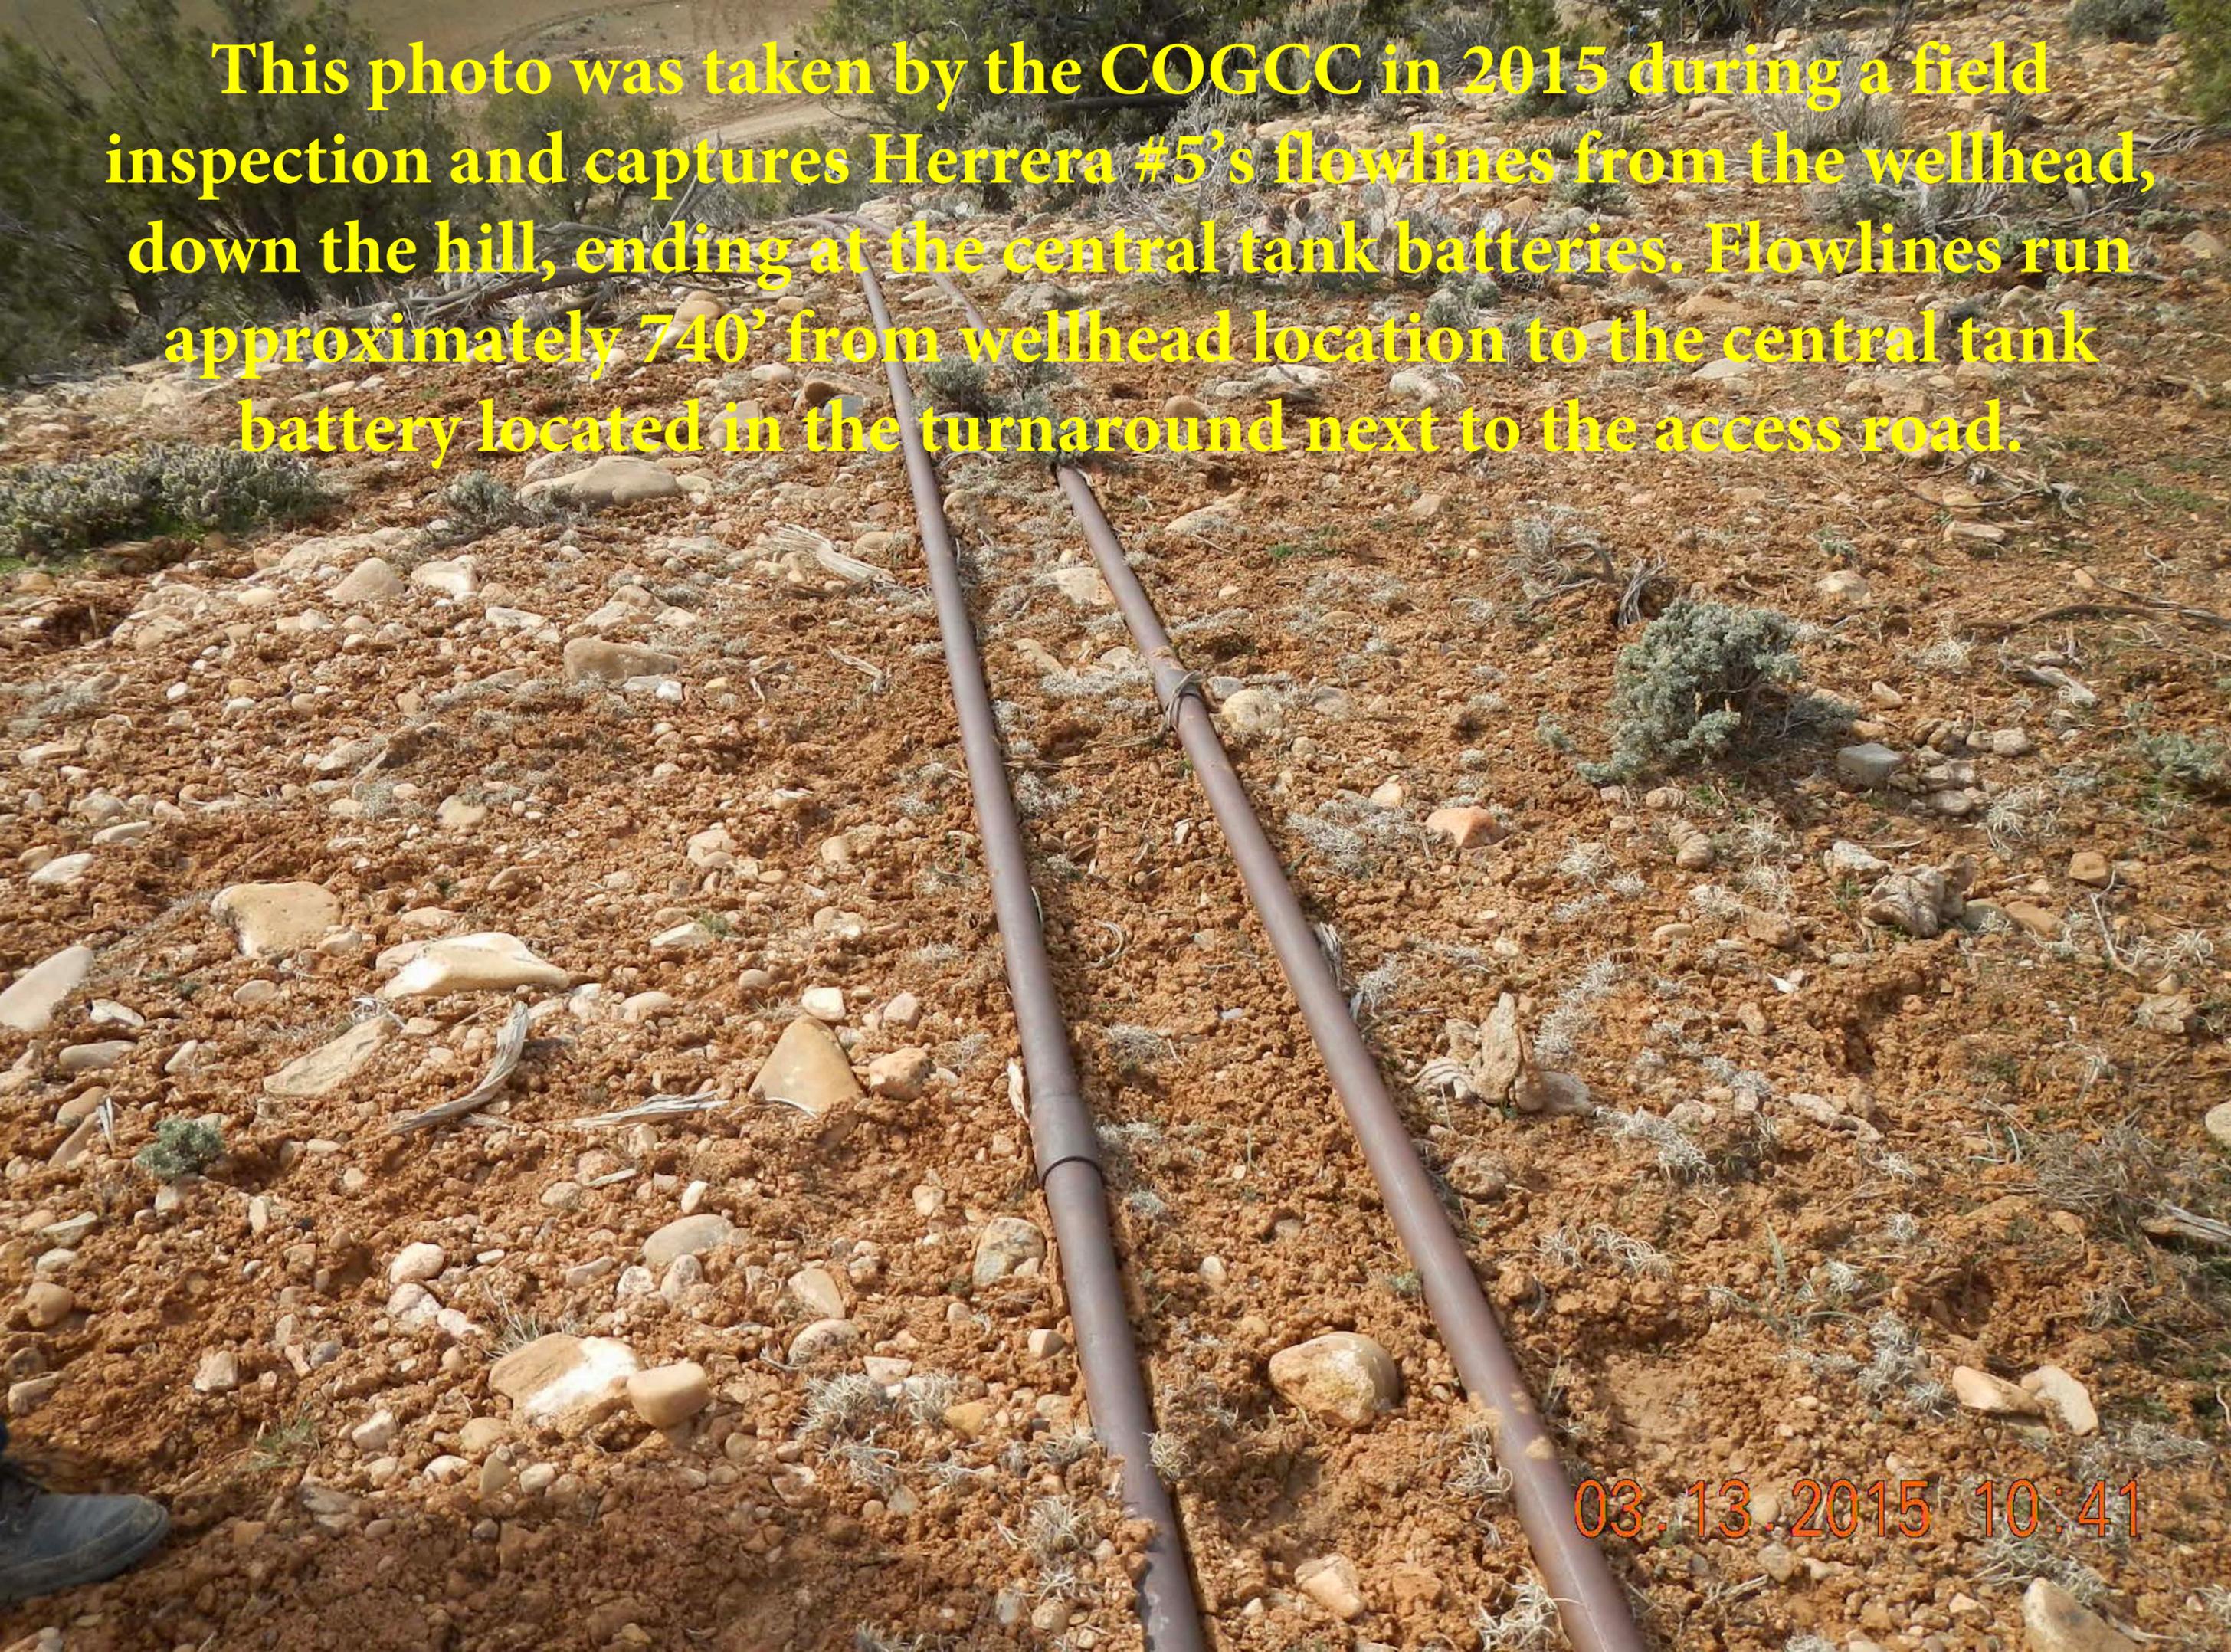
03.13.2015 10:41

This photo was taken by the COGCC in 2015 during a field inspection and captures Herrera #5's flowlines from the wellhead, down the hill, ending at the central tank batteries. Flowlines run approximately 740' from wellhead location to the central tank battery located in the turnaround next to the access road.

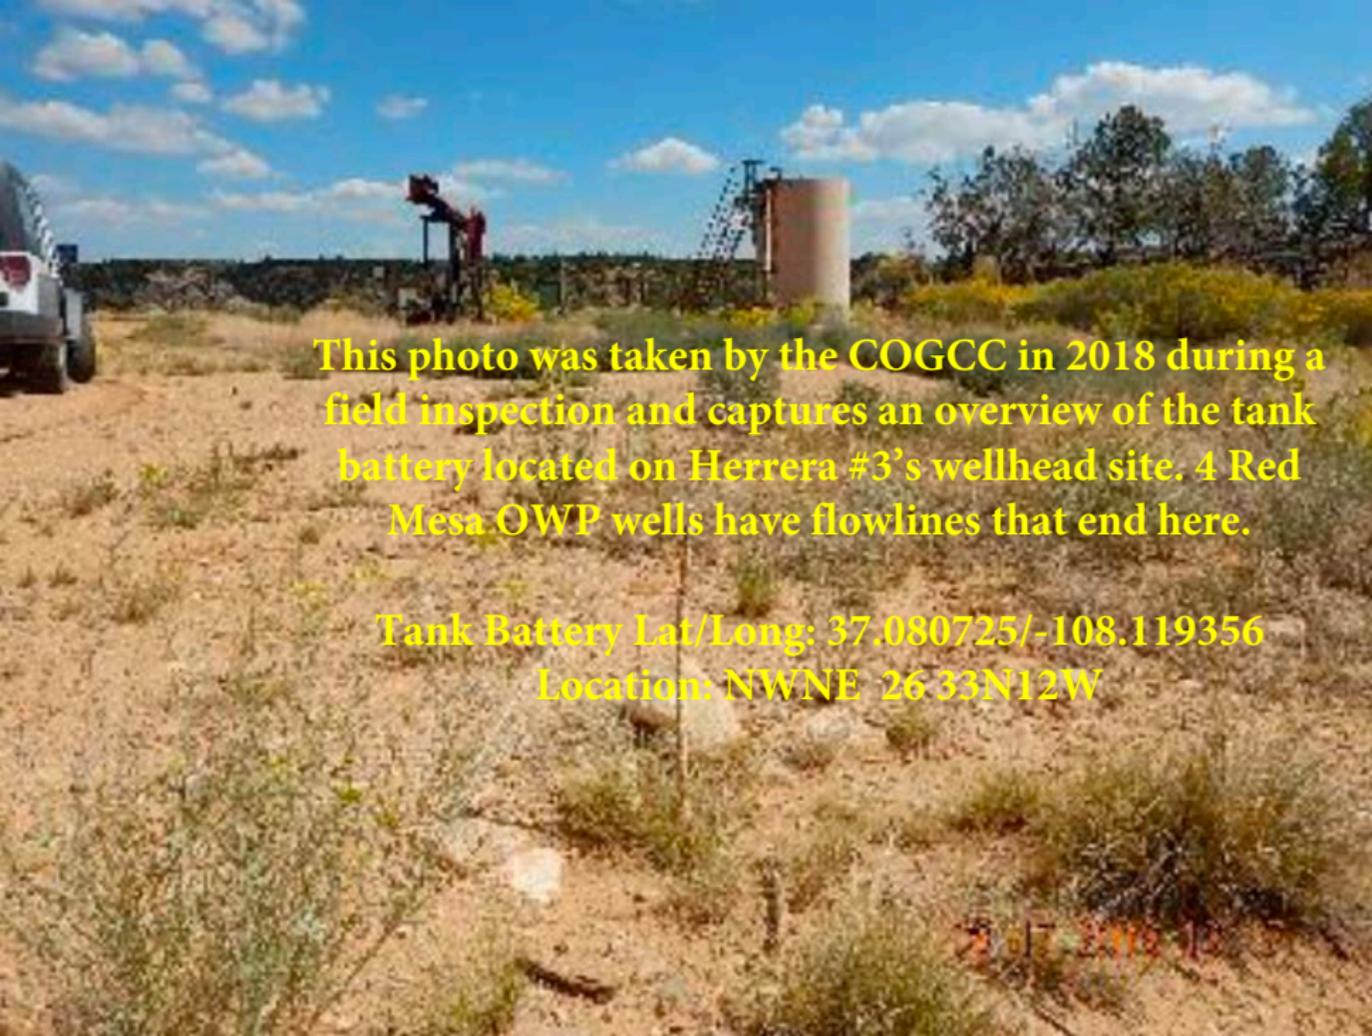
This photo was taken by the COGCC in 2018 during a field inspection and captures an overview of the tank battery located on Herrera #3's wellhead site. 4 Red Mesa OWP wells have flowlines that end here.

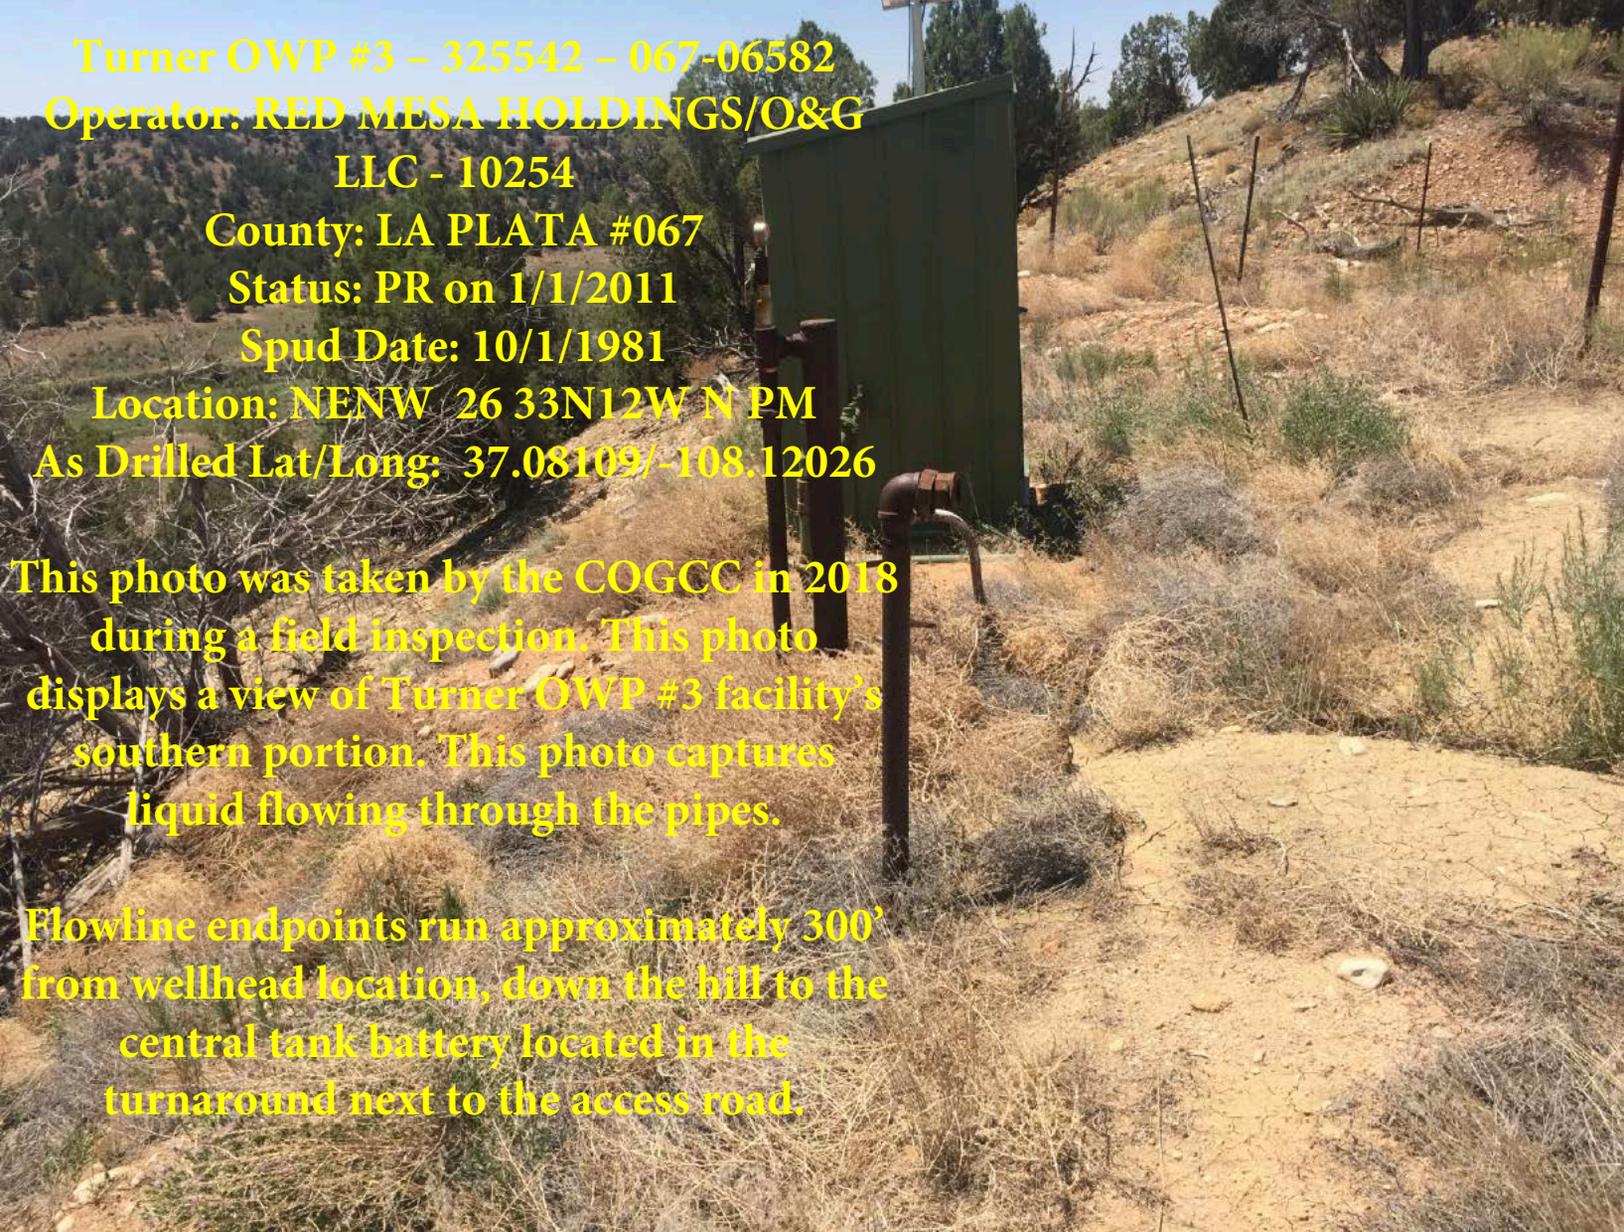
This photo was taken by the COGCC in 2018 during a field inspection. This photo displays a view of Turner OWP #3 facility's southern portion. This photo captures liquid flowing through the pipes.

Flowline endpoints run approximately 300' from wellhead location, down the hill to the central tank battery located in the turnaround next to the access road.

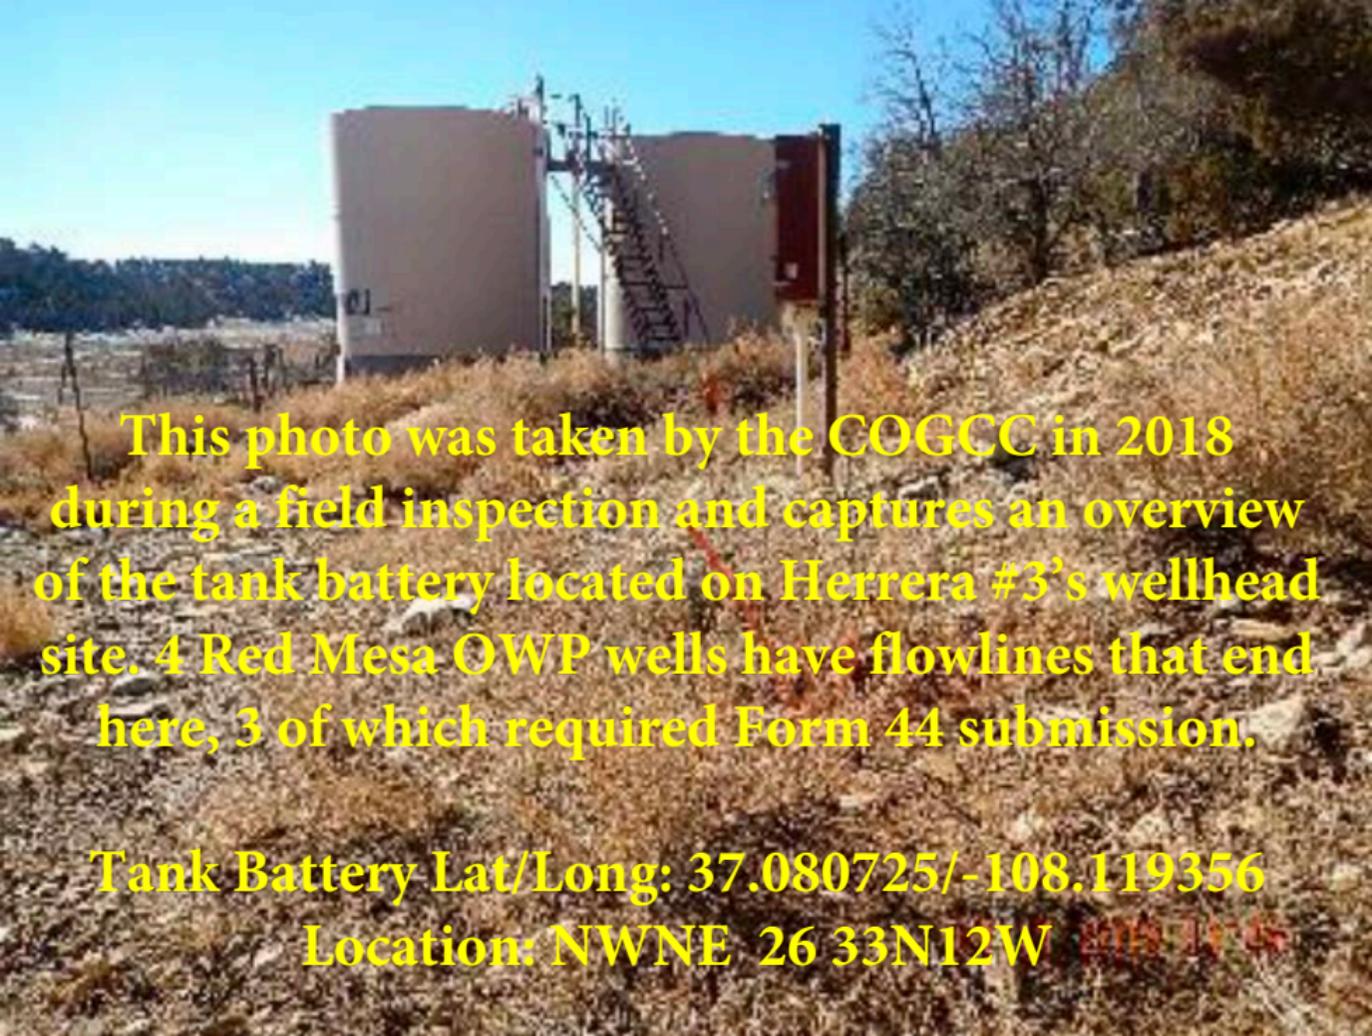
This photo was taken by the COGCC in 2018 during a field inspection and captures an overview of the tank battery located on Herrera #3's wellhead site. 4 Red Mesa OWP wells have flowlines that end here, 3 of which required Form 44 submission.
