Inspection Photos

API: 071-07711

Operator: EVERGREEN NATURAL RESOURCES

Inspection Date: 5/20/2020

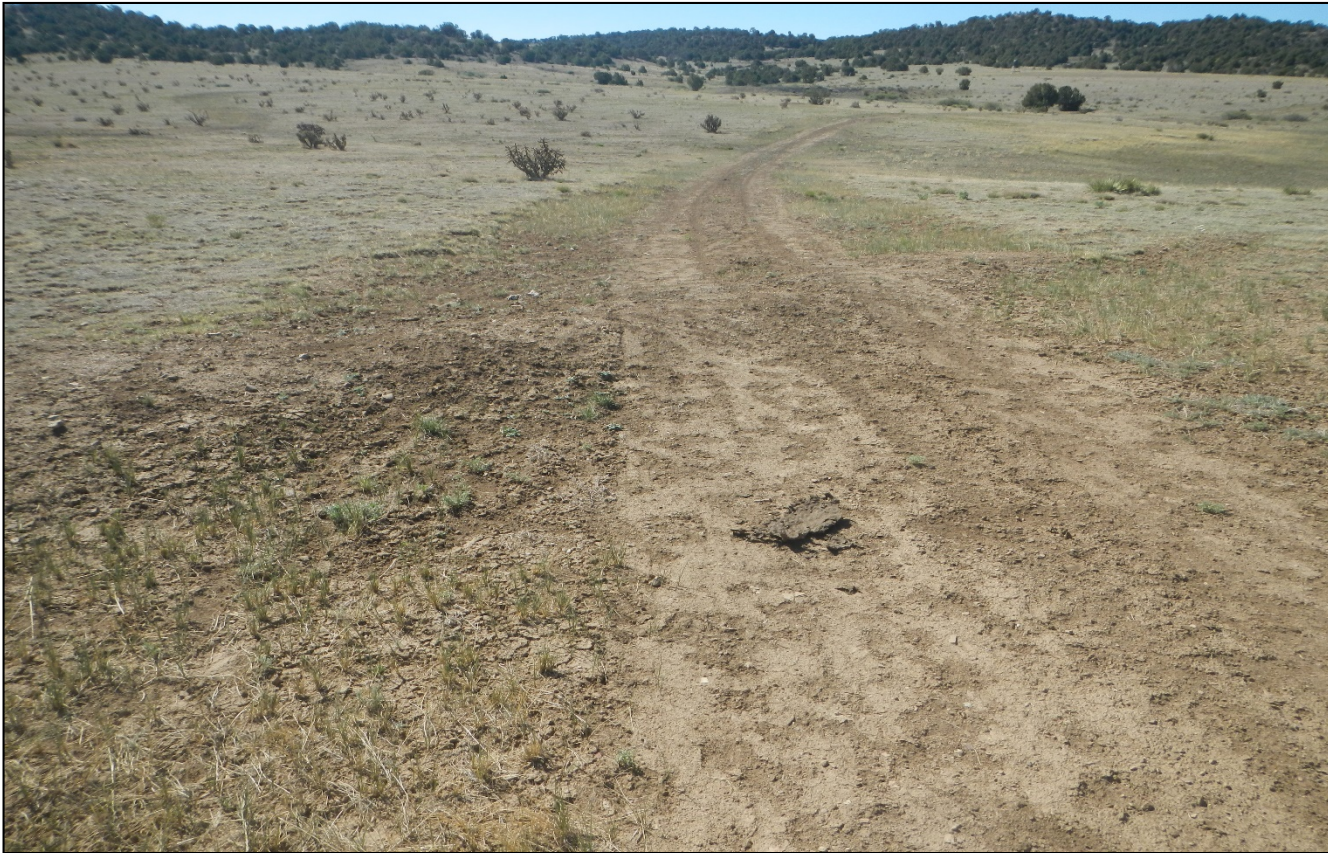
Photo 4. Facing southwest along the access road.

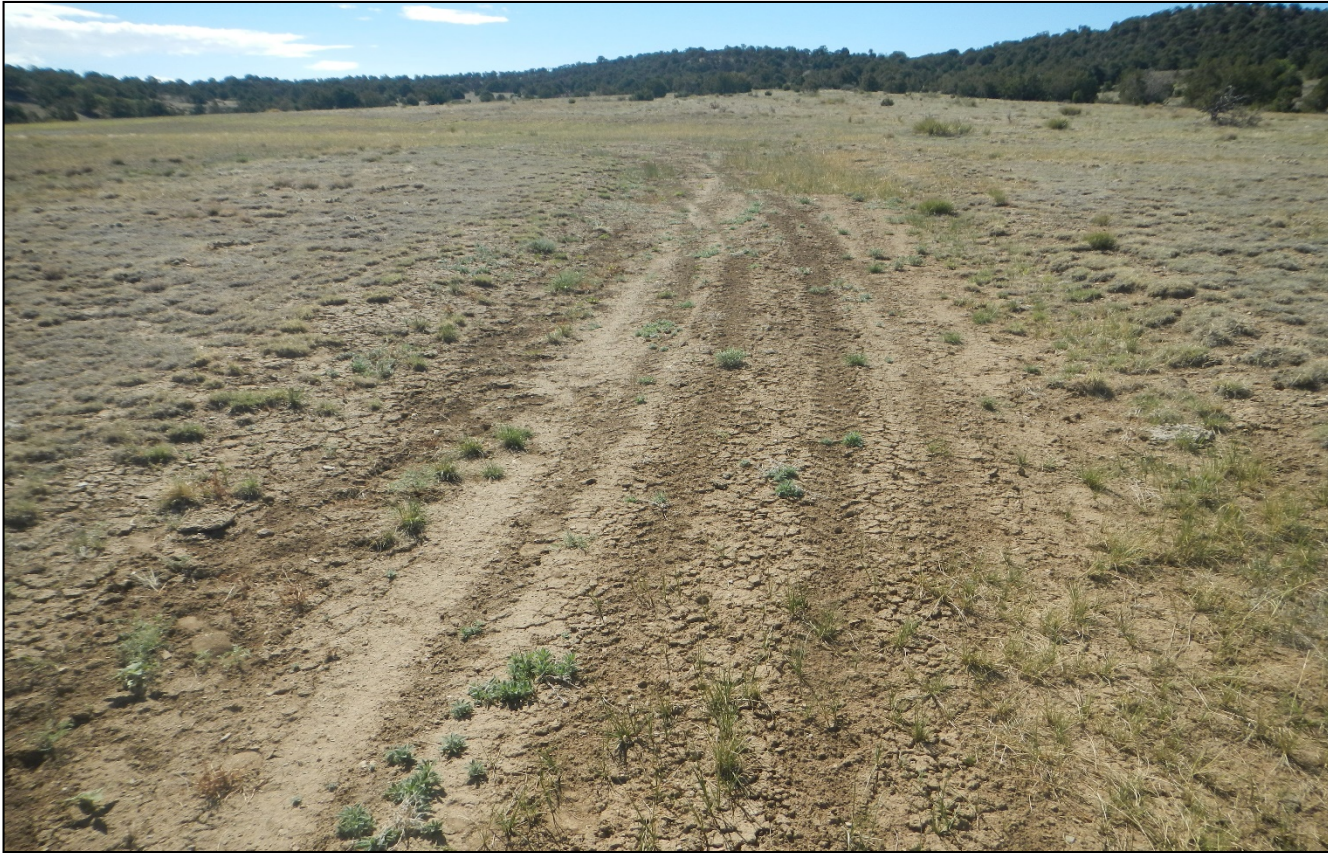
Photo 5. Facing southeast at the access road. The access road near the location needs to achieve 80% vegetation cover. There are areas along the section of access road which vegetation is well established and other areas shown above that have not yet established 80% vegetation.

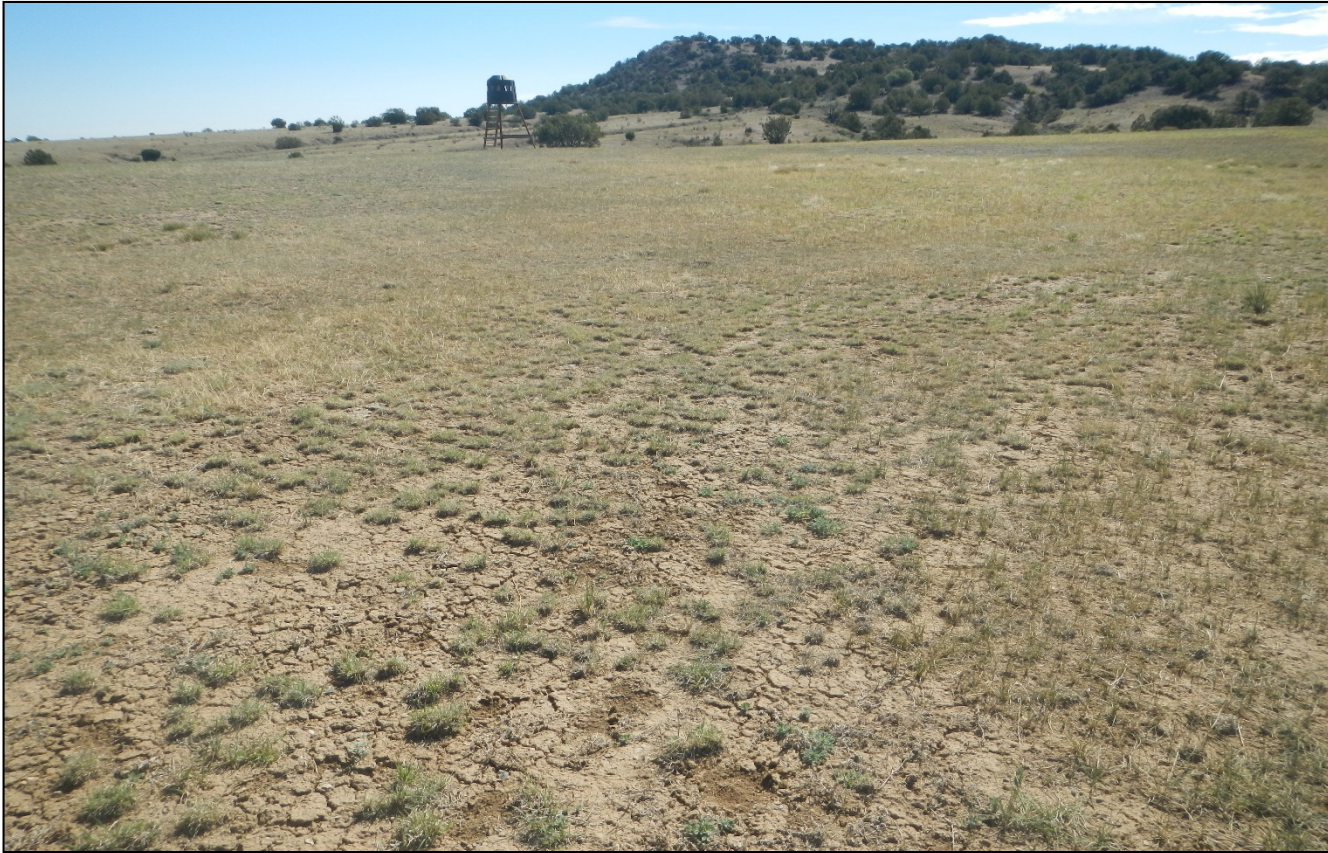
Photo 6. Facing east toward the location. Desirable vegetation is established well throughout most areas of the location.

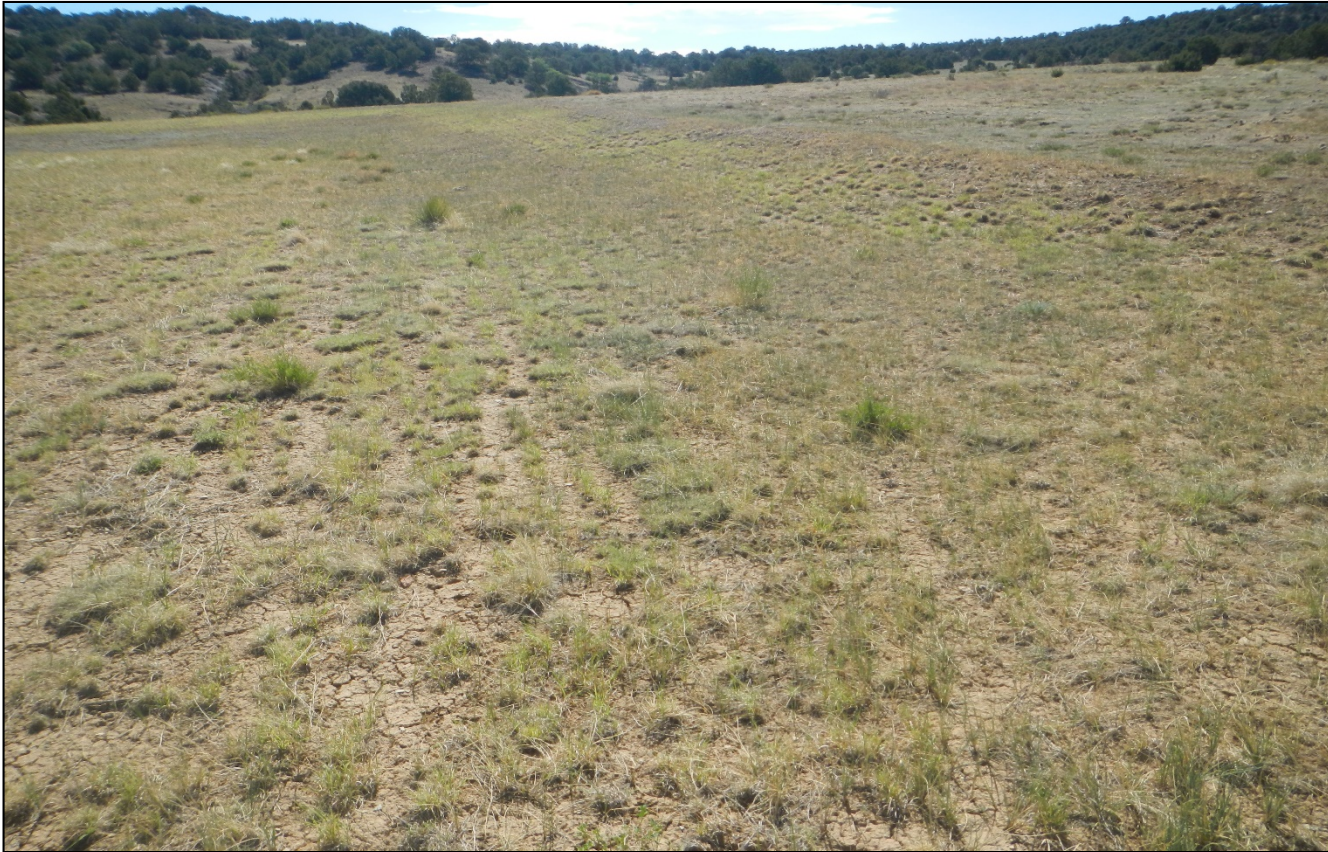
Photo 7. Facing southeast along the cut slope which is stabilized with vegetation.

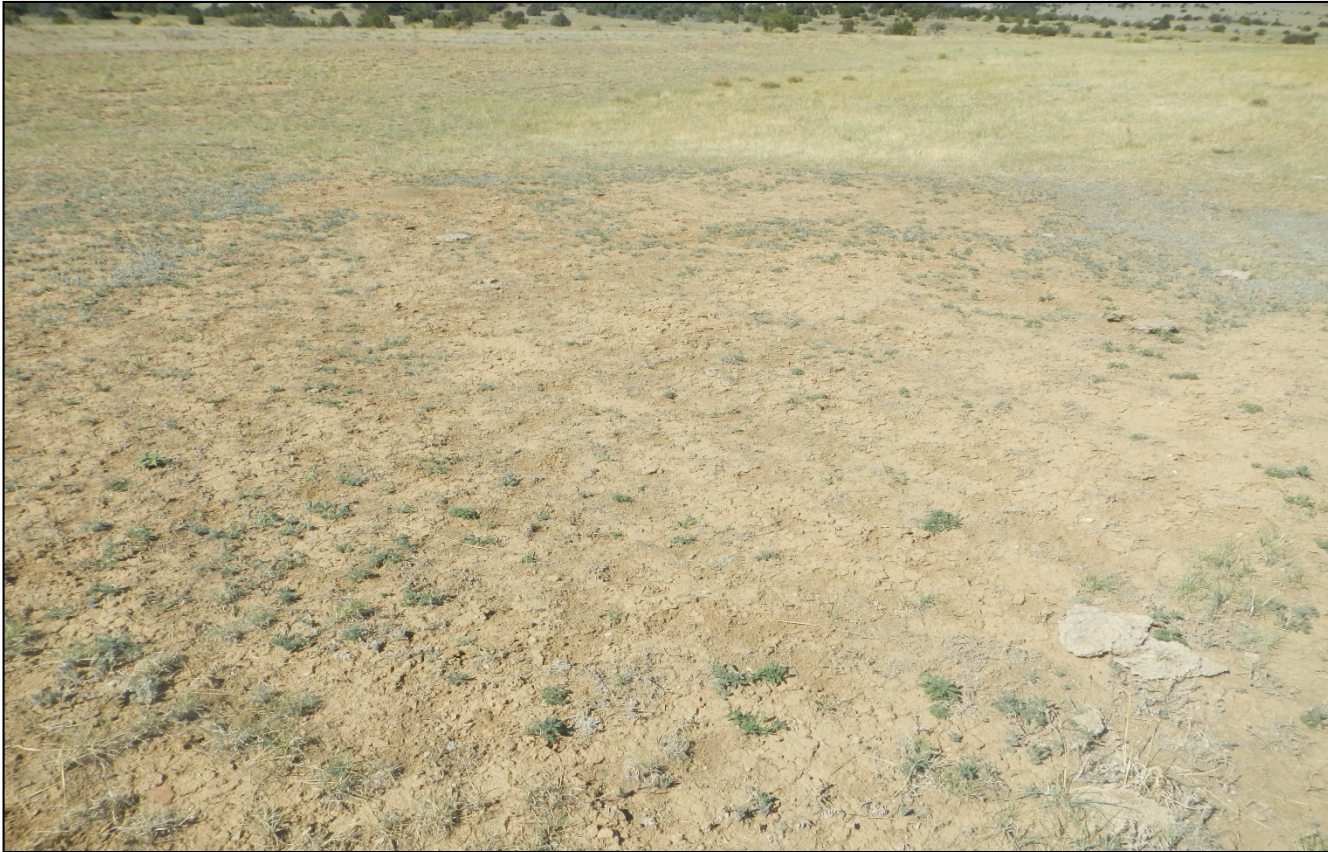
Photo 8. This area at the southeast side of the location approximately 50'x50' which has not established desirable vegetation. This area could use touch up hand seeding.

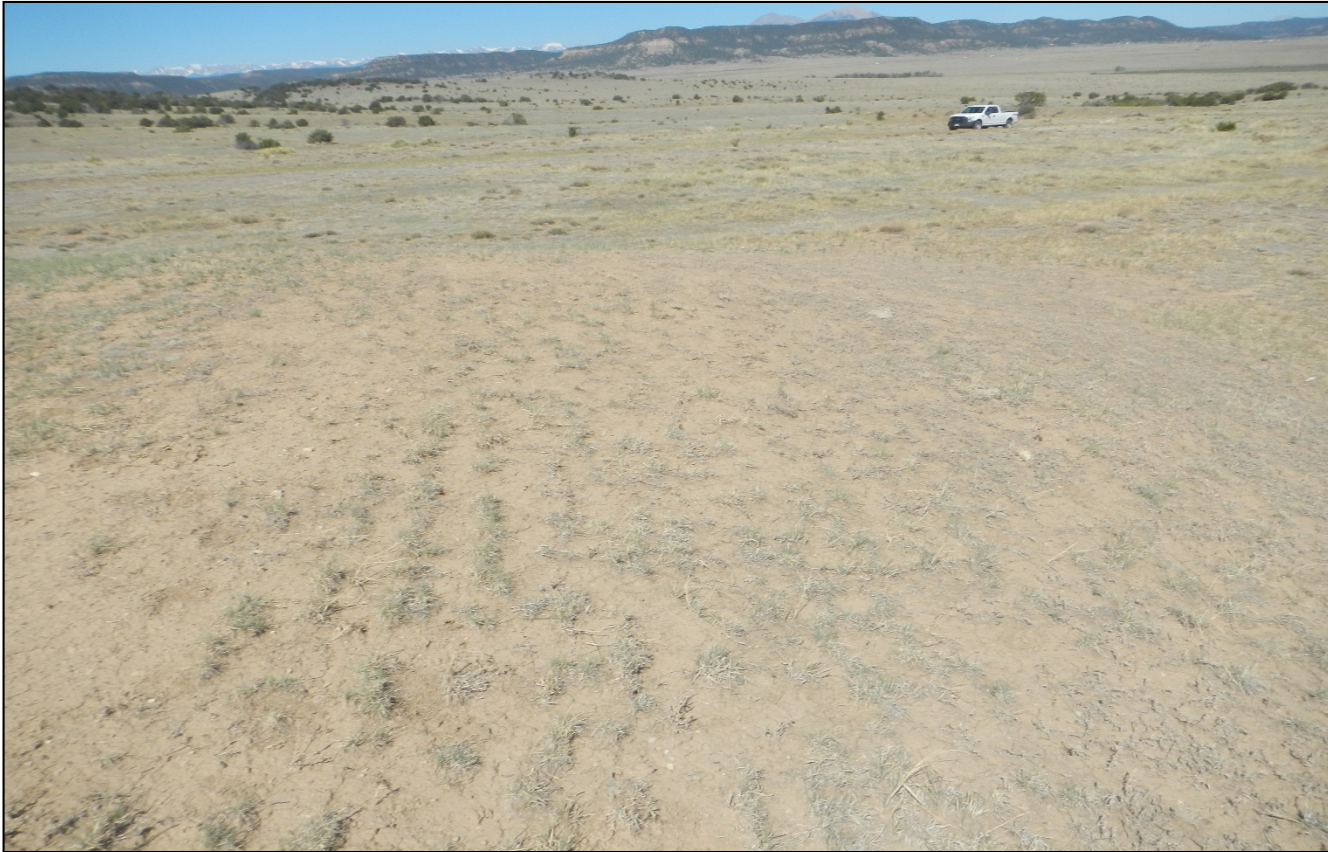
Photo 9. The area along the north/northwest fill slope has not adequately established vegetation and could use touch up hand seeding.

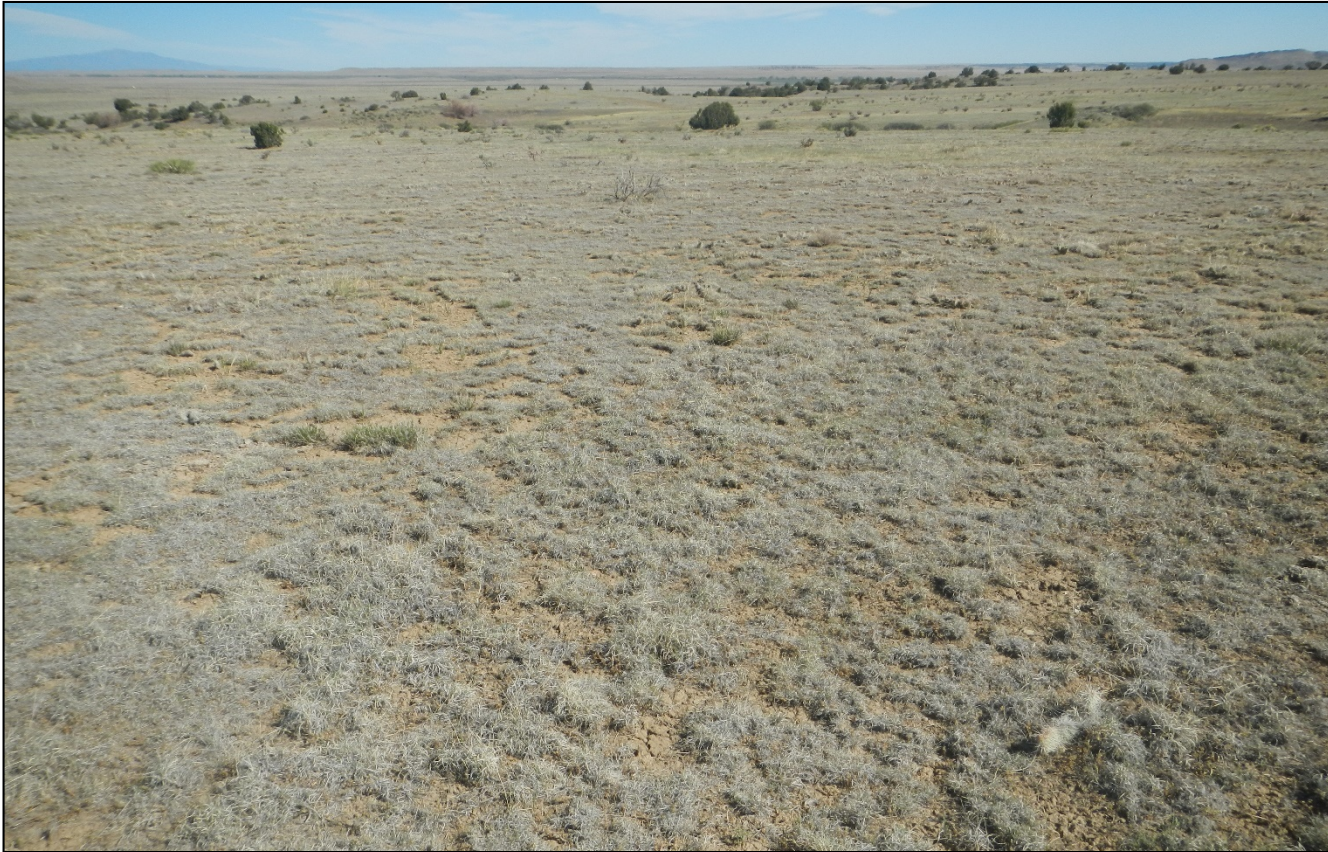
Photo 10. Facing south toward the surrounding undisturbed reference vegetation cover.
