Inspection Photos

6/05/2020

Operator: TEP ROCKY MOUNTAIN LLC - 96850

Location ID: 335275

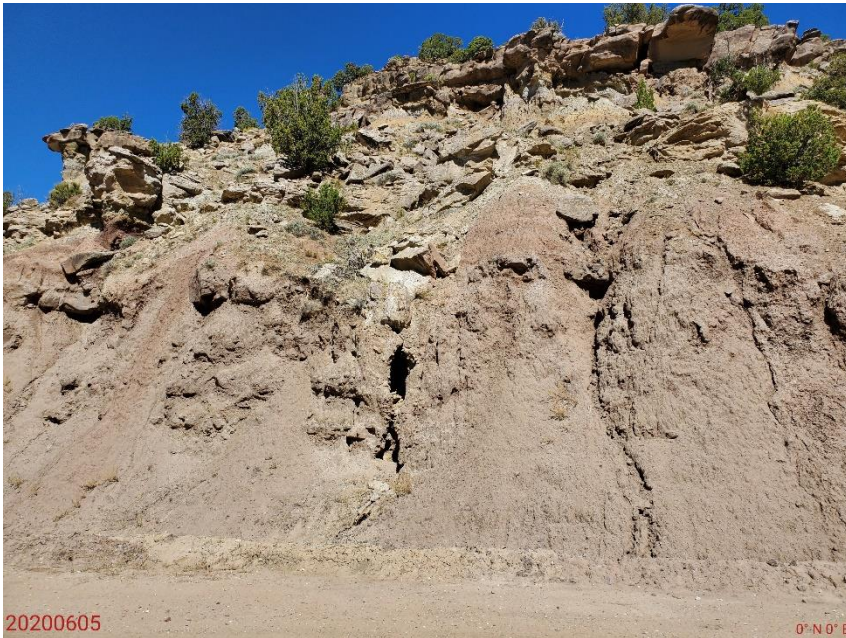
Photo 1: Photo taken from the west end of the Location, facing west. Photo shows BMPs remain insufficient or missing; stormwater runoff has caused erosion degradation on the slopes, cutting into the hillside; Water appears to be undercutting large rocks; potential rockfall risk.

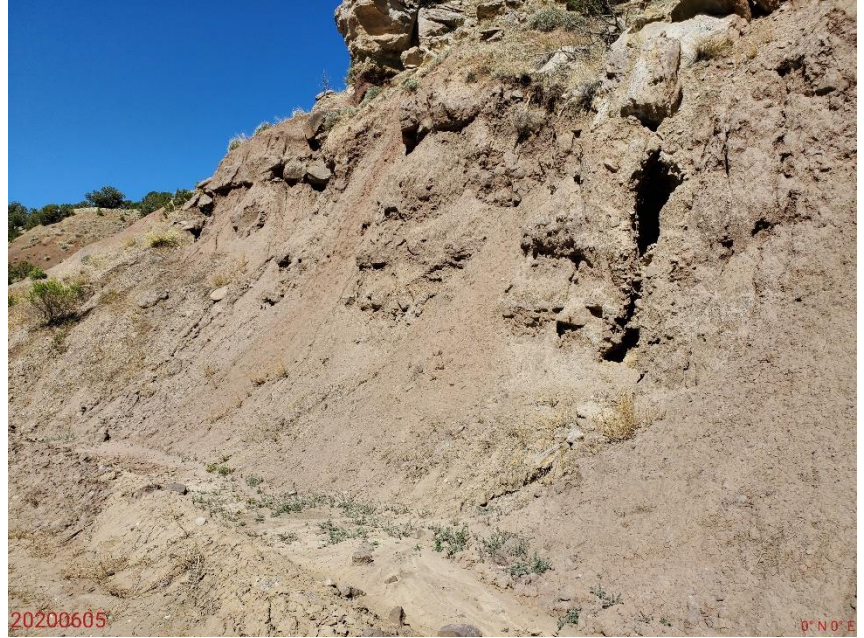
Photo 2: : Photo taken from the west end of the Location, facing southwest. See comments under photo 1.

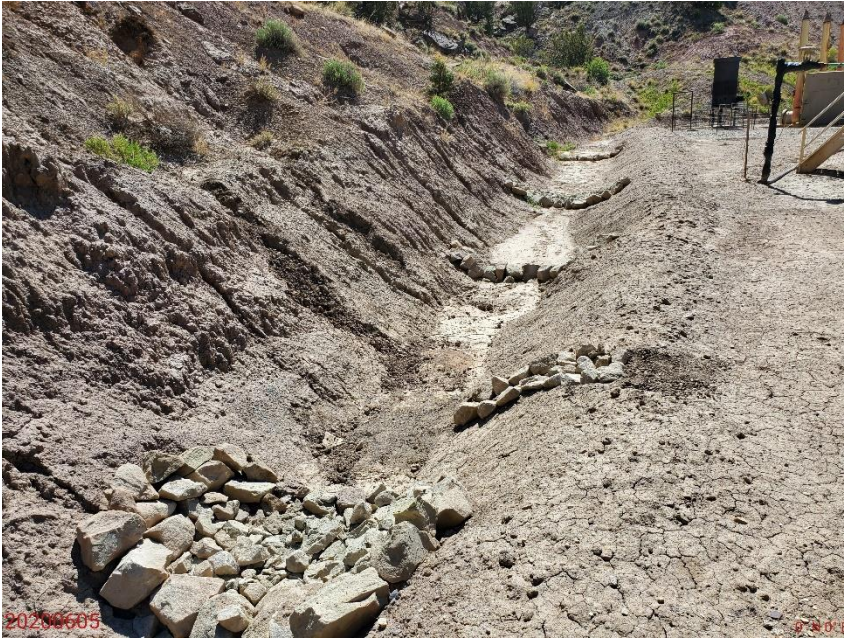
Photo 3: Photo shows additional armoring has been placed within ditch.

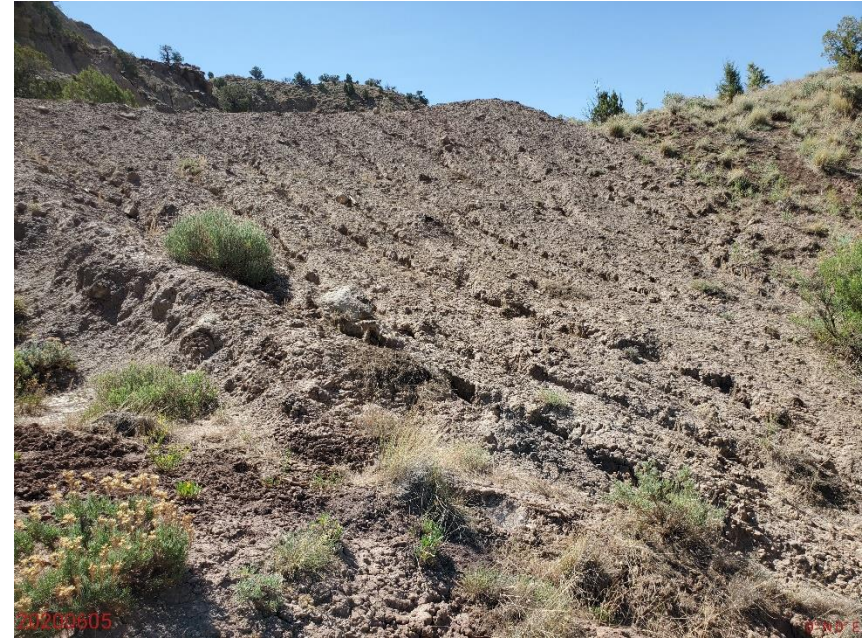
Photo 4: Photo taken from the east end of the Location, facing east. Photo shows erosion degradation on slopes; BMPs to stabilize and protect slopes remain insufficient or missing.

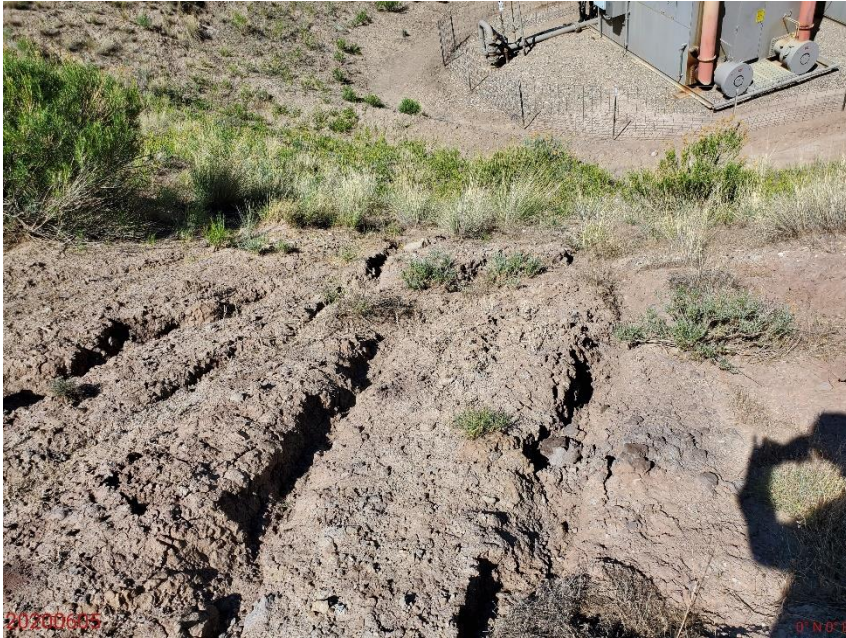
Photo 5: See comments under photo 4.

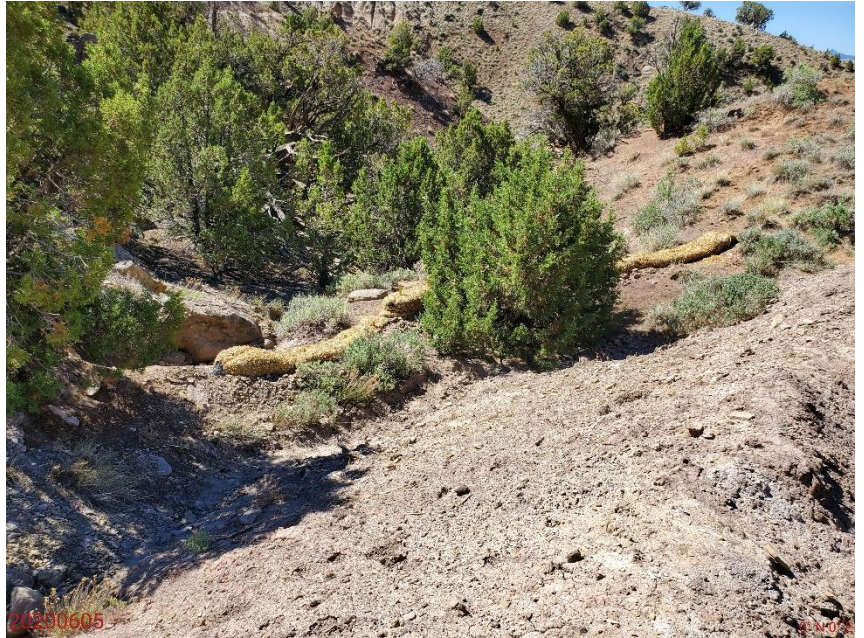
Photo 6: Photo taken from the slopes on the east end of the Location, facing east. Photo shows Operator has installed straw bales to prevent sediment deposition off location.
