# Inspection Photos

Operator: CAERUS PICEANCE LLC - 10456

Location ID: 335922

Garfield County, CO

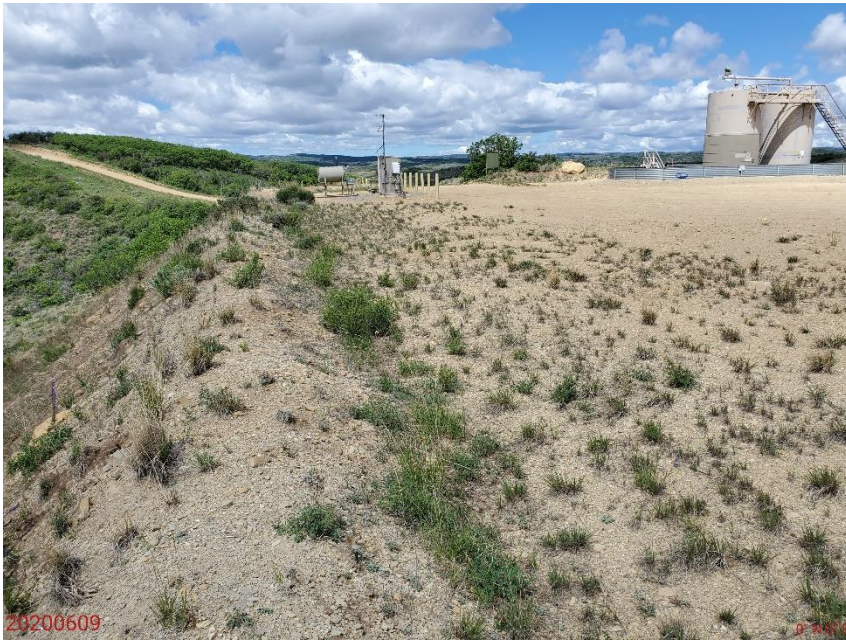
**Photo 1:** Photo taken from the south end of the Location facing west. Photos 1-4 provide an overview of the Location from west, northwest, northeast to east. Photo shows areas of the Location not necessary for production that have not been reclaimed in accordance with Rule 1003.b

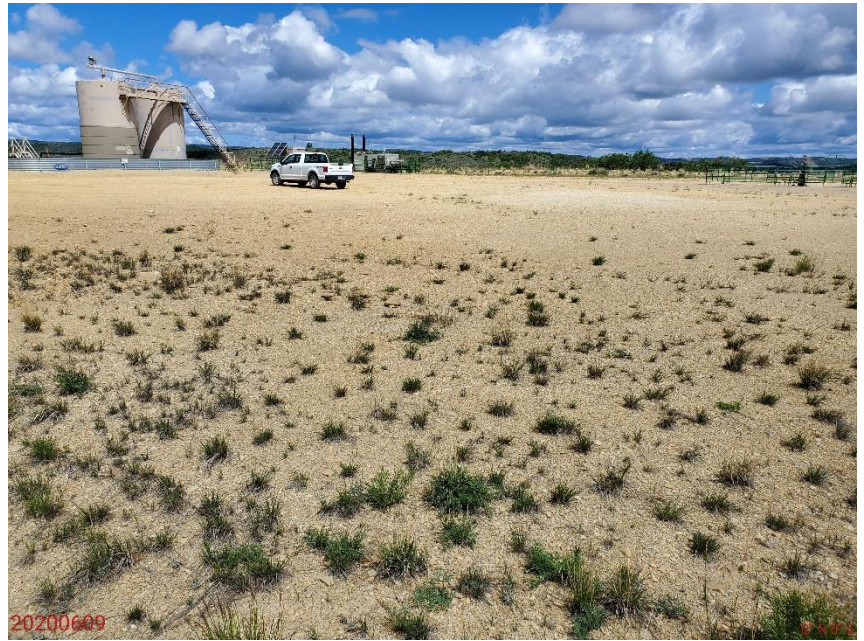
**Photo 2:** See comments under photo 1.

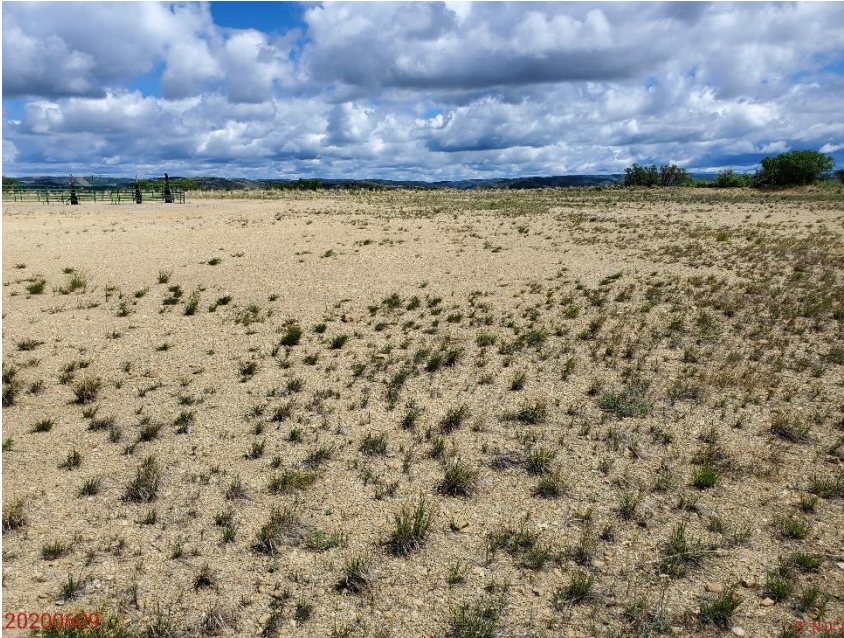
**Photo 3:** See comments under photo 1.

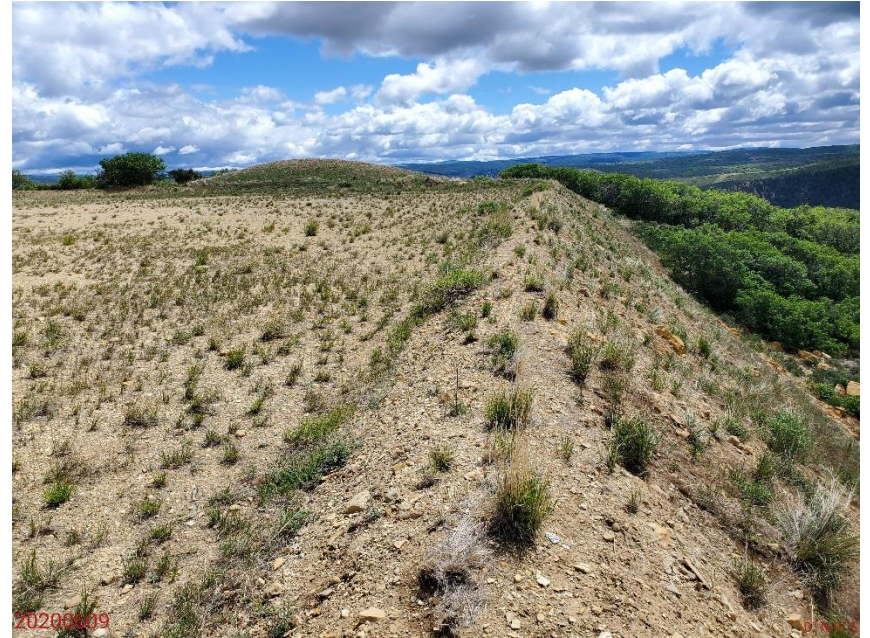
**Photo 4:** See comments under photo 1.

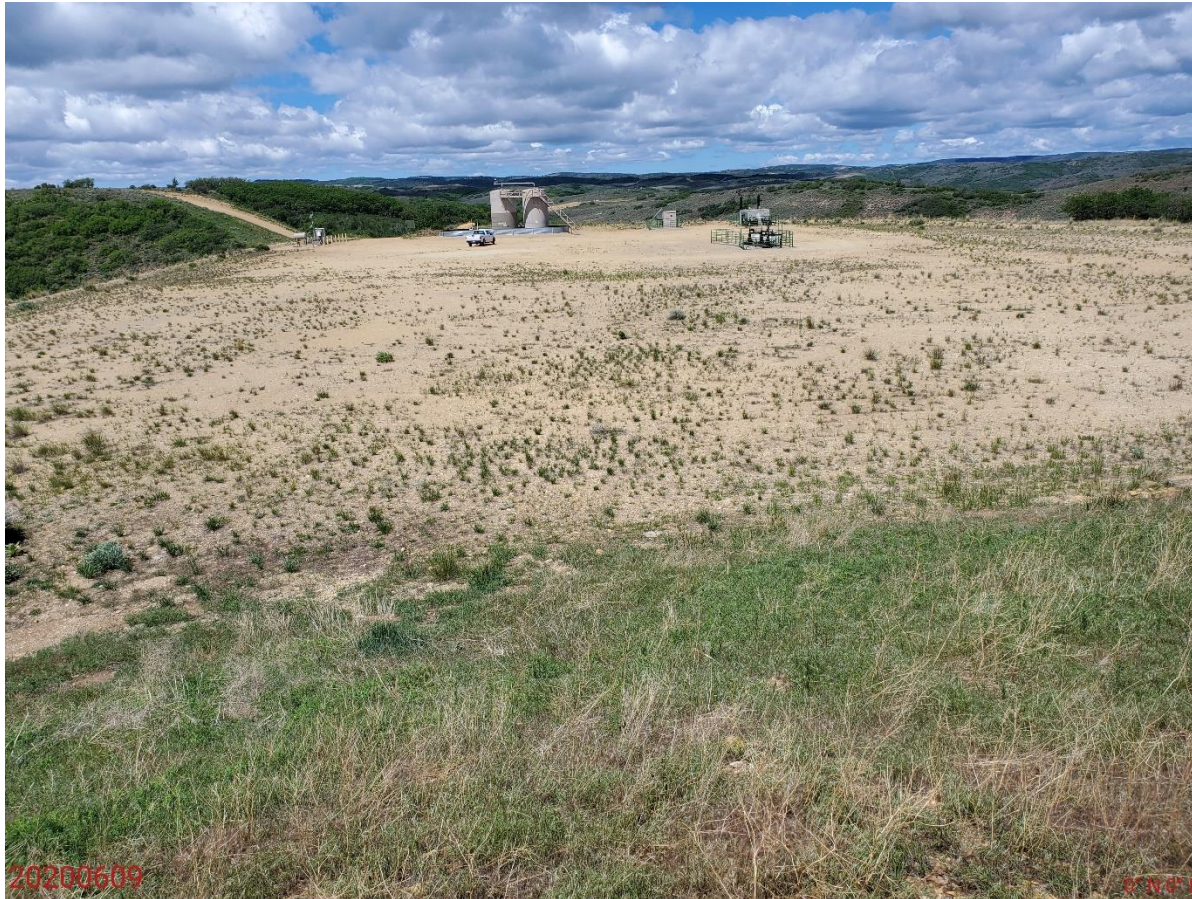
**Photo 5:** Photo taken from the soil stockpile on the east end of the Location, facing west. See comments under photo 1. Photo also shows vegetation on the soil stockpile remains predominantly undesirable weedy plant species such as *Bromus tectorum*. Weeds appear to have reached maturity and are viable; It does not appear that weed management has been performed.

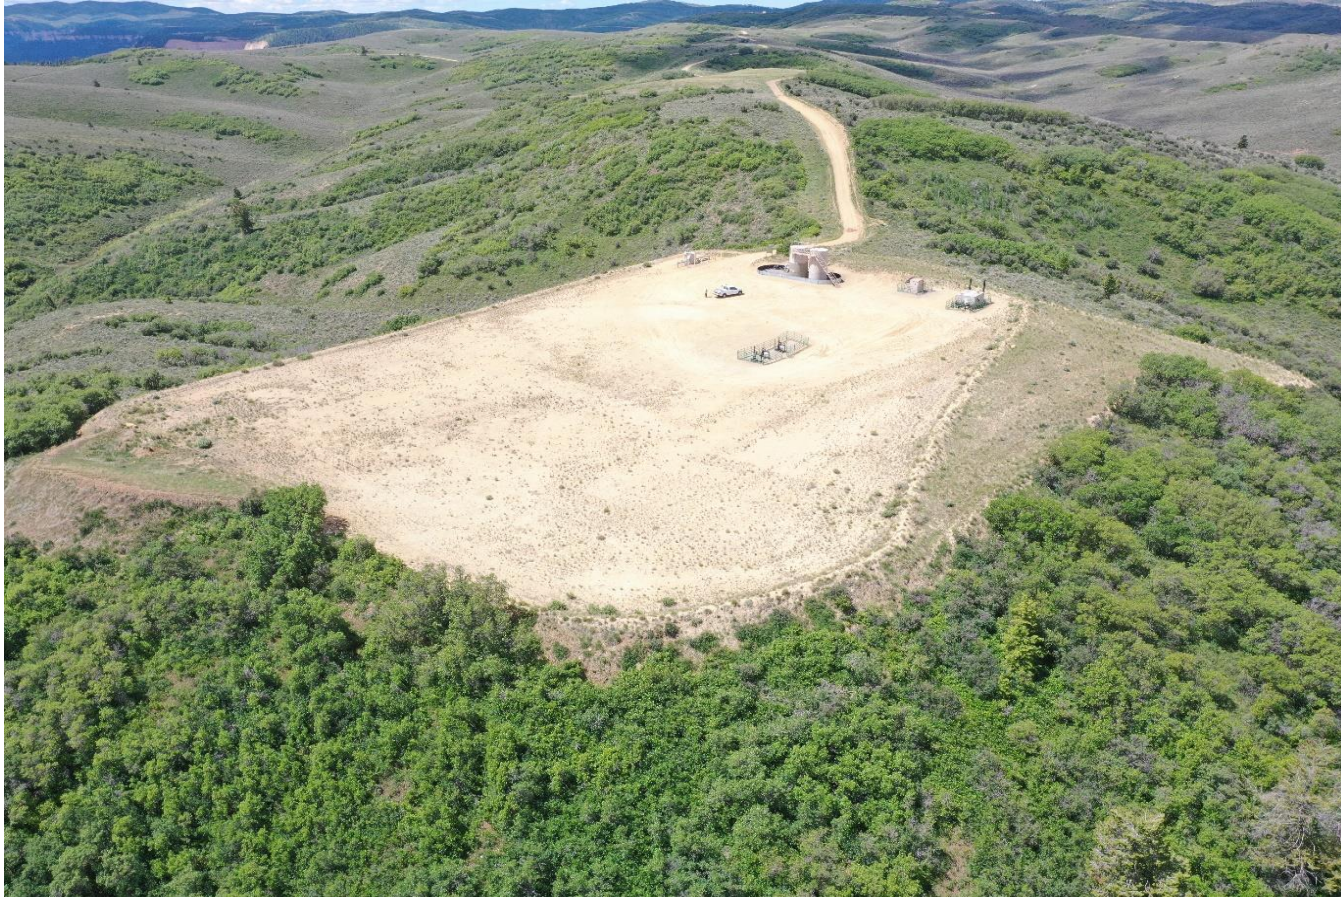
**Photo 6:** Photo taken from the northeast of the pad, facing southwest. Photo shows aerial image of the Location. Photo shows areas of the Location not necessary for production has not been reclaimed in accordance with Rule 1003.b

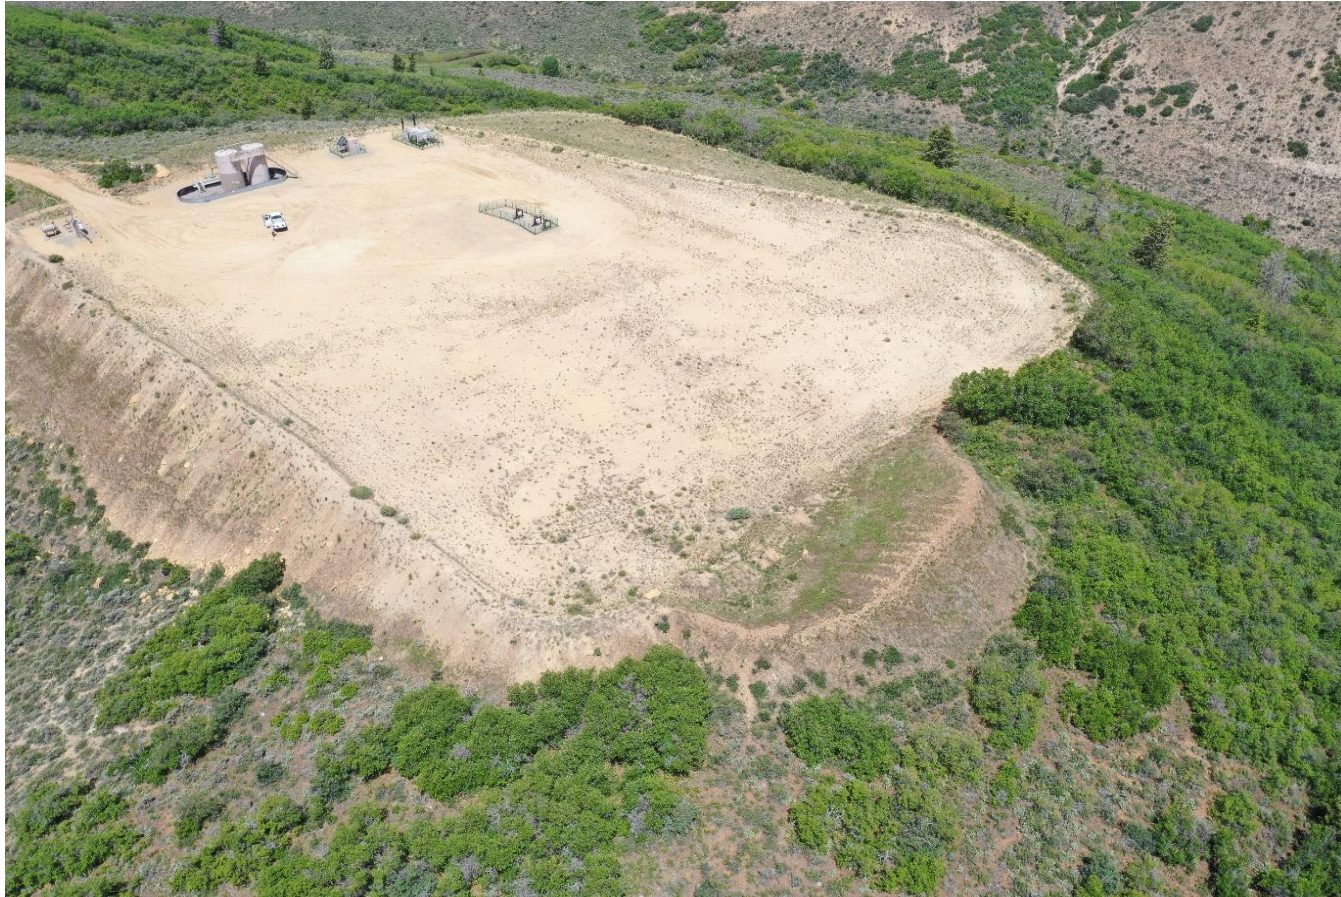
**Photo 7:** Photo taken from the southeast t of the pad, facing northwest. Photo shows aerial image of the Location. Photo shows areas of the Location not necessary for production has not been reclaimed in accordance with Rule 1003.b

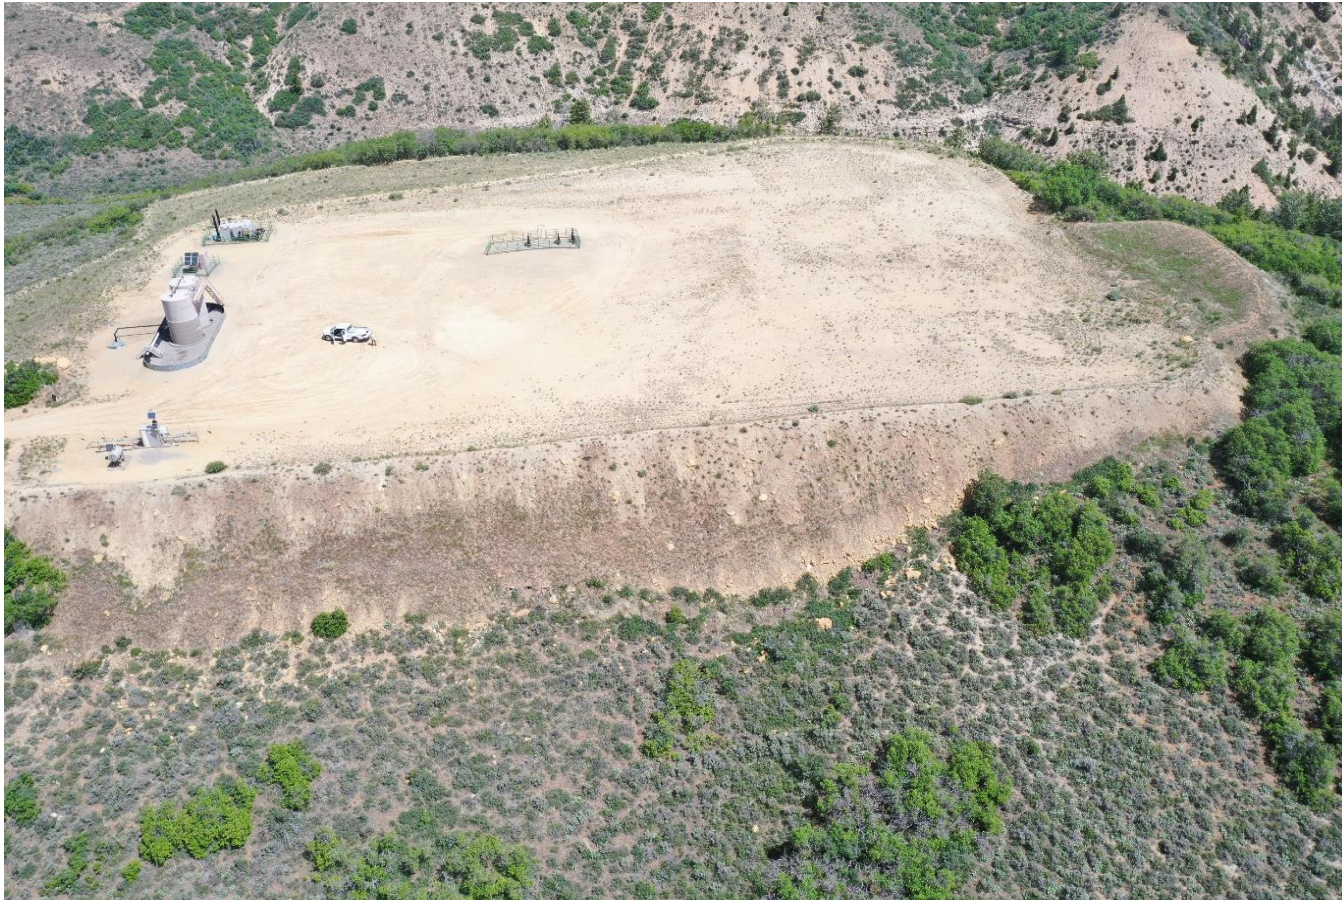
**Photo 8:** Photo taken from the south of the pad, facing north. Photo shows aerial image of the Location. Photo shows areas of the Location not necessary for production has not been reclaimed in accordance with Rule 1003.b

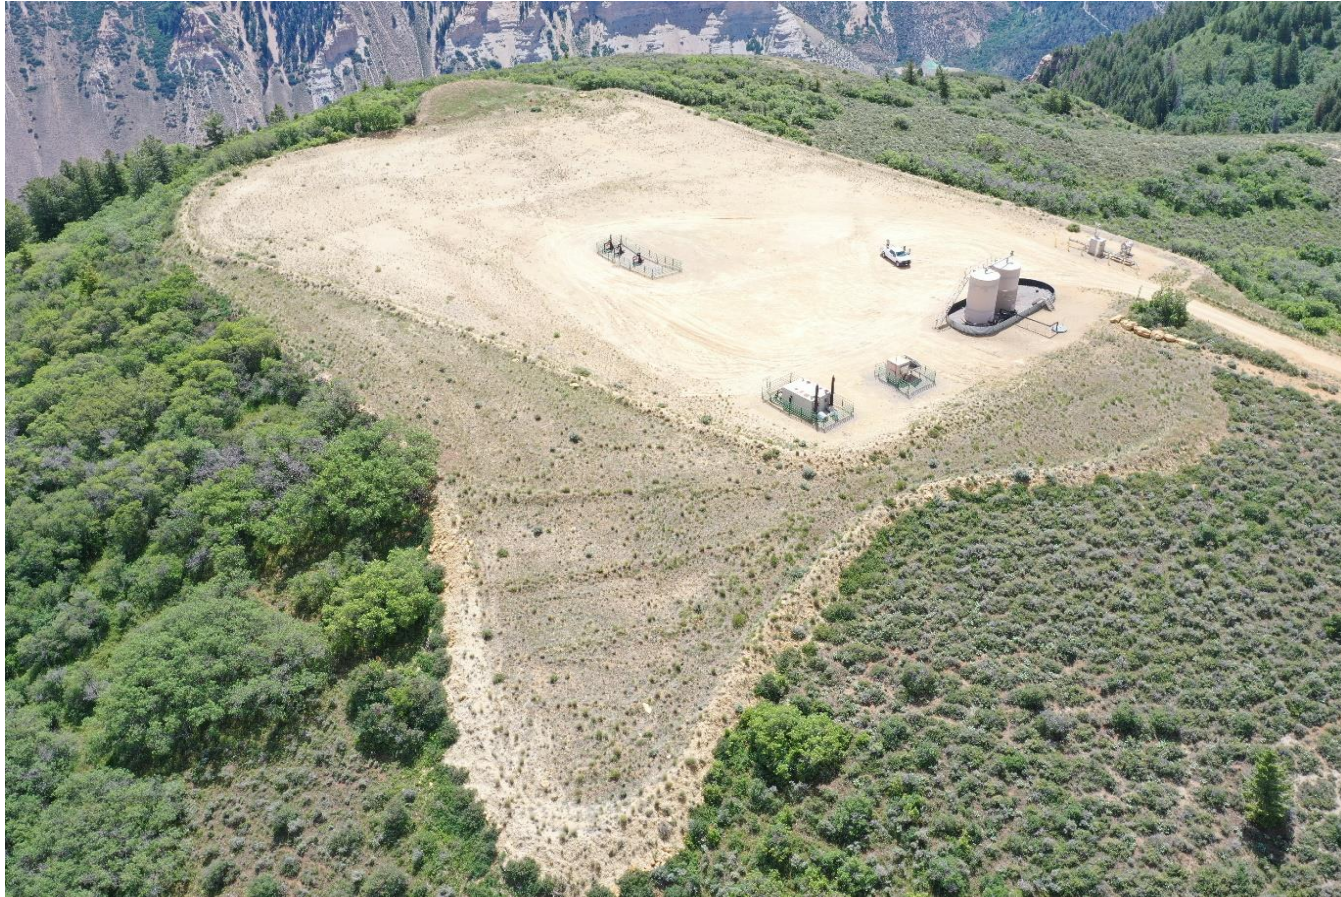
**Photo 9:** Photo taken from the northwest of the pad, facing southeast. Photo shows aerial image of the Location. Photo shows areas of the Location not necessary for production has not been reclaimed in accordance with Rule 1003.b

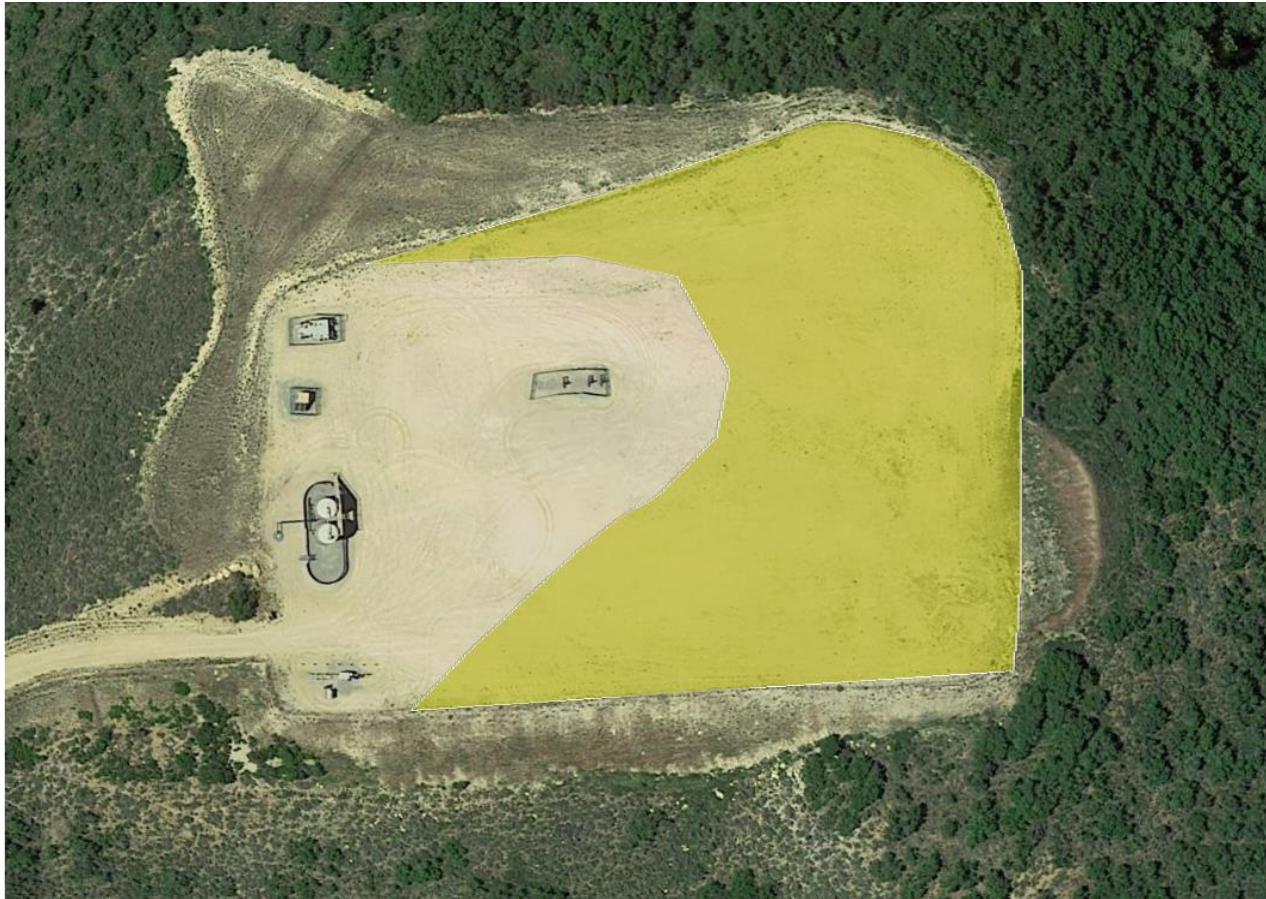
**Photo 10:** Photo copied from Doc. #696201149 (Photo #21). Photo shows areas (yellow) that do not appear to be necessary for production activities, and require reclamation in accordance with Rule 1003.b.
