Inspection Photos
Operator: BP America
API: 067-06641
Date: 6/29/2020

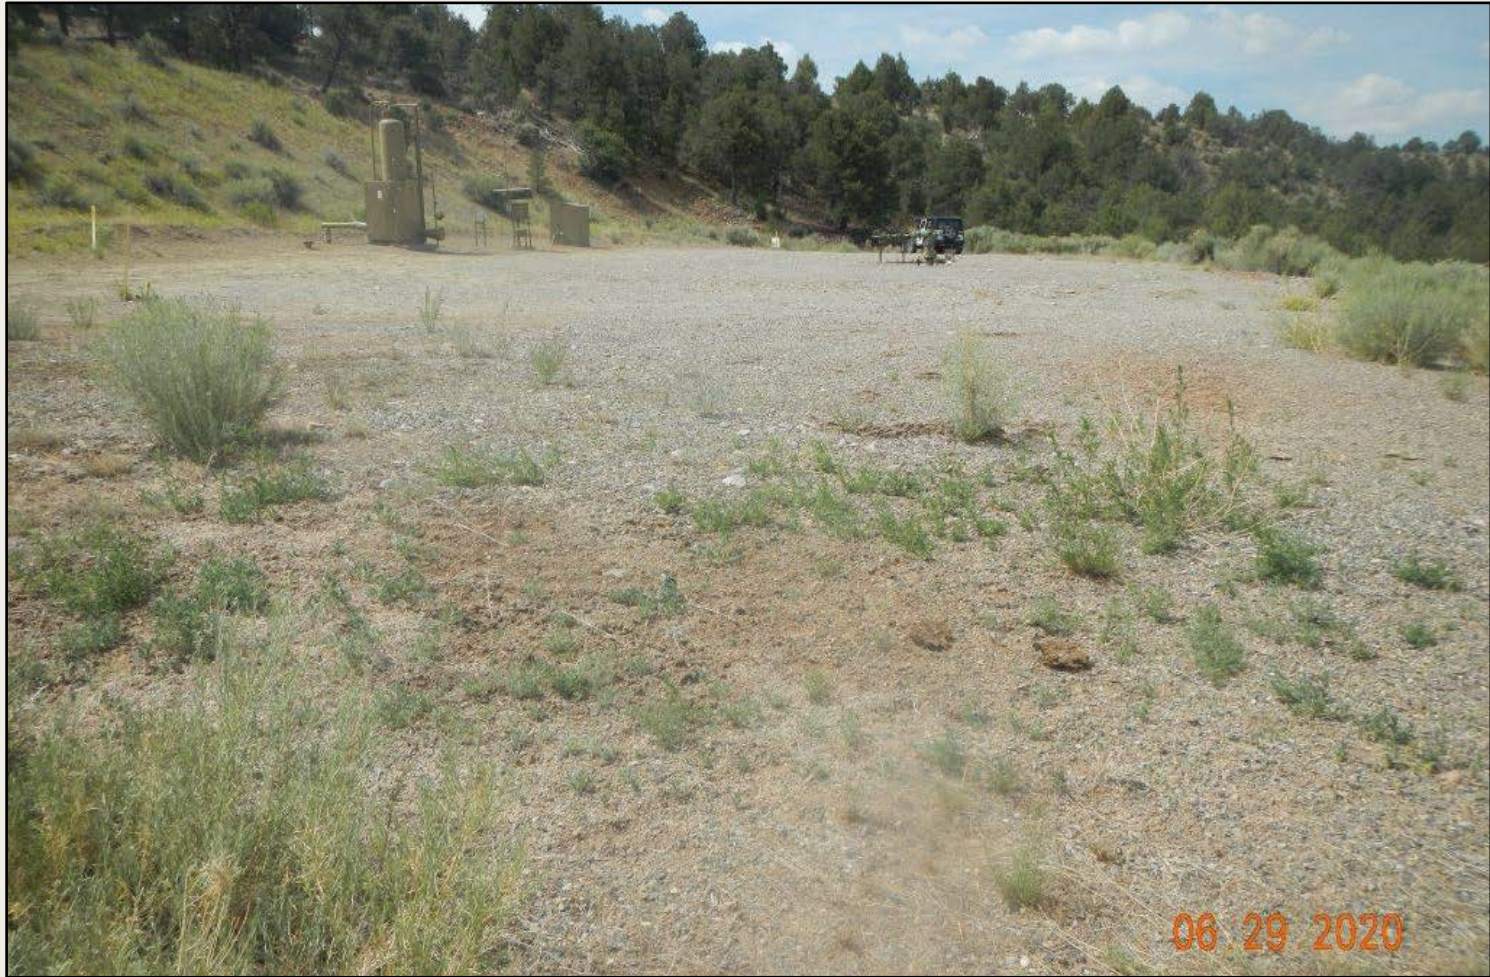
Photo 1. View of the project area from the southeastern corner facing center.

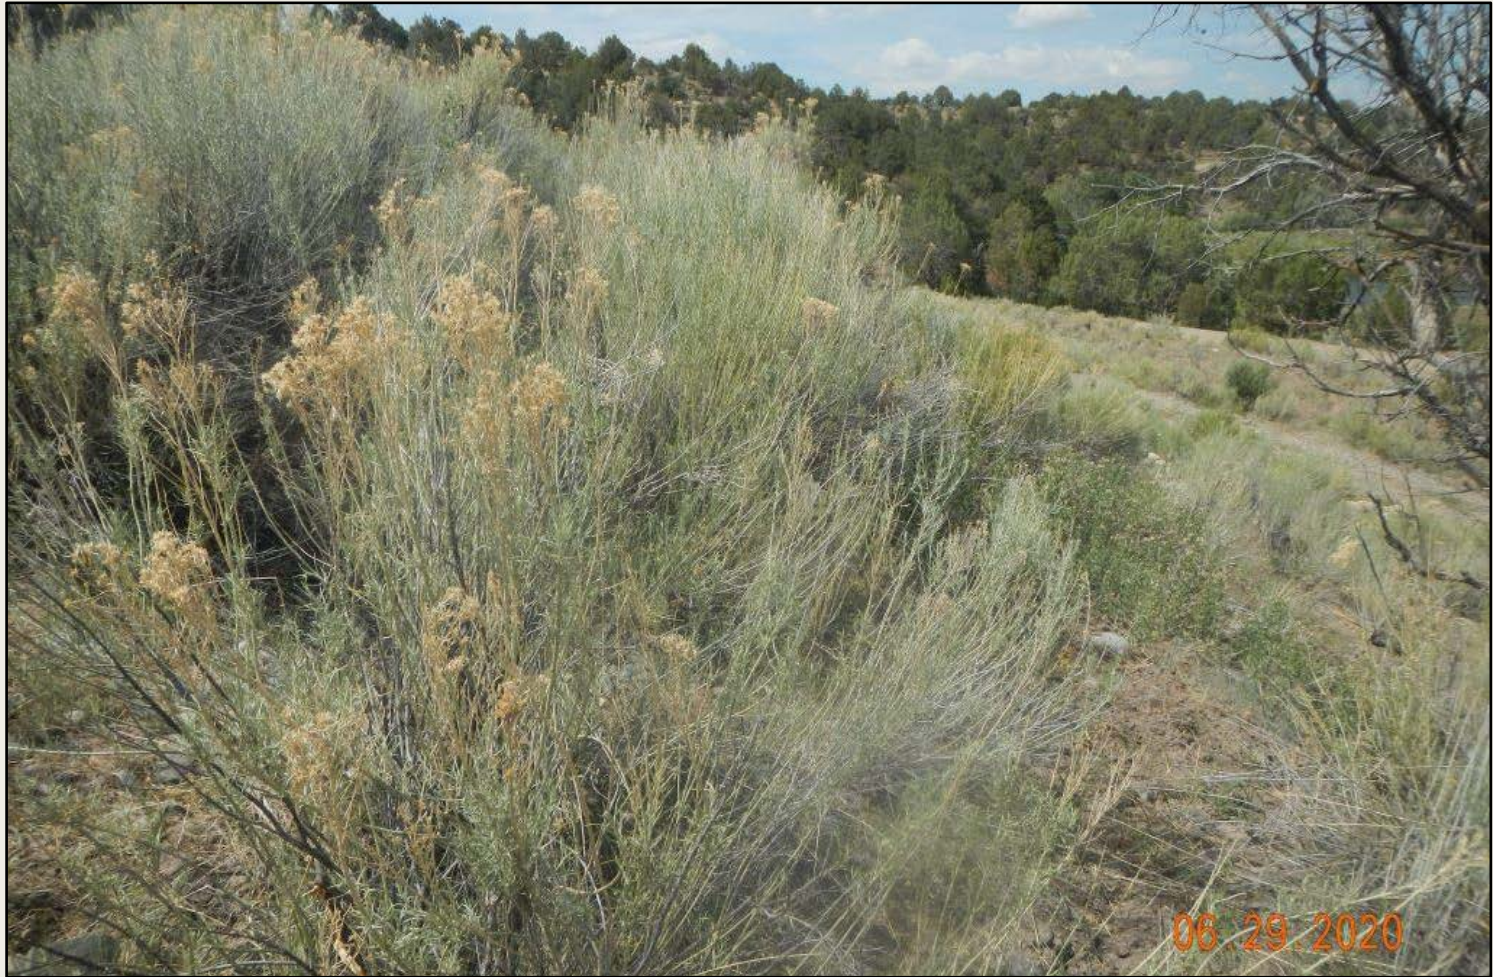
Photo 2. View of the northern fill slope from the northeastern corner facing westward.

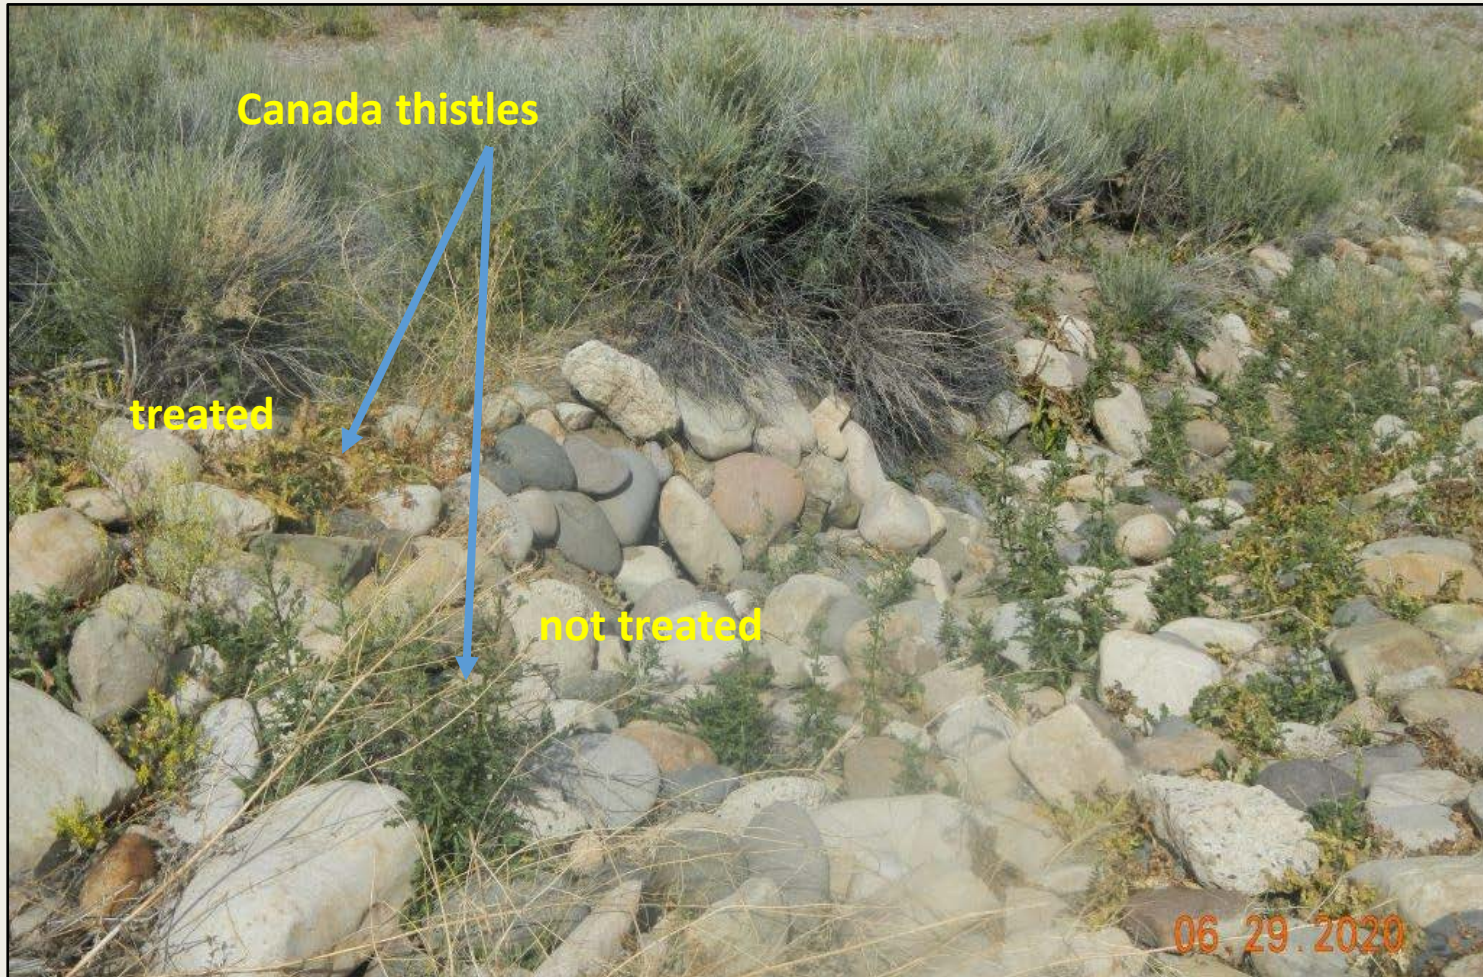
Photo 3. View of partially treated Canada thistles within the northern project area. Thistles on the edge of the rocks are herbicide treated (yellow), while those in the center (green) are not treated. Approximately 150 observed.

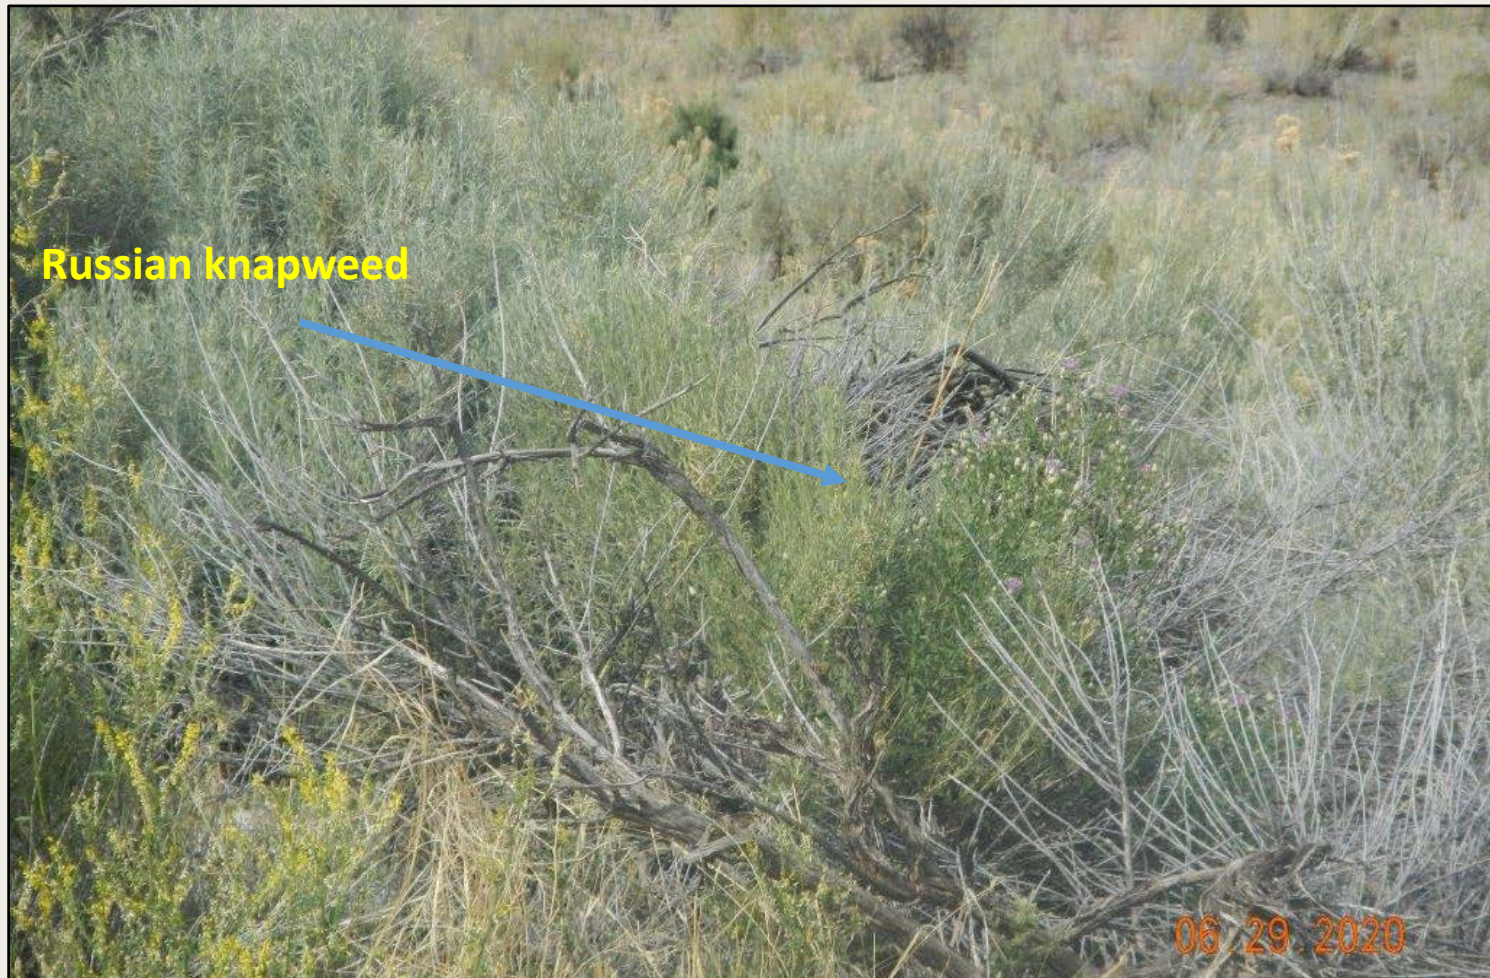
Photo 4. View of Russian knapweeds blooming within the northern project area. Approximately 200 individuals observed throughout the project area.
