Location Name: – Ward and Son Operating - Loc ID 317229
Inspection Date: 06/29/2020

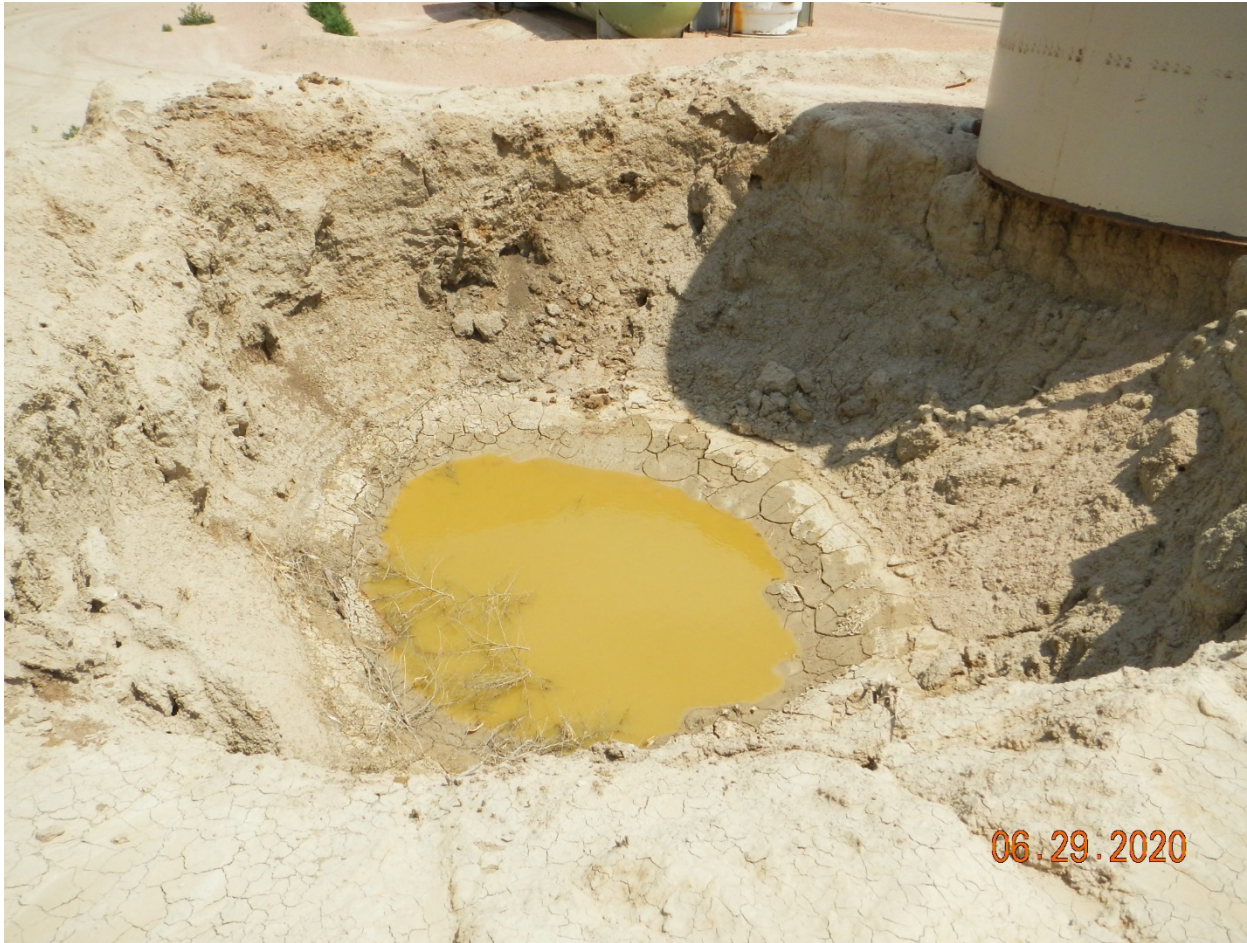
Photo # 2 – Open former oil skim pit excavation, no Form 27 has been provided for this project, produced water tank being undermined

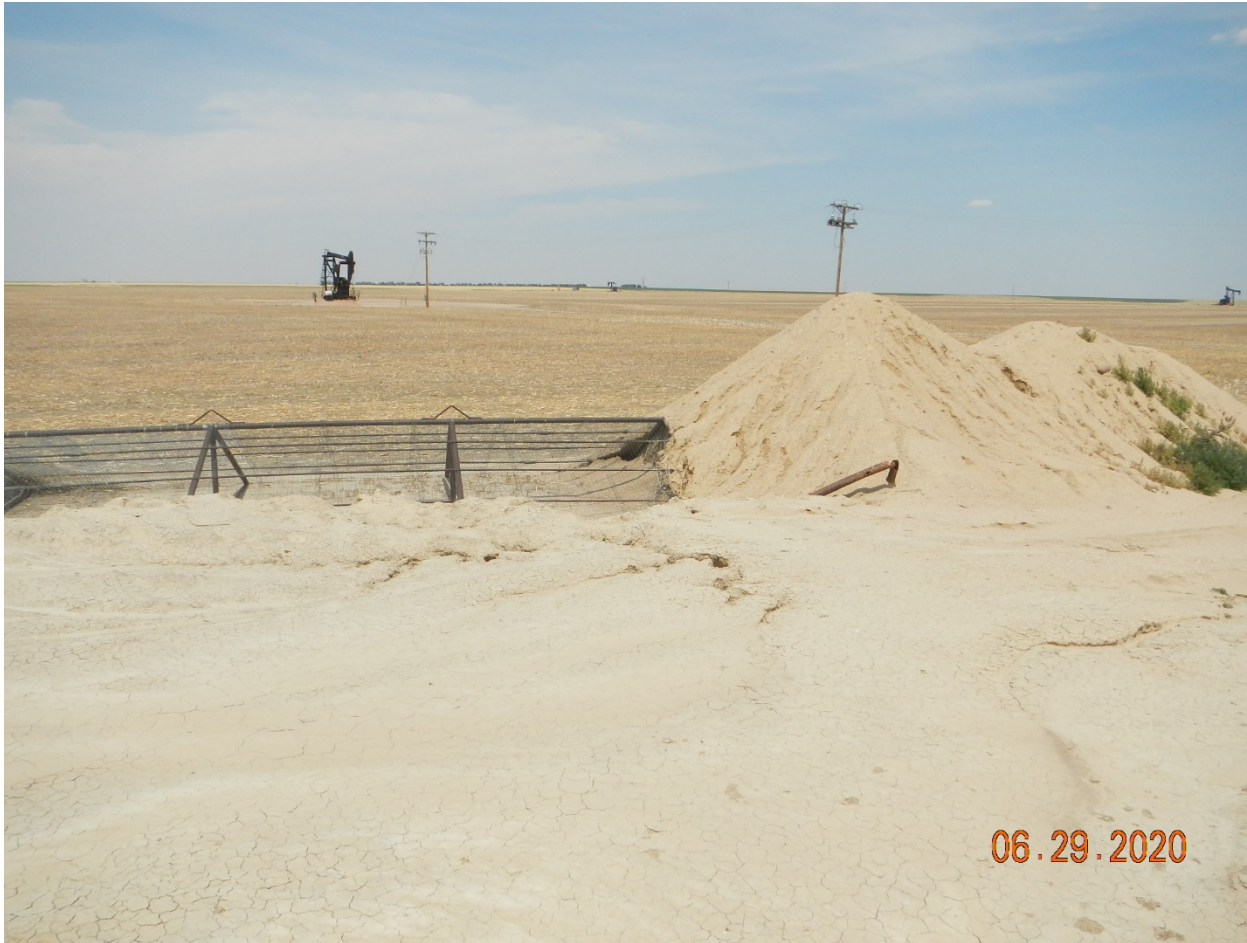
Photo # 3 – Former oil skim pit cover and impacted soil stockpile remain on site.
