# Inspection Photos

API: 071-06799

Operator: EVERGREEN NATURAL RESOURCES

Inspection Date: 6/30/2020

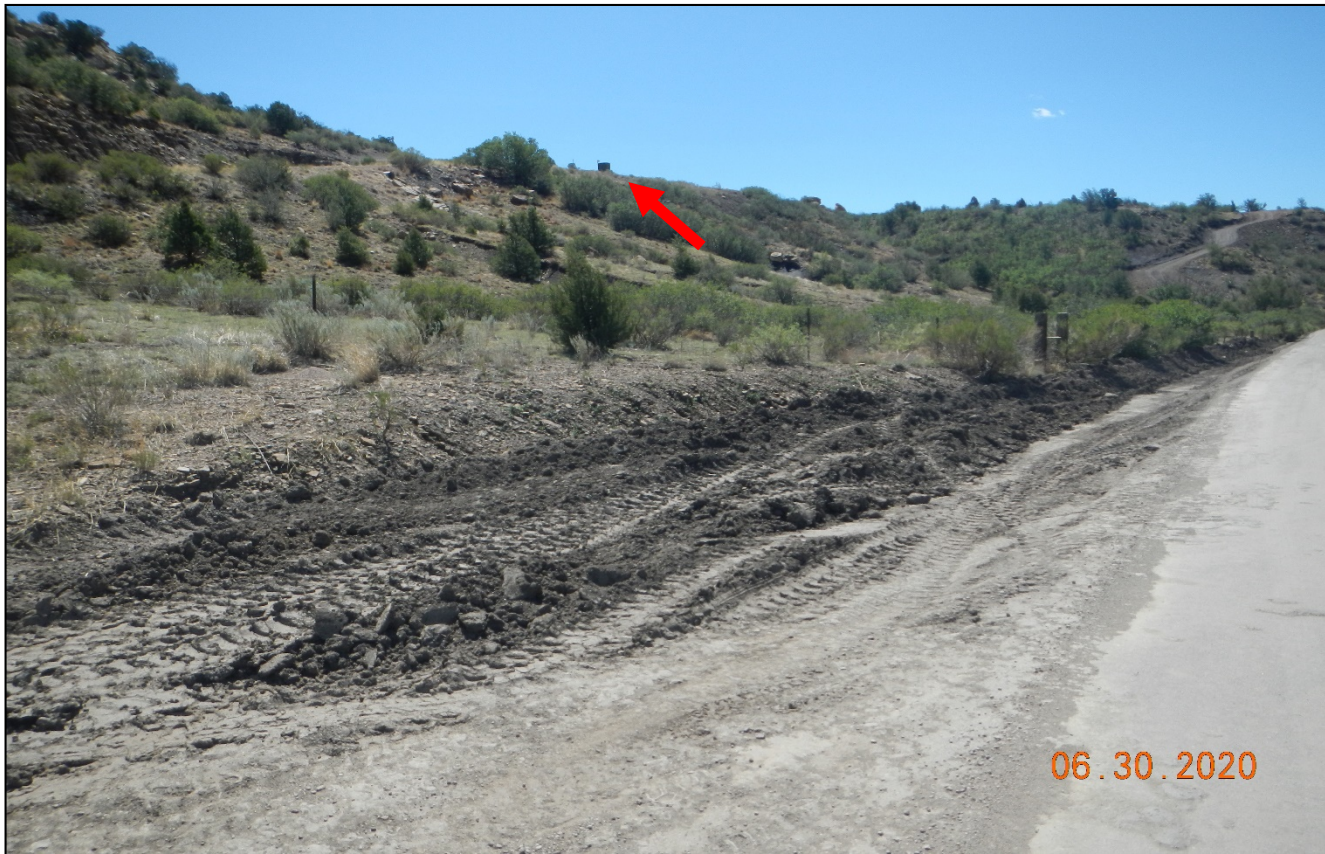
**Photo 1.** Facing southeast along CR 41.7. It appears sediment has deposited along the county road from recent precipitation event. Location is shown by red arrow.

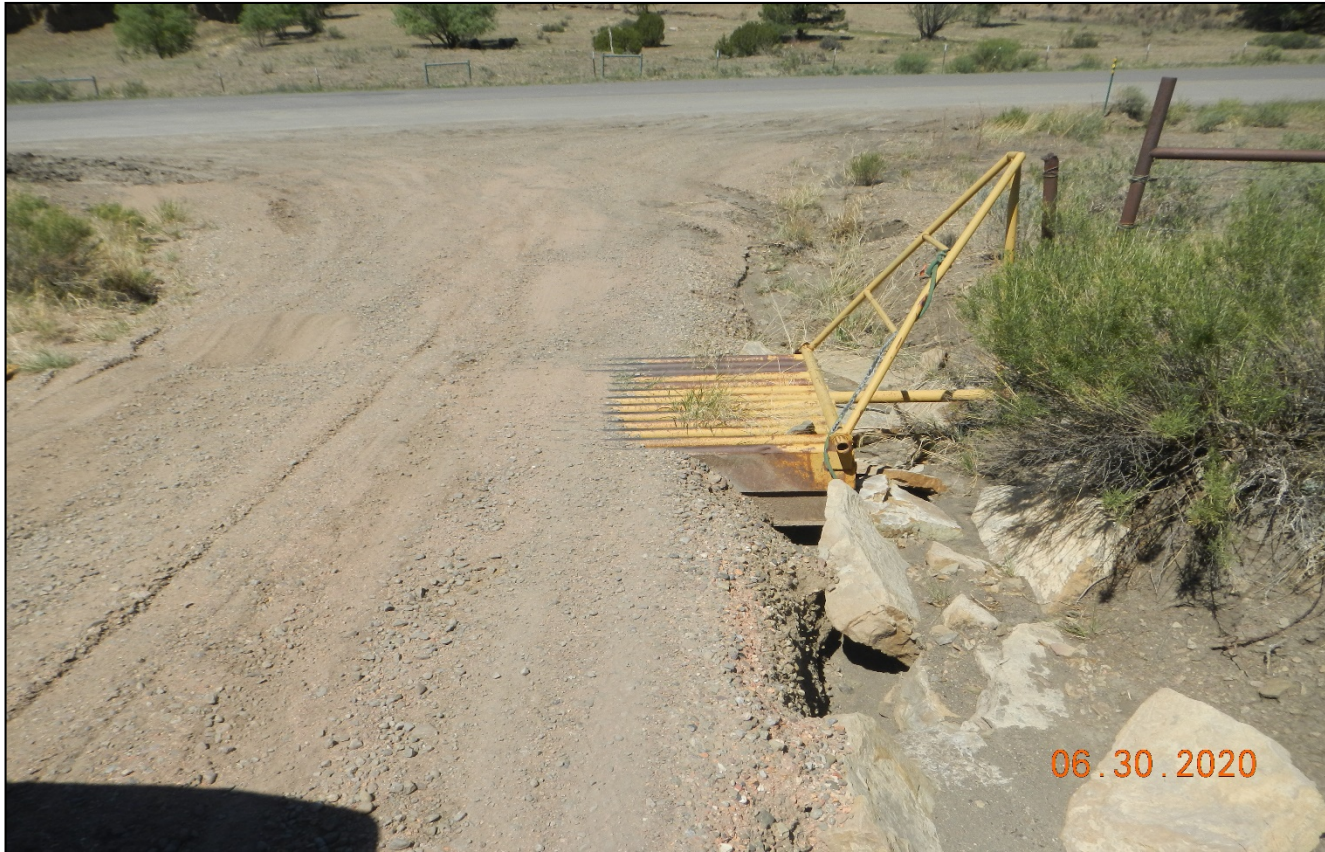
**Photo 2.** There is erosion occurring along the side of the cattleguard and the cattleguard is filled in with sediment.

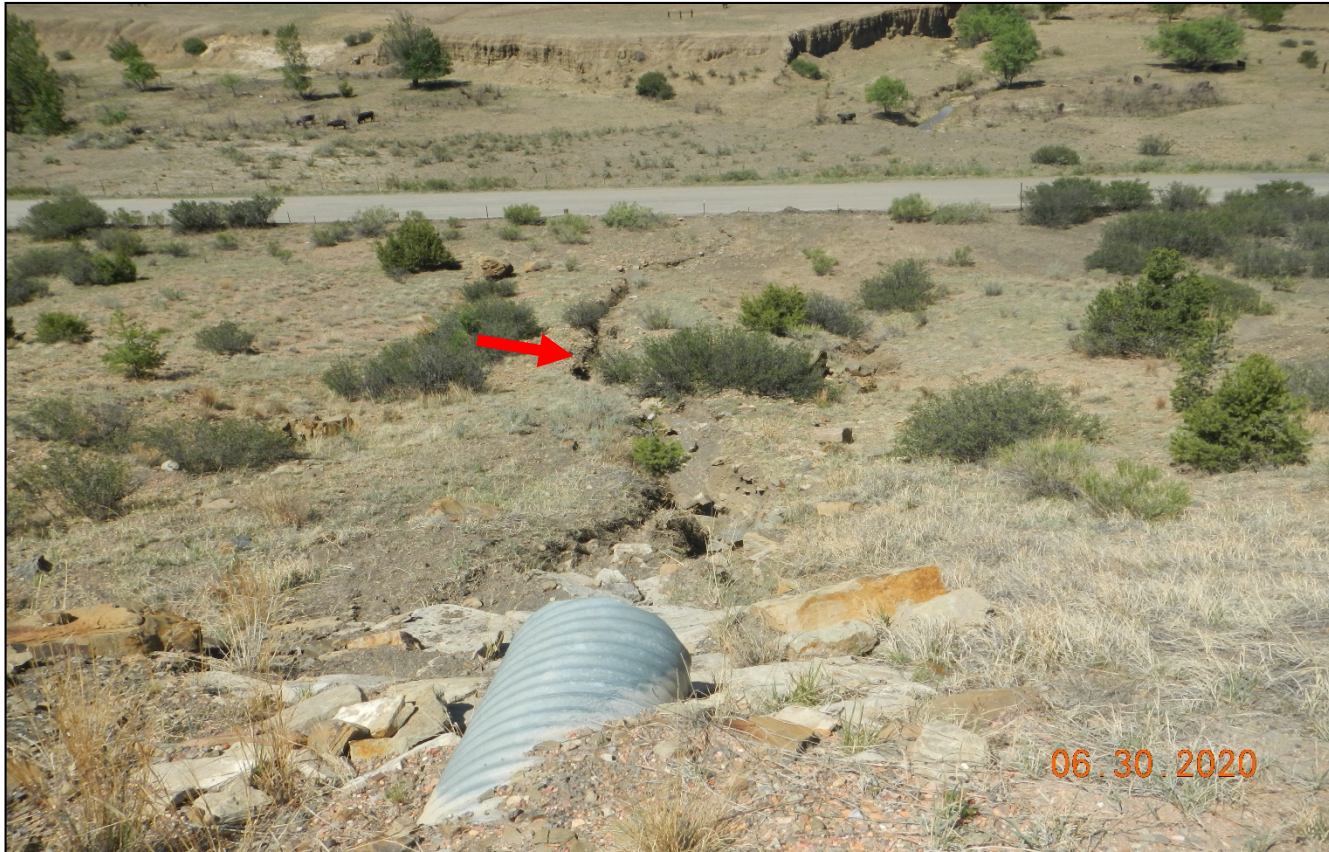
**Photo 3.** Facing southwest toward the culvert outlet. Stormwater is causing erosion which is directed toward the county road.

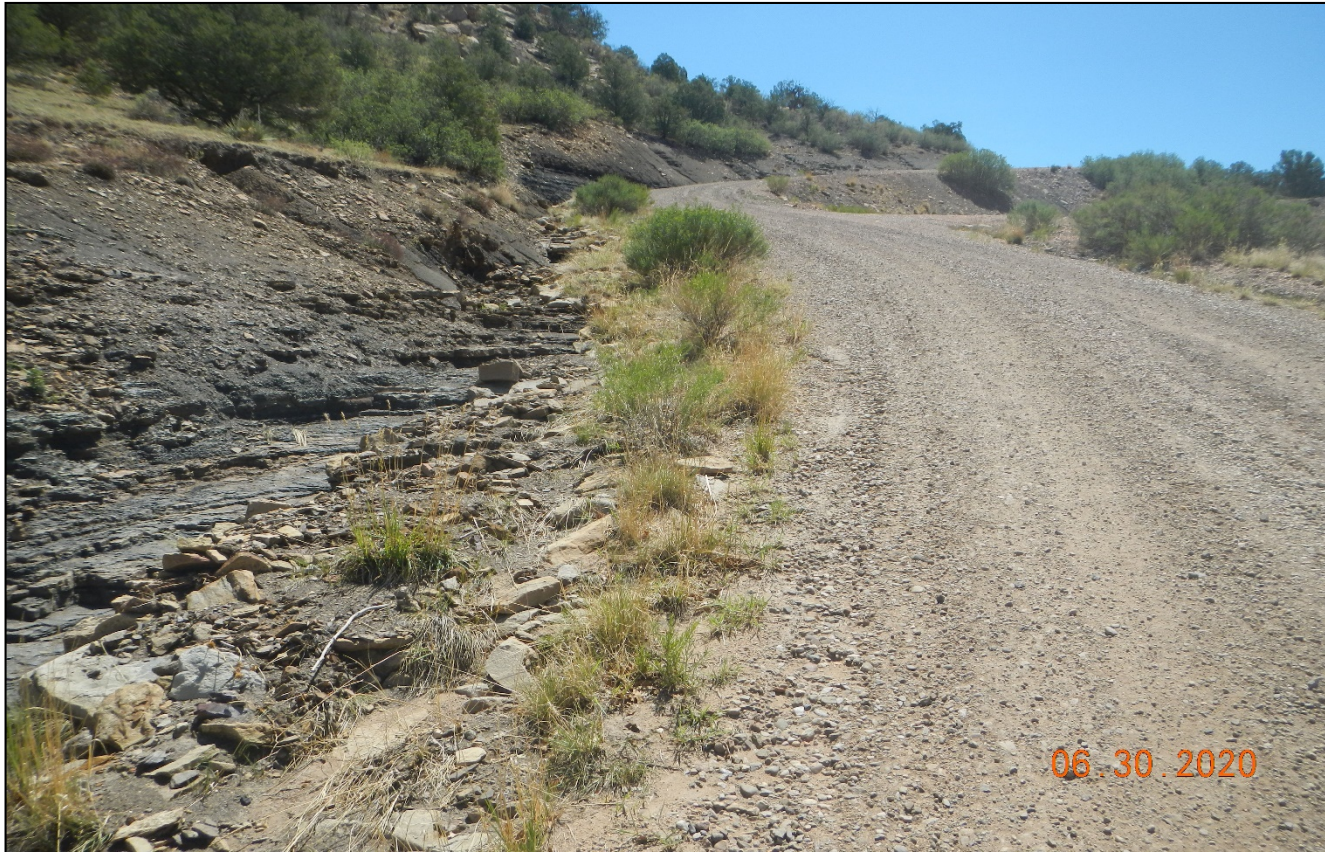
**Photo 4.** Facing east along the access road. There is a long stretch of road which does not have culverts or BMP's which is contributing to the volume of stormwater directed to the culvert shown in previous photo.

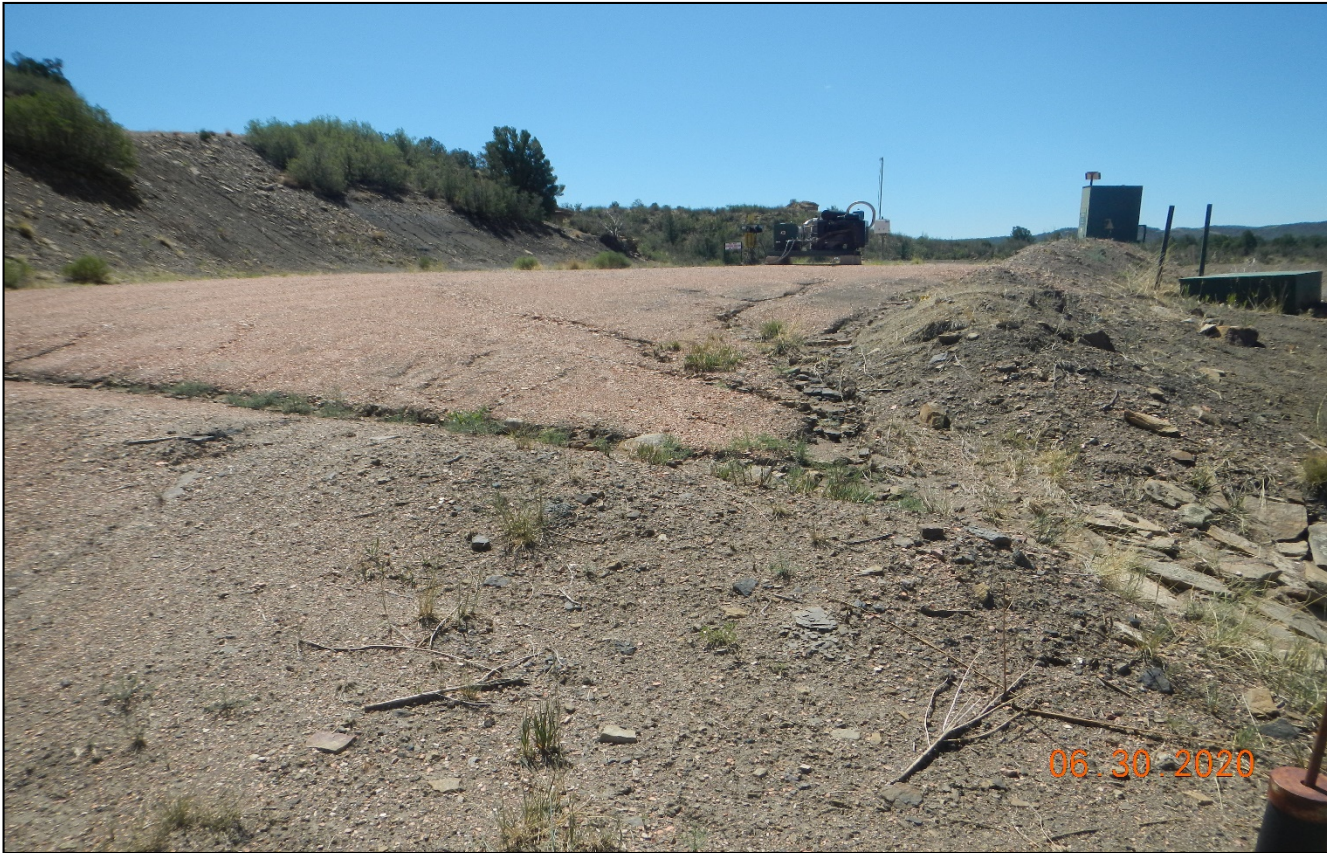
**Photo 5.** Facing toward the location. There is signs of stormwater erosion off the pad which is directed to a sediment trap shown in the next photo.

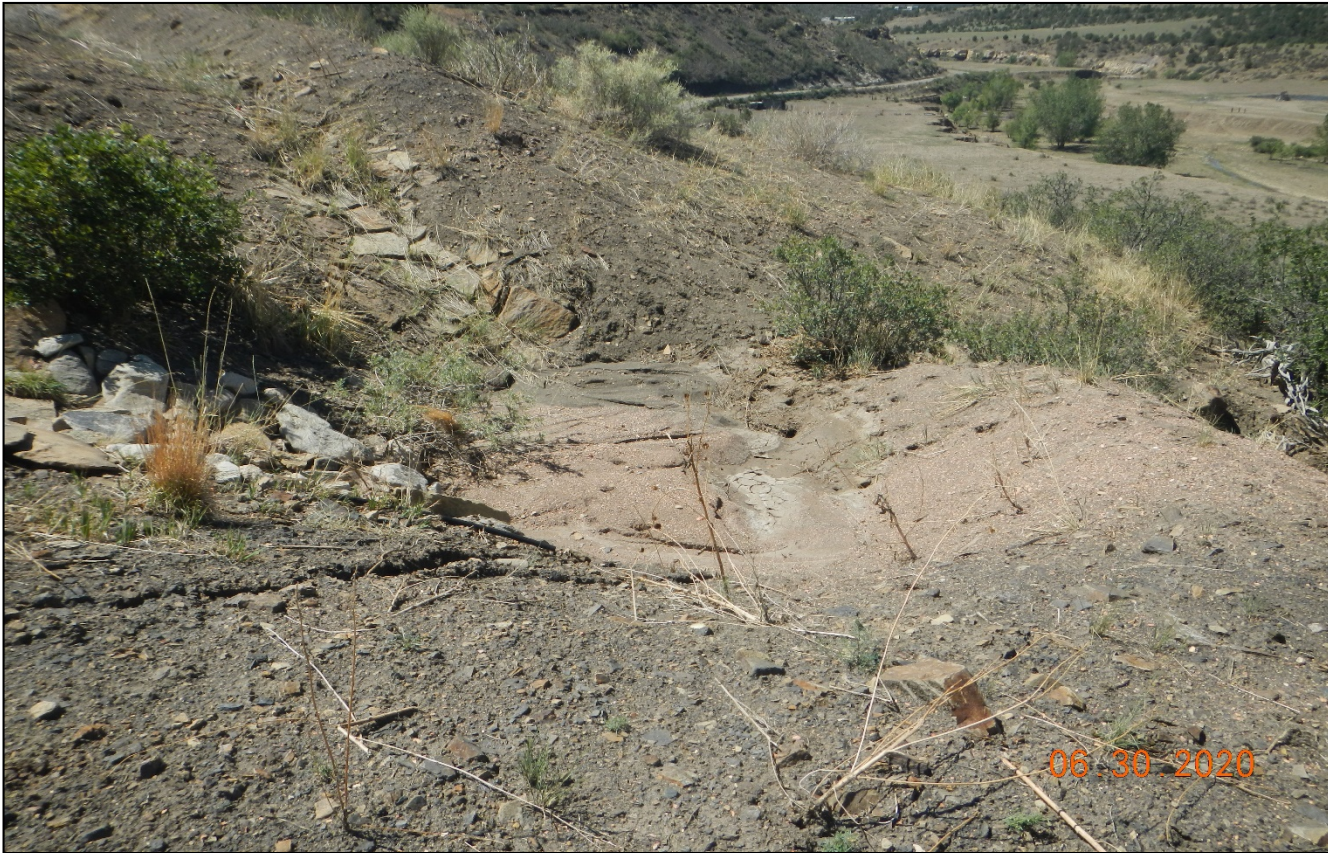
**Photo 6.** The sediment trap is full of sediment.

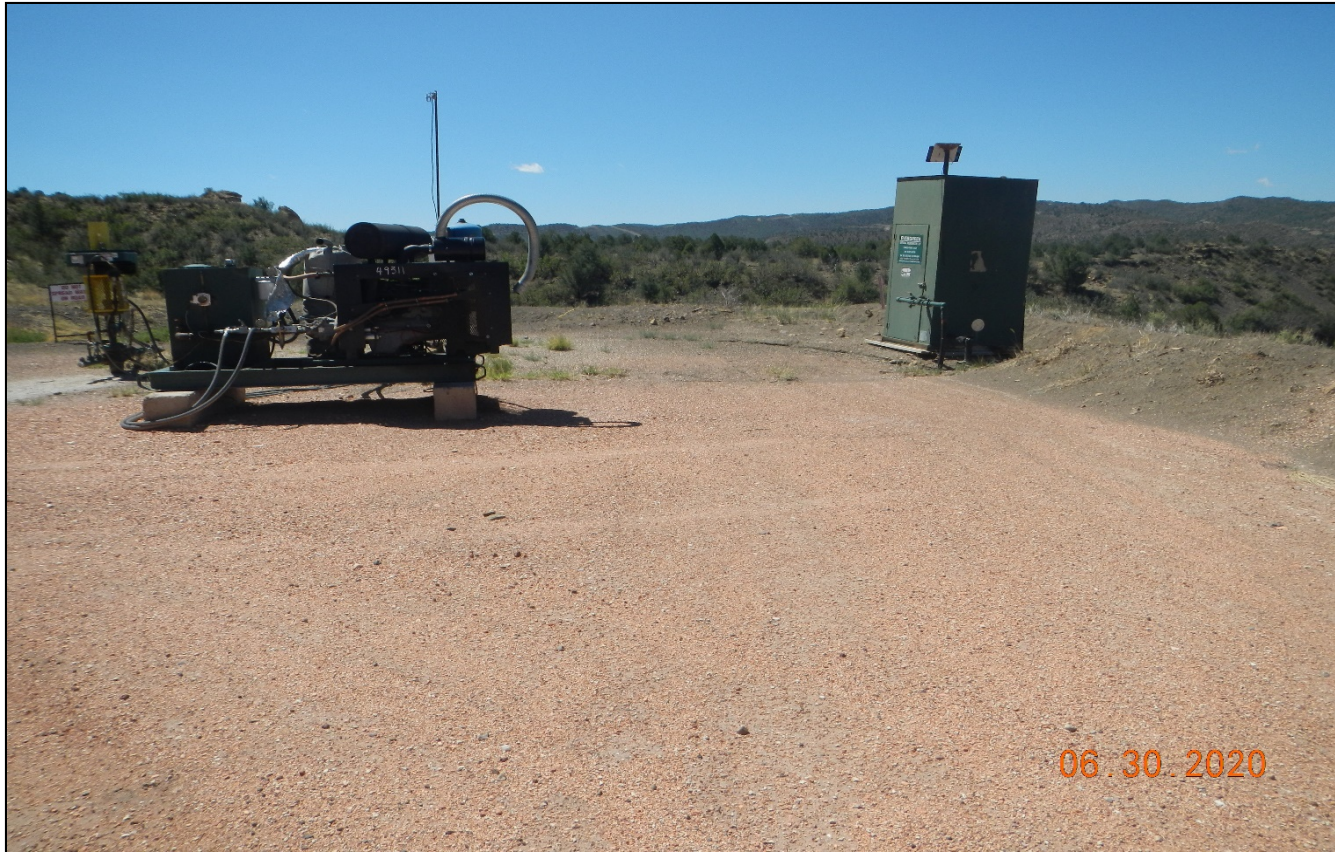
**Photo 7.** Facing southeast toward the location. Well sign is posted at the meter shed.
