Inspection Photos

Operator: BP America
API: 067-09513
Date: 7/6/2020

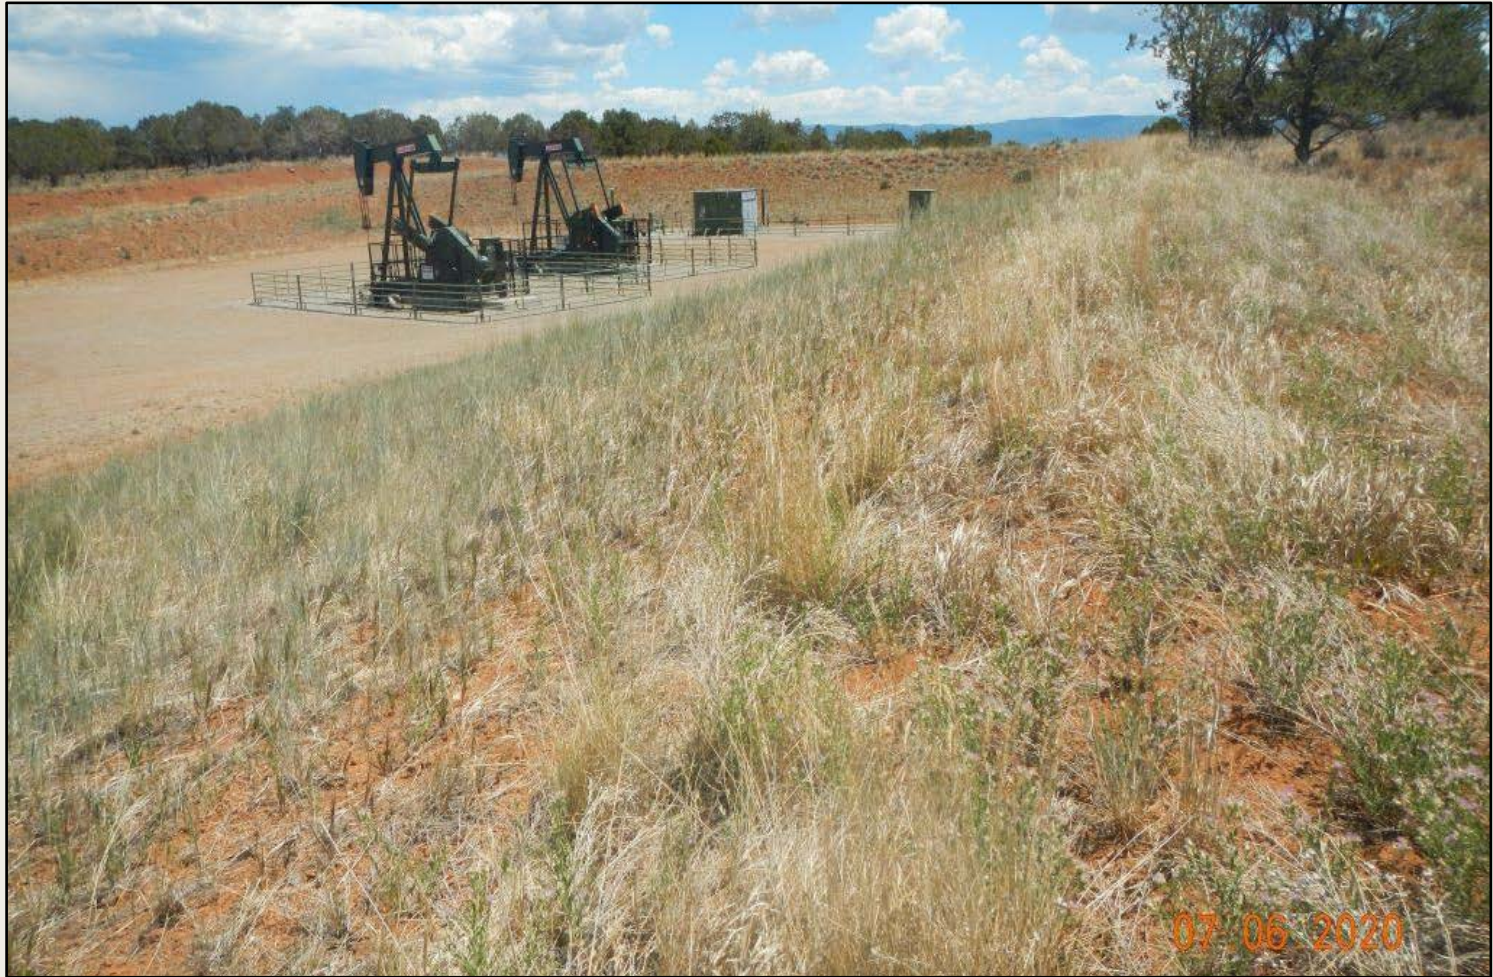
Photo 1. View of the project area from the southwestern edge facing northward.

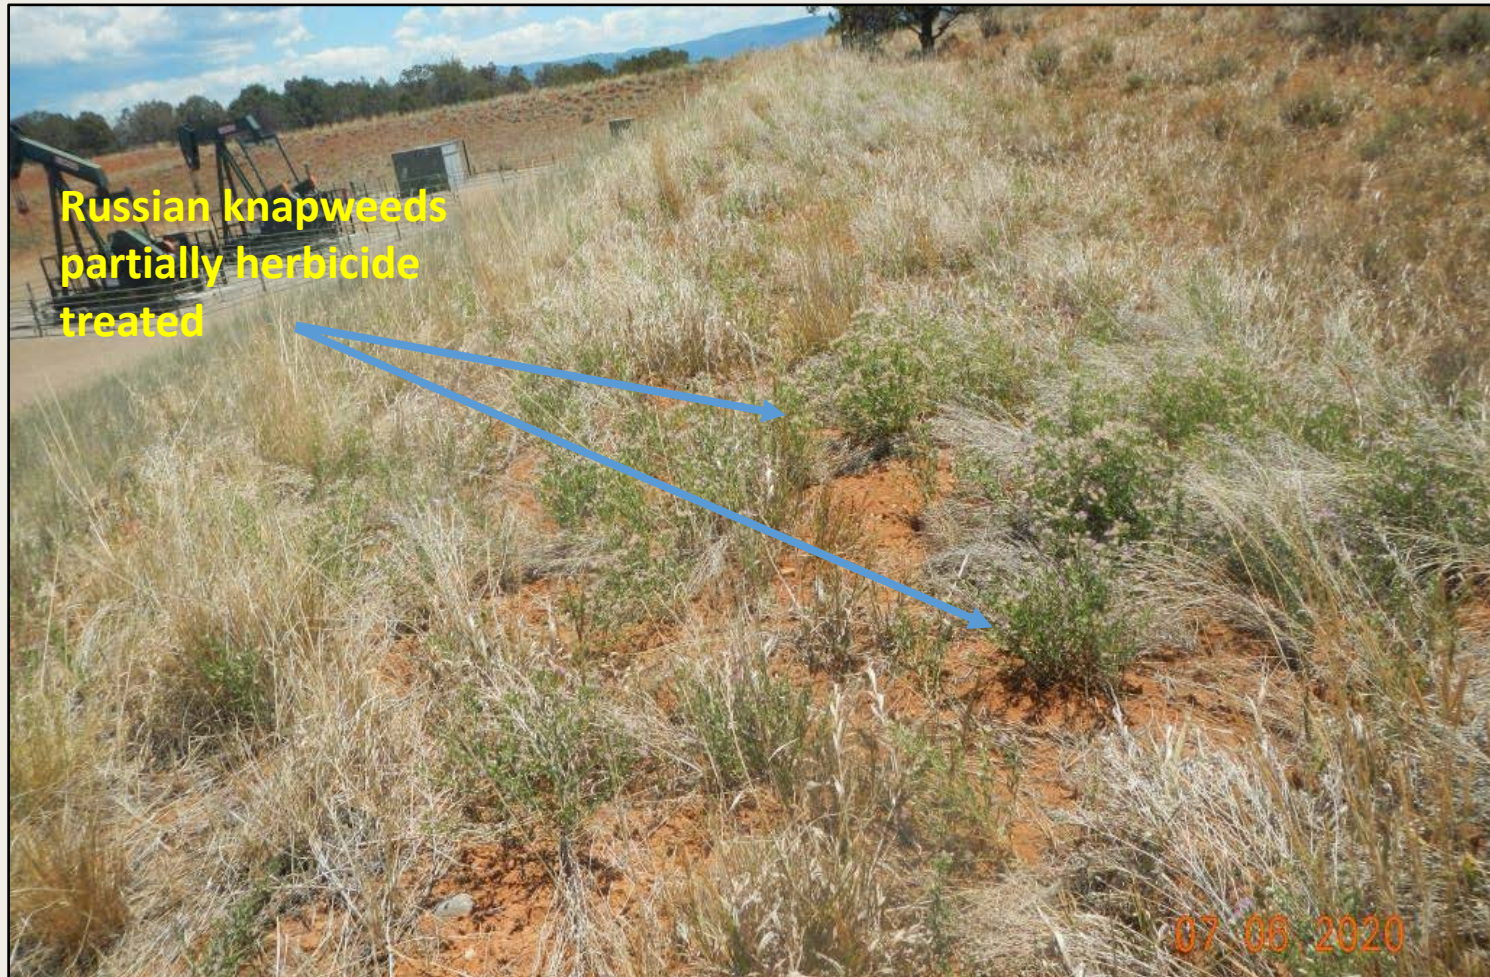
Photo 2. View of the southern project area from the southwestern corner facing eastward. Revegetation is progressing with grasses such as smooth brome, western wheatgrass, and crested wheatgrass. Russian knapweed infestation along the southern edge of the project area is partially treated. Approx. 500 individuals observed.

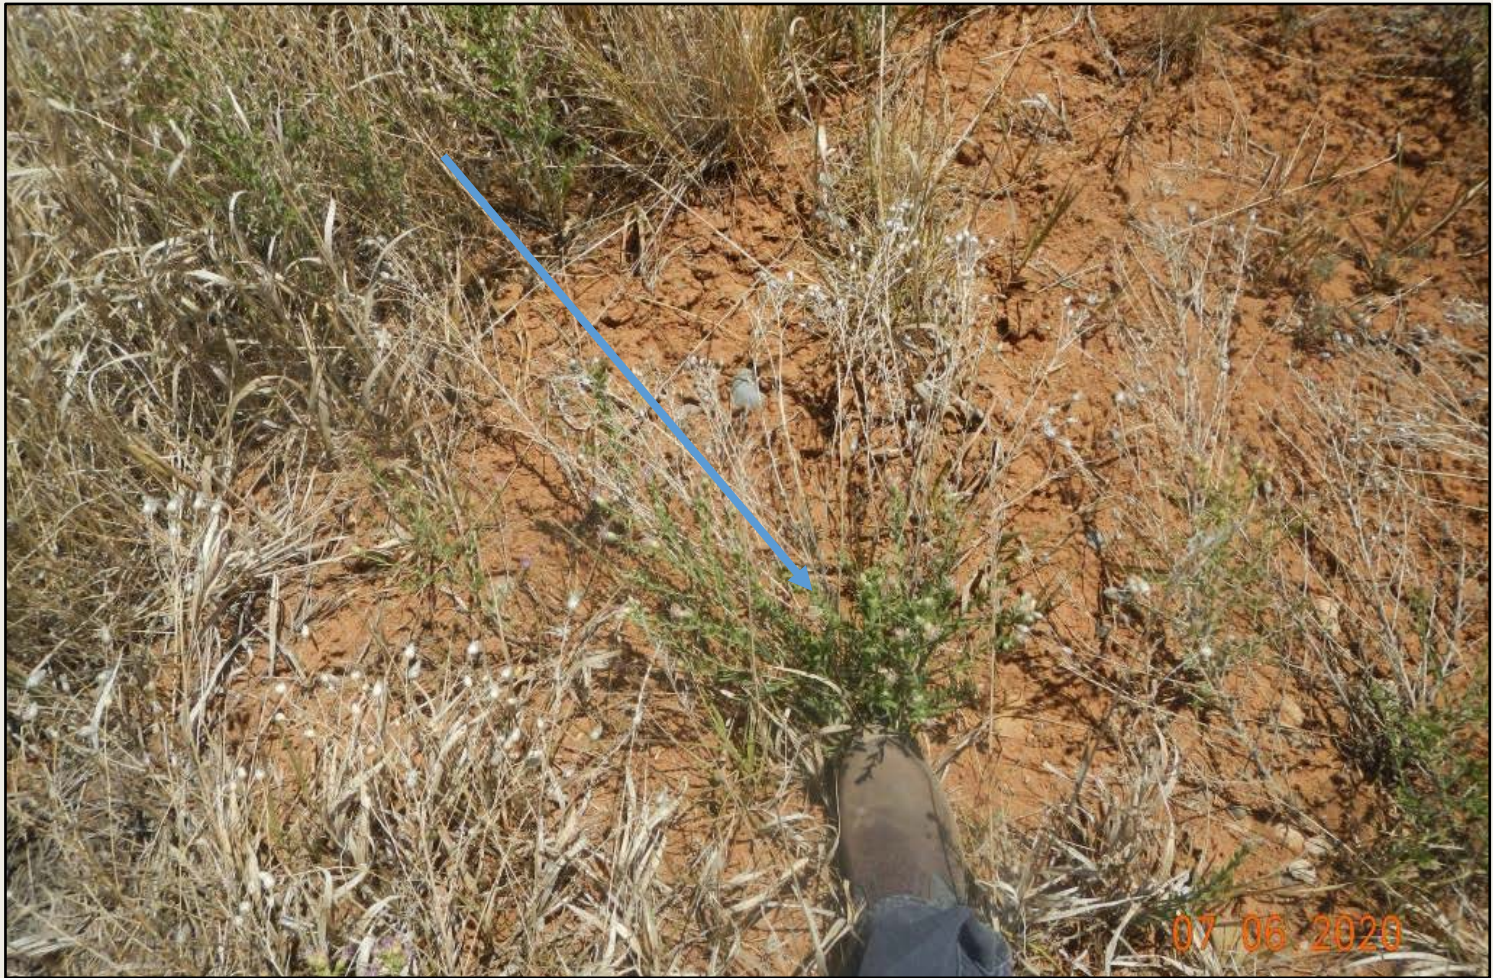
Photo 3. View of Russian knapweed that does not appear to be treated with herbicide.
