# Interim Reclamation and Stormwater Inspection

July 13, 2020

Operator: EXTRACTION OIL & GAS LLC- #10459

Location ID: 430703

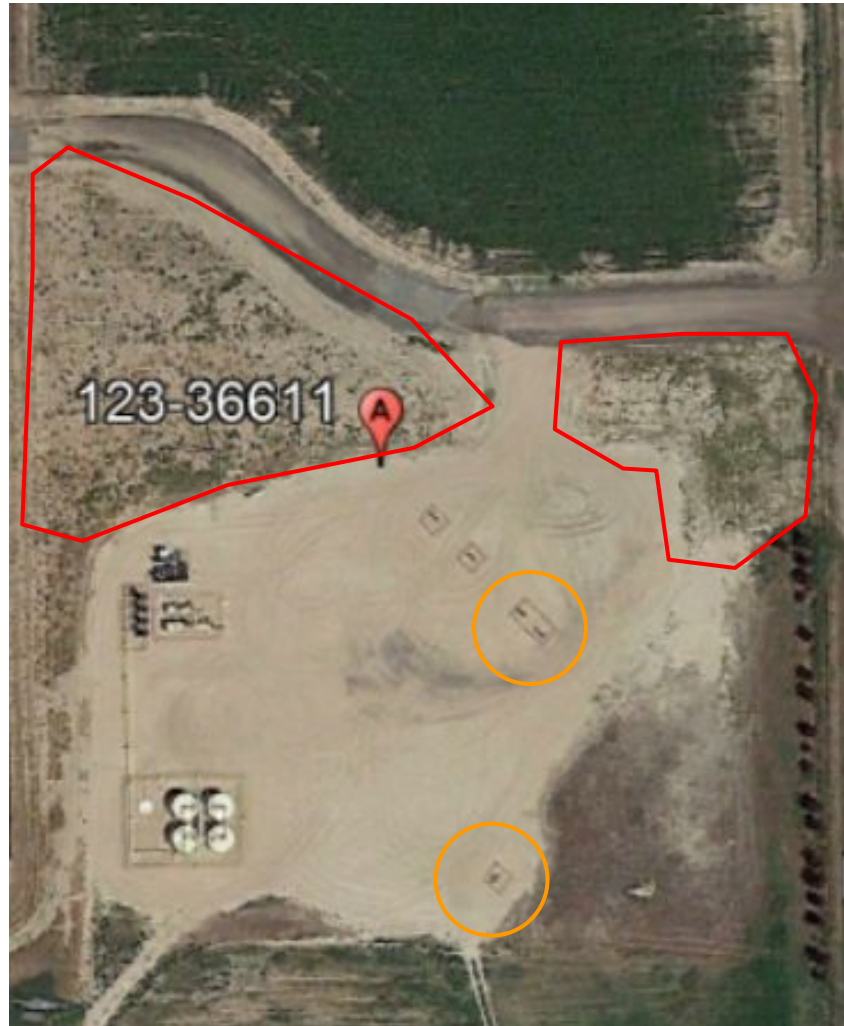
**Photo 1.** Google Earth aerial imagery taken 7/17/2019. The red polygon areas currently have weeds. The orange circles wells have been plugged; therefore, the Operator will likely have to perform interim reclamation to reduce all areas not needed for production operations.

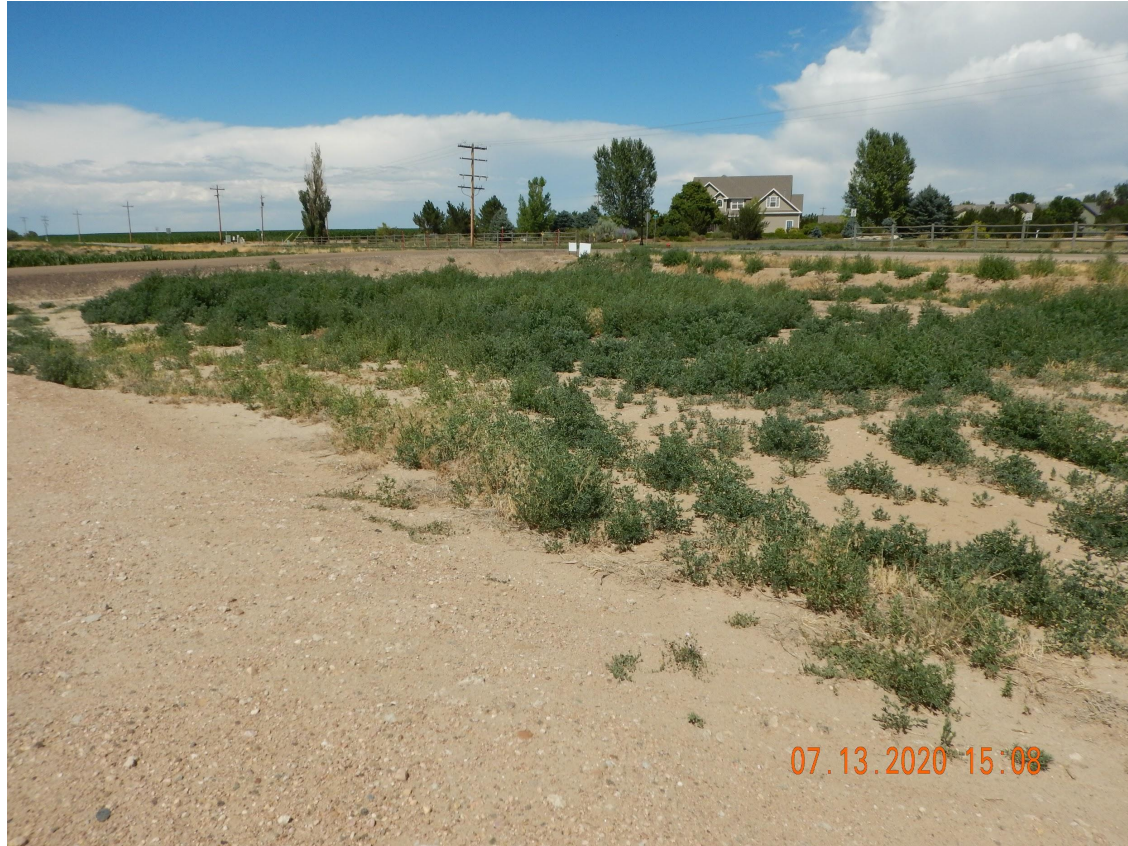
**Photo 2.** Photo taken from the northern location, facing Northeast. Photo illustrates an area that was previously the original access entrance before the adjacent Lind location was built. This area has unmanaged Kochia weeds.

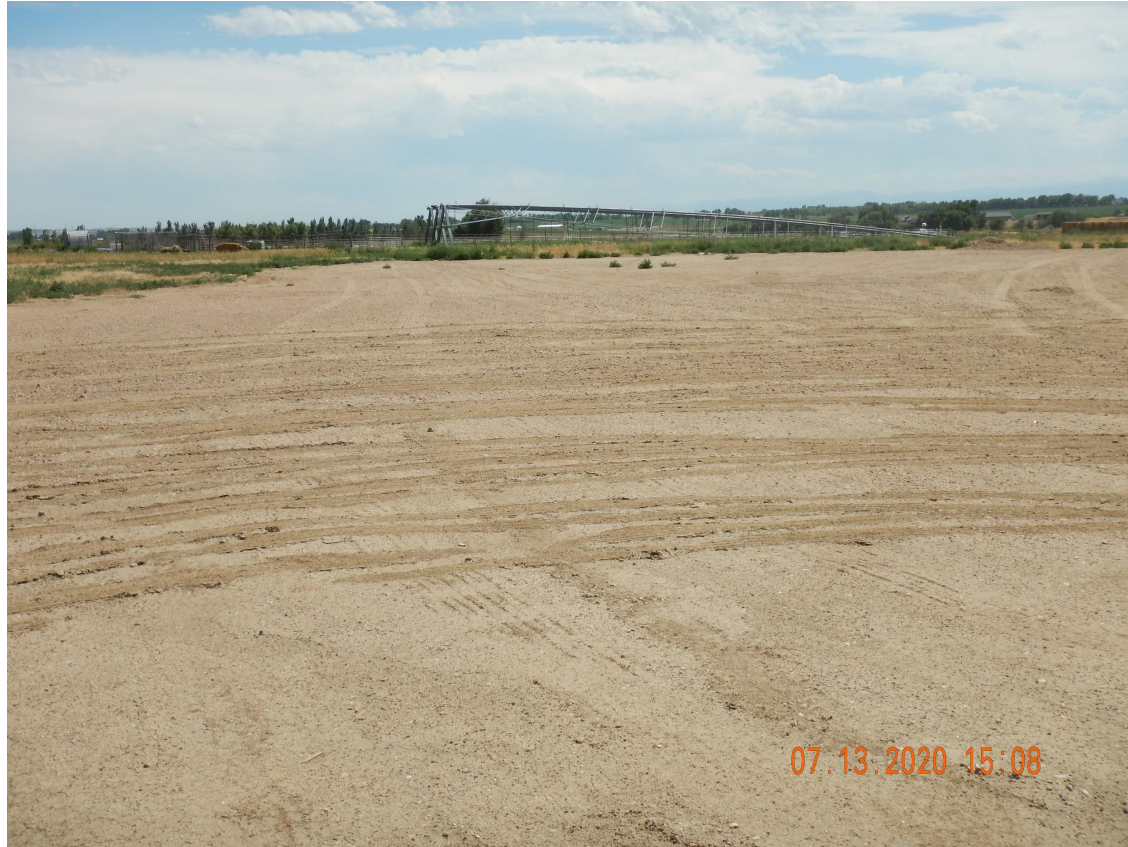
**Photo 3.** Photo taken from the northeastern location, facing South. Photo illustrates an area where wells have been plugged. Operator will likely have to perform interim reclamation to reduce all areas not needed for production operations.

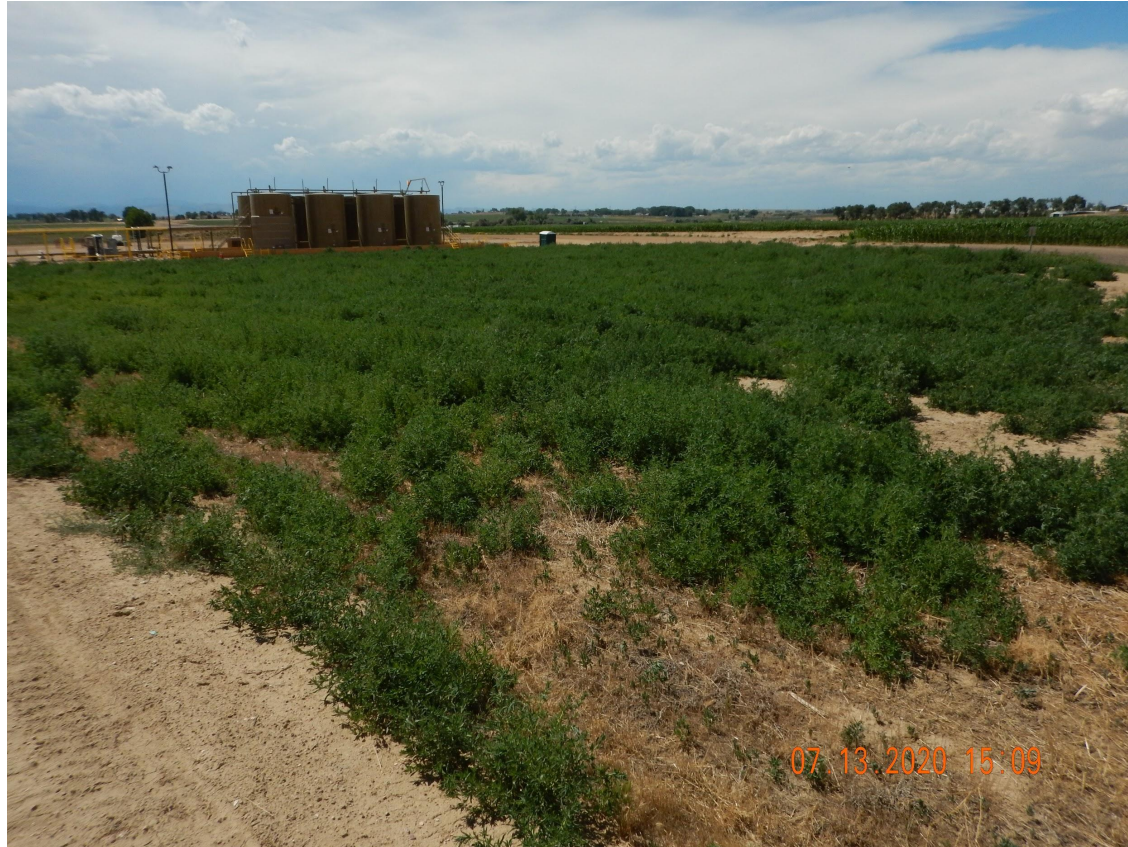
**Photo 4.** Photo taken from the entrance of location, facing West. Photo illustrates unmanaged Kochia weeds. It is unclear whether this location is associated with the adjacent Lind location to the west or whether this is from this location.
