# Inspection Photos

Operator: Paradox Upstream  
API: 113-06229  
Date: 7/15/2020

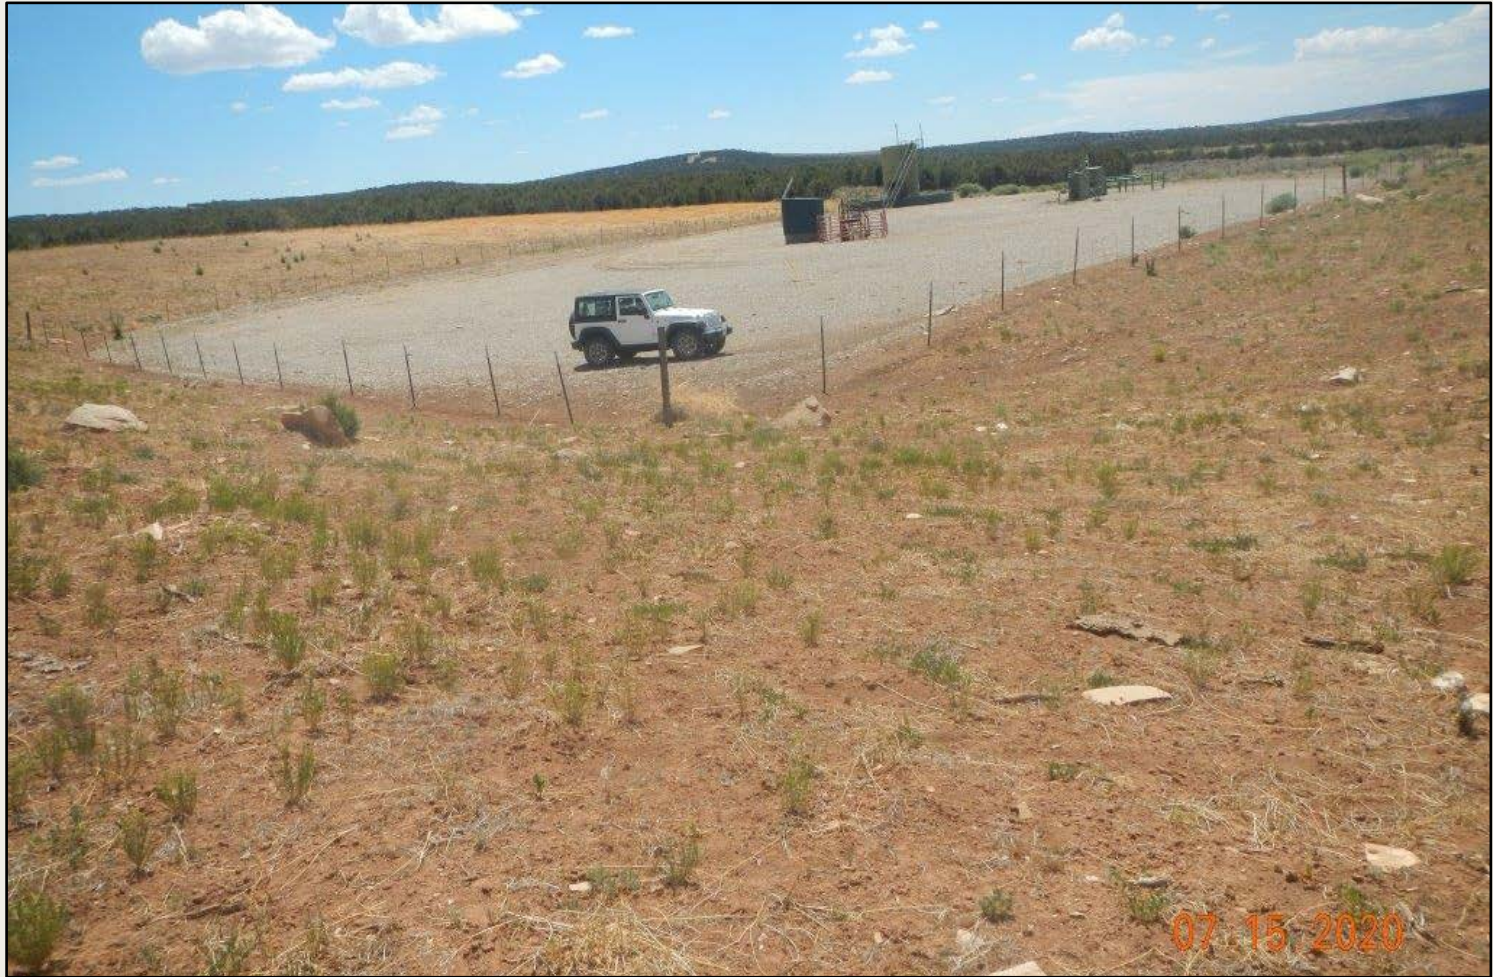
Photo 1. View of the project area from the northeastern corner facing center.

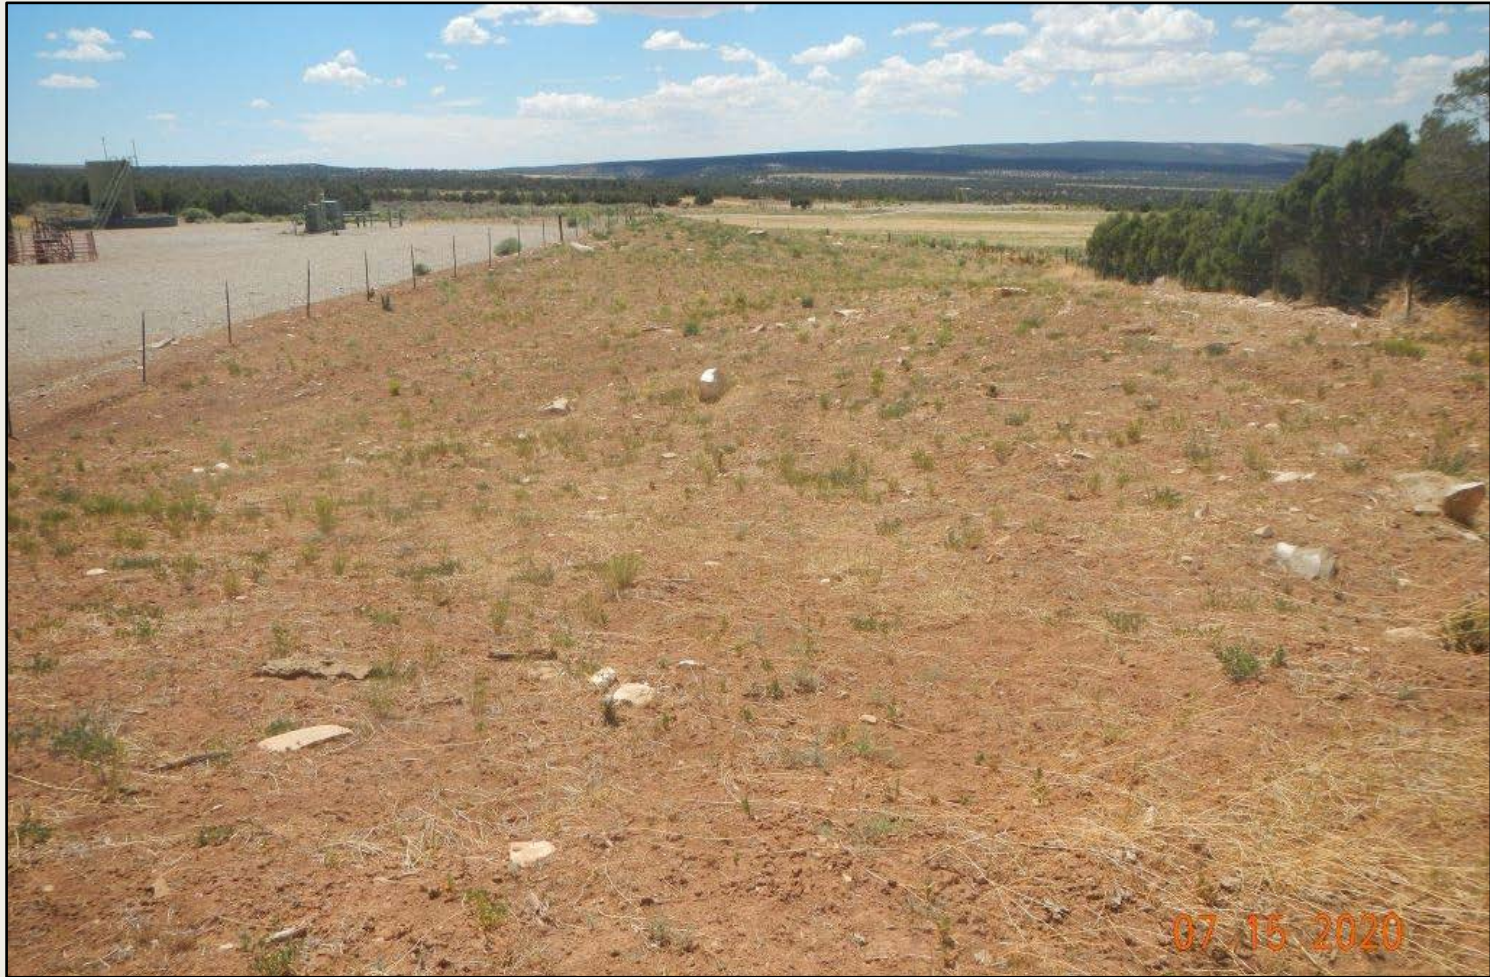
Photo 2. View of the northern project area from the northeastern corner facing westward. Revegetation is progressing and is comprised of grasses and shrubs such as western wheatgrass, crested wheatgrass, rubber rabbitbrush, largely in a grazed vegetative condition.

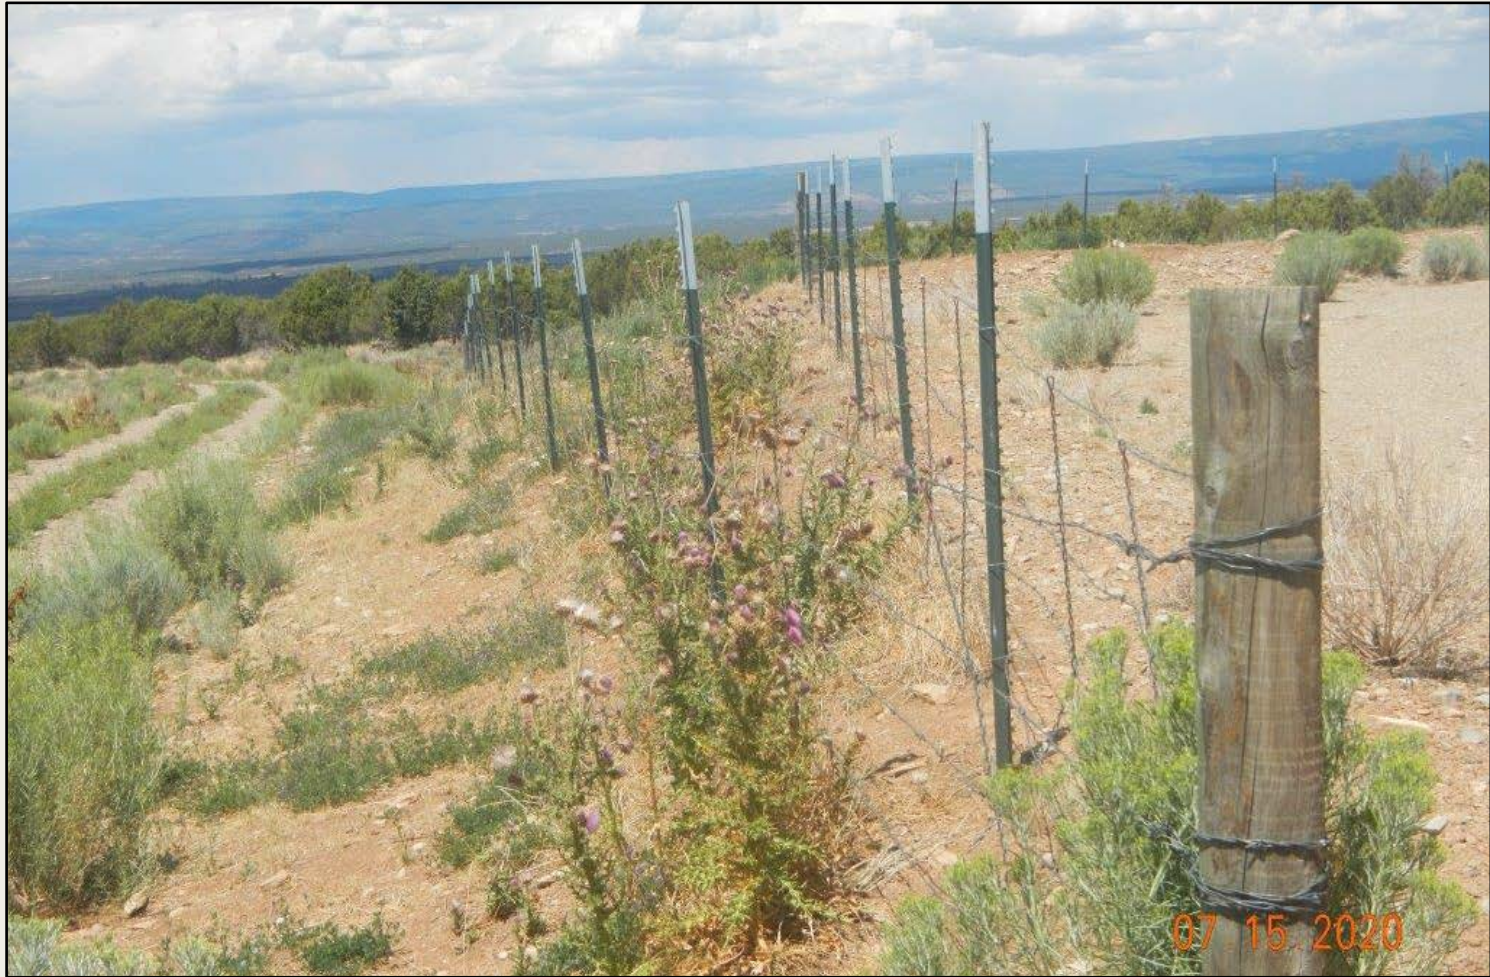
Photo 3. View of musk thistles within the western project area. Approximately 75 individuals observed.

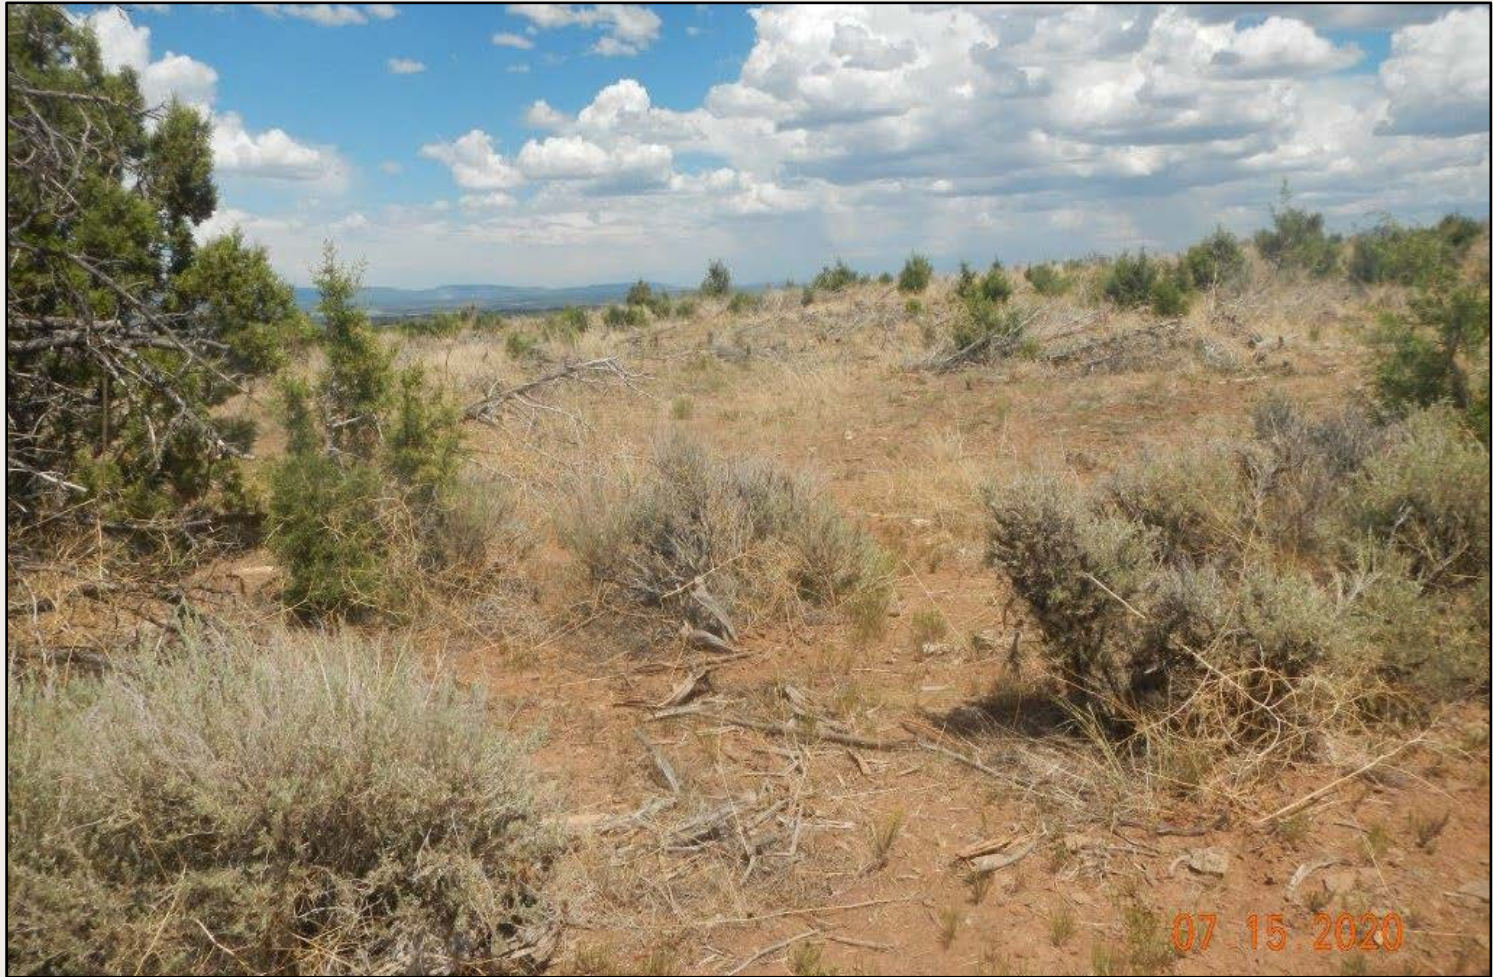
Photo 4. View of reference area comprised of big sagebrush shrubland with scattered pinyon and juniper trees and grassy understory of blue grama and western wheatgrass.
