Inspection Photos
Location Name: SMITH-WOLTER 1
API#: 05-067-07236
INSP. #: 695103016

Colorado Oil & Gas Conservation Commission
37.23958, -107.65735, 2243.0m, 102°
2020/07/23 07:14:00

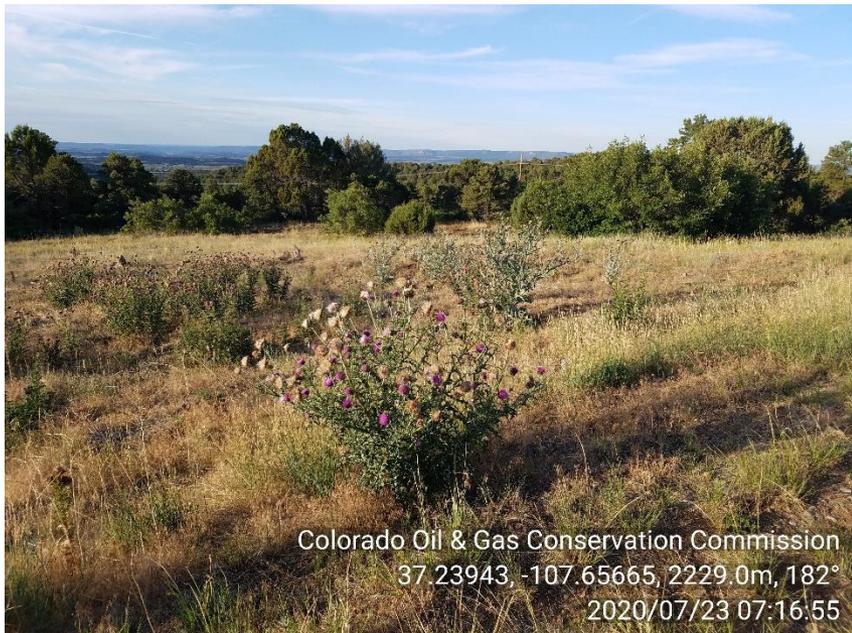
PHOTO 3: NOXIOUS WEEDS (THISTLE) ON AND AROUND LOCATION AND IN INTERIM RECLAMATION AREA. REMOVE NOXIOUS WEEDS, COMPLY WITH RULE 1003.f. CA DATE 7-27-20.

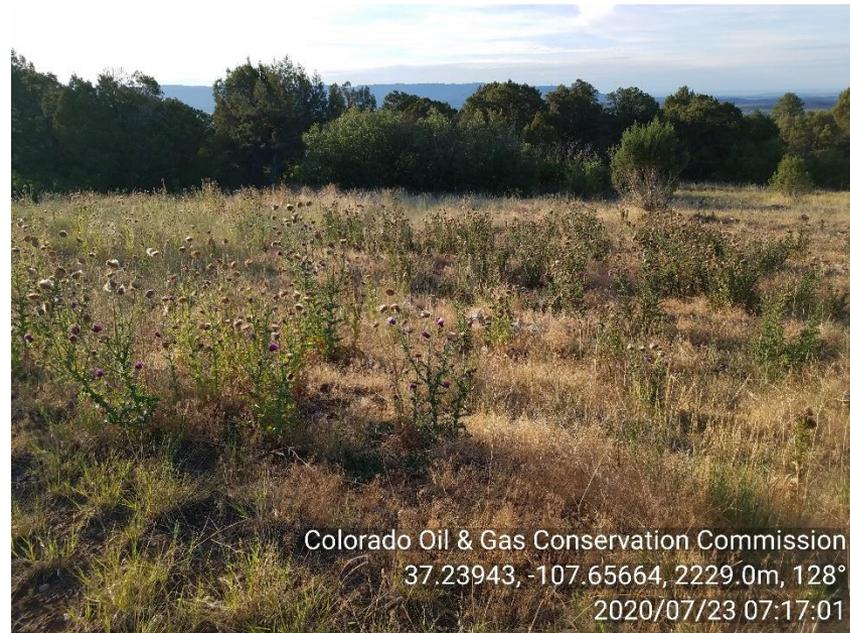
PHOTO 4: ANOTHER IMAGE OF CA FROM PHOTO 3.
