Inspection Photos
Operator: BP America
API: 067-09327
Date: 7/23/2020

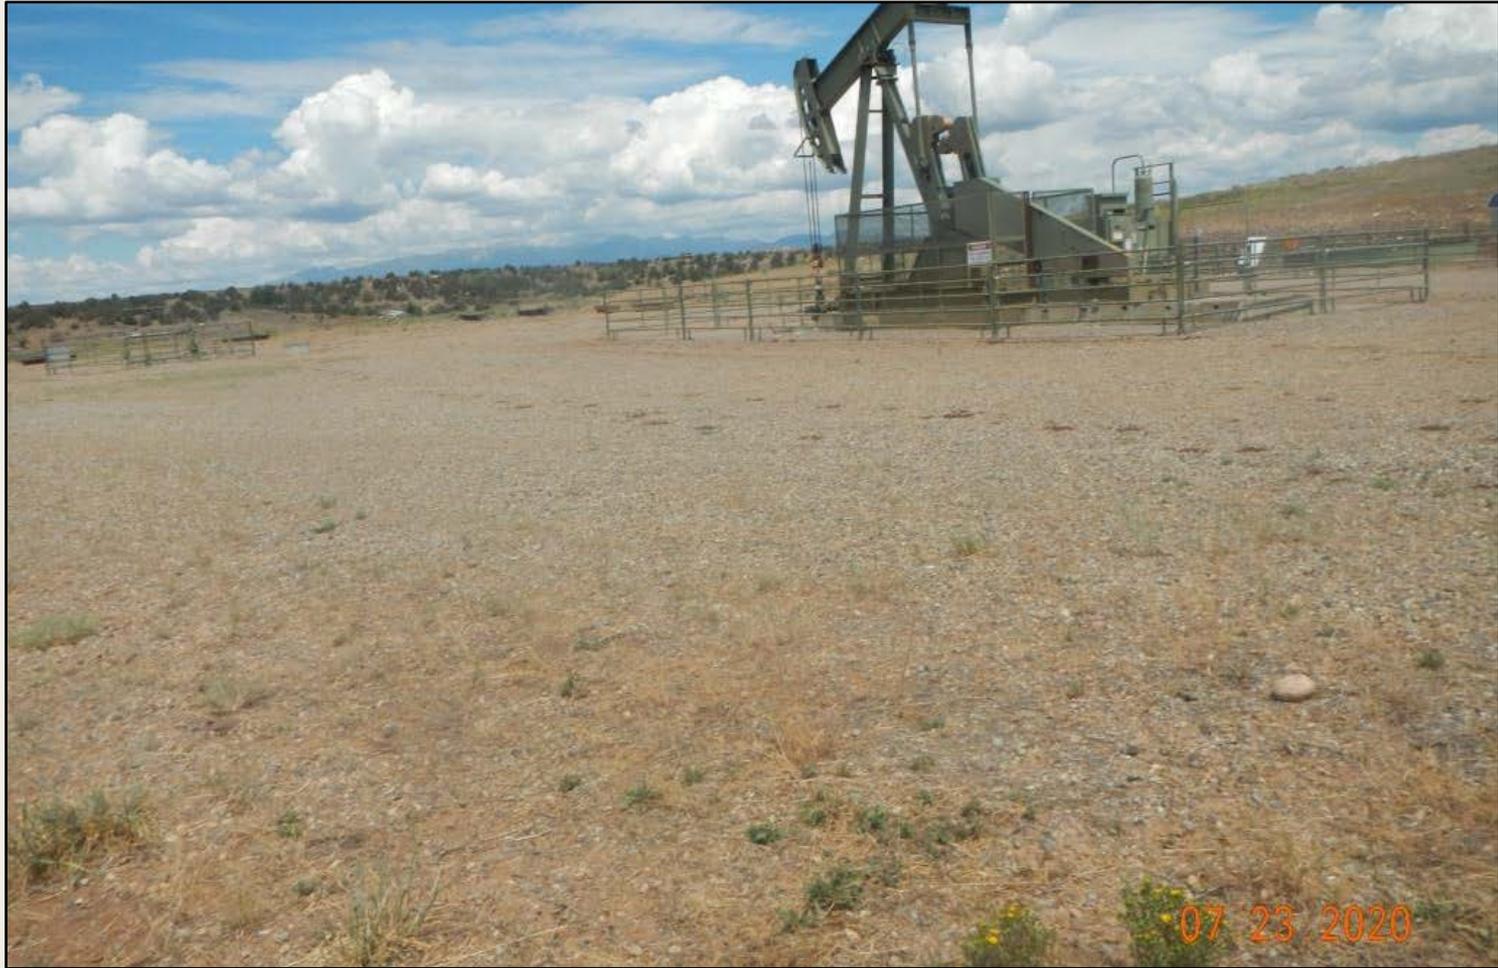
Photo 1. View of the project area from the southeastern corner facing center.

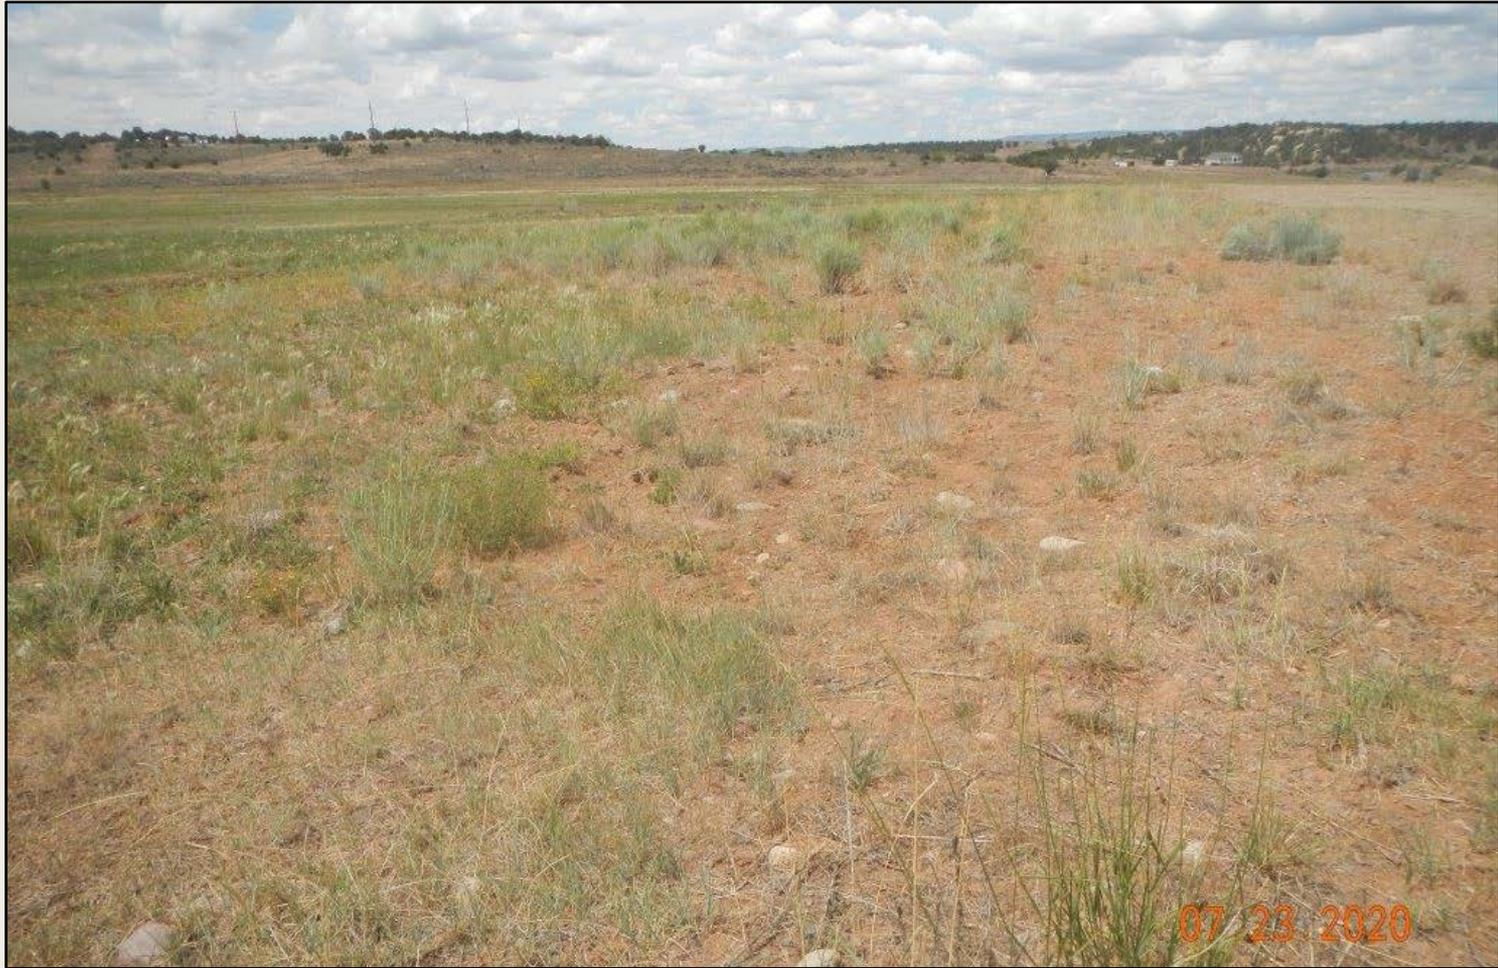
Photo 2. View of the southern fill slope from the southeastern corner facing westward. Revegetation is progressing with crested wheatgrass, western wheatgrass, and sand dropseed.

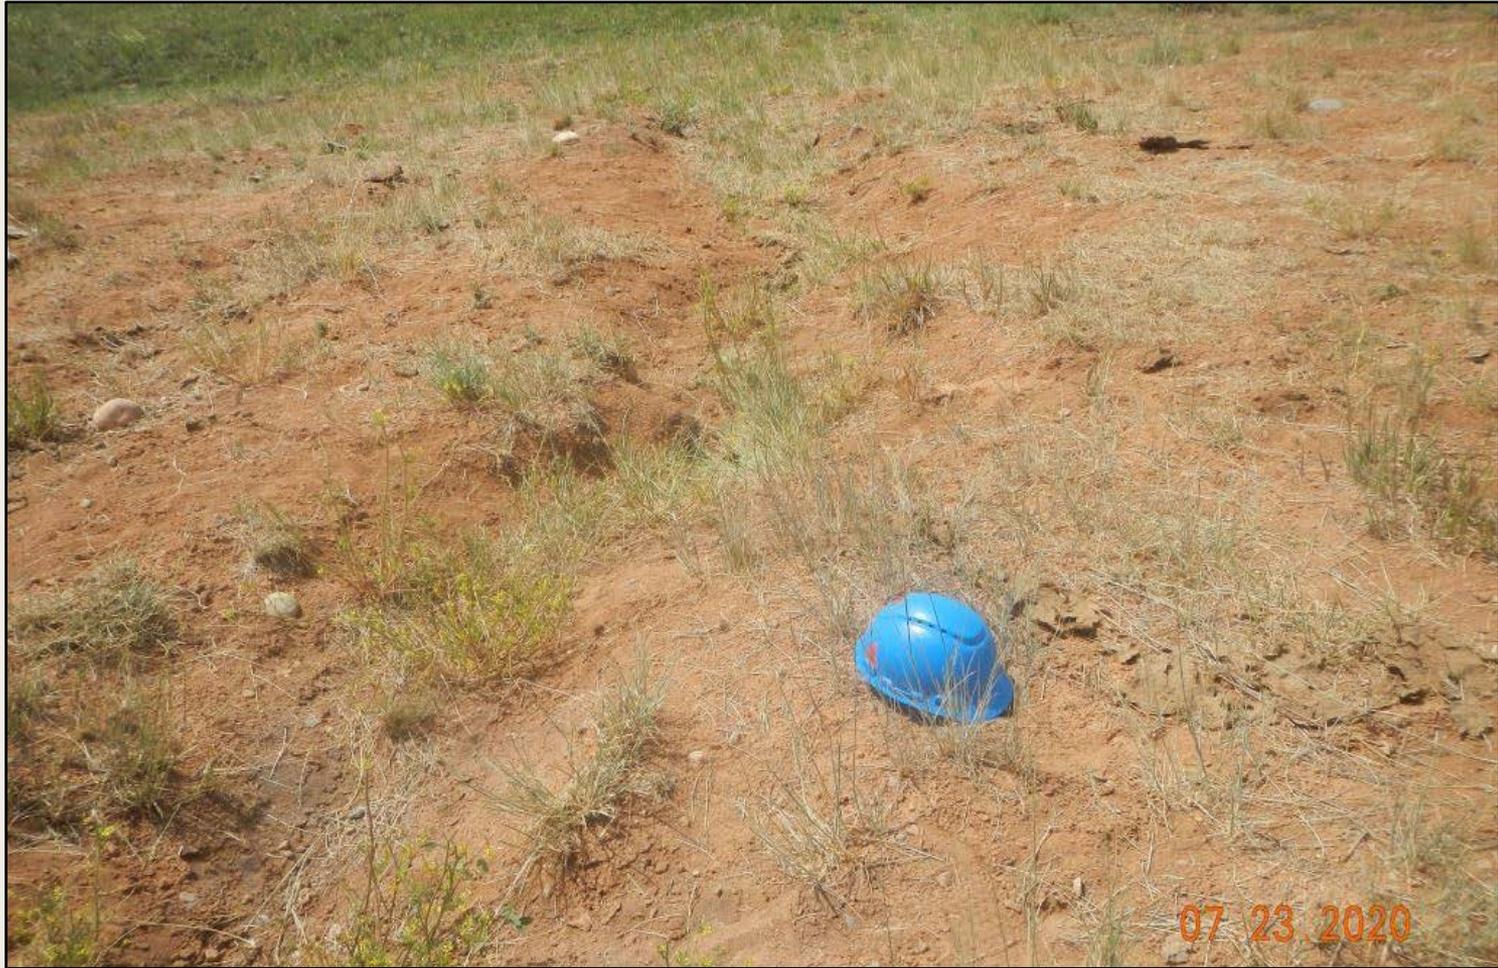
Photo 3. View of erosional channel forming, approximately 2 feet wide and 1 foot deep within the southern project area.

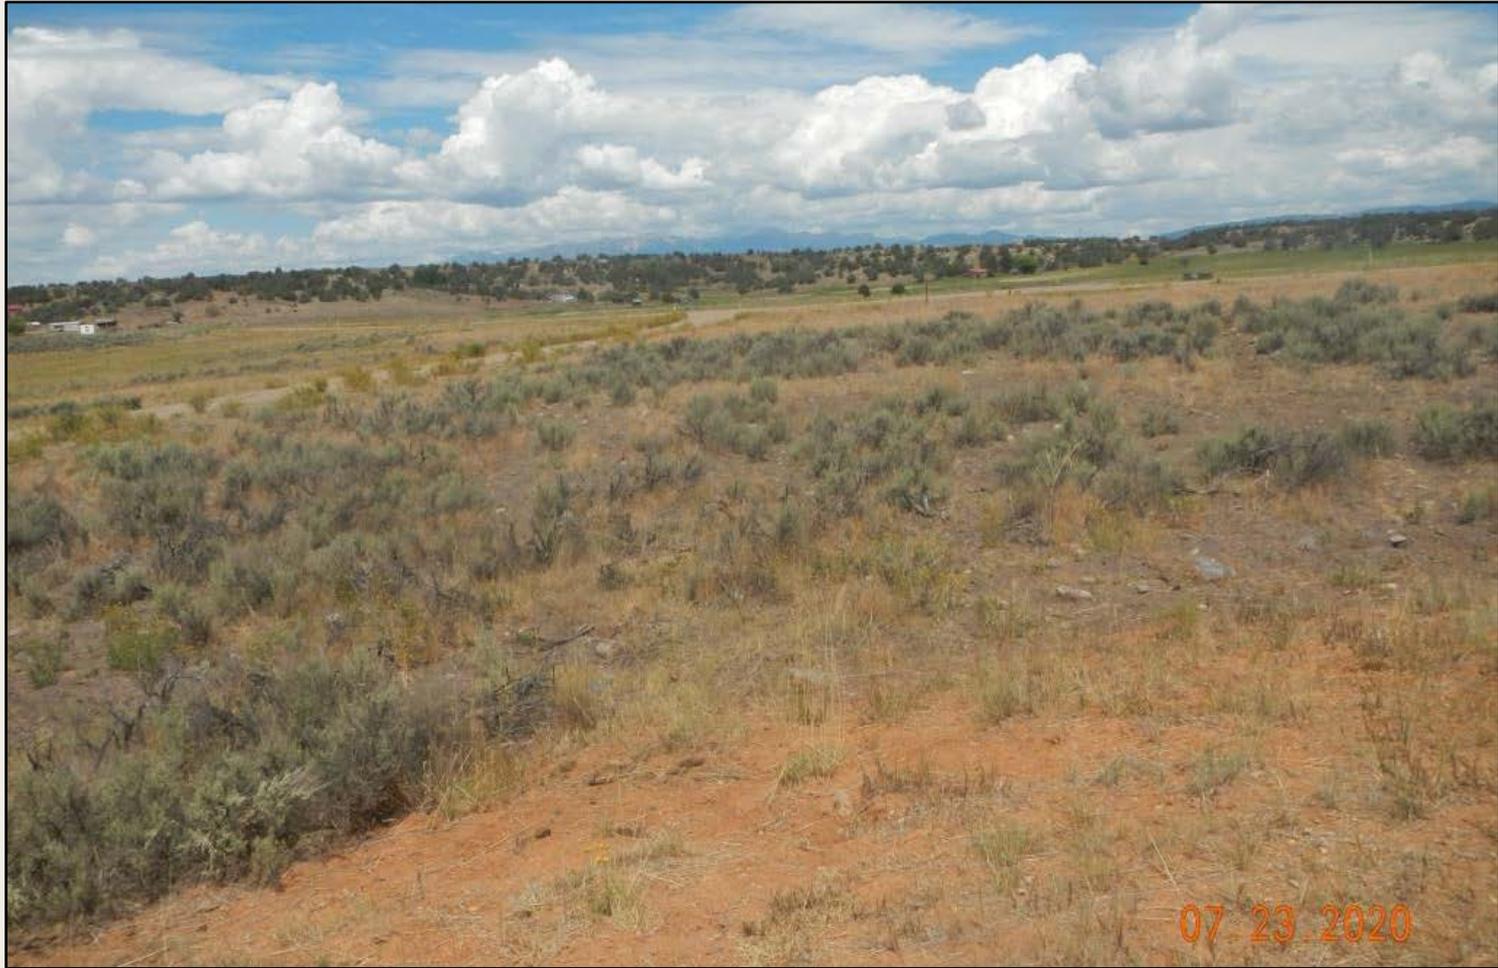
Photo 5. View of reference area comprised of sagebrush shrubland with understory of grasses such as western wheatgrass, crested wheatgrass, and Indian ricegrass.
