Inspection Photos

Location Name: IGNACIO 33-7 7

API#: 05-067-05469

INSP. #: 695103033

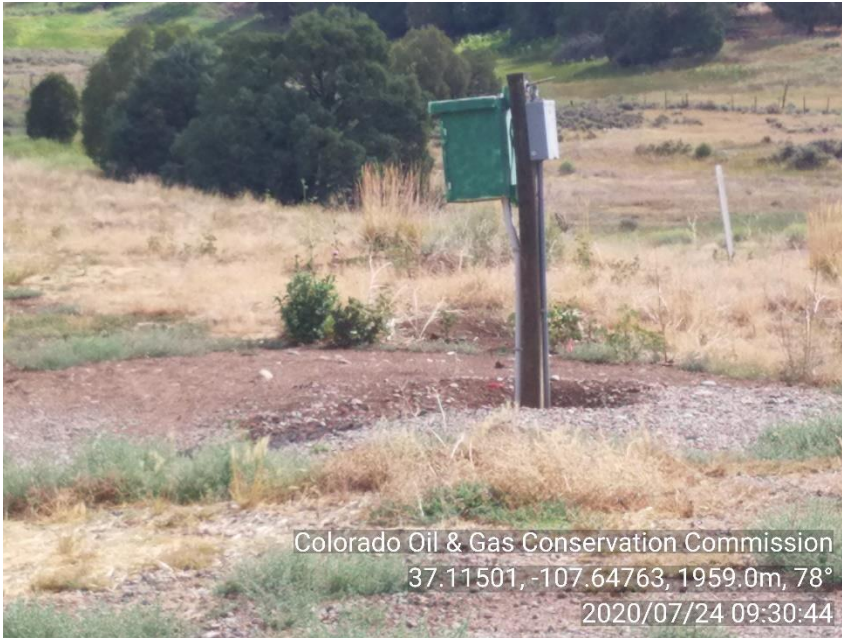
**PHOTO 3: MATURE FLOWERING NOXIOUS WEEDS (THISTLE)
AROUND LOCATION ON THE INTERIM RECLAMATION AREA.
CONTROL WEEDS CA DATE 7-31-20.**

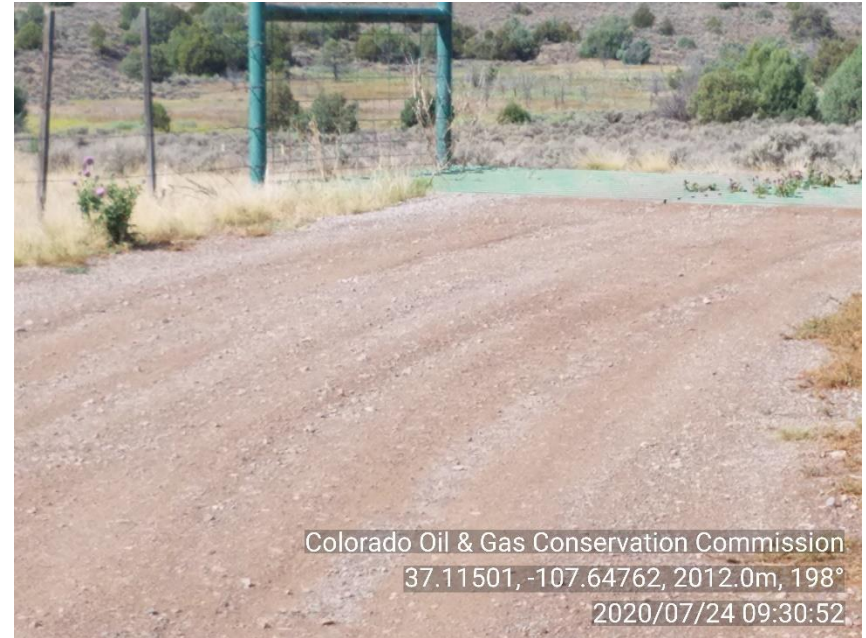
**PHOTO 4: IMAGE OF MATURE FLOWERING NOXIOUS WEEDS
(THISTLE) AT ENTRANCE OF ACCESS ROAD. **CONTROL WEEDS**
CA DATE 7-31-20.**

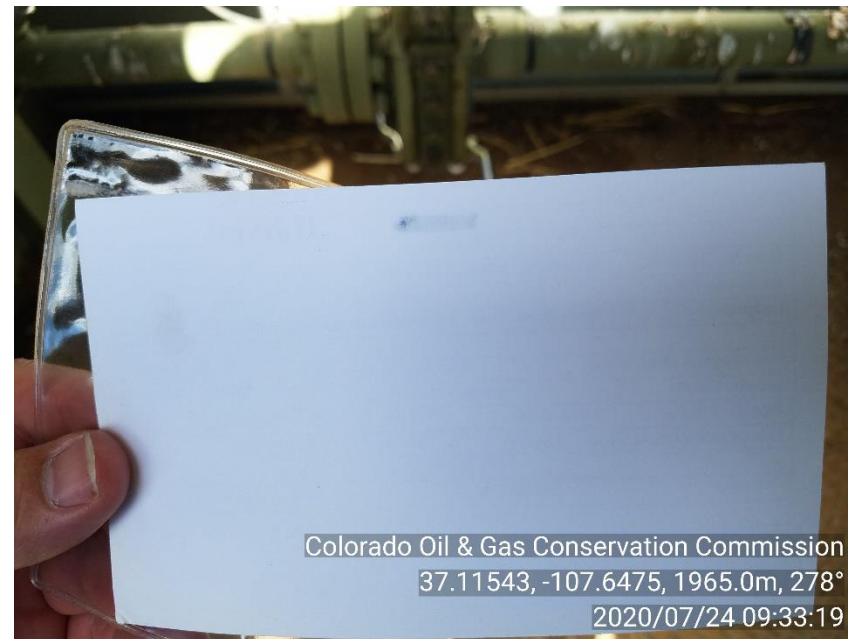
PHOTO 6: IMAGE SHOWING BACK OF CARD IS BLANK.
