Interim Reclamation and Stormwater Inspection

Operator: PAINTED PEGASUS PETROLEUM LLC - #10711

Location ID: 320095

Inspection Photos
Location Name: PENNY #32-8
Location ID: 320095

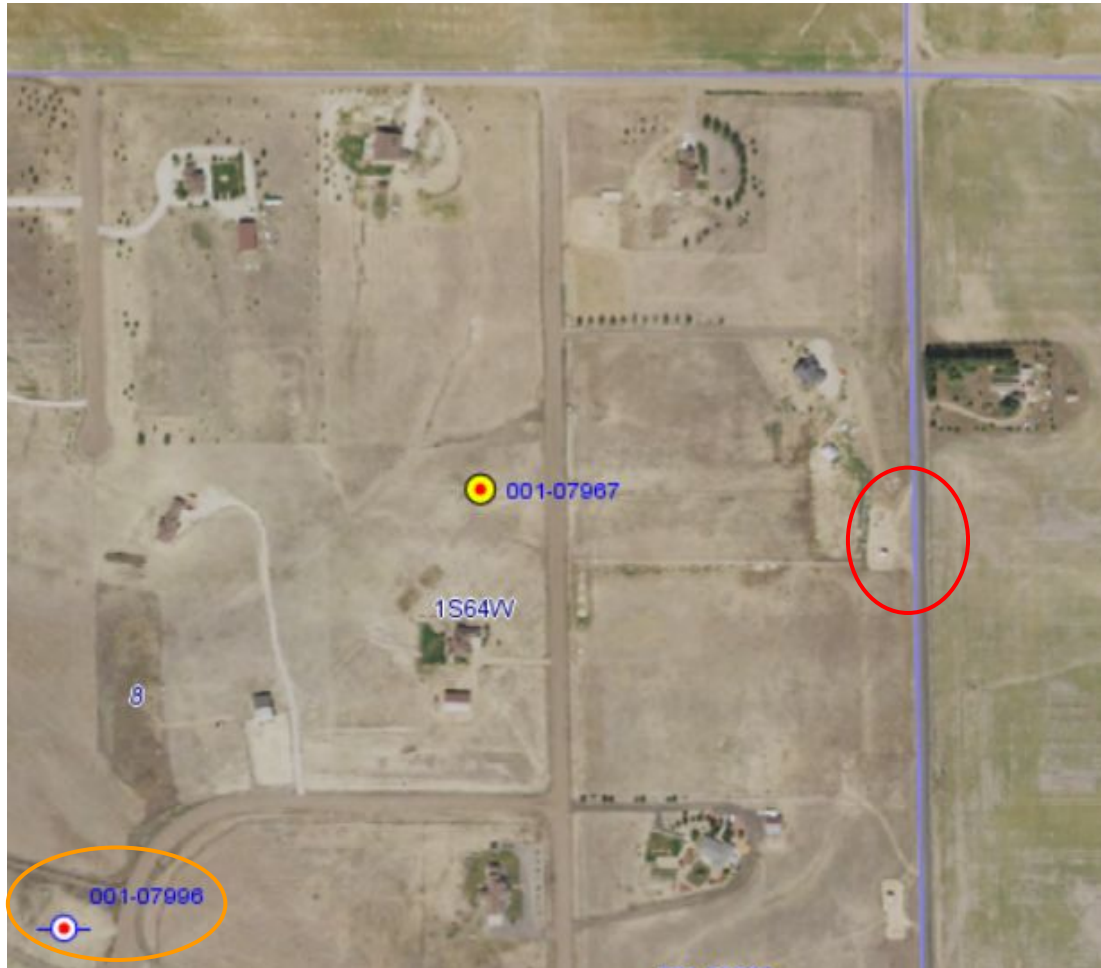
Photo 1. COGCC GISOnline aerial imagery taken 2017. Imagery illustrates the associated offsite tank battery (red circle) and a well location (orange circle). This complaint was in regards to the tank battery. COGCC staff also inspected the well location and observed weeds there as well.

Note: The tank battery also services the well directly to the west (001-07967); however, there were no observed reclamation compliance issues.

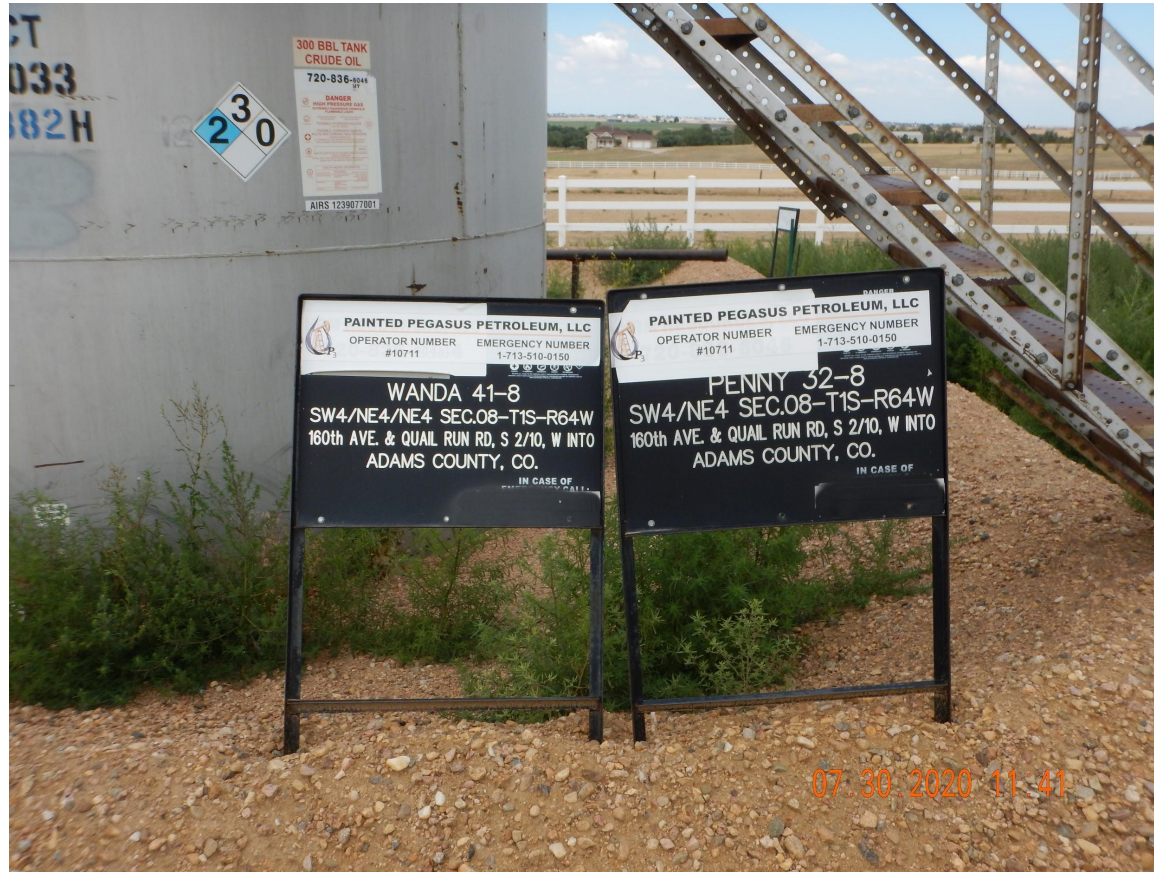
Photo 2. Photo taken from the tank battery, facing West. Photo illustrates Operator signs and which wells the tank battery services.

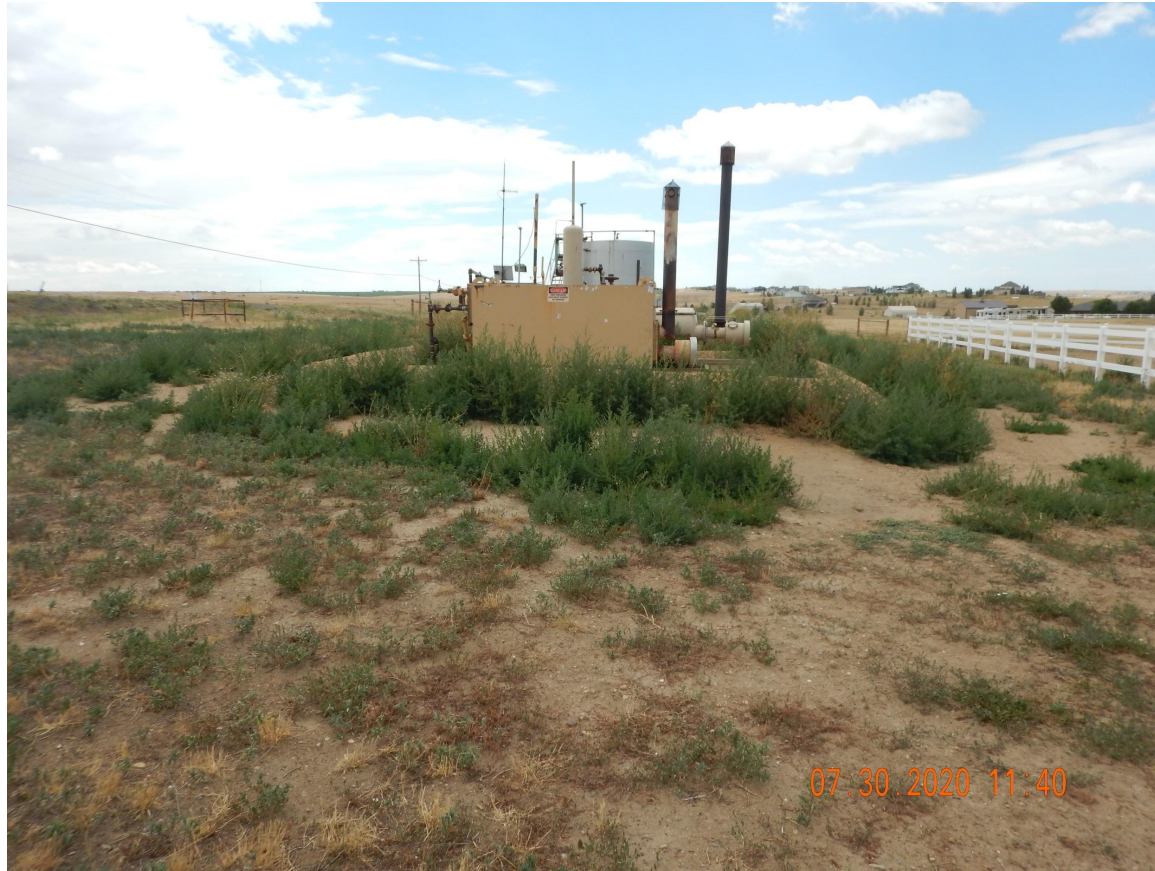
Photo 3. Photo taken from the northern tank battery, facing South. Photo illustrates unmanaged weeds.

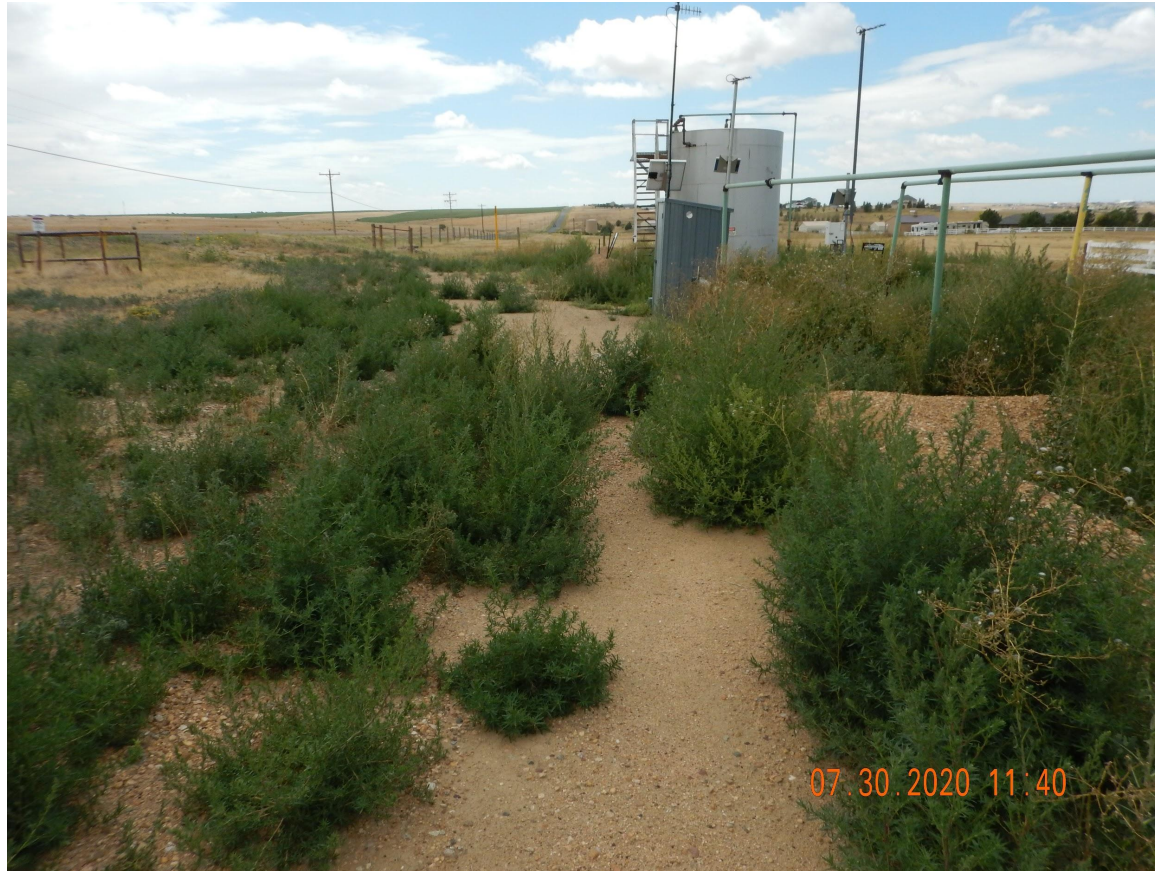
Photo 4. Photo taken from the central tank battery, facing South. See comments under Photo 3.

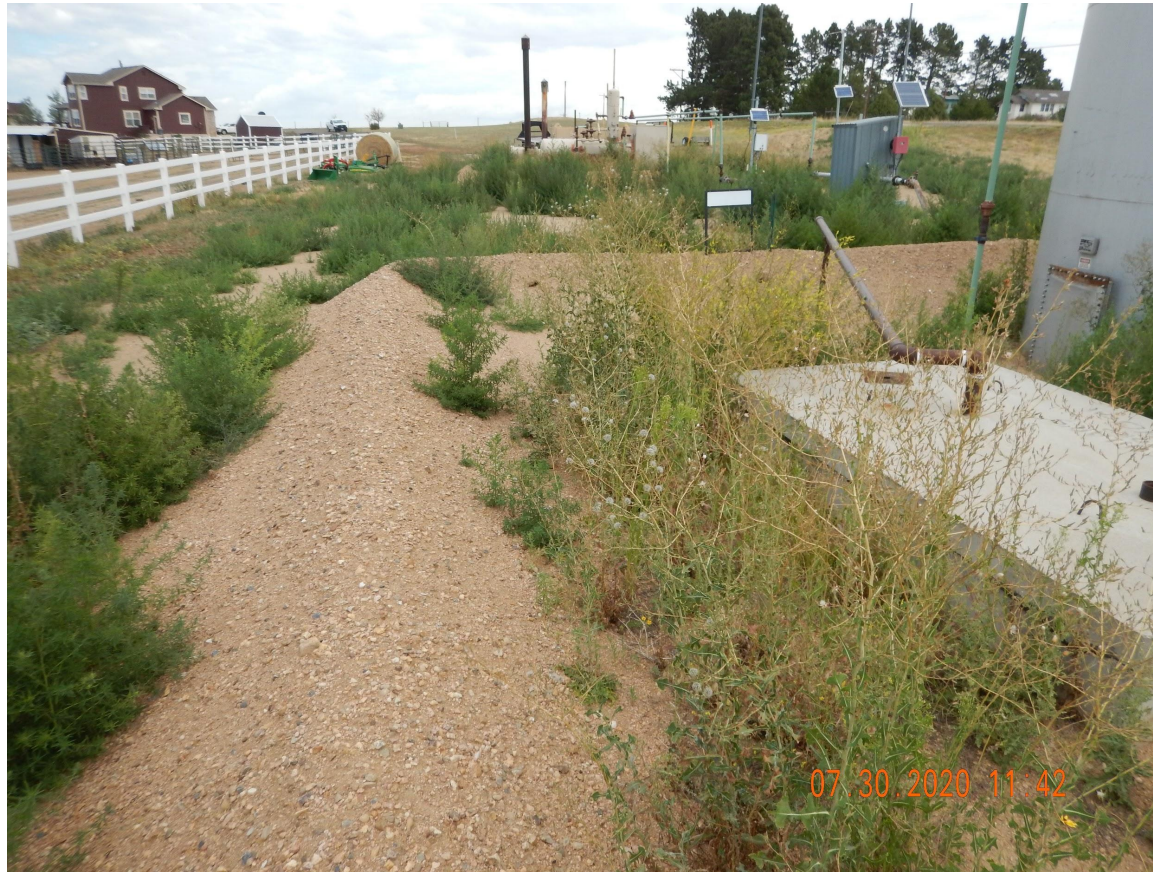
Photo 5. Photo taken from the southwestern tank battery, facing North. See comments under Photo 3.

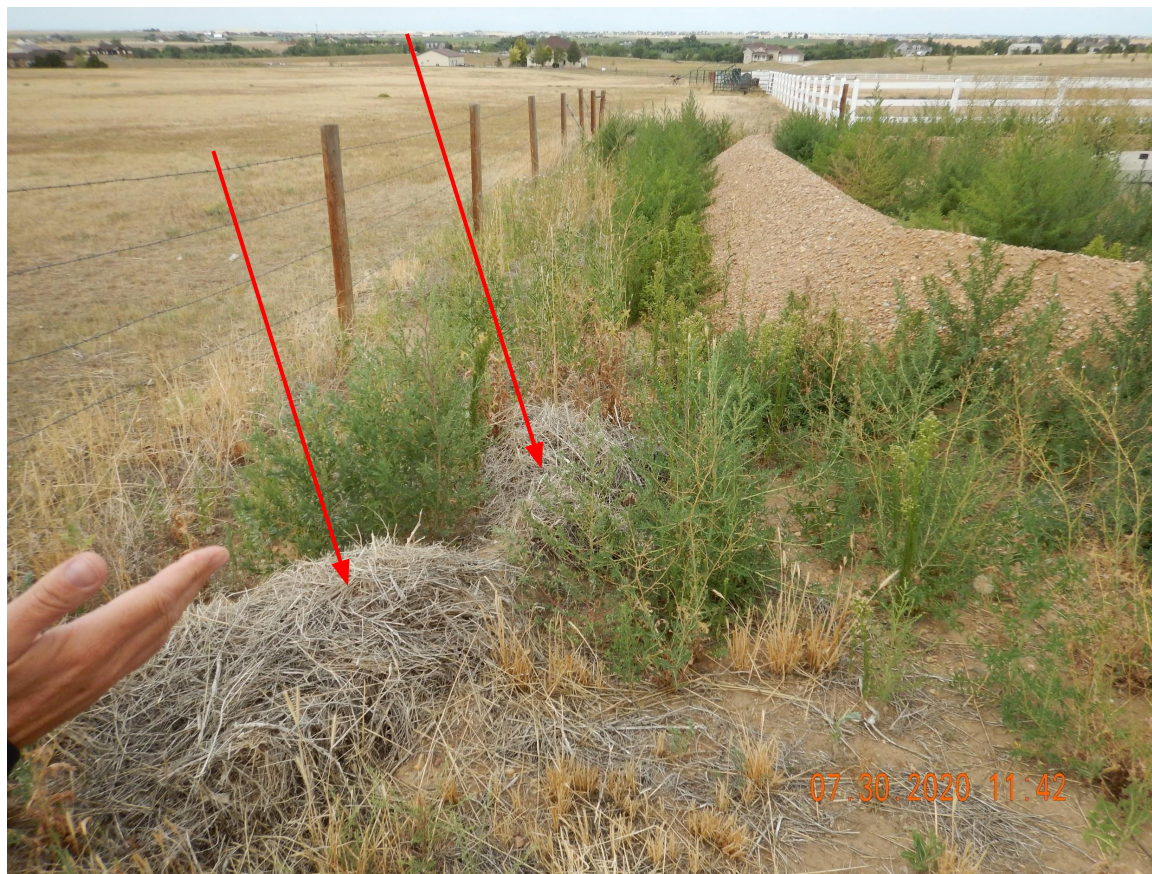
Photo 6. Photo taken from the southeastern tank battery, facing West. Photo illustrates weed debris mixed with piled gravel from previous weed management; appears the Operator used a skid-steer to pile up weed debris/gravel. Surface owner can no longer drive mower through this section of land.

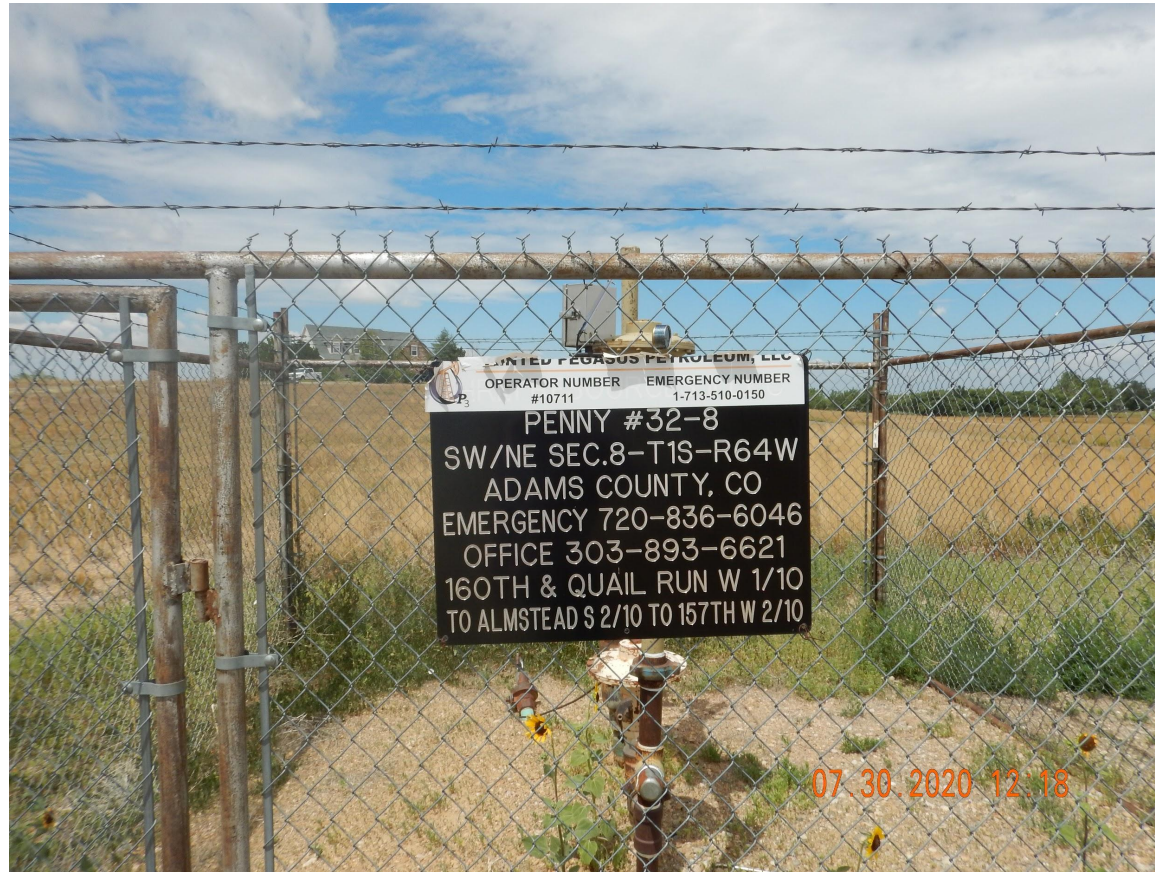
Photo 7. Photo taken from the Penny well location, facing West. Photo illustrates the Operator sign. Note- per Rule 210.e., signs shall be legible. The Operator name is starting to wear.

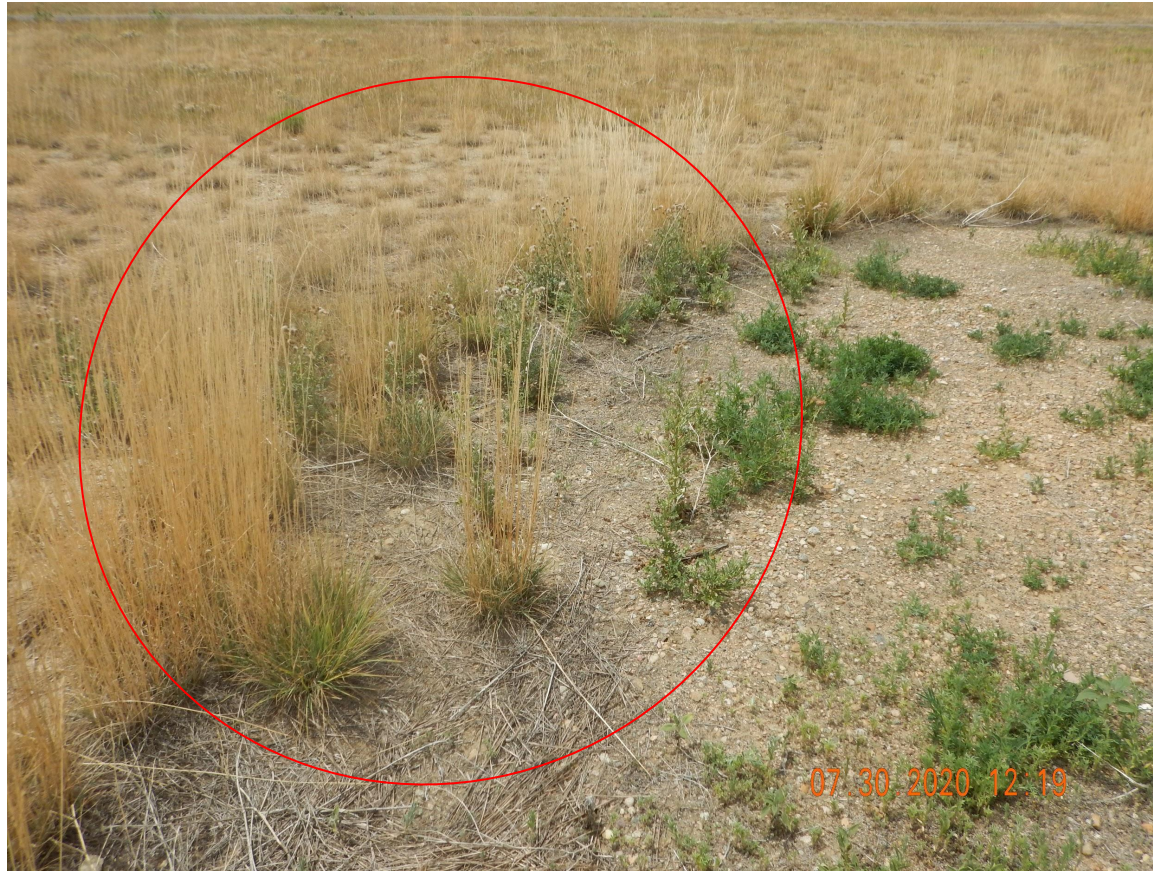
Photo 8. Photo taken from the Penny well location, facing South. Photo illustrates a List B Colorado noxious weed, Canada thistle, which has already flowered. Canada thistle can be a very troublesome weed and can spread rapidly via roots and seeds.
