Inspection Photos

7/31/2020

Operator: CHEVRON USA INC - 16700

Location ID: 336051

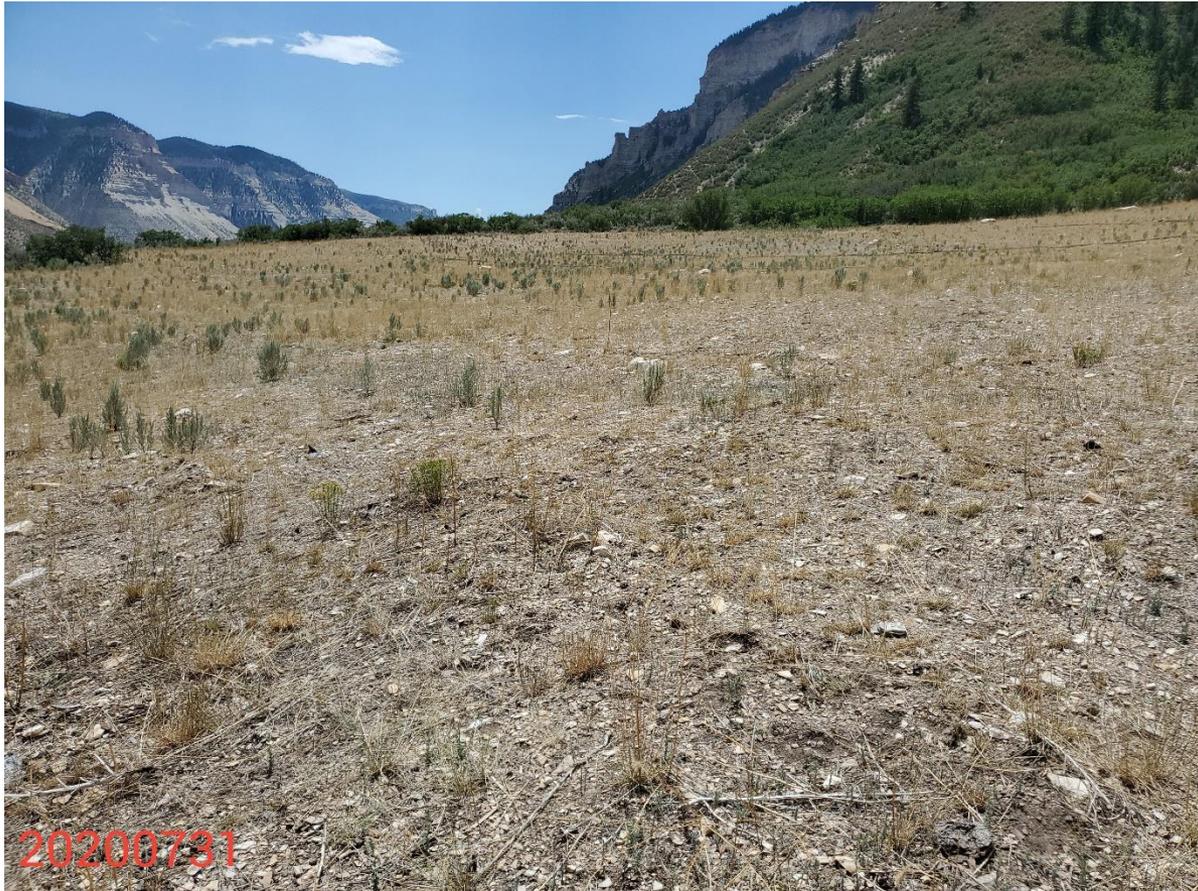
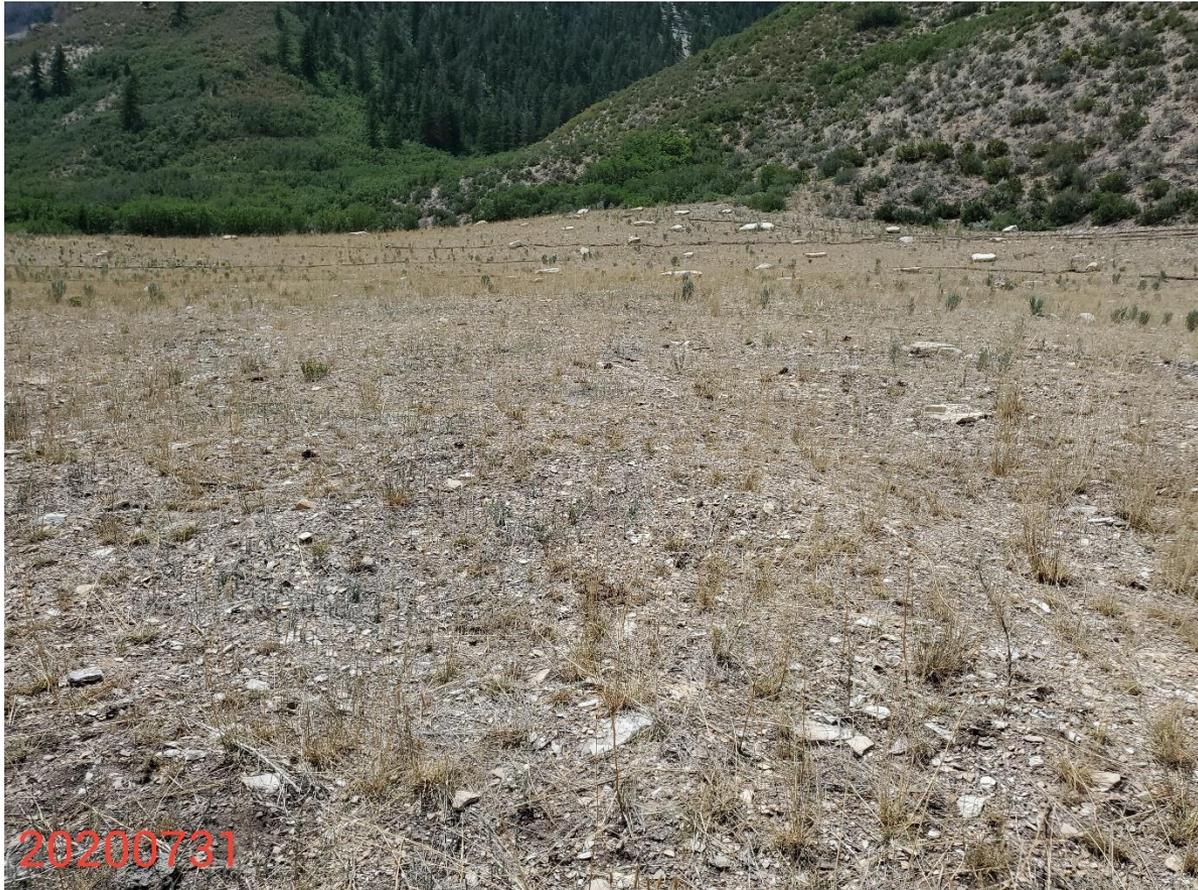
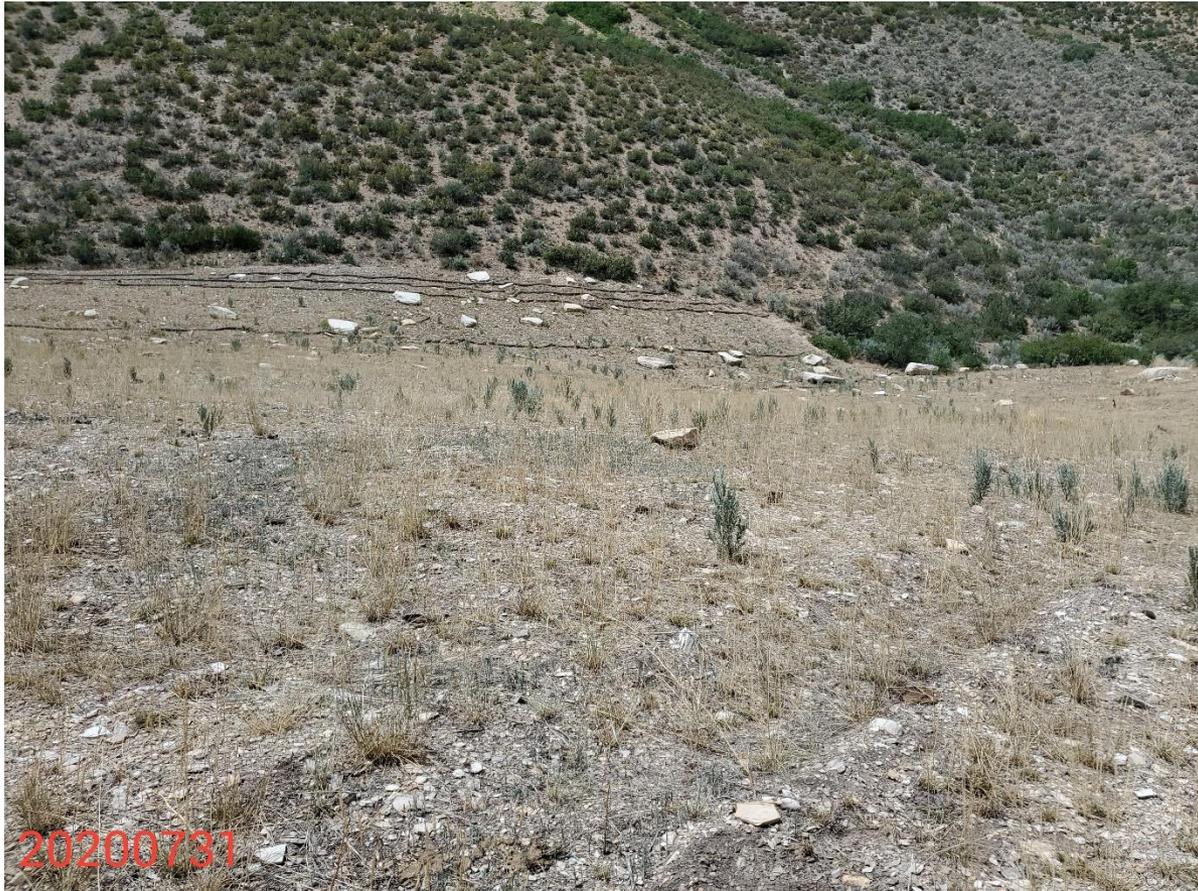
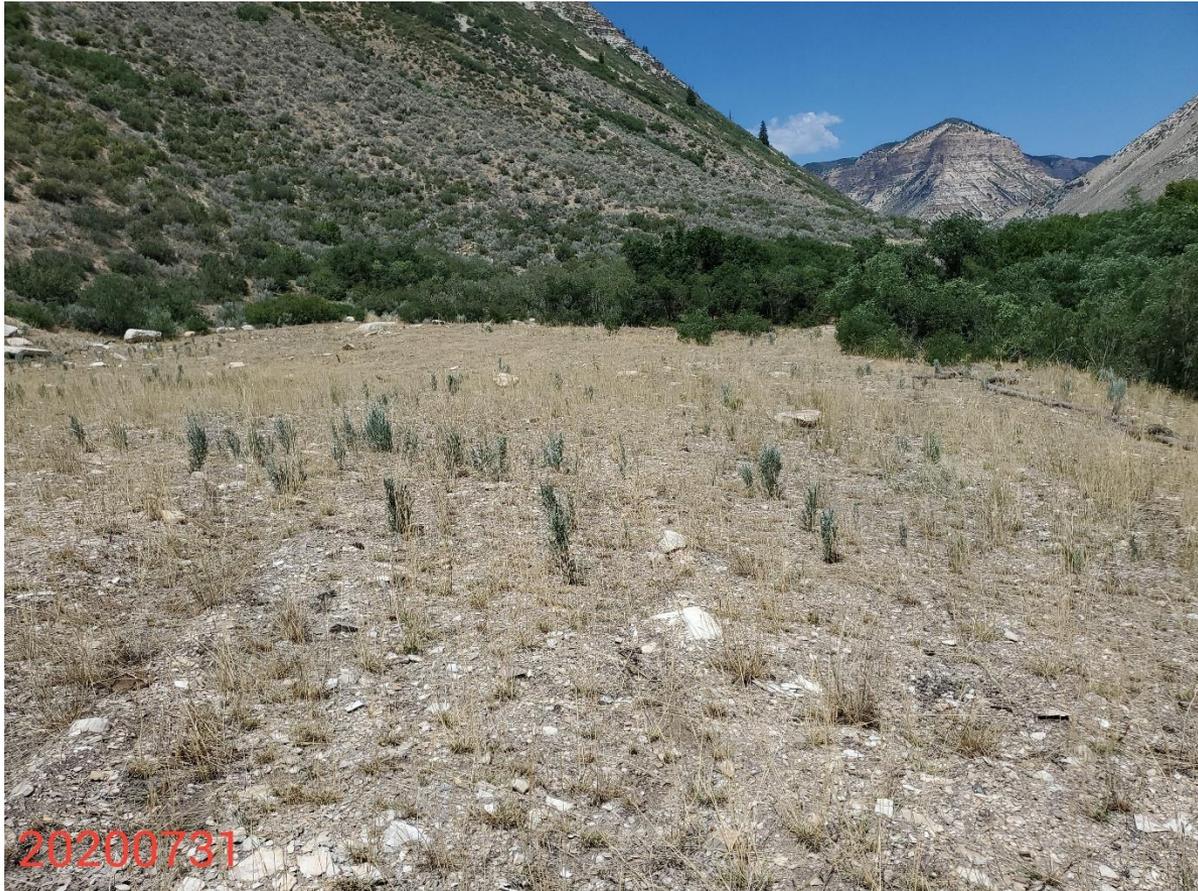
Photo 1: Photo taken from the east end of the Location facing south. Photo shows 1-4 provide an overview of the Location from south, southwest, northwest to north.

Photo 2: See comments under photo 1.

Photo 3: See comments under photo 1.

Photo 4: See comments under photo 1.

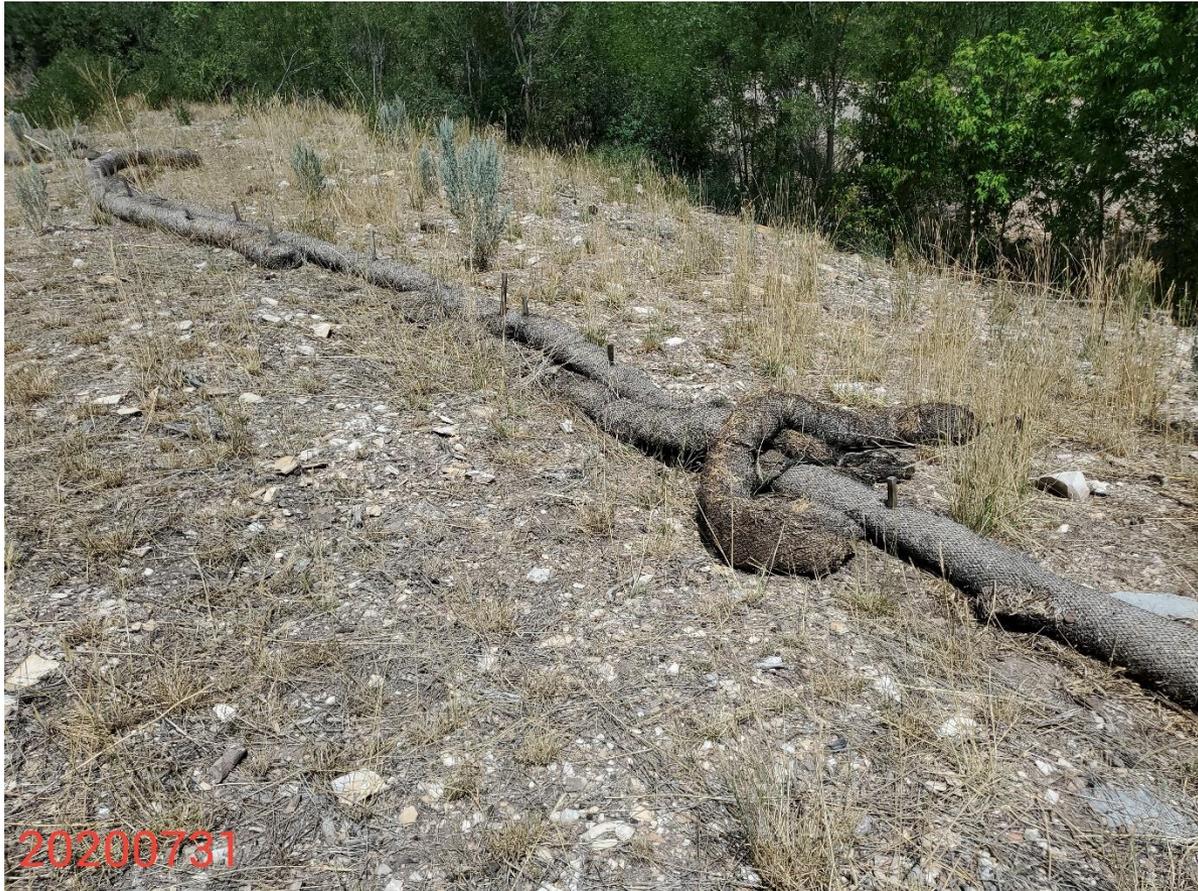
Photo 5: Photo taken from the east end of the Location. Photo shows straw wattles have not been installed or maintained in proper functioning condition.

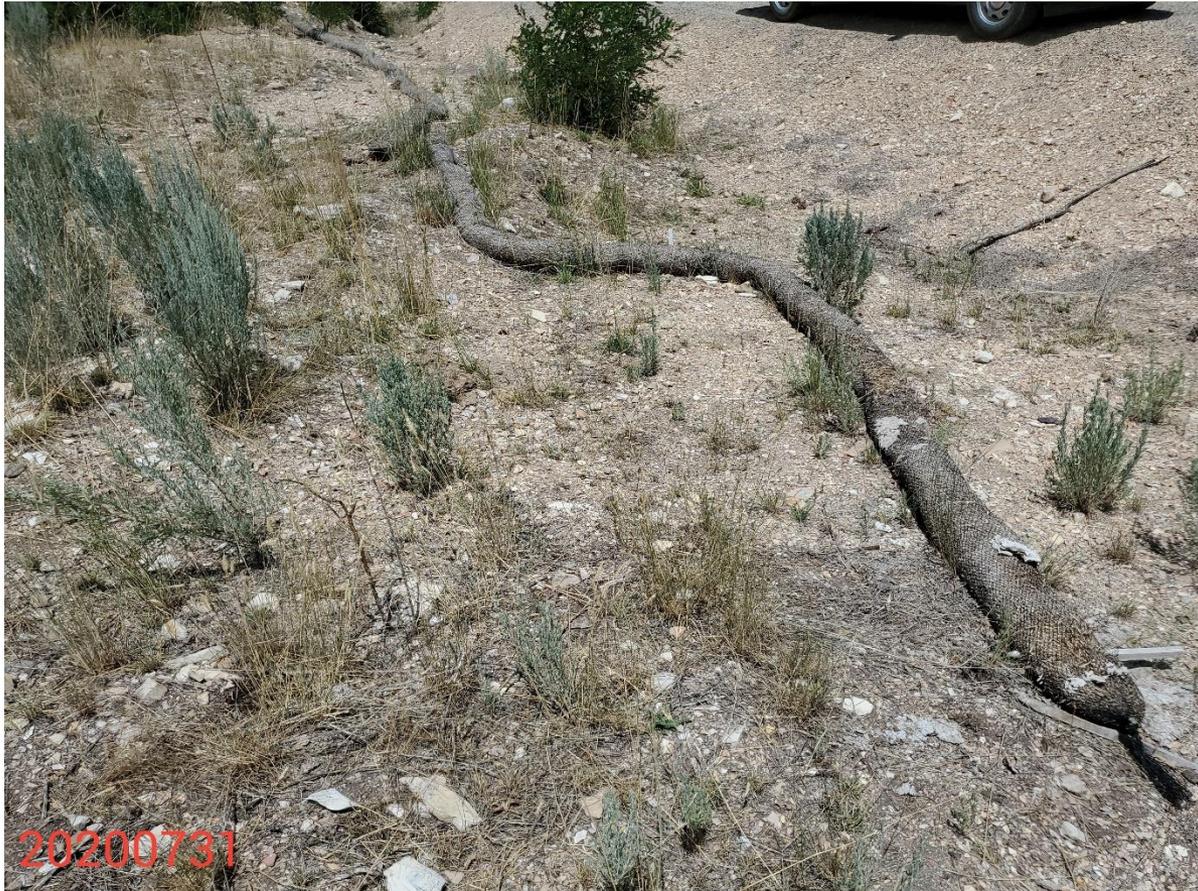
Photo 6: Photo taken from the east end of the Location. Photo shows straw wattles have not been installed or maintained in proper functioning condition.

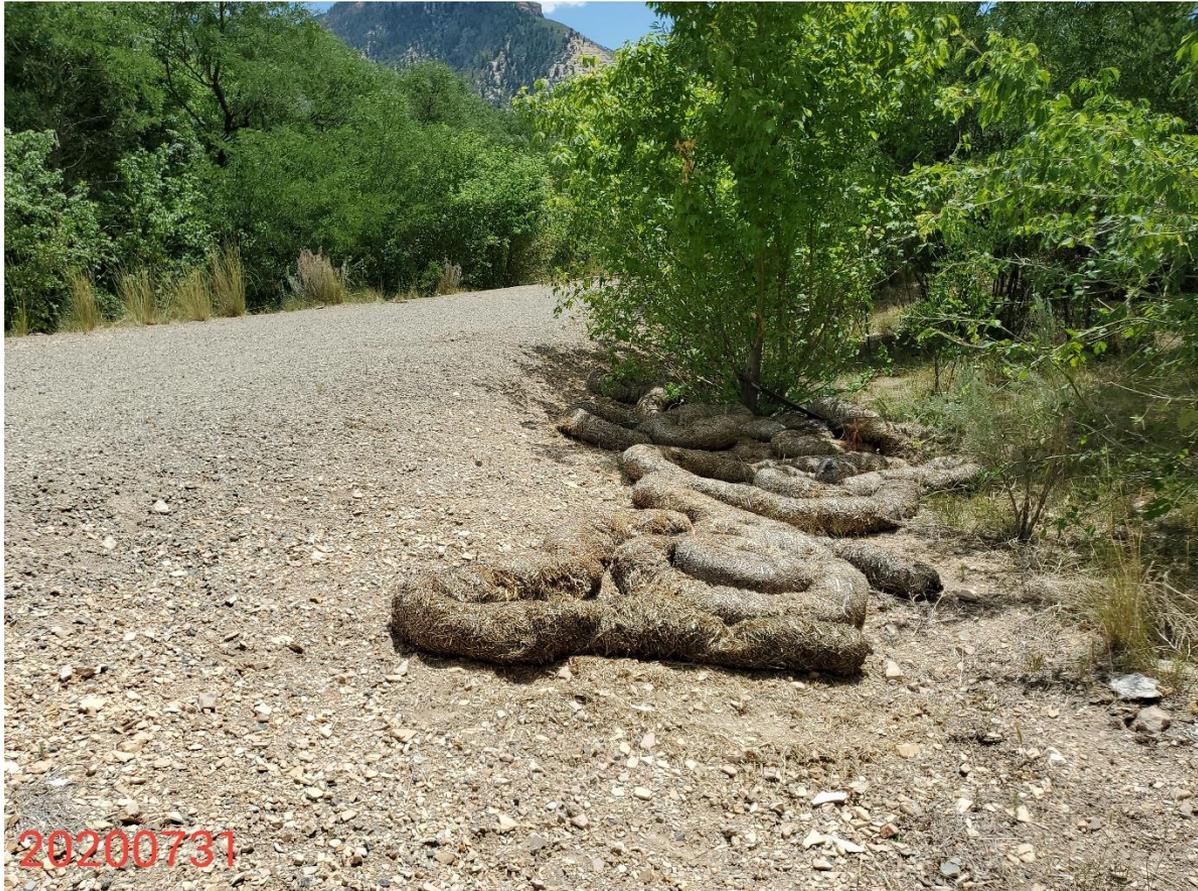
Photo 7: Photo taken from the ditch on the east end of the Location. Photo shows wattles within ditch; this is now considered debris.
