Final Reclamation Inspection

Operator: CRESTONE PEAK RESOURCES OPERATING LLC - 10633

Location ID: 317615

Inspection Photos
Location Name: HINGLEY FARMS #1
Location ID: 317615

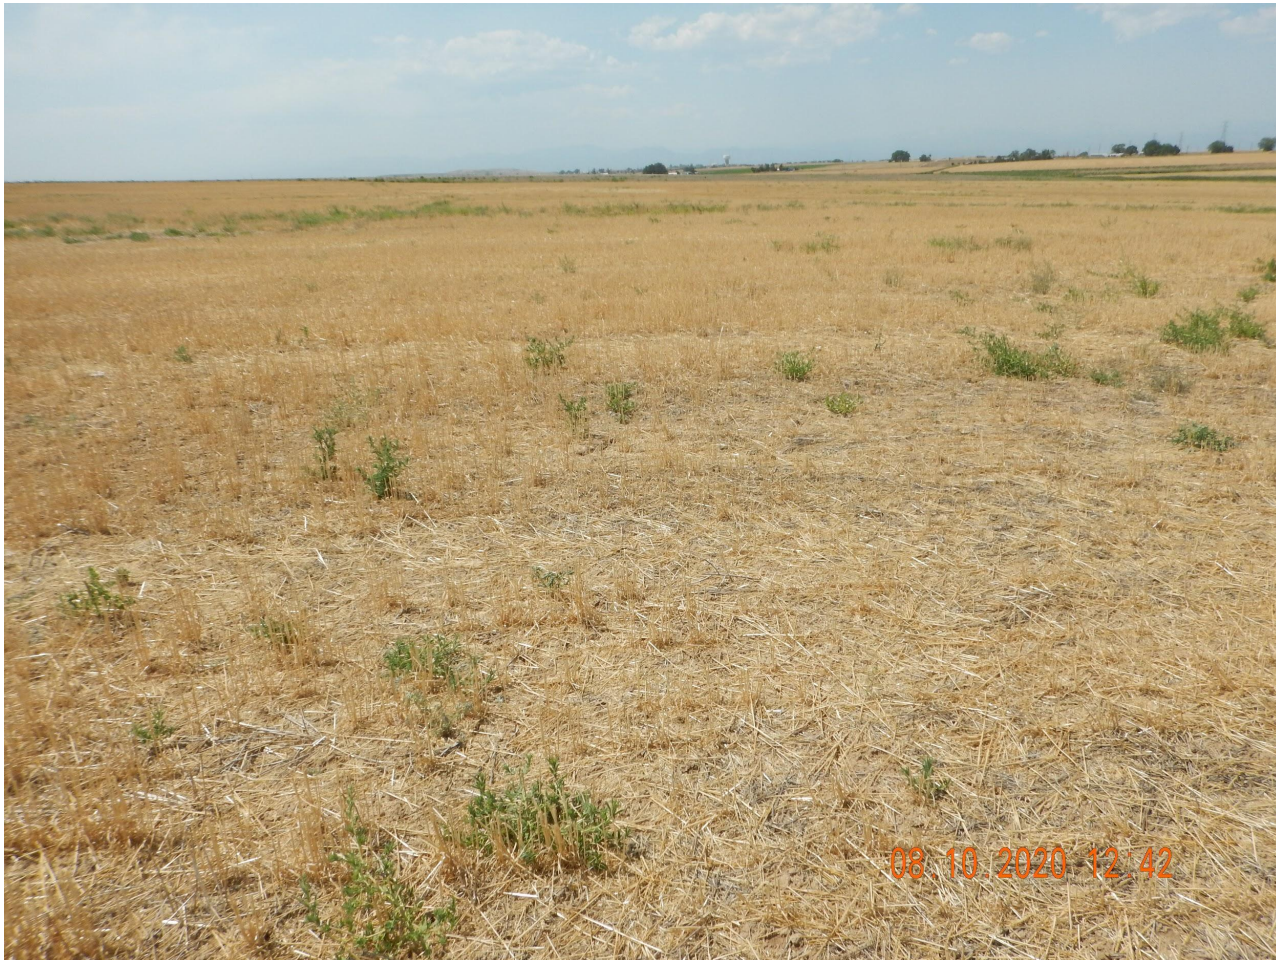
Photo 1. Photo taken from the plugged and abandoned well location, facing West. Photo illustrates wheat has already been harvested. Establishment of crop appears to be reflective of reference areas.

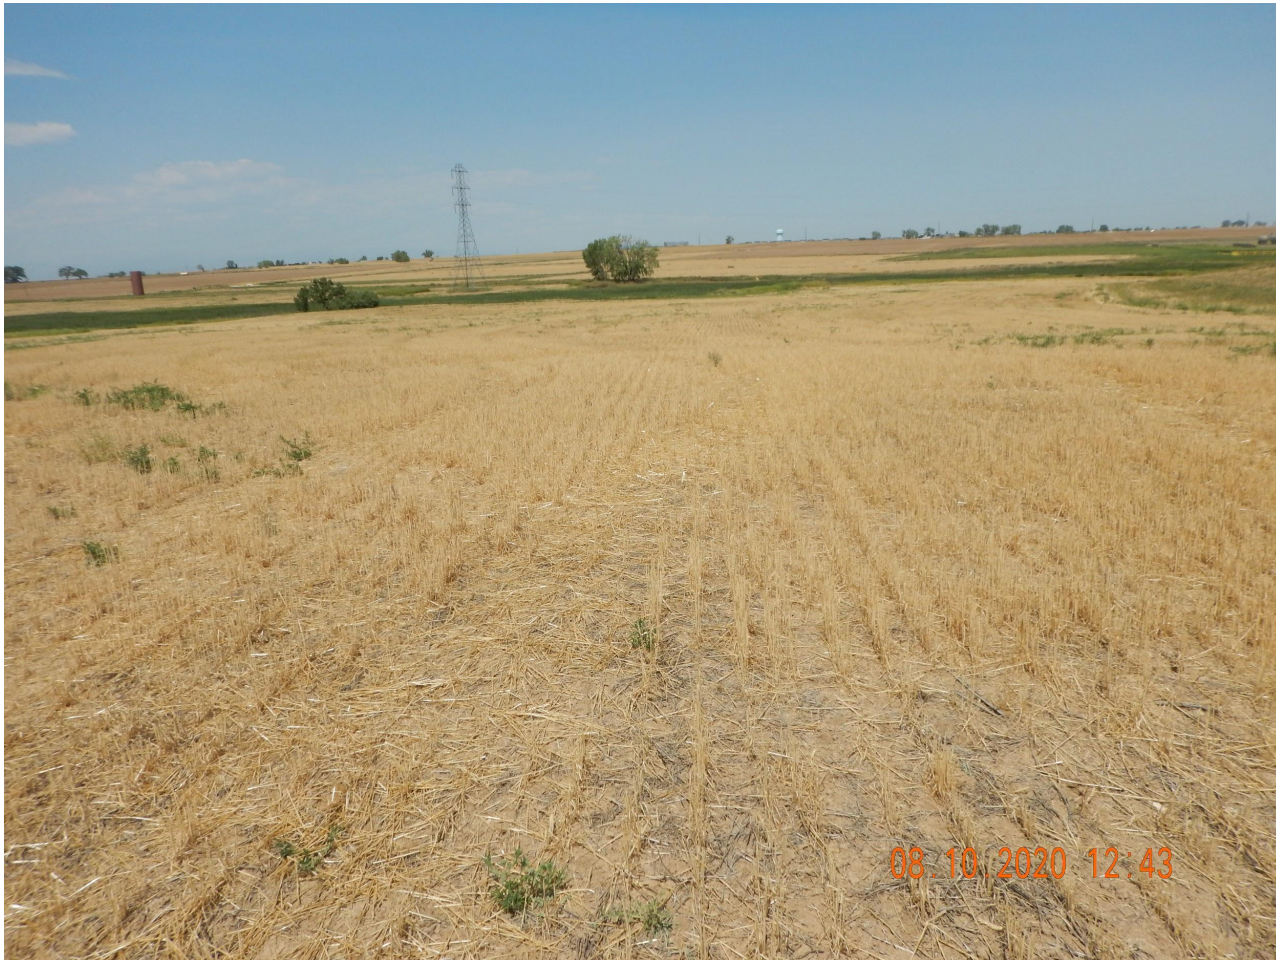
Photo 2. Reference photo taken north of plugged and abandoned well location, facing North. See comments under Photo 1.

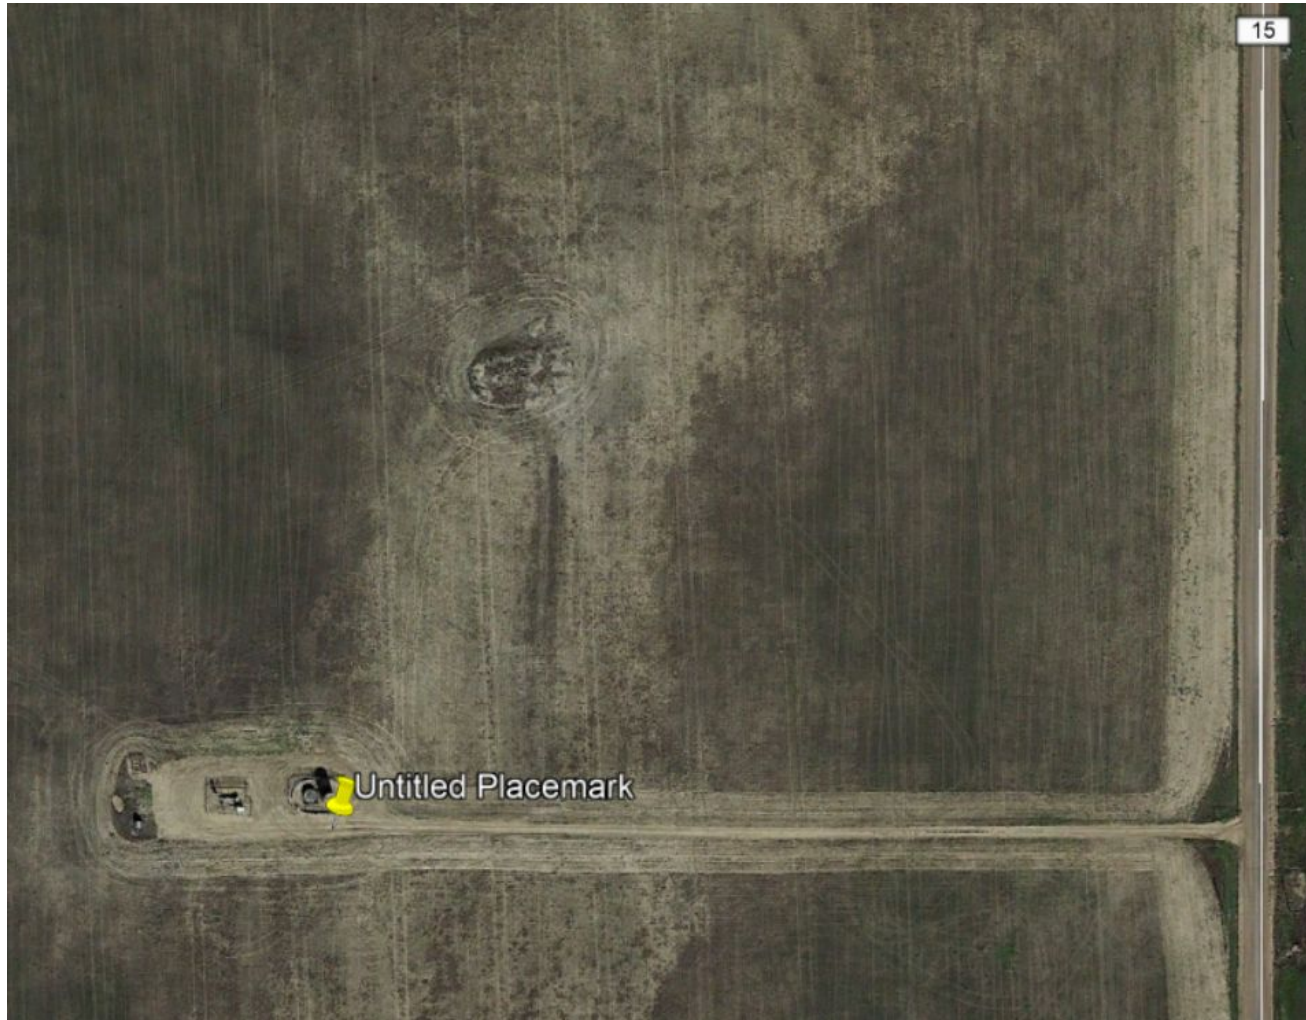
Photo 3. Google Earth aerial imagery taken 10/6/2013 illustrates the access road and location (well and tank battery).

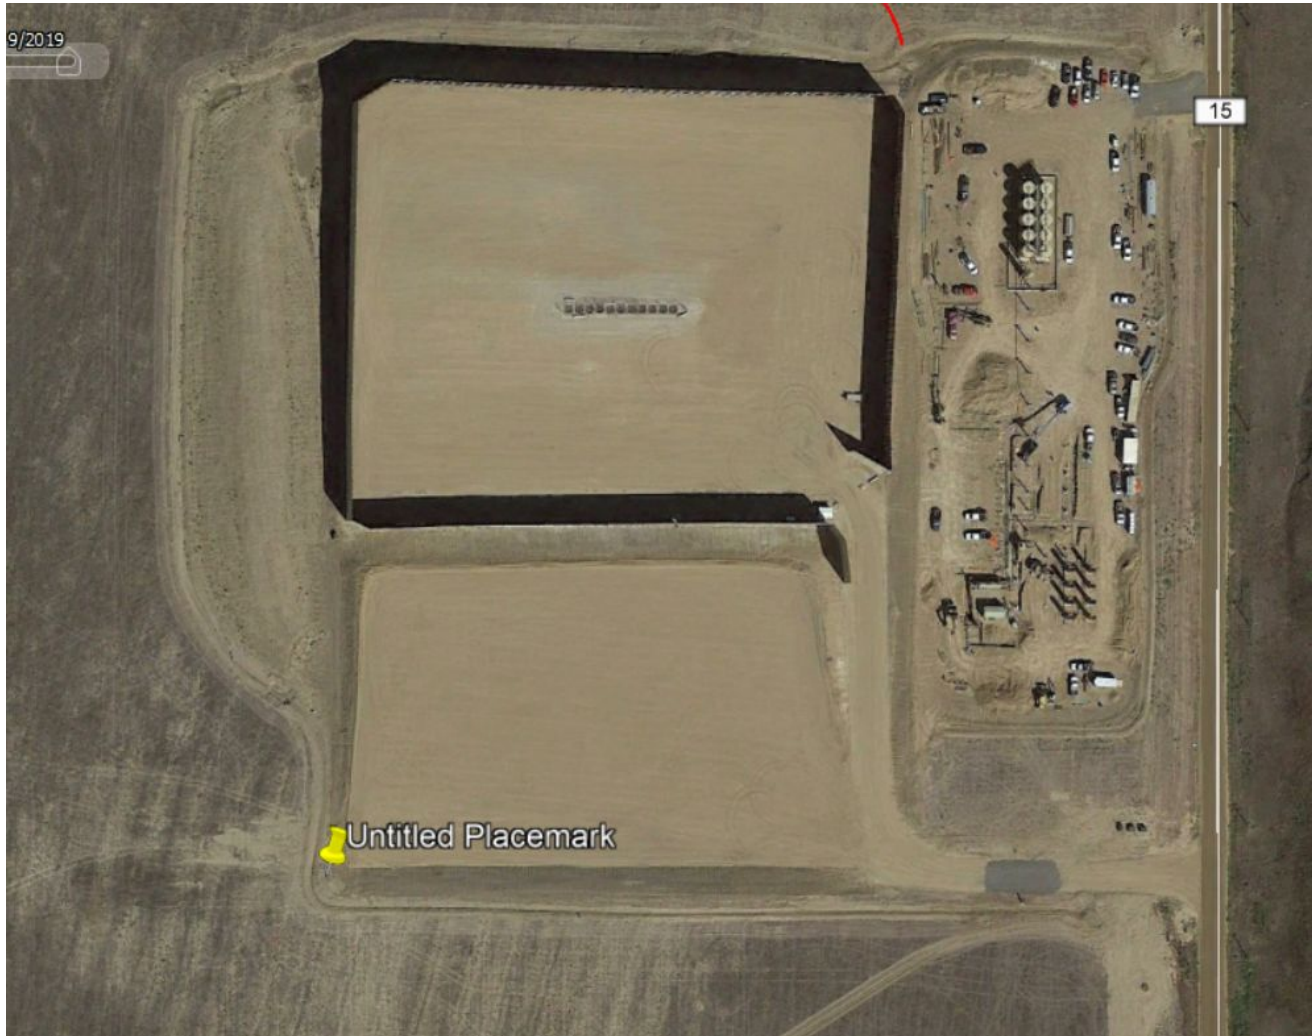
Photo 4. Google Earth aerial imagery taken 9/12/2019 illustrates a new location (Location ID 455598; Hingley /18H-A167) built by Crestone Peak that overlaps most of the previous disturbance areas (i.e, access road and the eastern location); therefore this will be a well release on an active location.
