Inspection Photos

Location Name: HORN SPRINGS GAS COM 33-33

API#: 05-071-06105

INSP. #: 695103152

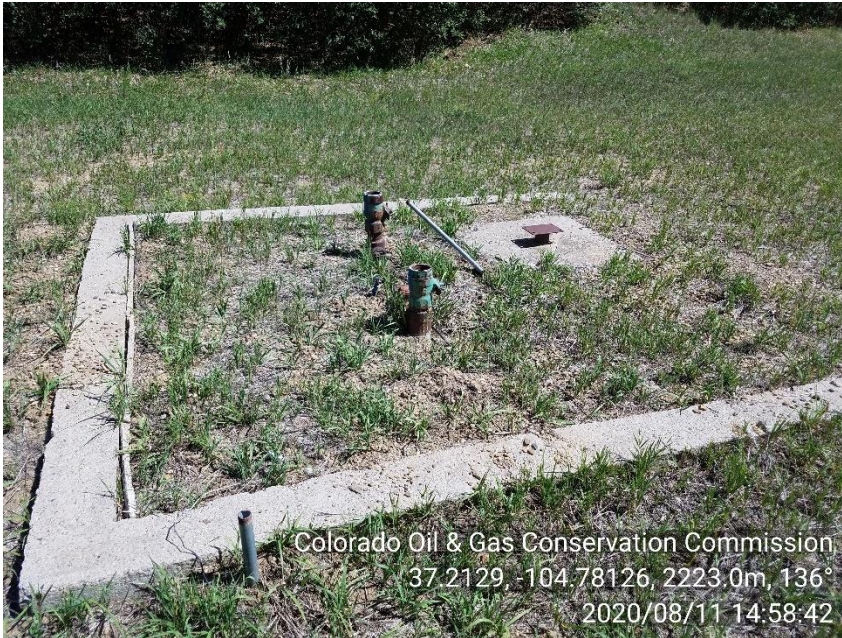
**PHOTO 3: UNUSED RISERS JUST SOUTH OF LOCATION.
REMOVE UNUSED RISERS, COMPLY WITH RULE 603.f. CA
DATE 11-11-20.**

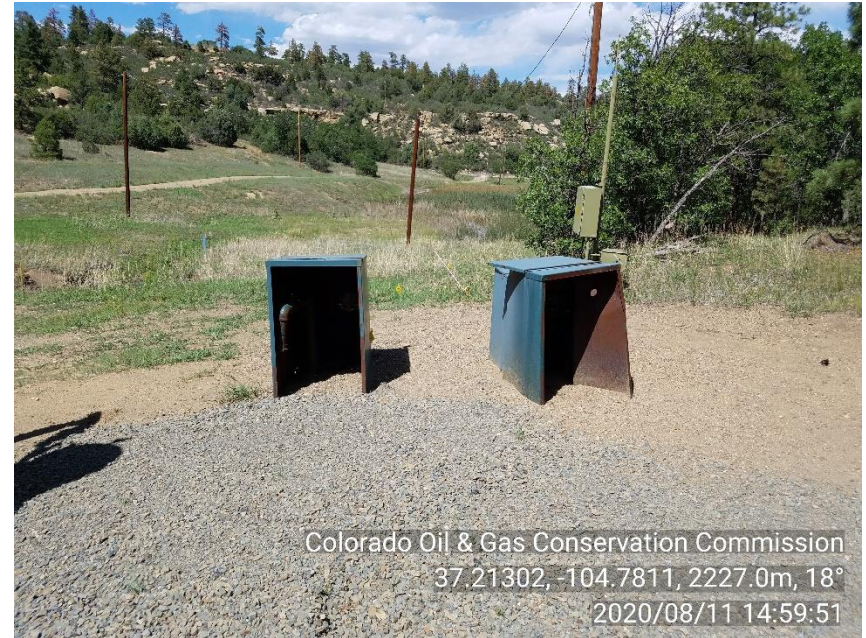
**PHOTO 4: UNUSED RISERS UNDER STEEL BOXES NORTHEAST
OF METERHOUSE. REMOVE UNUSED RISERS, COMPLY WITH
RULE 603.f. CA DATE 11-11-20.**

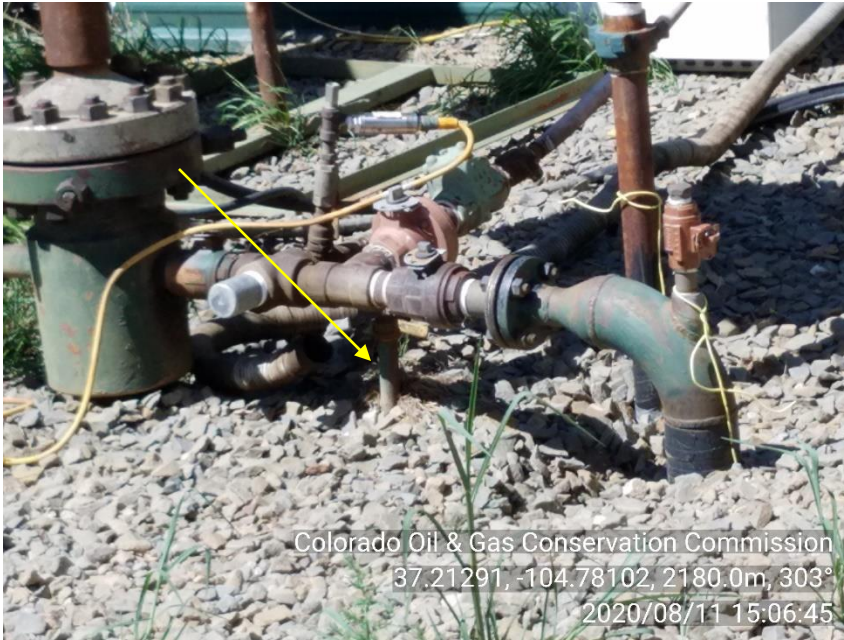
PHOTO 5: UNUSED 1" RISERS NEXT TO WELLHEAD UNDER 2" PRODUCTION LINE. REMOVE UNUSED RISERS, COMPLY WITH RULE 603.f. CA DATE 11-11-20.

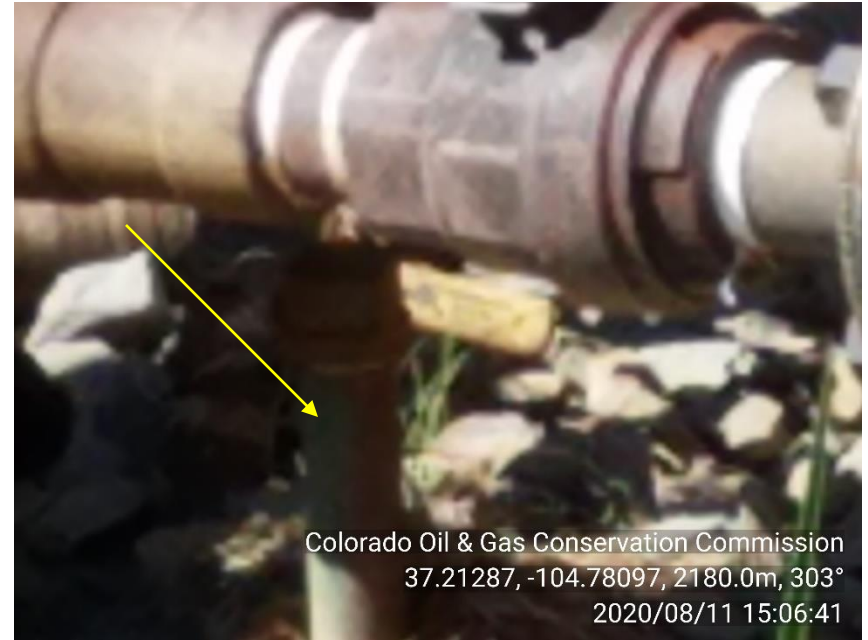
PHOTO 6: CLOSER IMAGE OF 1" RISER MENTIONED IN PREVIOUS PHOTO.
