# Inspection Photos

Operator: EAGLE OPERATING INC - 26155

Location ID: 397838

Rio Blanco County, CO

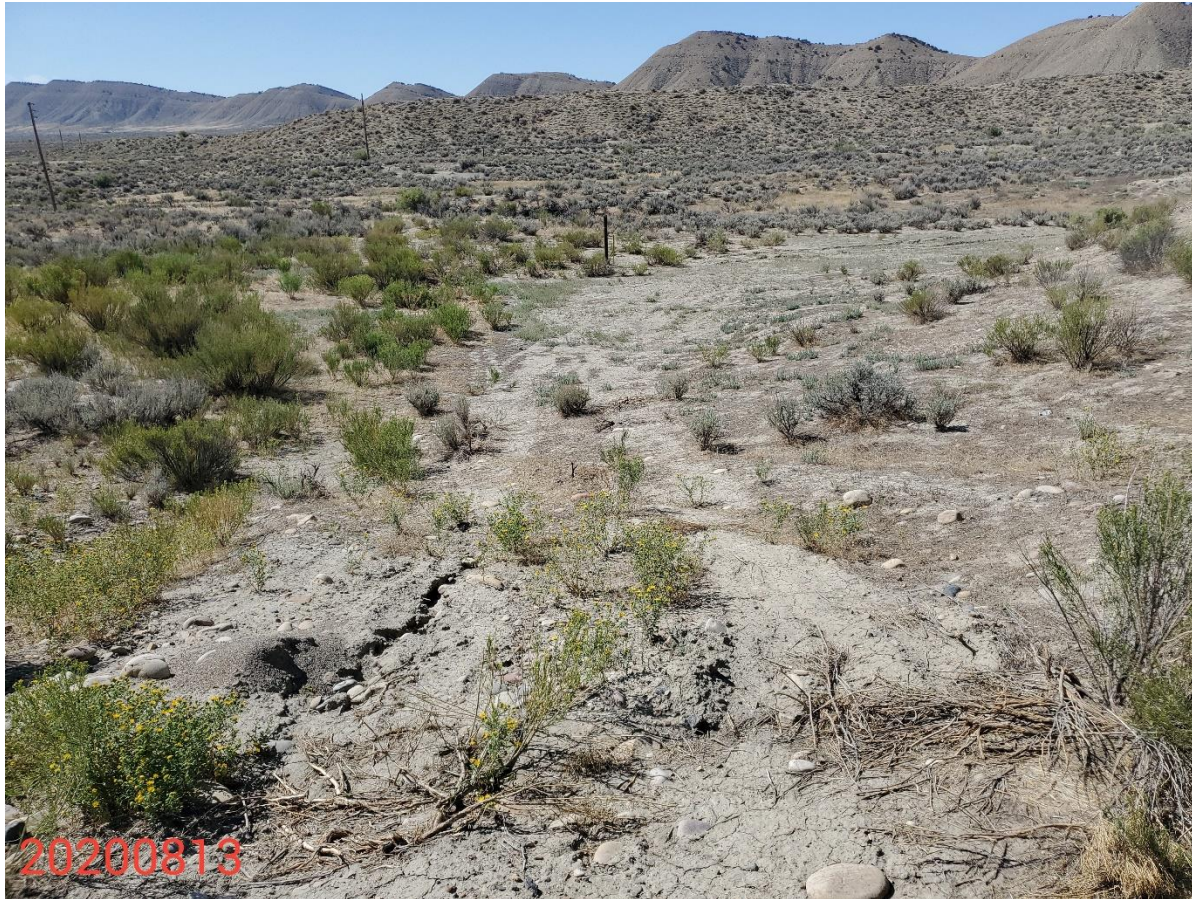
**Photo 1:** Photo taken from the north end of the Location, facing south. Photo shows areas off the access road that were utilized for access the location. Erosion degradation evident.

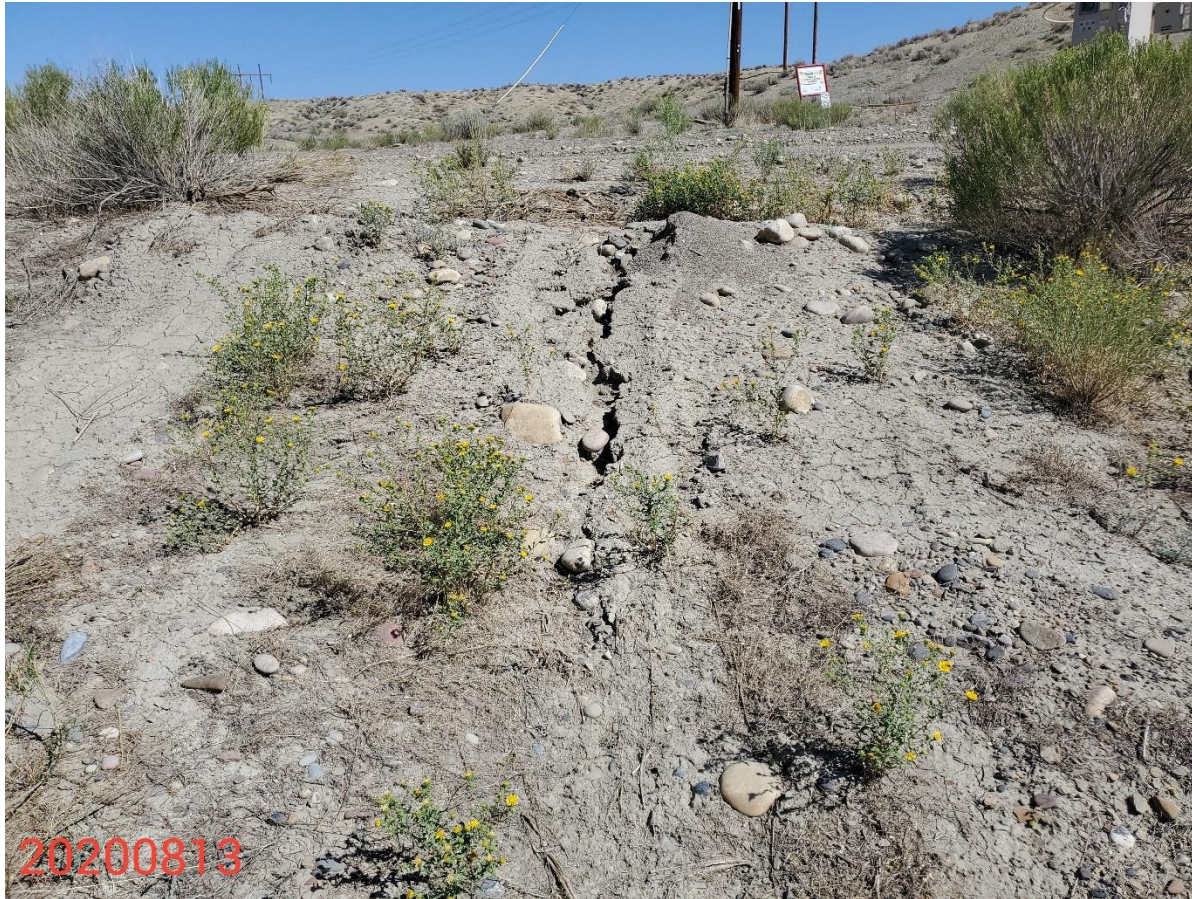
**Photo 2:** Continued from photo 1.

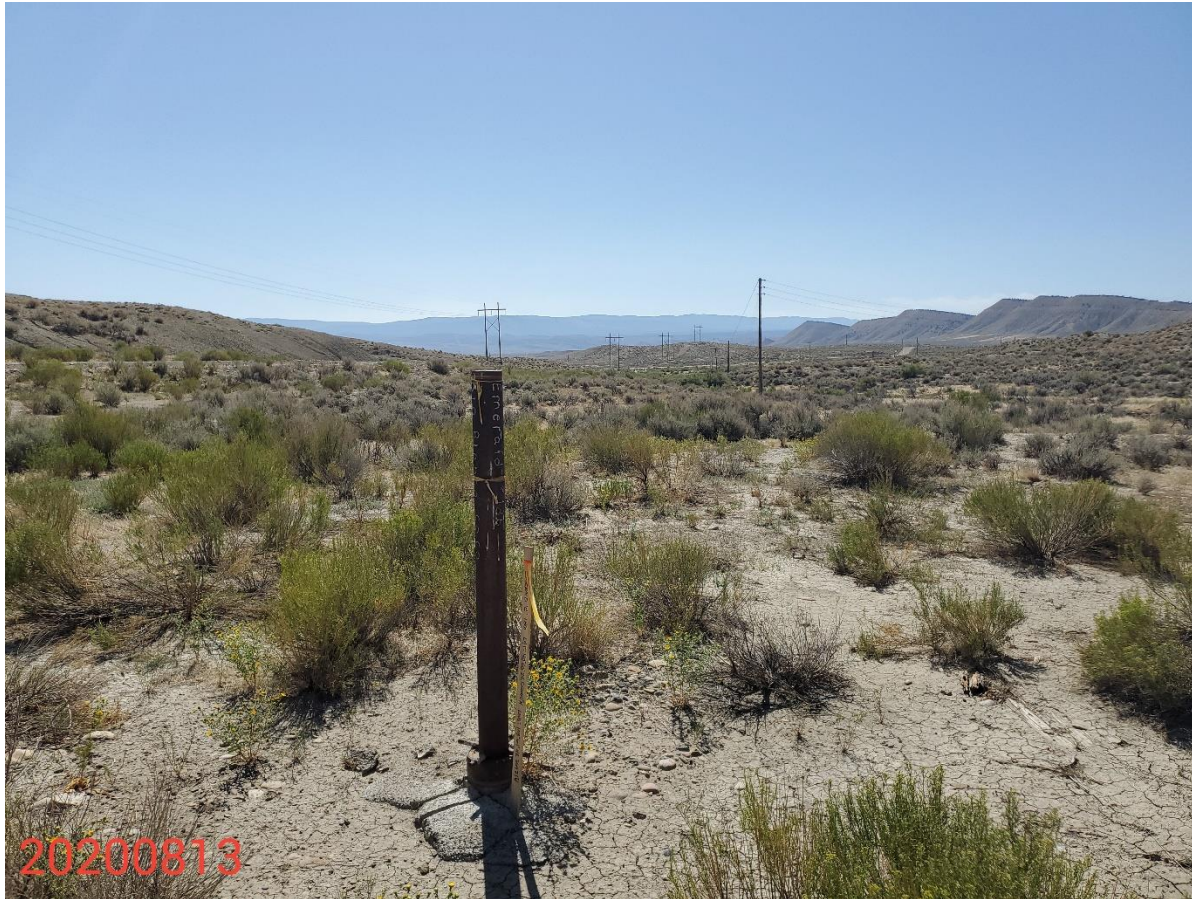
**Photo 3:** Photo taken from the Location, facing south. Photo show utility equipment has been removed.

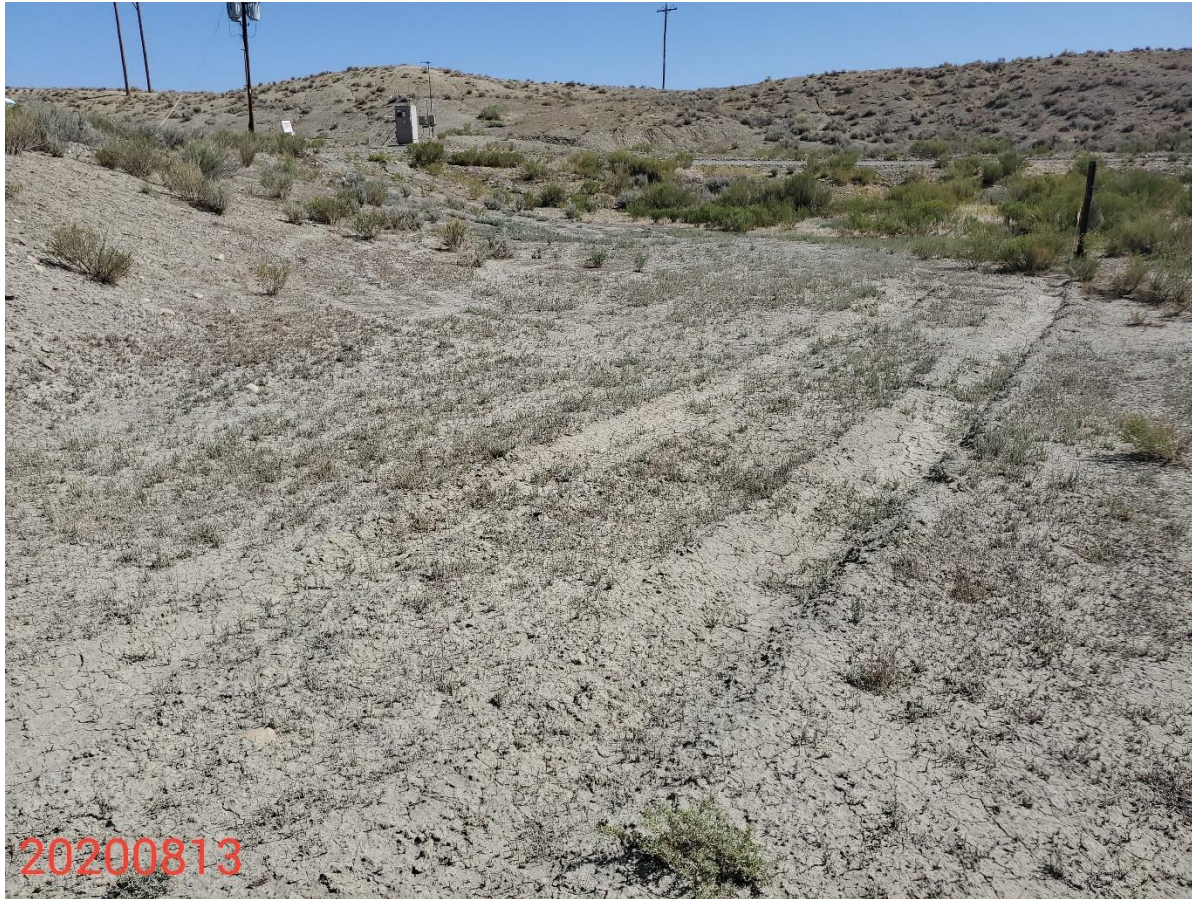
**Photo 4:** Photo taken from the west end of the Location, facing east. Photo shows areas that appears to have been disturbed during work. Additional disturbance do not appear to have been reclaimed.

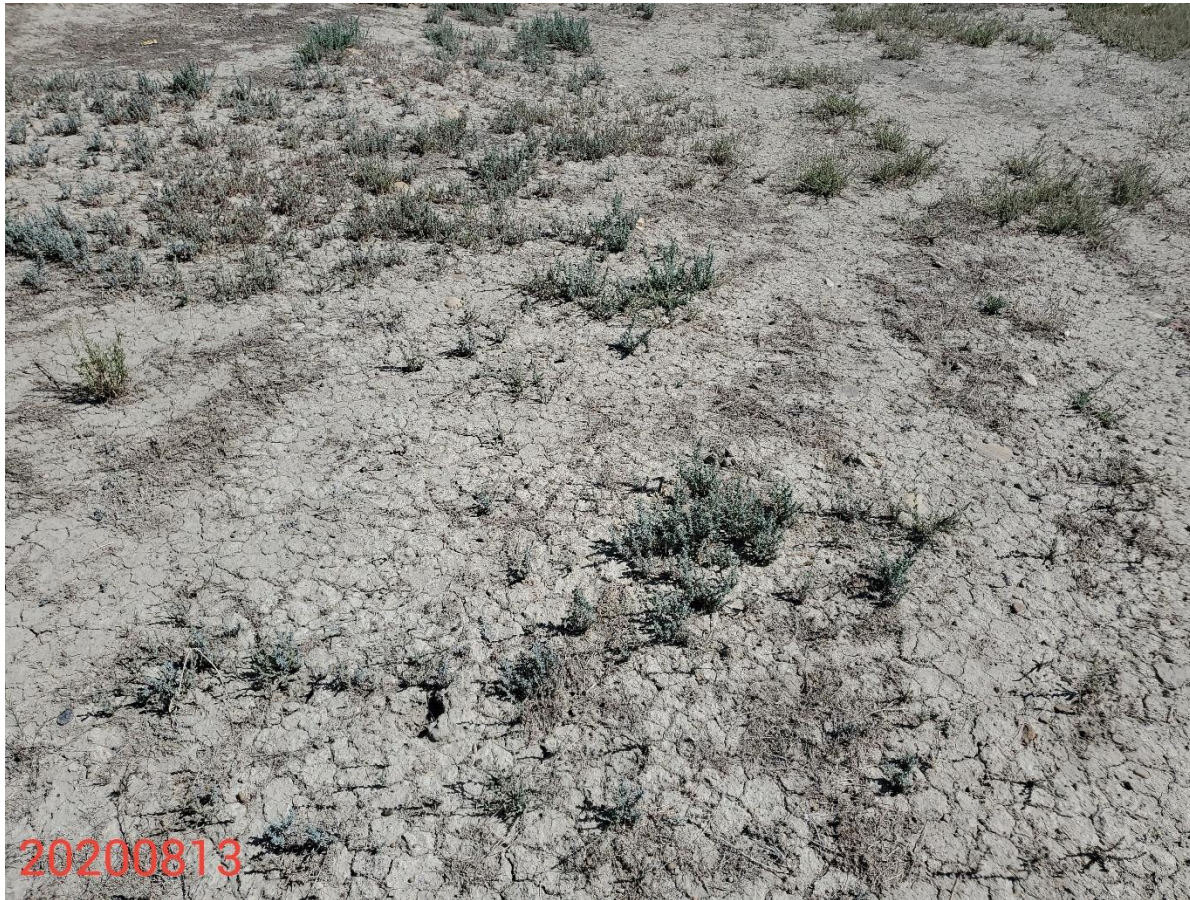
**Photo 5:** Photo taken from the Location. Photo shows Halogeton establishment on the Location. This is a Colorado State Listed noxious weed that requires management.
