# Inspection Photos

Location Name: BLUESKY 44-17

API#: 05-071-08511

INSP. #: 695103160

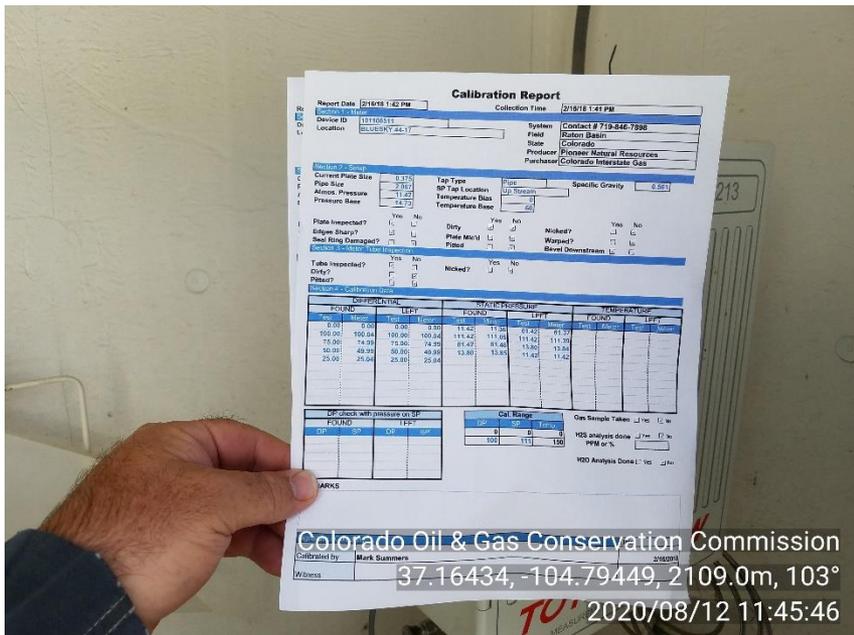
**PHOTO 3: NO CURRENT CALIBRATION ON GAS METER.**  
 Provide calibration records or calibrate meter as required by Rule 329. CA DATE 9-12-20.

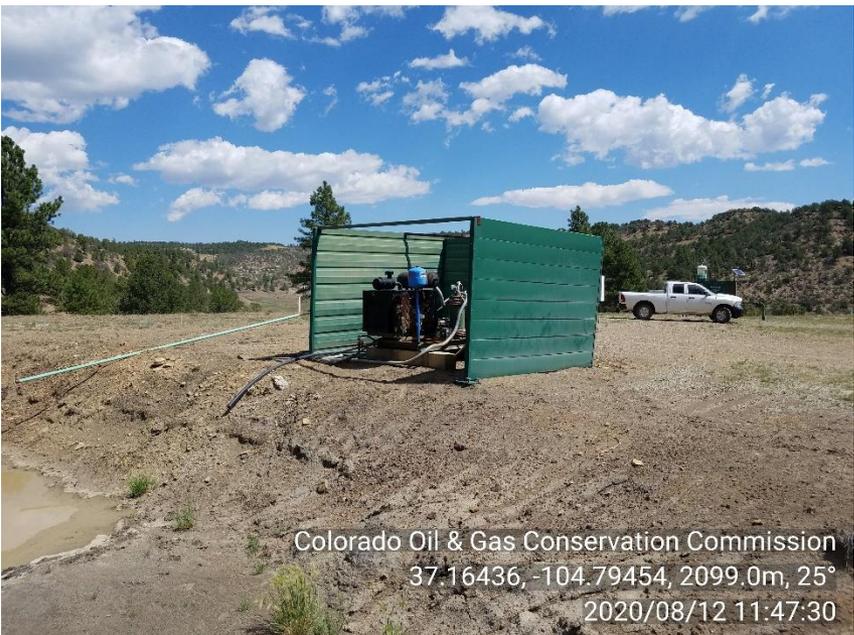
**PHOTO 4: UNUSED EQUIPMENT (GAS ENGINE SKID IS NOT CONNECTED). REMOVE UNUSED EQUIPEMNT OR PUT EQUIPMENT INTO USE, COMPLY WITH RULE 603.f. CA DATE 11-12-20.**

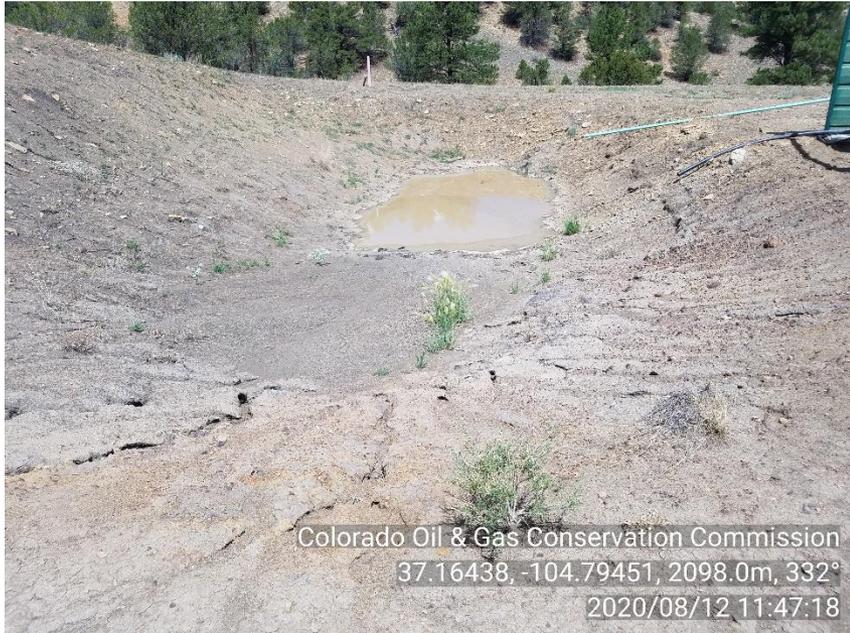
**PHOTO 5: NO FREEBOARD MARKER IN PRODUCED WATER  
PIT. INSTALL FREEBOARD MARKER, COMPLY WITH RULE  
902.b. CA DATE 11-12-20.**
