Inspection Photos
Location Name: PORTABELLO 23-20
API#: 05-071-06810
INSP. #: 695103162

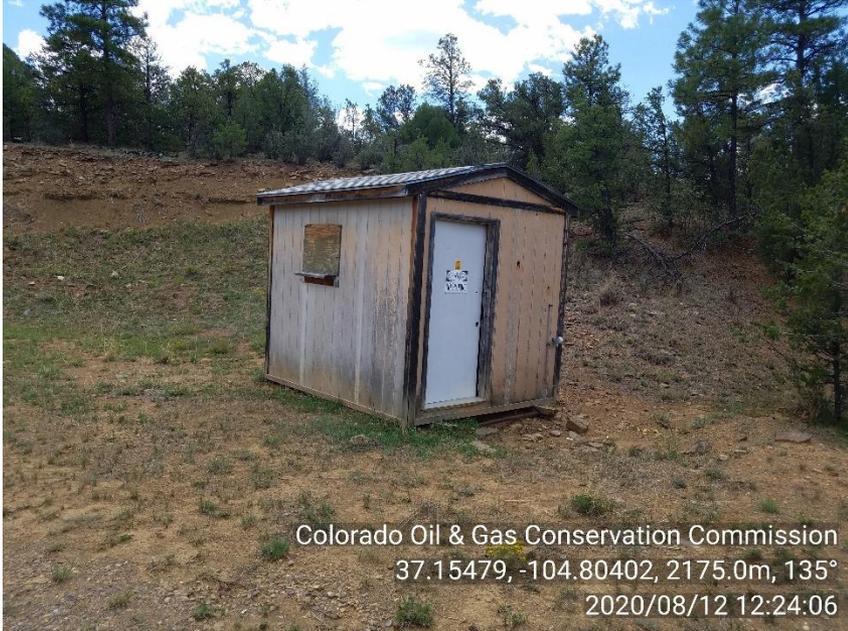
PHOTO 3: UNUSED EQUIPMENT (SHED ON SOUTHEAST CORNER OF LOCATION). REMOVE UNUSED EQUIPMENT, COMPLY WITH RULE 603.f. CA DATE 11-12-20.

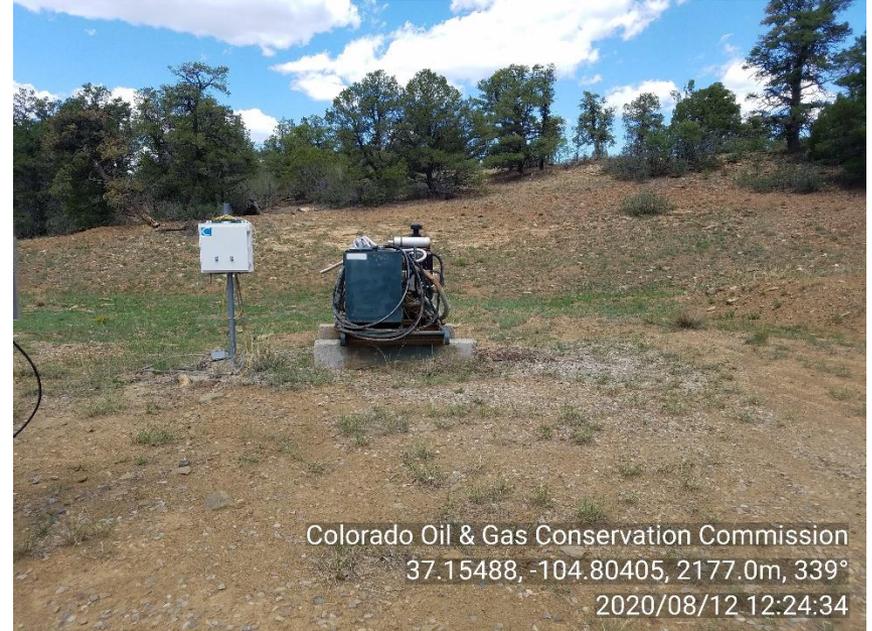
PHOTO 4: UNUSED EQUIPMENT (ENGINE SKID AND TELEMETRY TOWER). REMOVE UNUSED EQUIPMENT, COMPLY WITH RULE 603.f. CA DATE 11-12-20.
