**Inspection Photos**  
**Location Name: VPR C NO. 29**  
**API#: 05-071-06931**  
**INSP. #: 695103168**

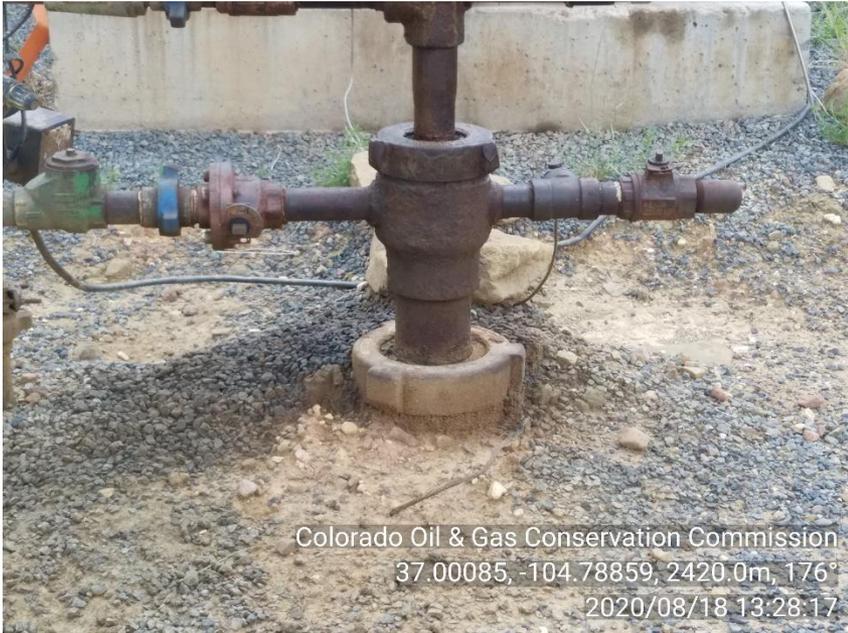
**PHOTO 3: AREA OF IMPACTED SOIL AROUND WELLHEAD. REMOVE IMPACTED SOIL, Non E&P Waste not properly stored, handled, transported, treated, or disposed per Rule 907A. CA DATE 11-18-20.**

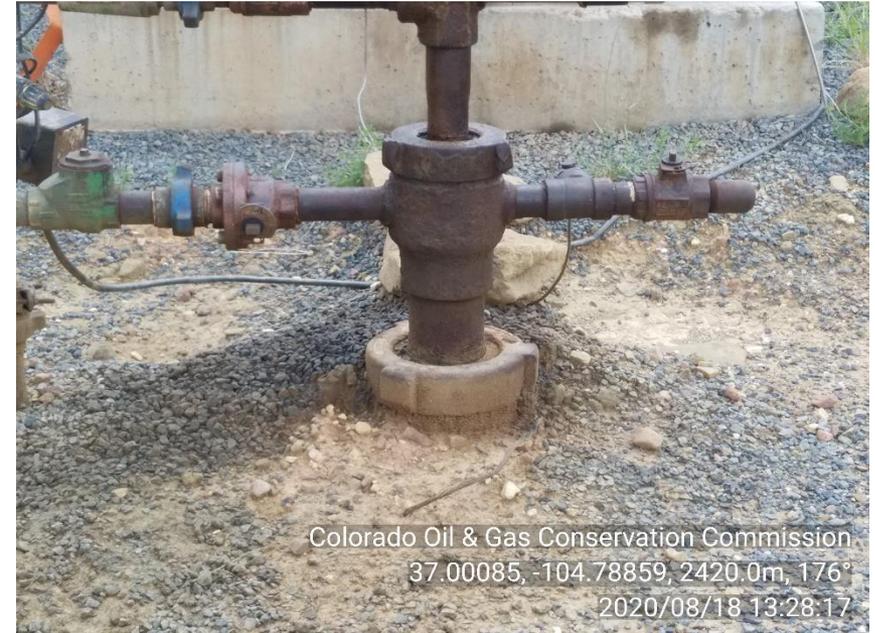
**PHOTO 4: BRADENHEAD IS NOT PLUMBED TO SURFACE. PLUMB BRADENHEAD TO SURFACE, COMPLY WITH RULE 608e. CA DATE 11-18-20.**
