# Inspection Photos

API: 071-06128

Operator: TIMBER CREEK OPERATING

Inspection Date: 8/27/2020

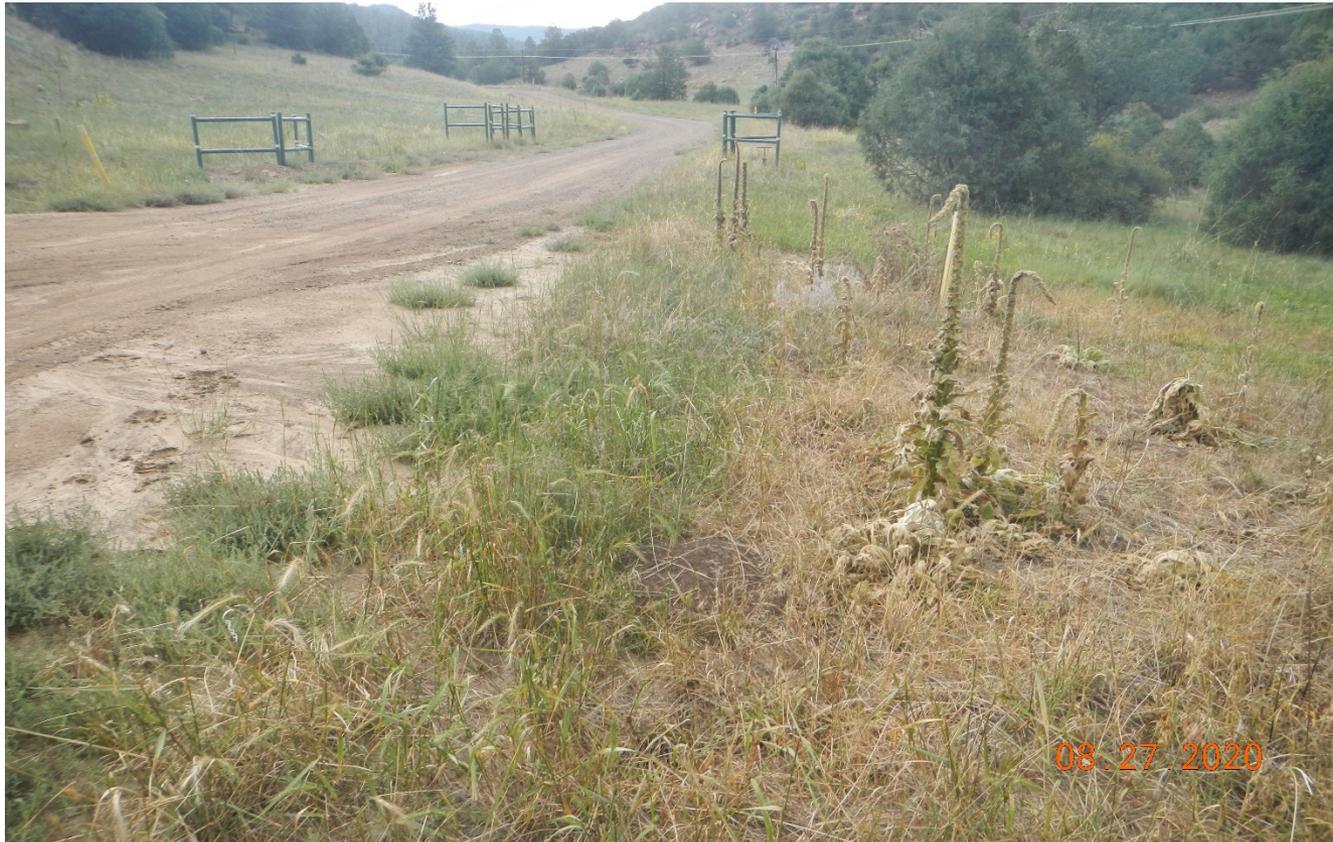
**Photo 1.** It appears noxious weeds were controlled along the road. Some of the grass vegetation appears to be browning as well.

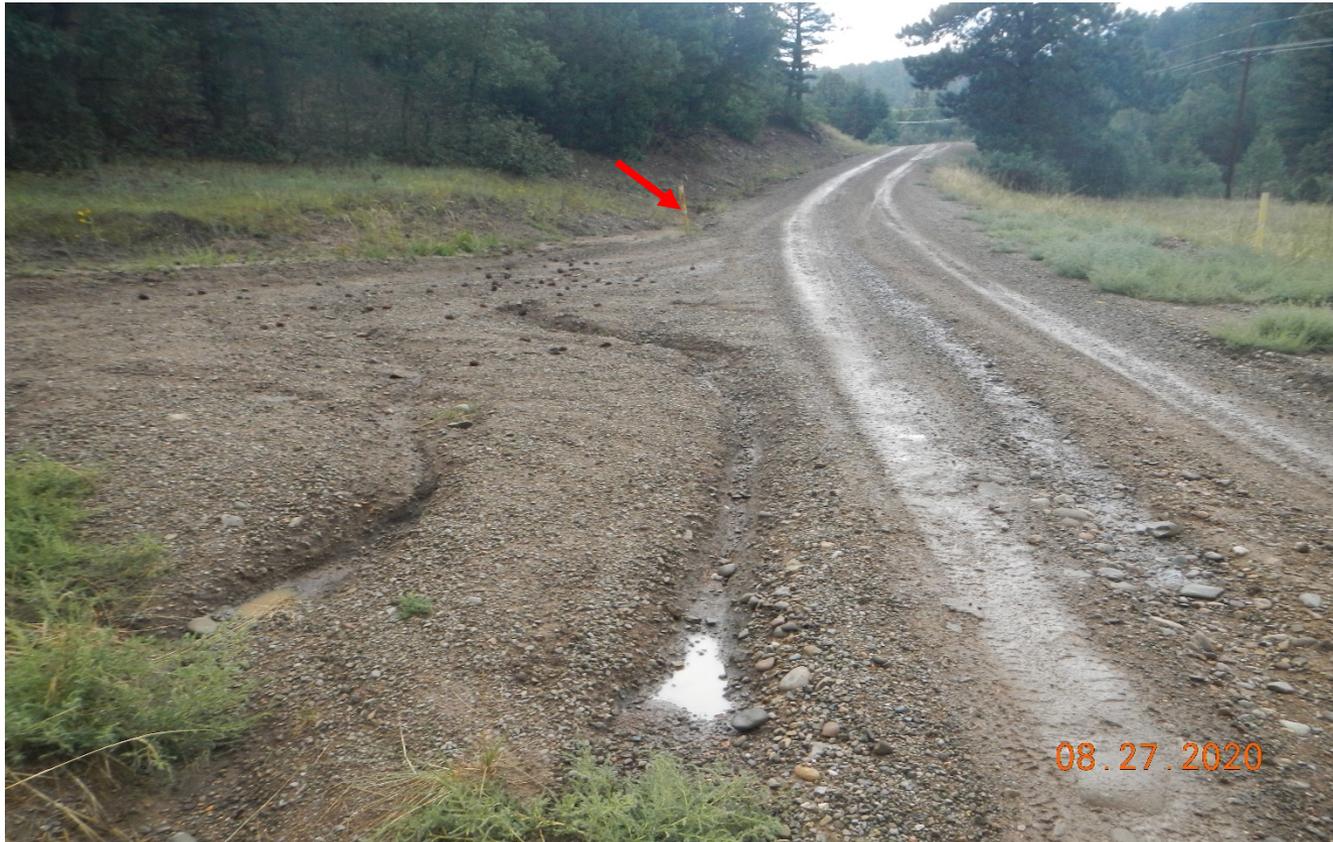
**Photo 2.** There is a plugged culvert along the main road (red arrow) causing stormwater to flow down the road. Lat/Long:37.09178,-104.93688.

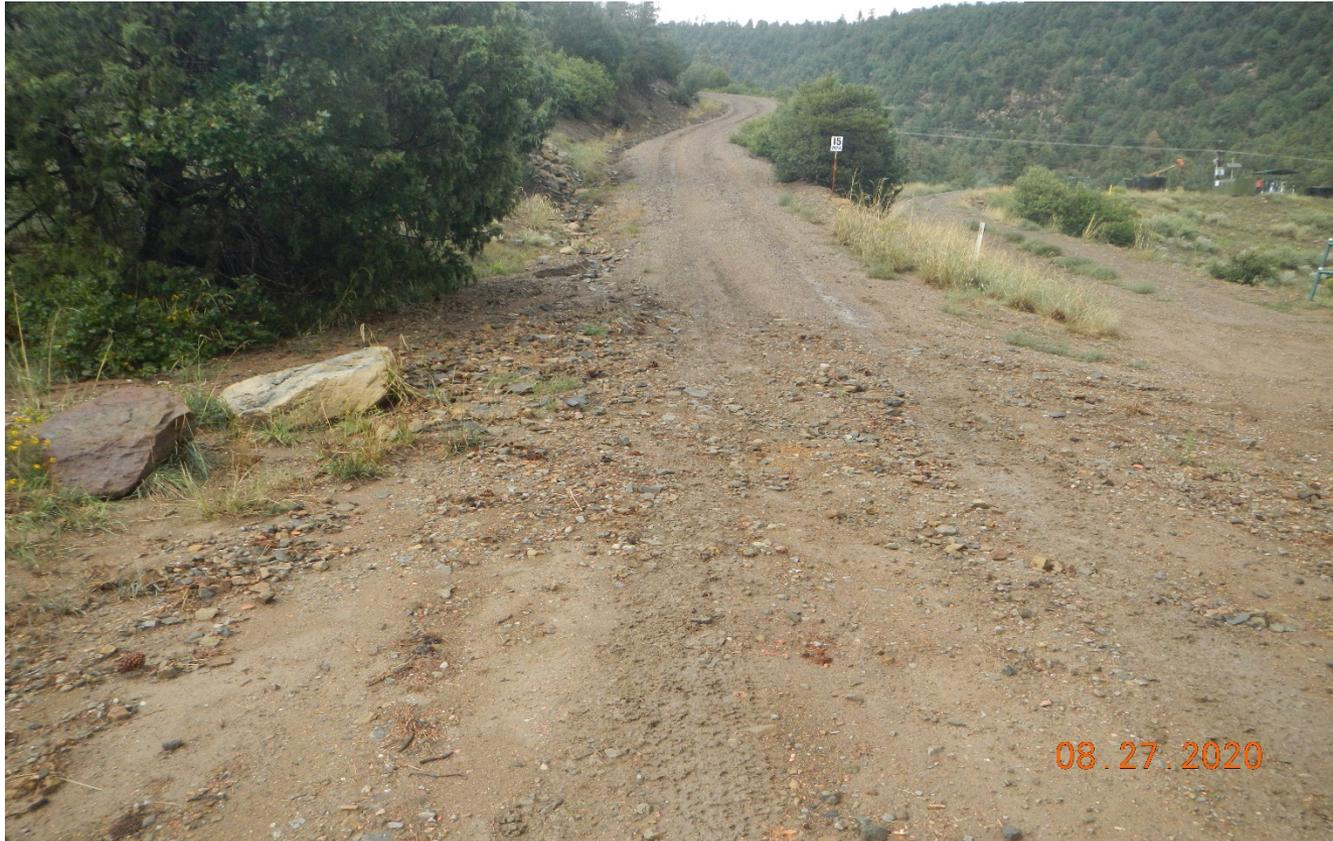
**Photo 3.** There is sediment accumulation at the bottom of the road which appears to be coming uphill from the access road or pipeline area.

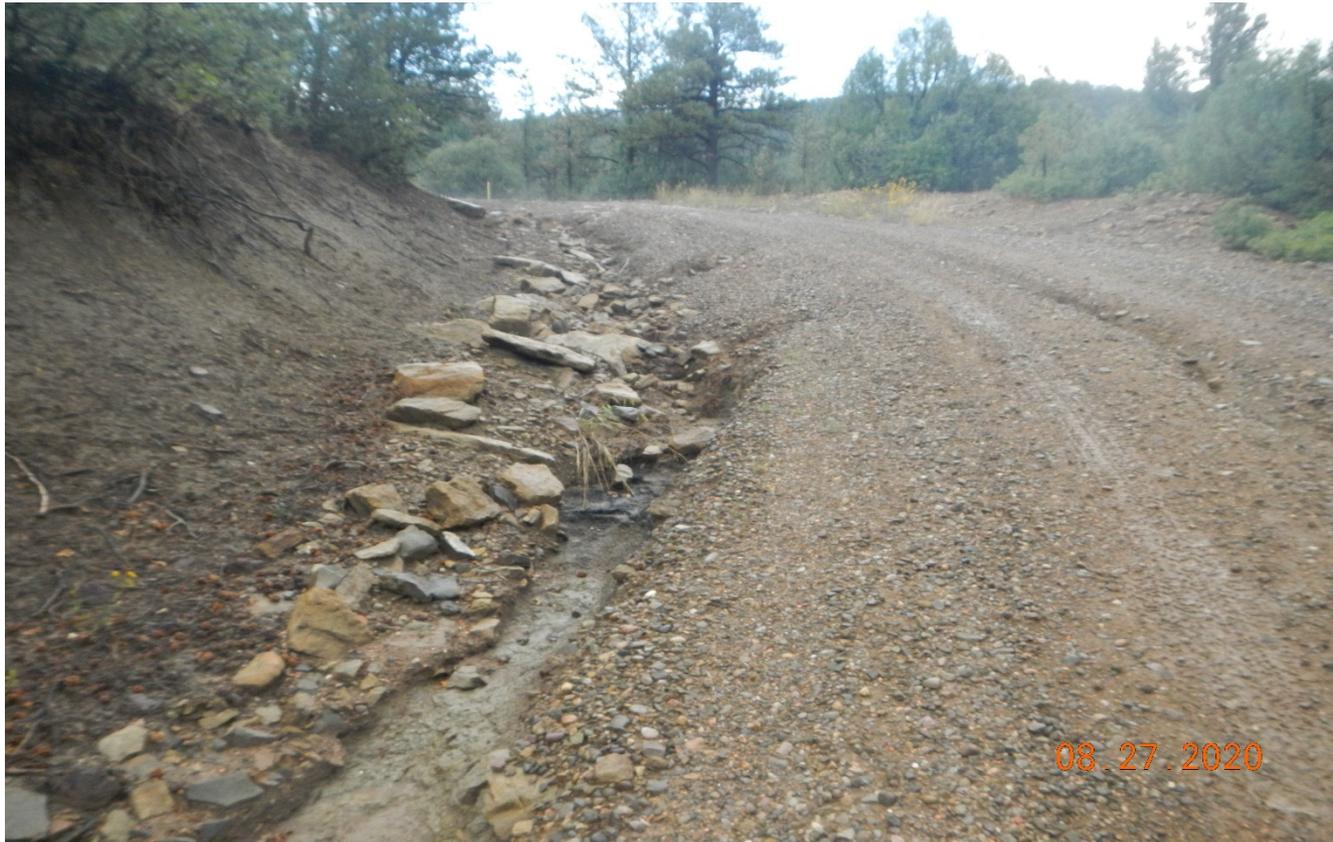
**Photo 4.** BMP's are needed along the side of the road to dissipate stormwater flow.

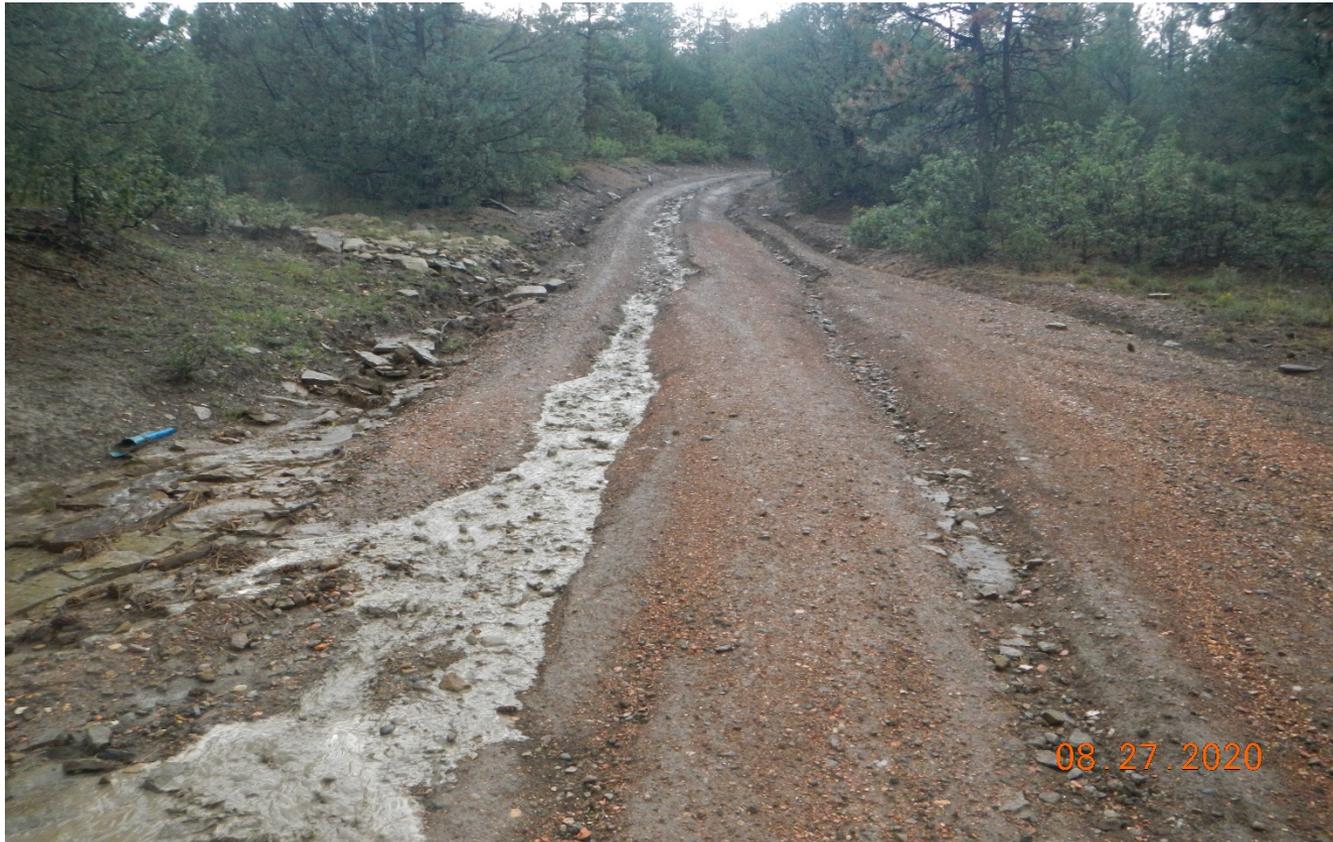
**Photo 5.** Stormwater is flowing down the road which is causing erosion and degradation of the road.

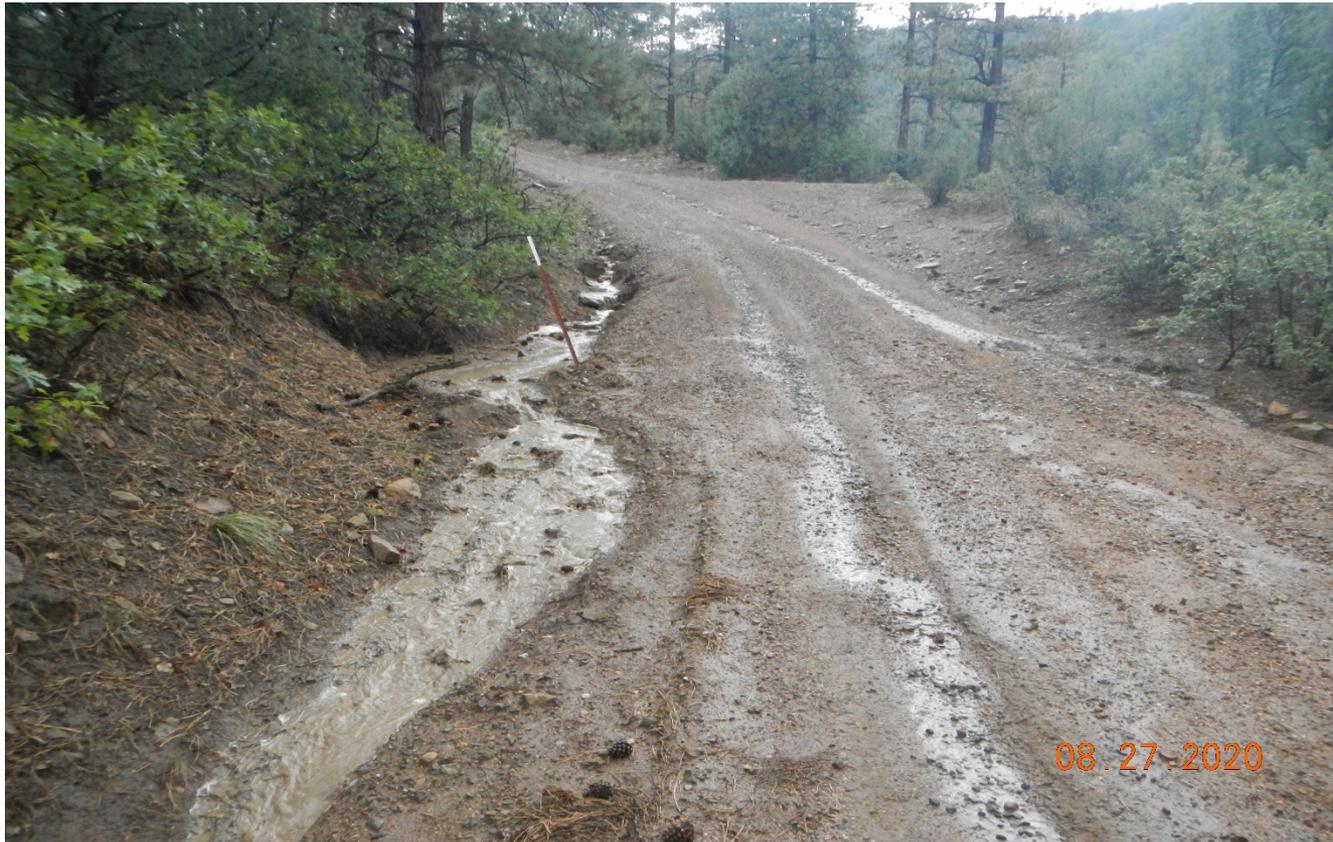
**Photo 6.** The culvert is plugged up along the road causing stormwater to flow down the road as shown in the previous photo.

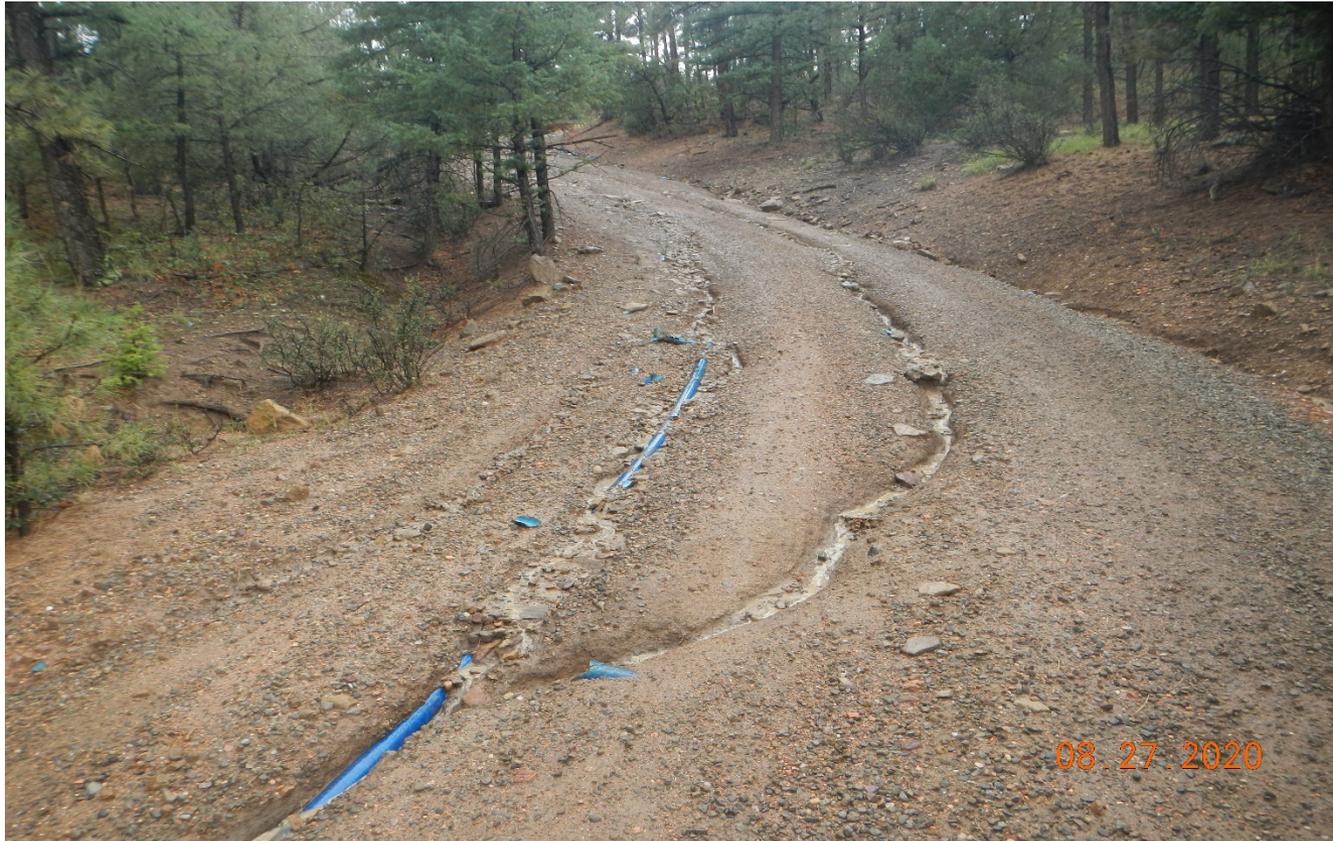
**Photo 7.** Facing southwest along the access road. There is erosion occurring down the road. The blue plastic debris from pipe should be picked up.

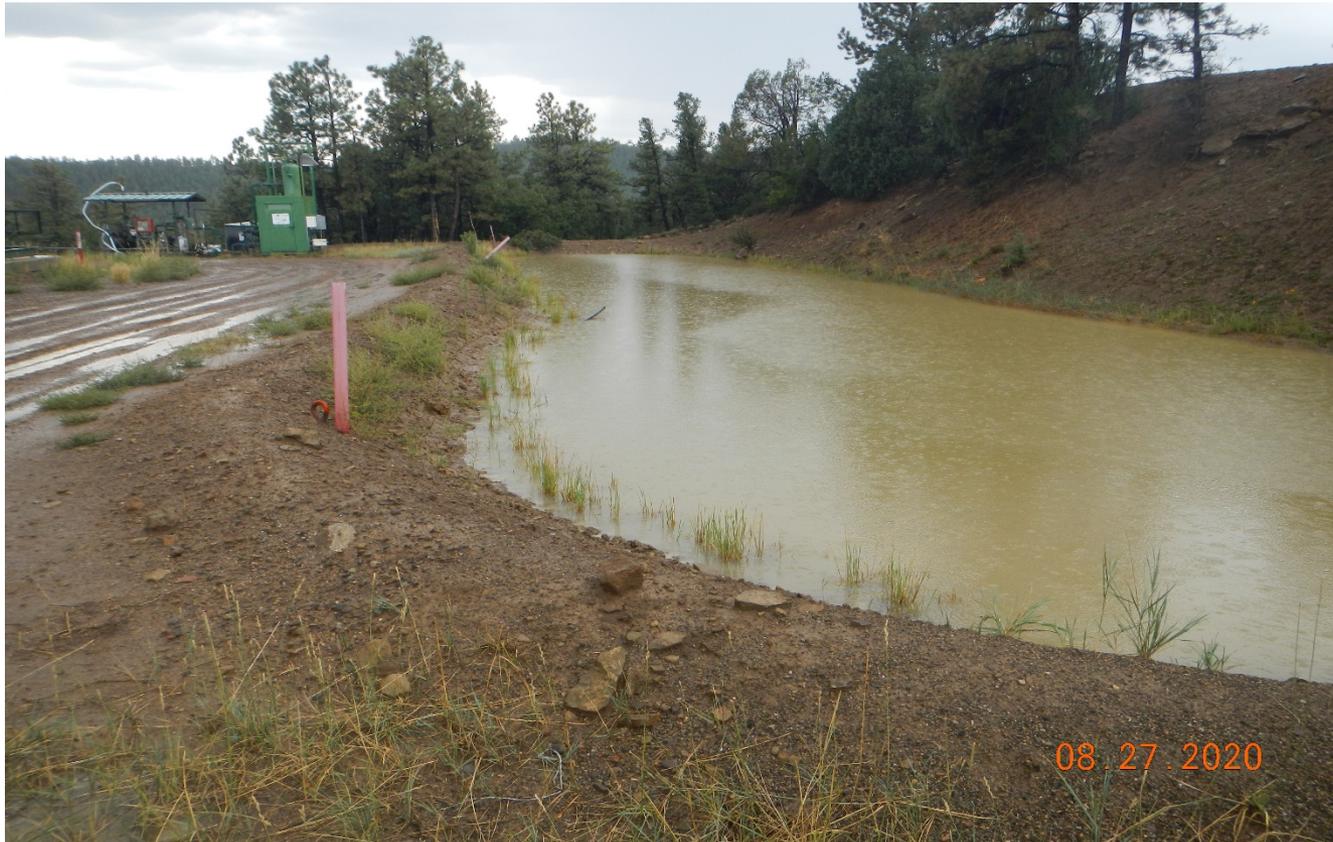
**Photo 8.** The water in the pit is approaching 2 ft. freeboard.
