Inspection Photos
Spill ID 449632
Remediation Project 10149
Inspection Date: 8/26/2020
All Photos taken by Kris Neidel

COLORADO
Oil & Gas Conservation
Commission
Department of Natural Resources

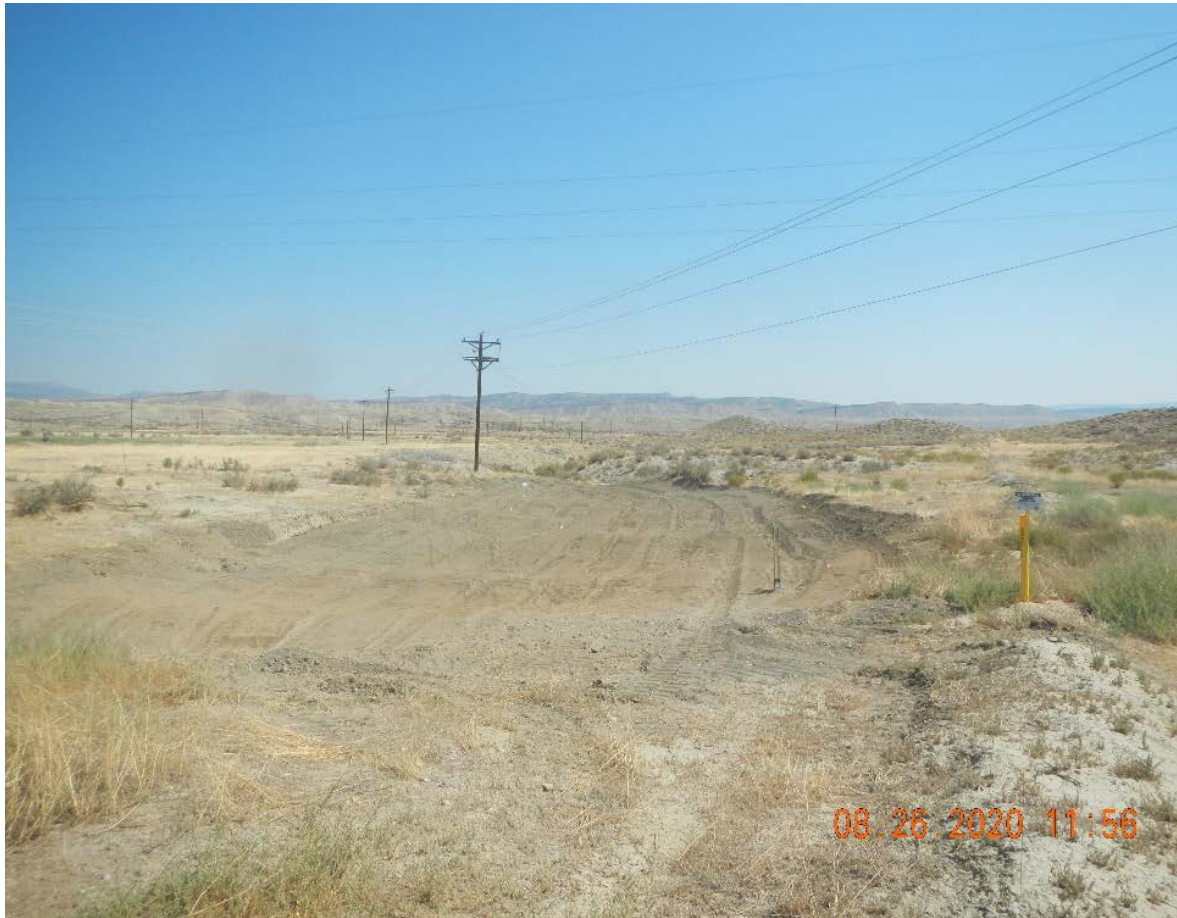
Photo #1 Overview of the Bowl Area looking northeast. Note tilled soil in center of bowl. Soil will need to be imported to restore the original contour of the bowl.

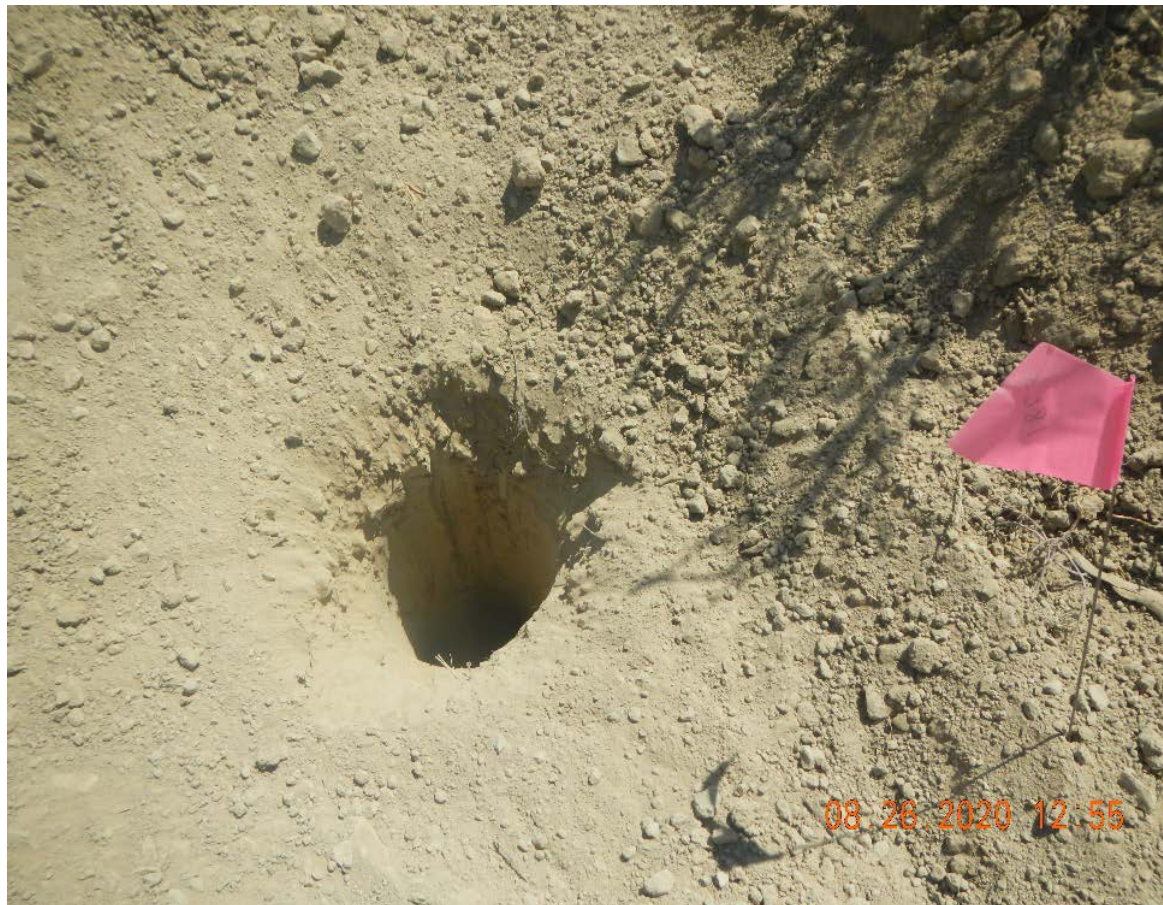
Photo #2 Holes were drilled with a gas powered auger, loose soil removed with a post hole digger, then soils taken from the wall of the hole at the appropriate depth.

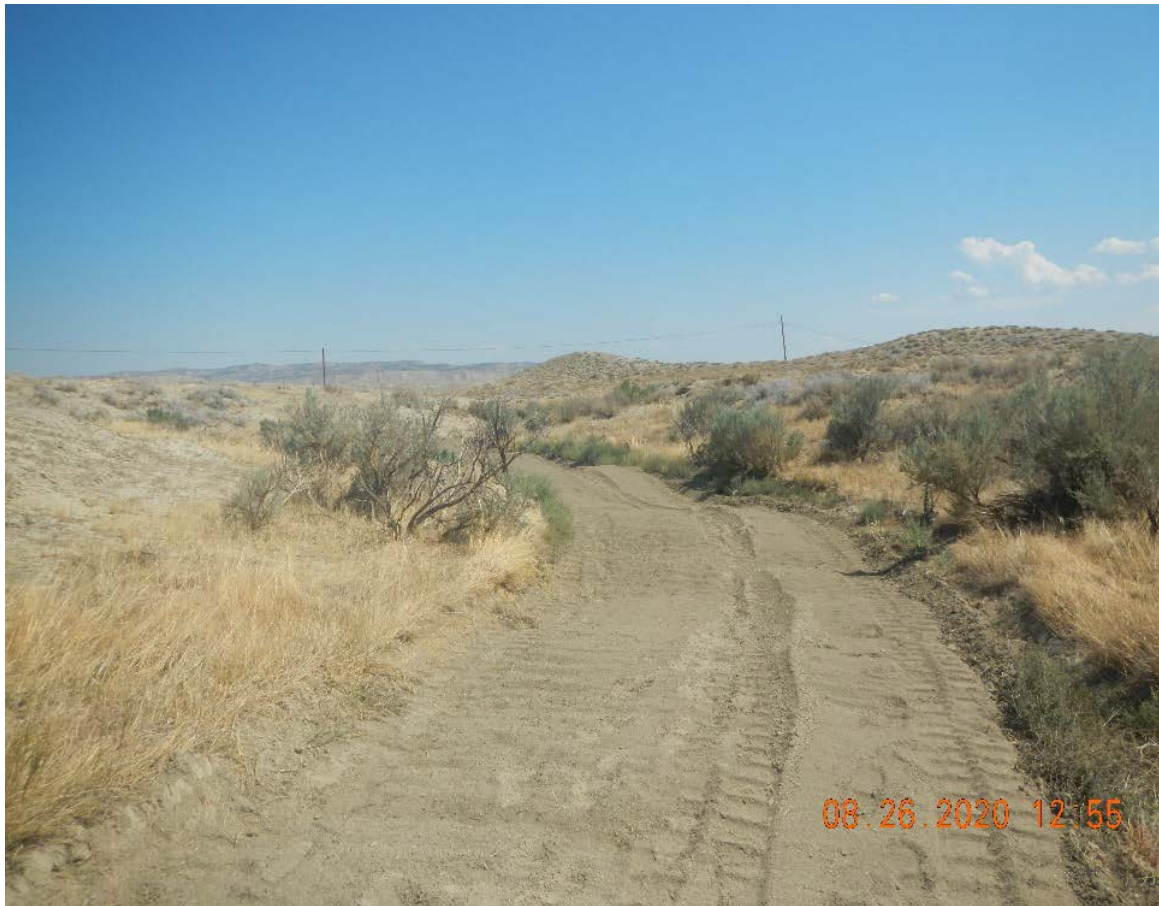
Photo #3 Photo of the spill path below the Bowl, referred to as Division 1 in Remediation document. This area has been tilled regularly with a skid steer mounted implement. The entire spill path is free of any visible hydrocarbon.

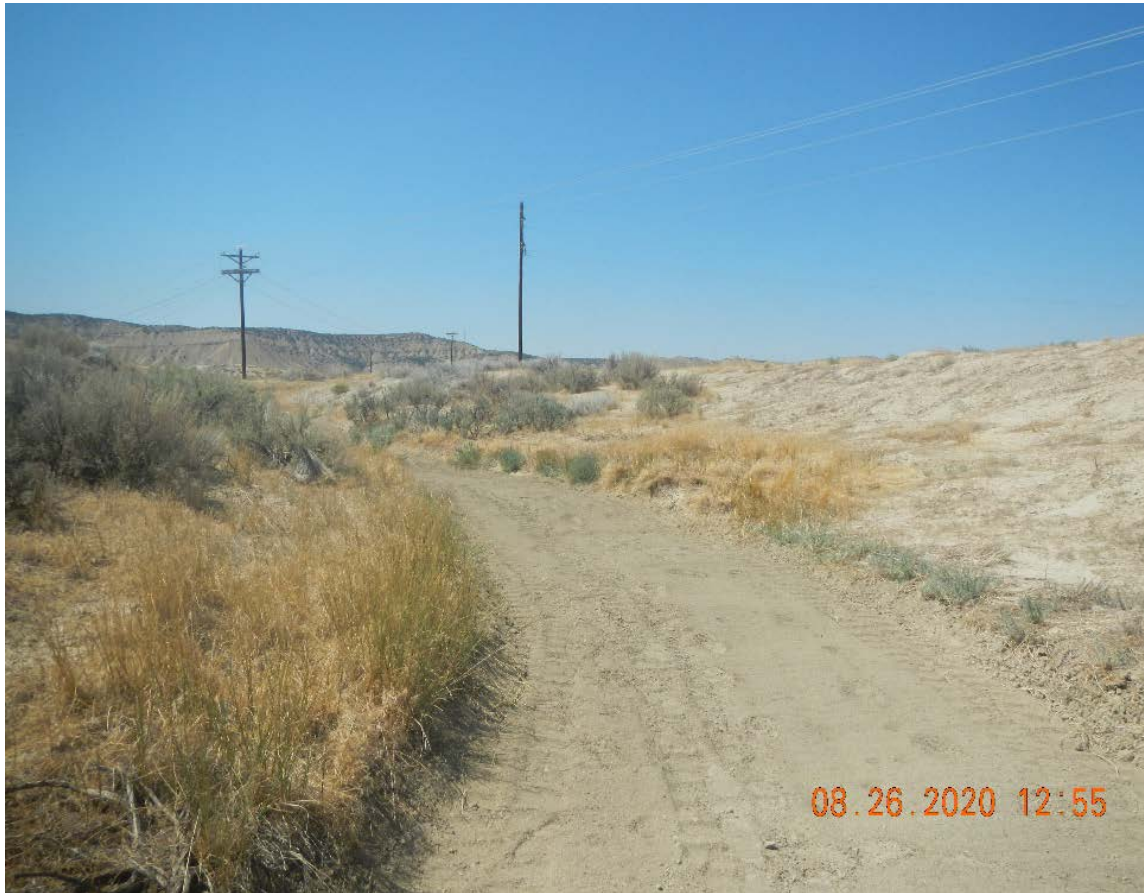
Photo #4 of Division 1. No vegetation is present in this division due to the frequency of tilling (see remediation project for tilling details). The entire spill path is free of any visible hydrocarbon.

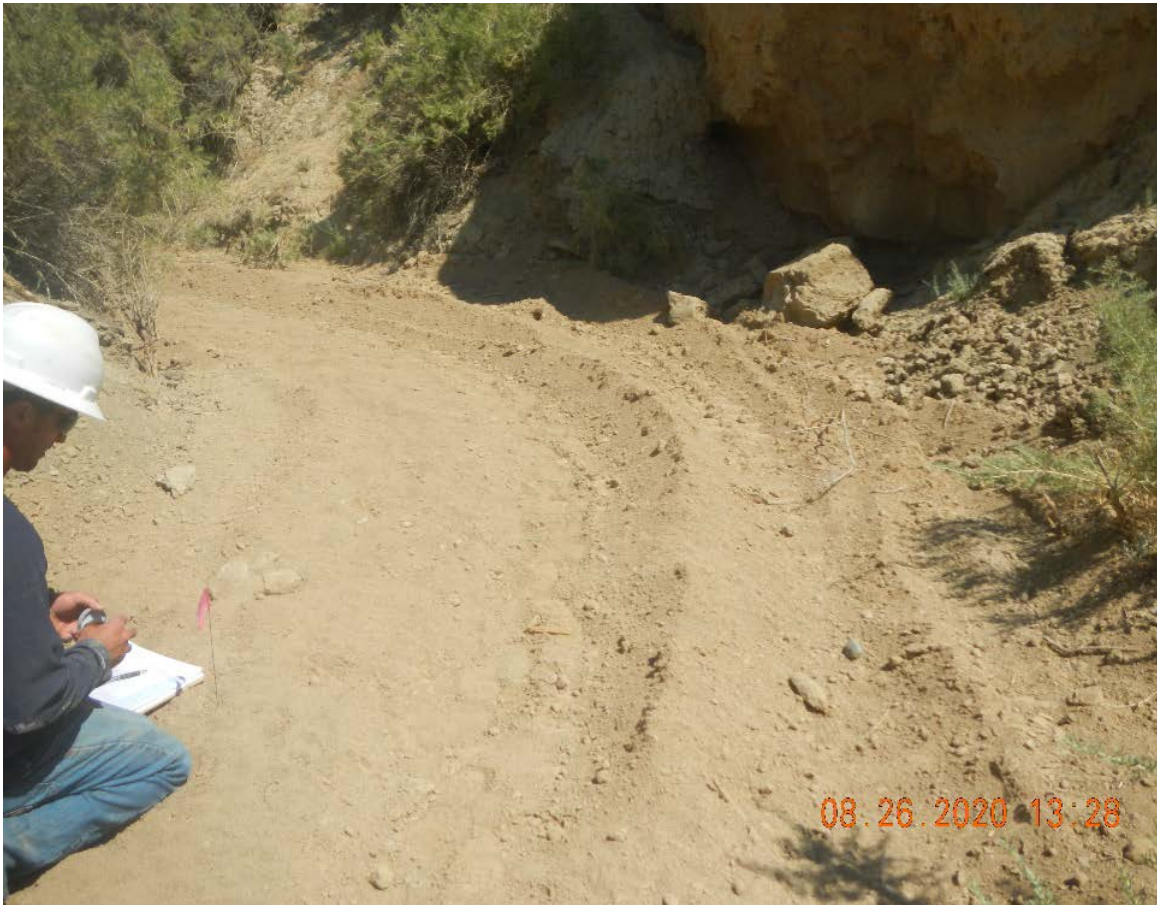
Photo #5 Chevron Staff collecting a sample in Division 3.
