Inspection Photos

Operator: TEP ROCKY MOUNTAIN LLC -
96850

Location ID: 324181
Garfield County, CO

Aaron Trujillo
NW Reclamation Specialist
COGCC

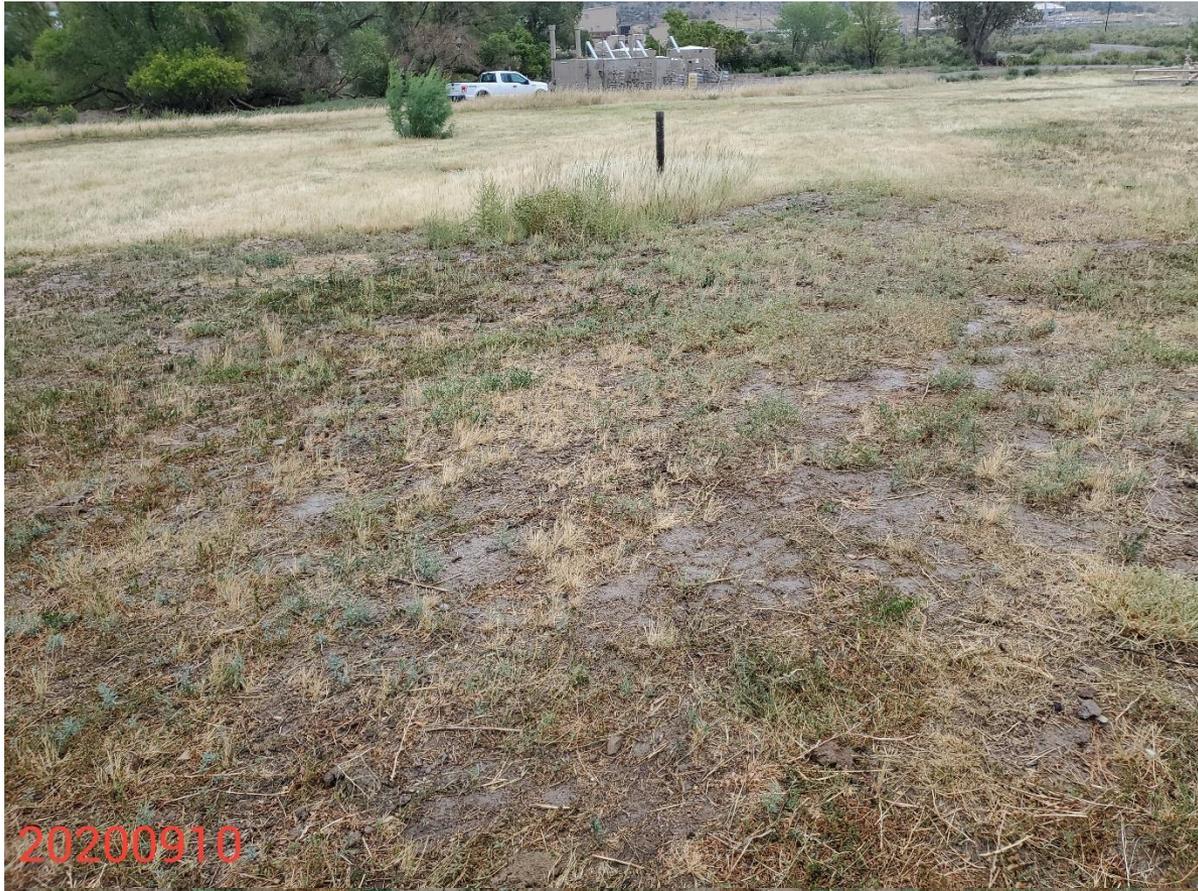
Photo 1: Photo taken from the south end of the Location, facing north. Photo shows large areas of the location is not progressing towards reclamation requirements.

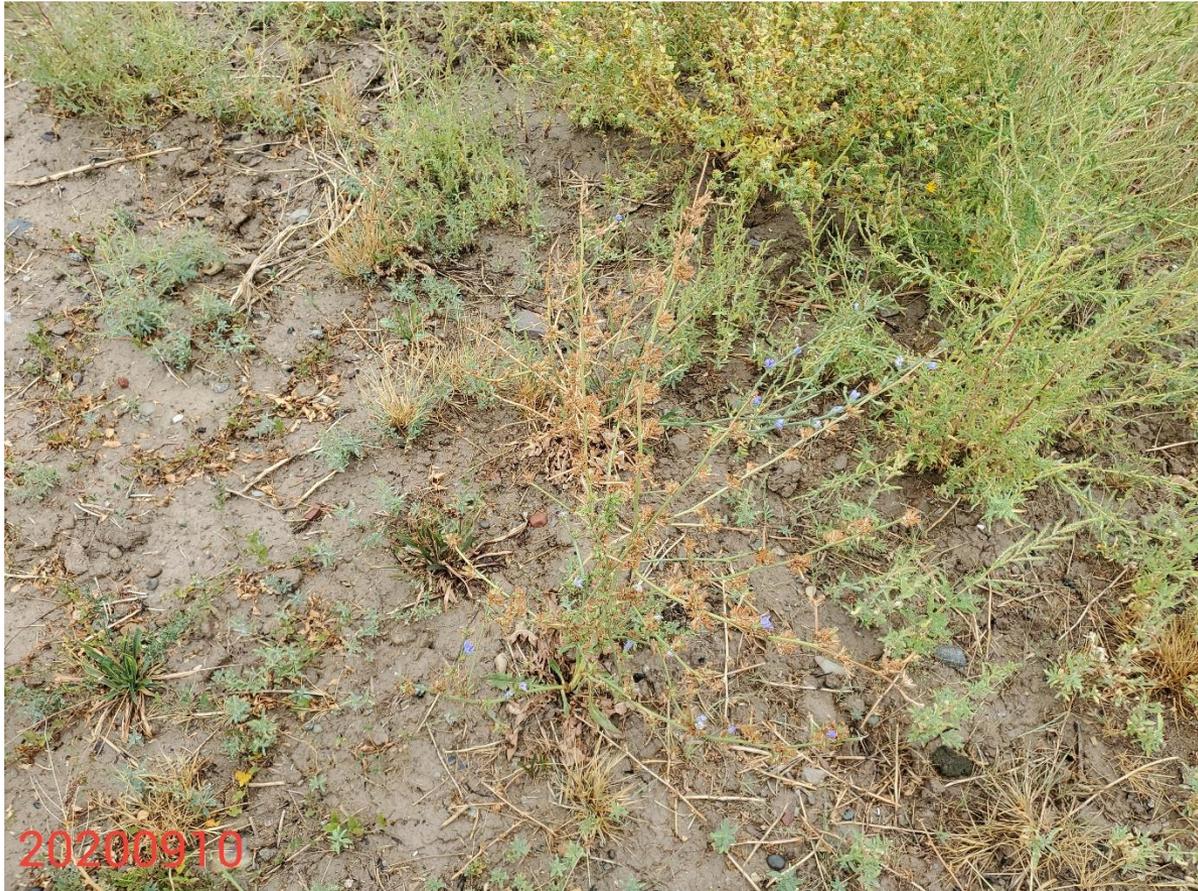
Photo 2: Photo taken from the Location. Photo shows location is not progressing towards uniform perennial vegetative establishment reflective of the reference. Photo also show Chicory plants on Location; This is a Colorado State listed noxious weed.

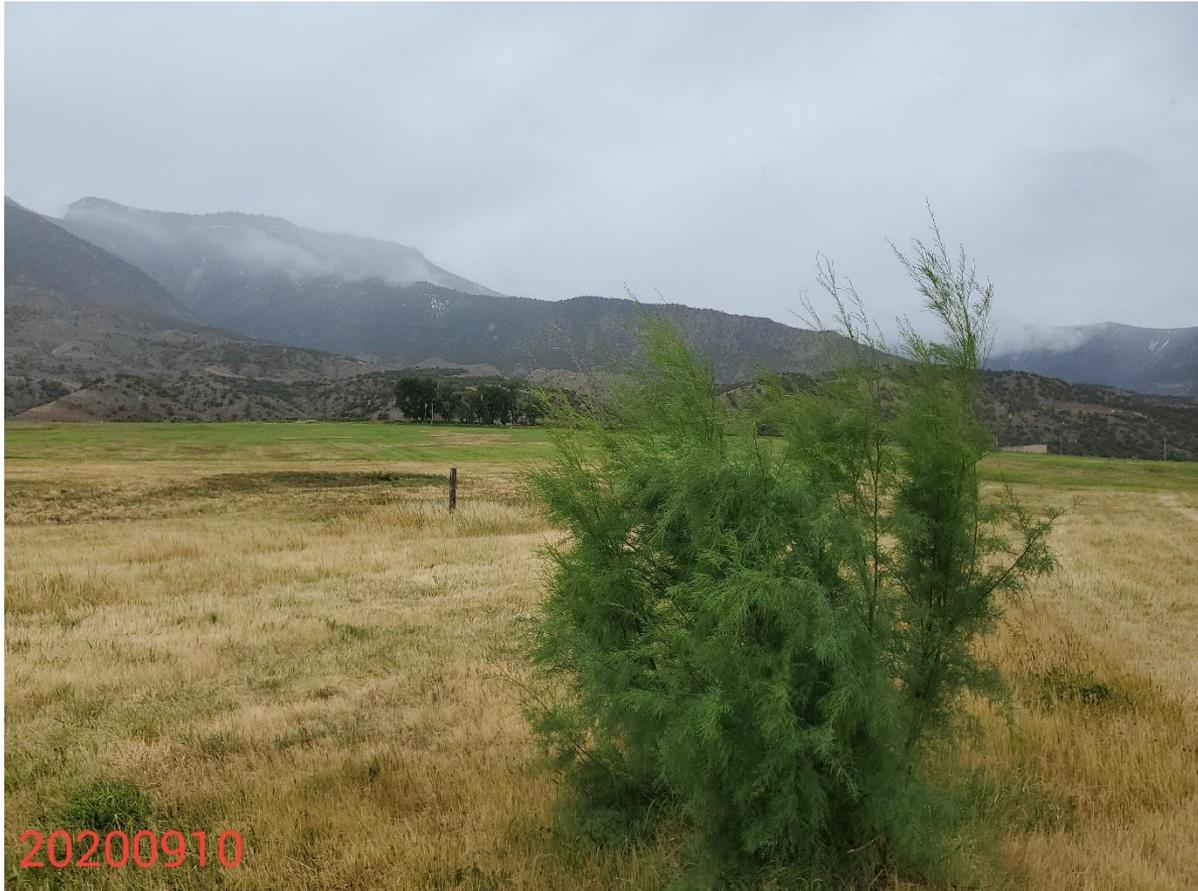
Photo 3: Photo taken from the north end of the Location, facing south. Photo shows an individual Takarisk plant on Location. This is a Colorado State listed noxious weed.

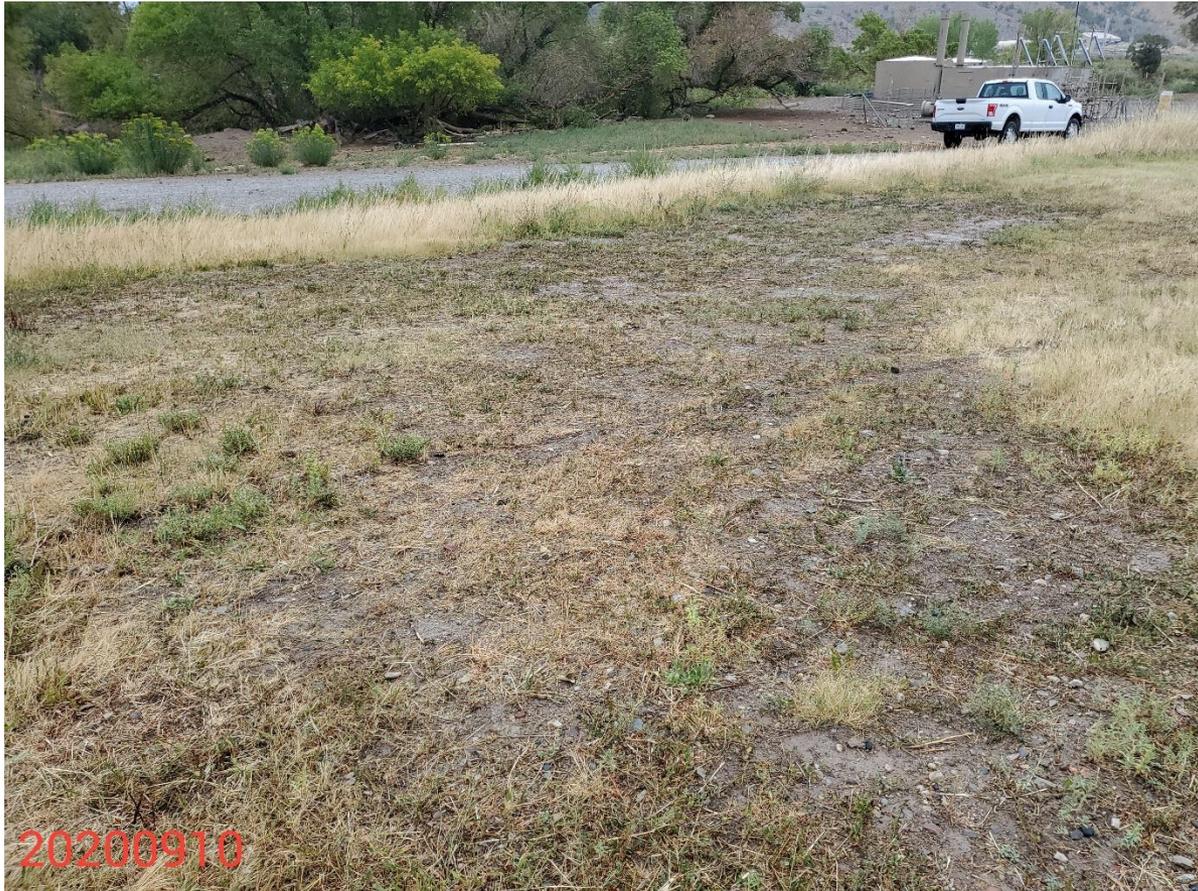
Photo 4: Photo taken from the access road, racing north. Photo shows areas of the access road disturbance that is not progressing towards reclamation requirements.

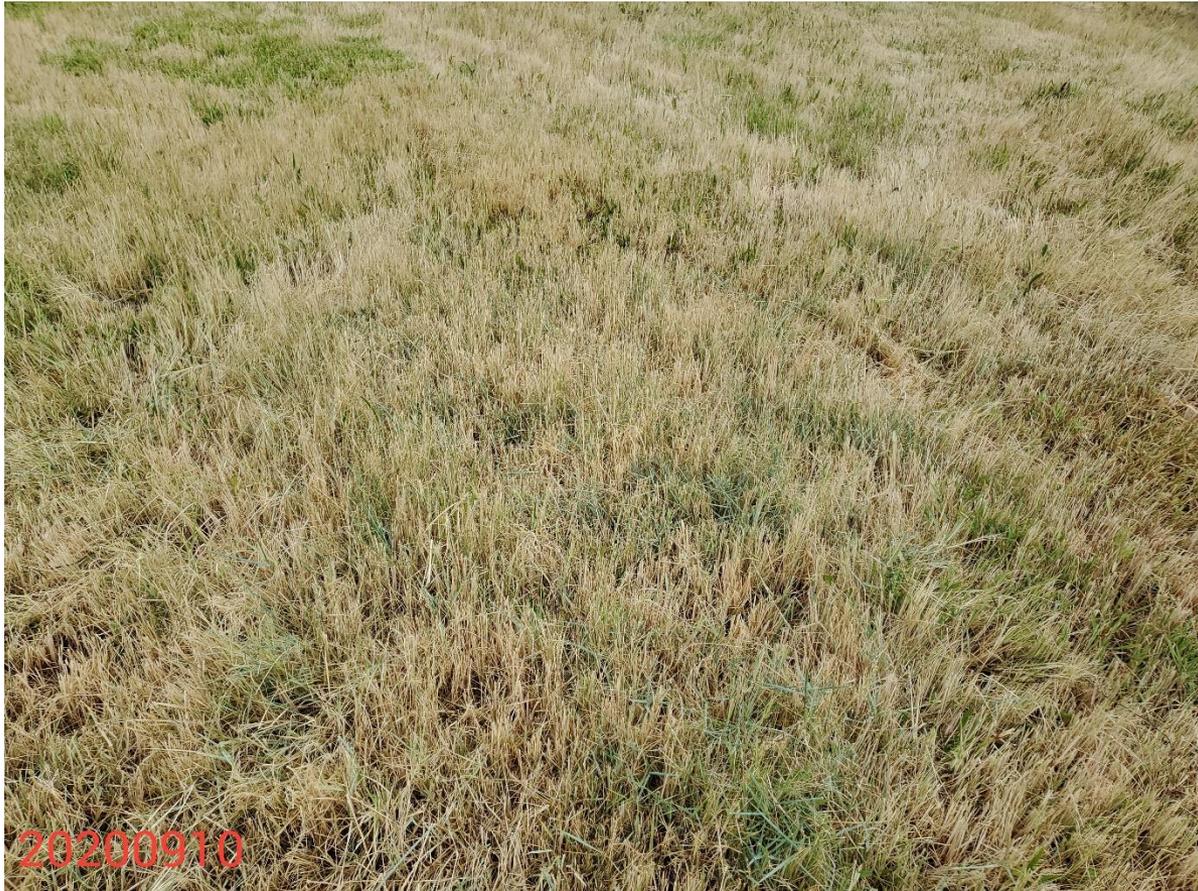
Photo 5: Photo shows vegetation on the adjacent reference area. Location/access road is not reflective of the reference.

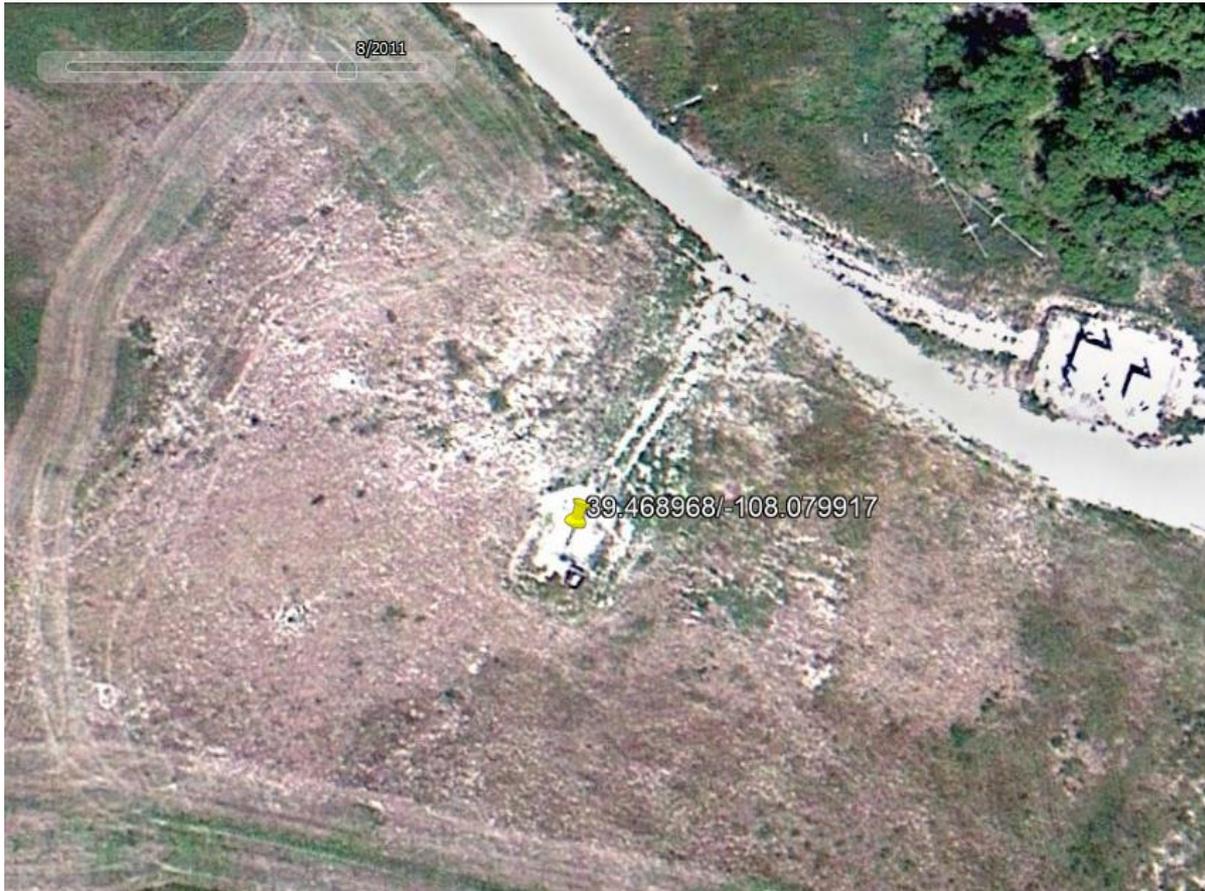
Photo 6: 2014 Google Earth aerial imagery. Photo shows Location and access road disturbance
