Inspection Photos

9/14/2020

Operator: BERRY PETROLEUM COMPANY LLC
- 10091

Location ID: 335716
Garfield County, CO

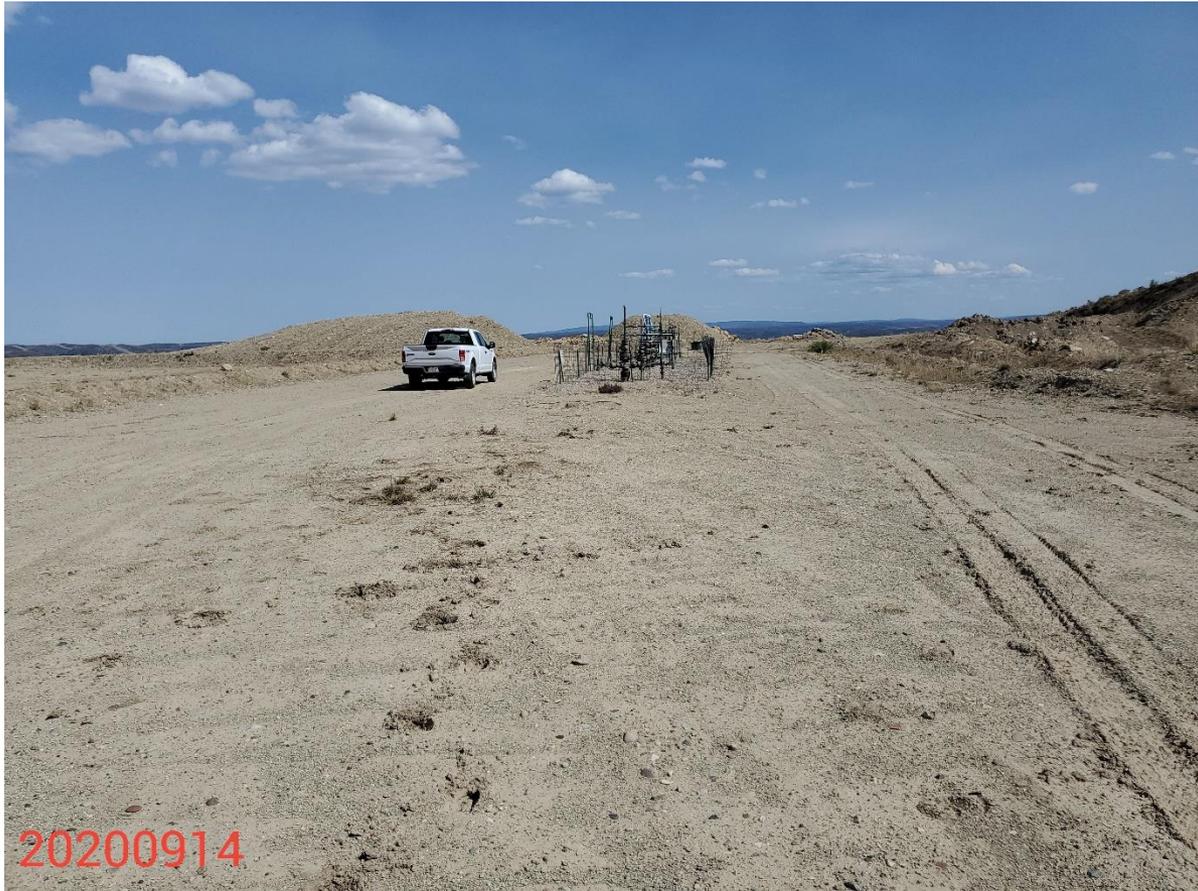
Photo 1: Photo shows active wells on the Location, facing north.

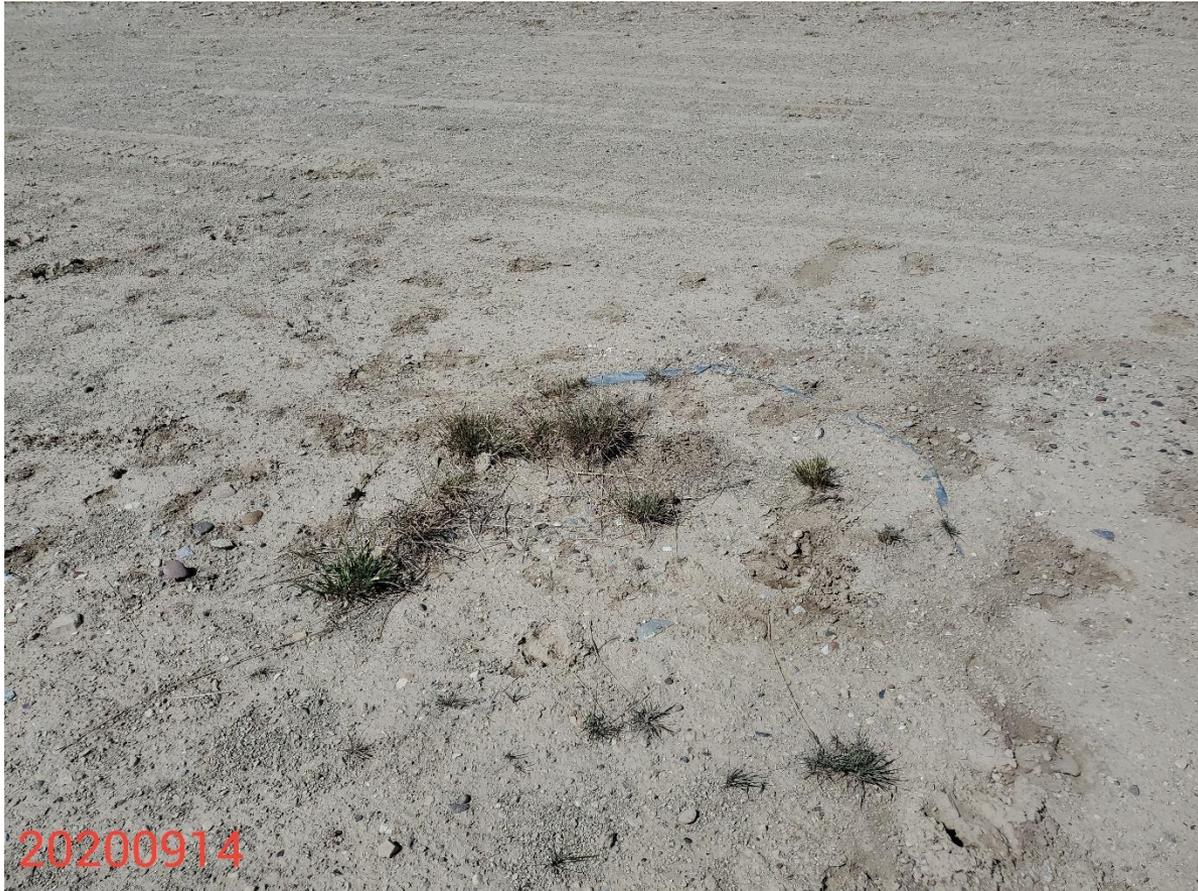
Photo 2: Photo taken south of the wells. Photo shows unused or unneeded cellars/conductor settings have not been removed.

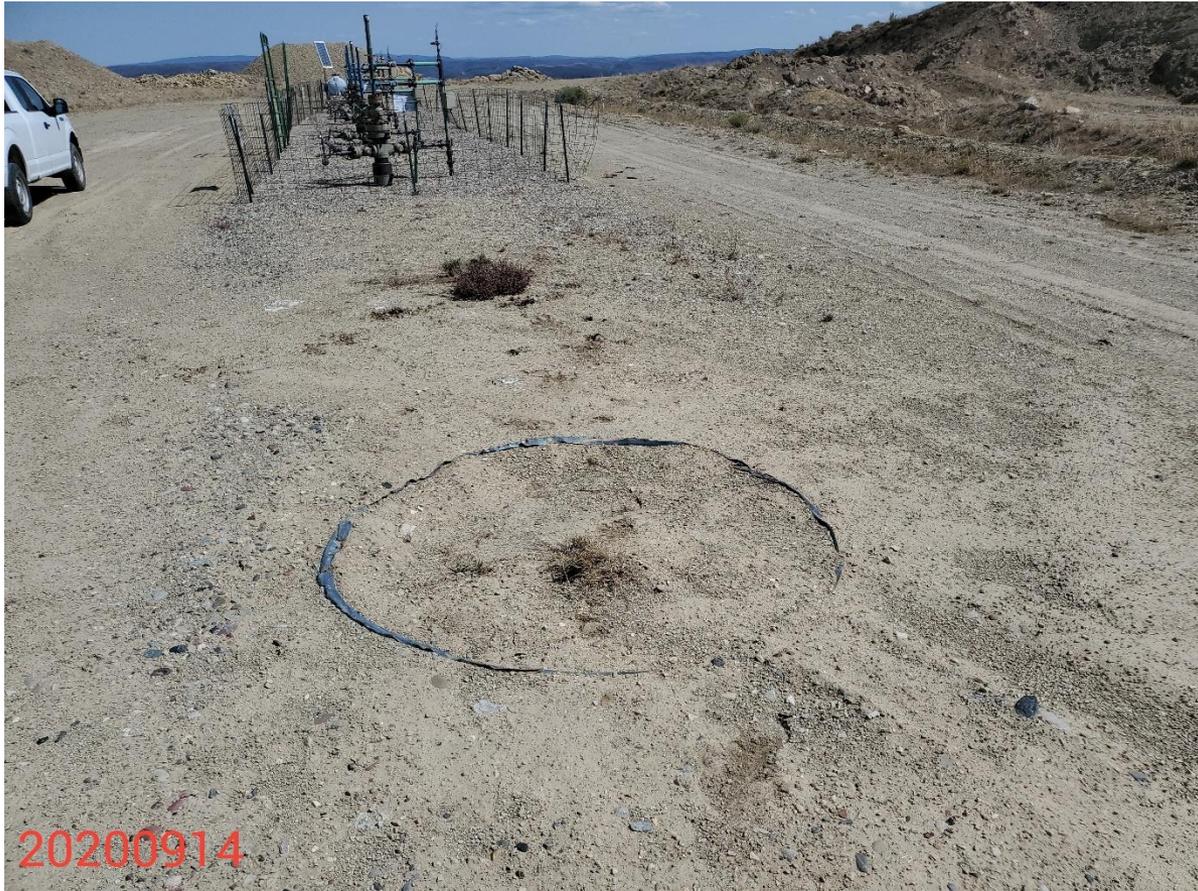
Photo 3: Photo taken south of the wells. Photo shows unused or unneeded cellars/conductor settings have not been removed.

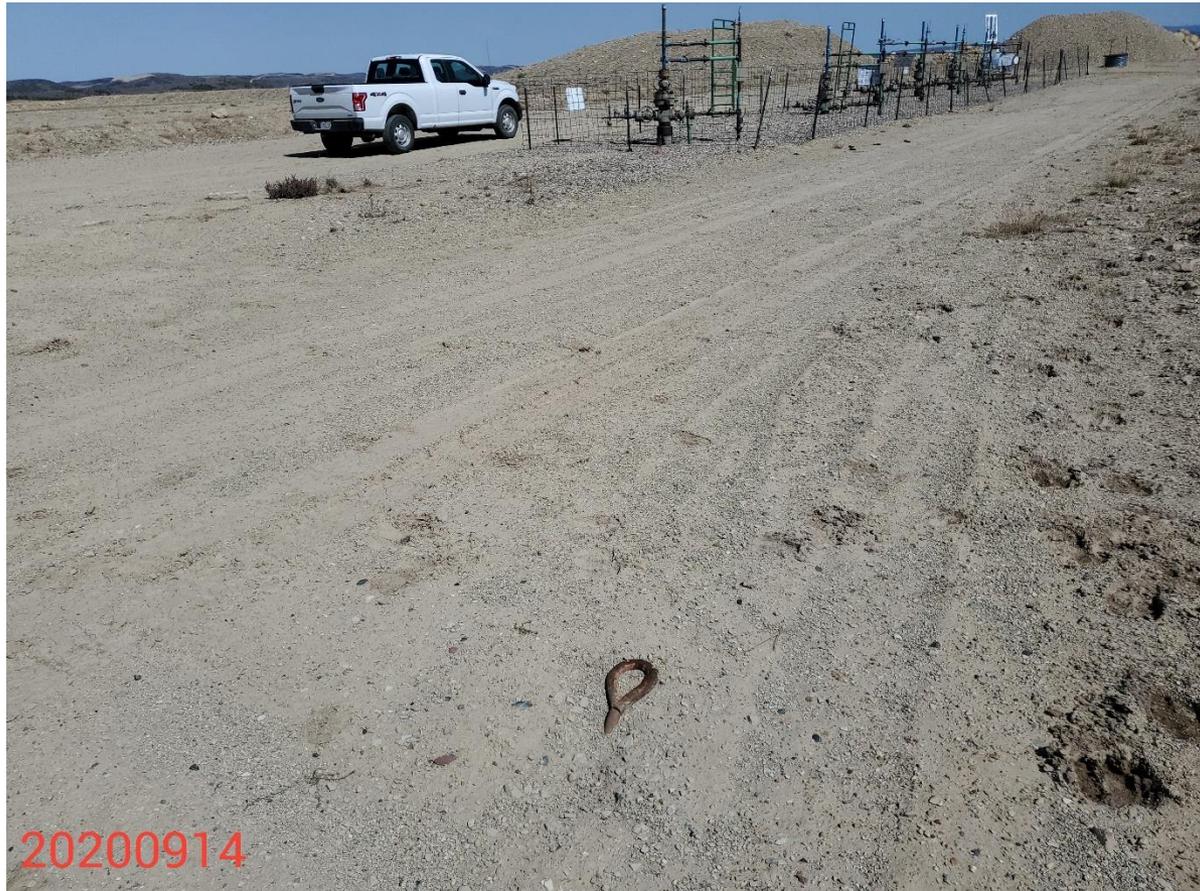
Photo 4: Photo shows example of guy line anchors observed on the Location without proper markers pursuant to Rule 1003.a

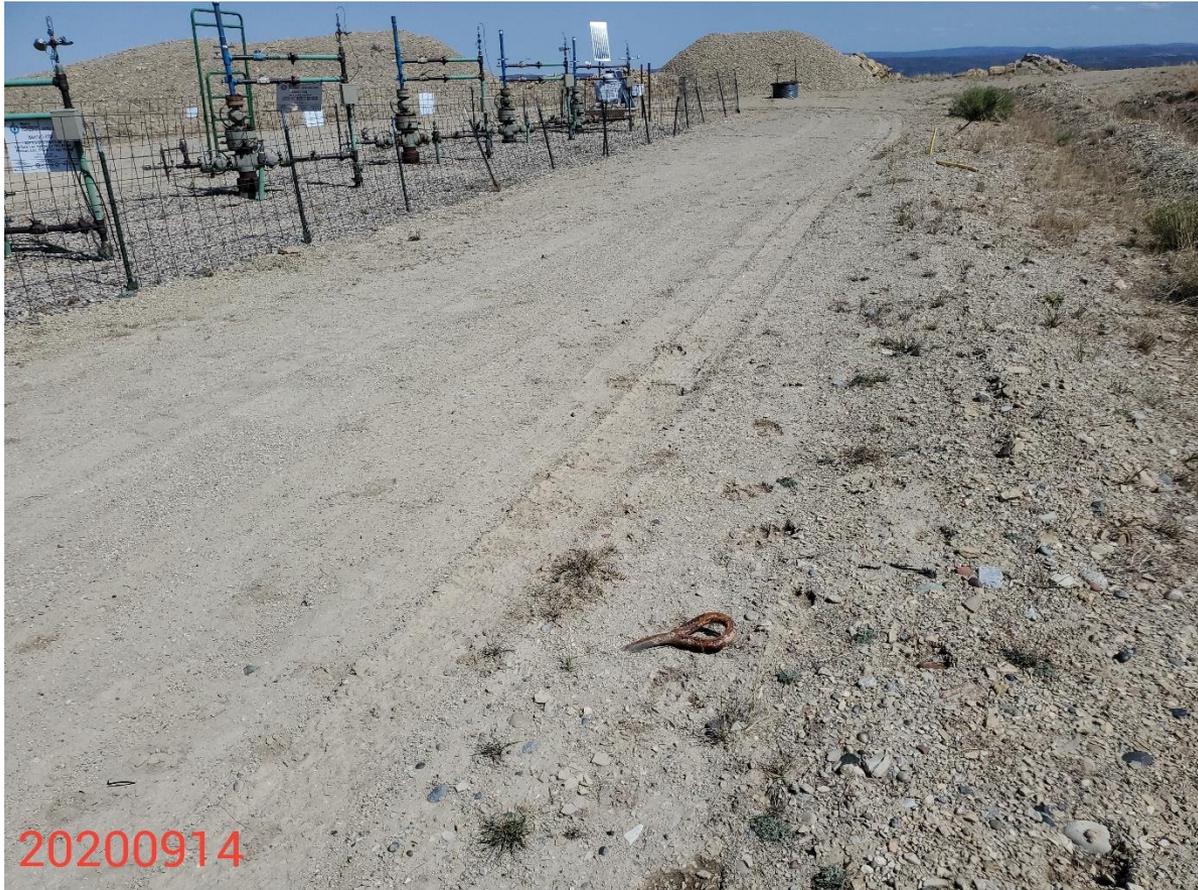
Photo 5: Photo shows example of guy line anchors observed on the Location without proper markers pursuant to Rule 1003.a

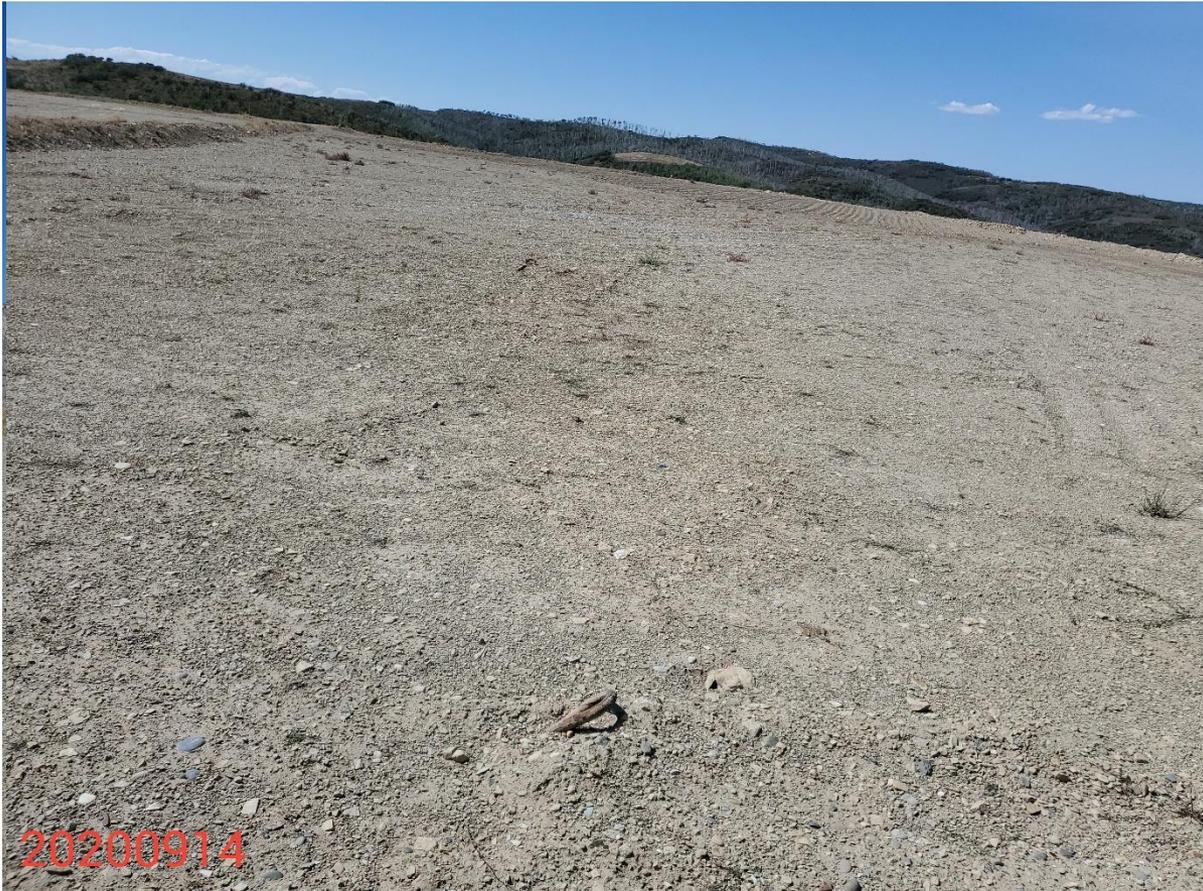
Photo 6: Photo shows example of guy line anchors observed on the Location without proper markers pursuant to Rule 1003.a
