# Inspection Photos

10/12/2020

Operator: CAERUS PICEANCE LLC # 10456

Location ID: 334128

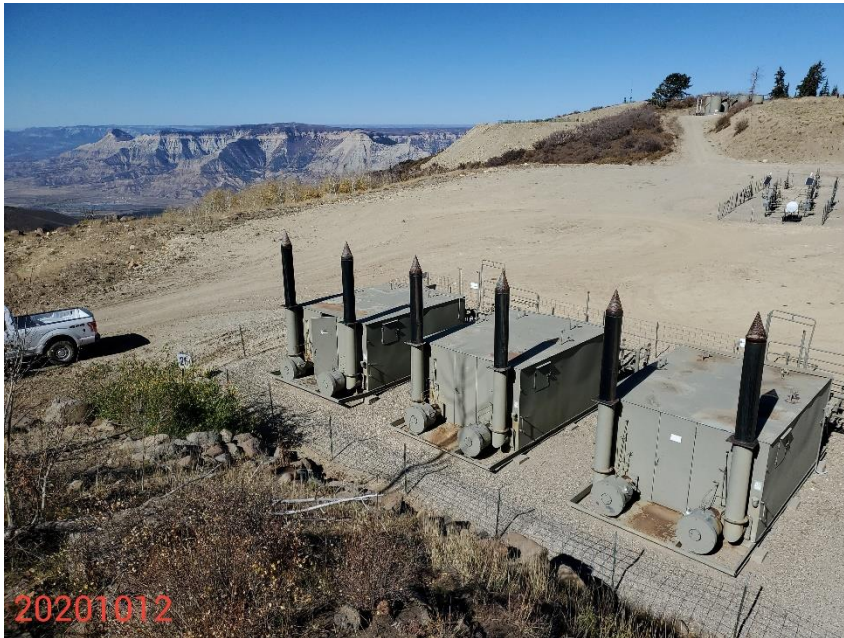
**Photo 1:** Photo taken from the south end of the Location, facing northwest. Photo provides an overview of the production areas.

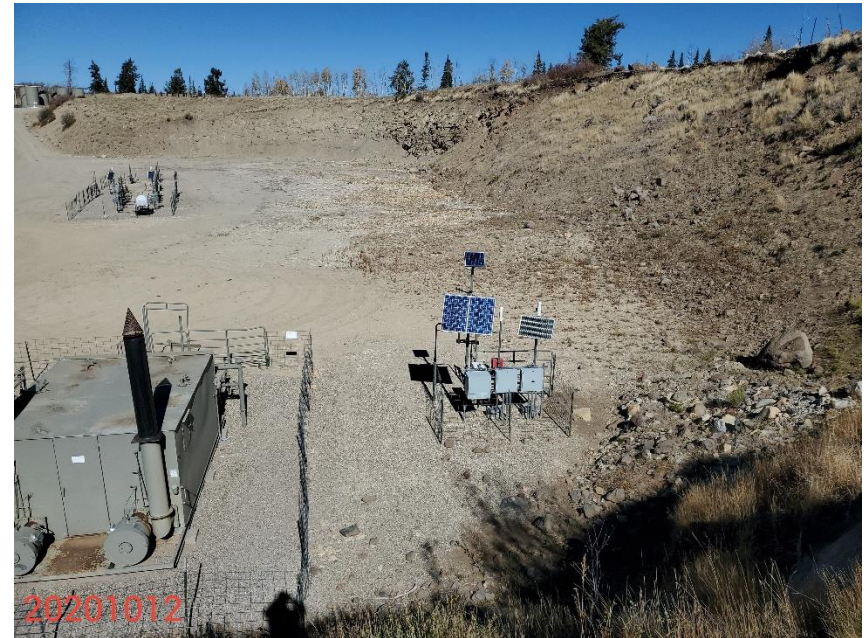
**Photo 2:** Photo taken from the south end of the Location, facing north. Photo provides an overview of the production areas.

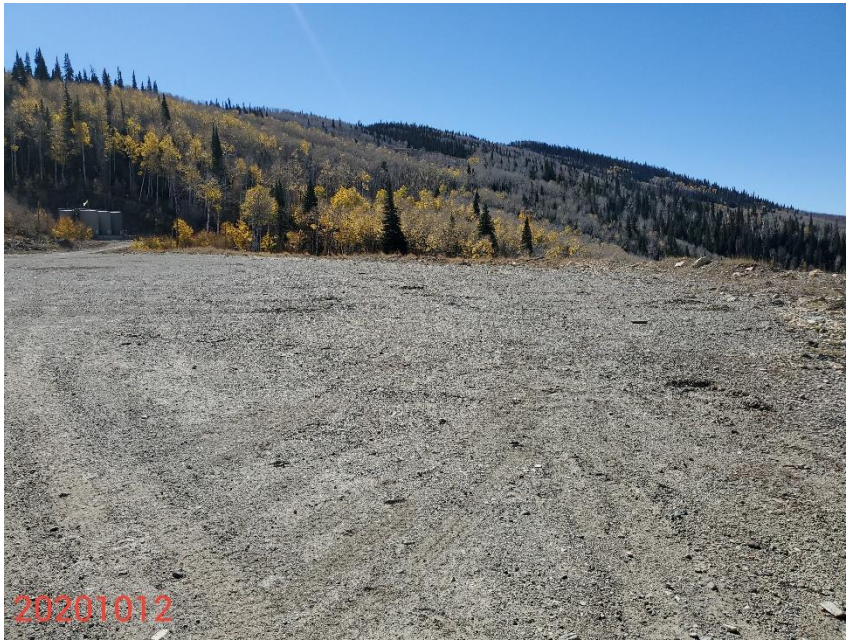
**Photo 3:** Photo taken from the northwest end of the Location, facing south/southeast. Photo shows areas of the pad that do not appear to be needed for production areas and should be considered for reclamation. However the current pad size and "areas needed for production operations" on the Location is not exceedingly unreasonable.

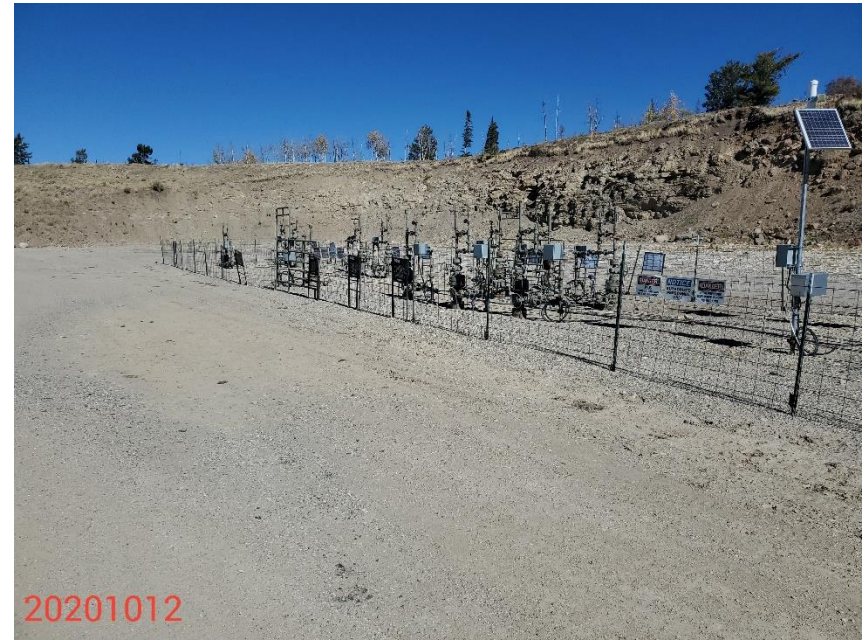
**Photo 4:** Photo shows wells on the Location.

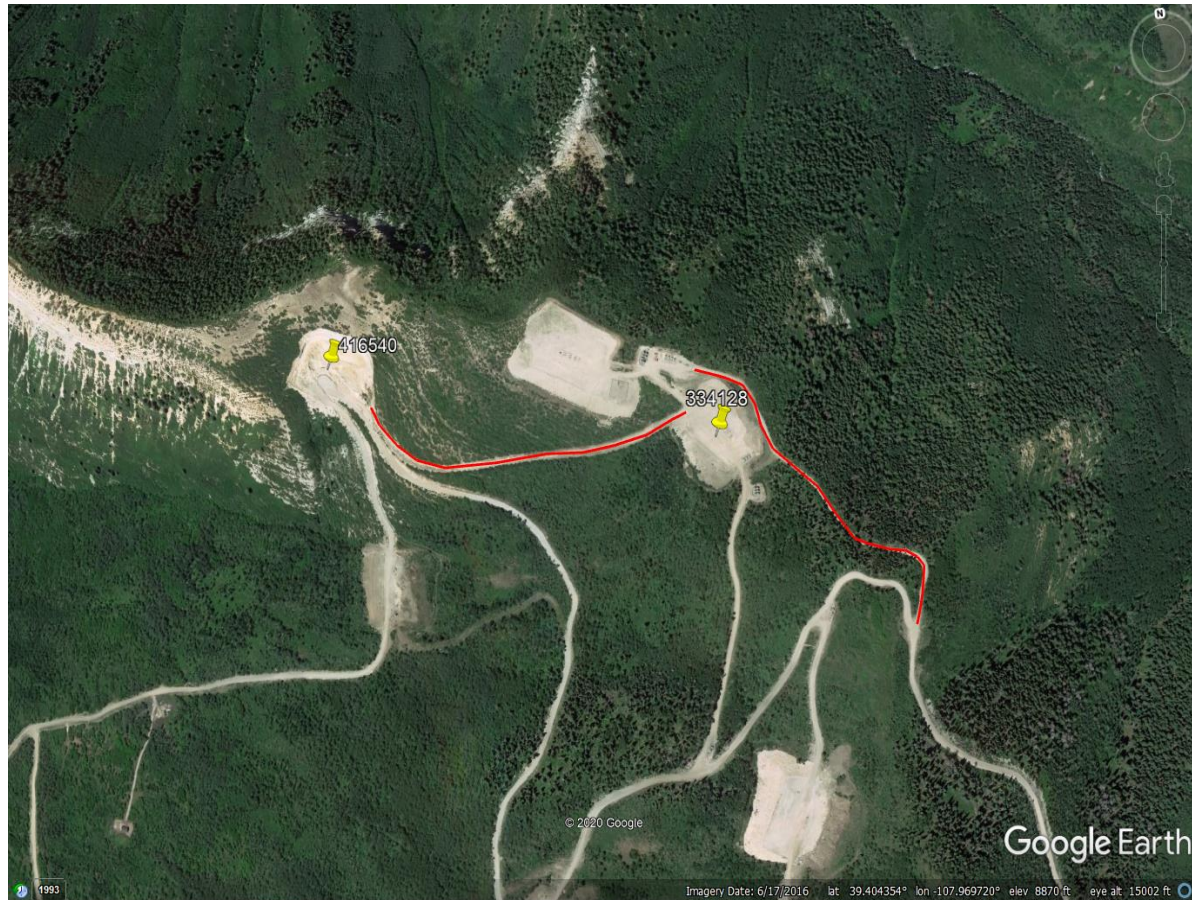
**Photo 5:** 2016 Google Earth Aerial image. Photo shows Location (#334128), and access roads (red lines) requiring reclamation pursuant to COGCC 1004 requirements; Access roads are considered additional, unnecessary disturbances that do not comport with Rule 1002.e(4)
