Inspection Photos  
Operator: Logos Operating  
API: 067-05363  
Date: 10/13/2020

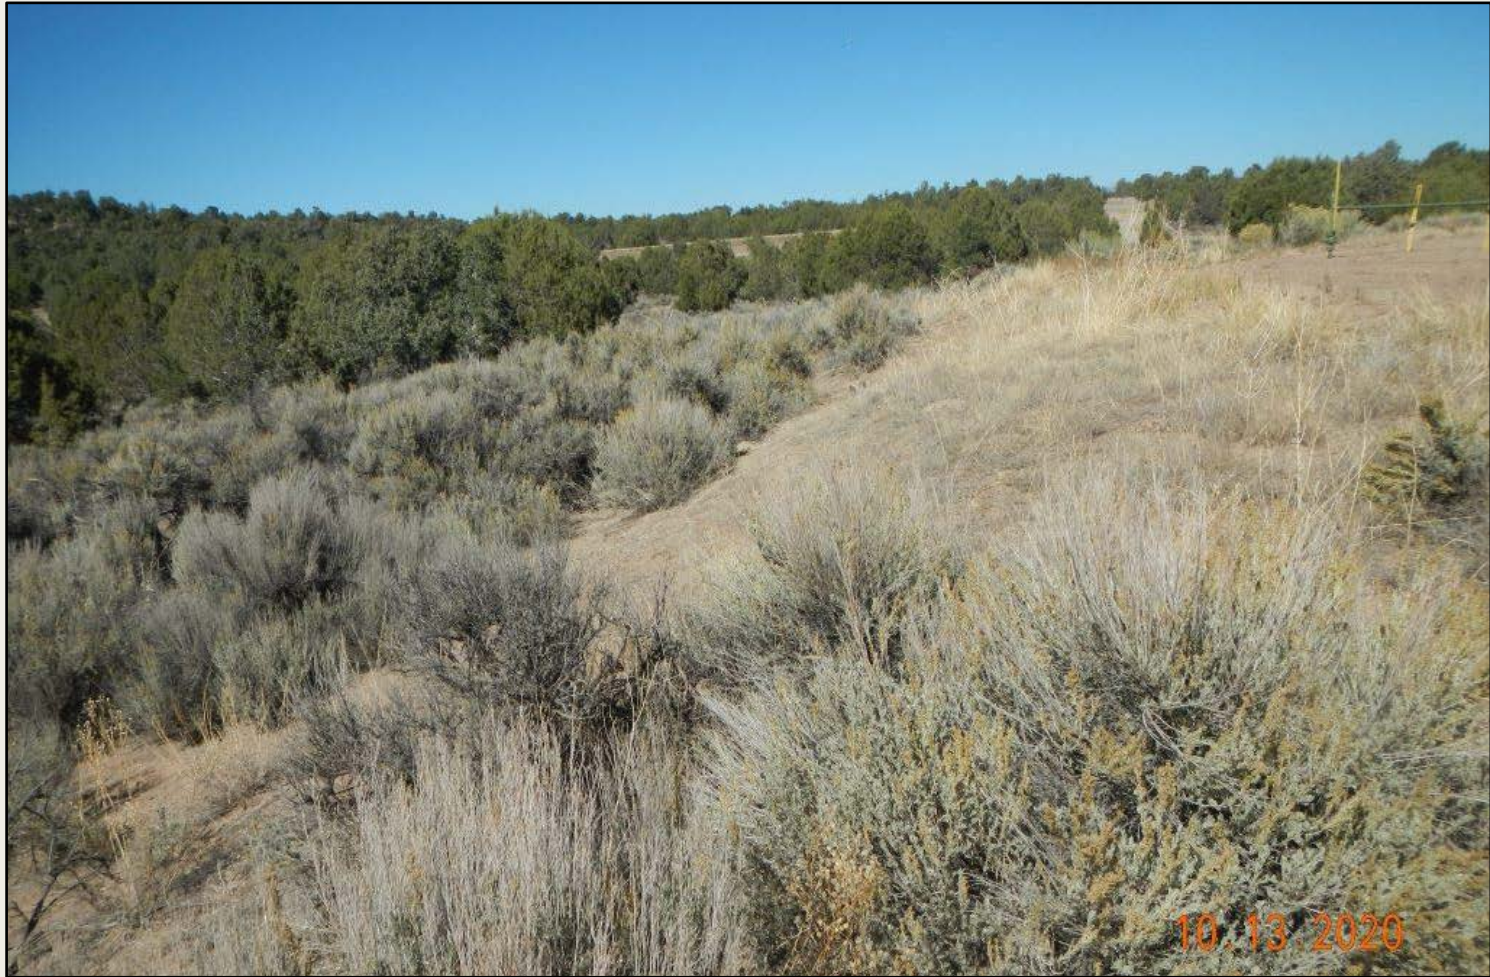
Photo 2. View of the western fill slope from the southwestern corner facing northward. Revegetation is progressing with western wheatgrass, sand dropseed, and sagebrush. Weeds such as Russian thistle and cheatgrass present.

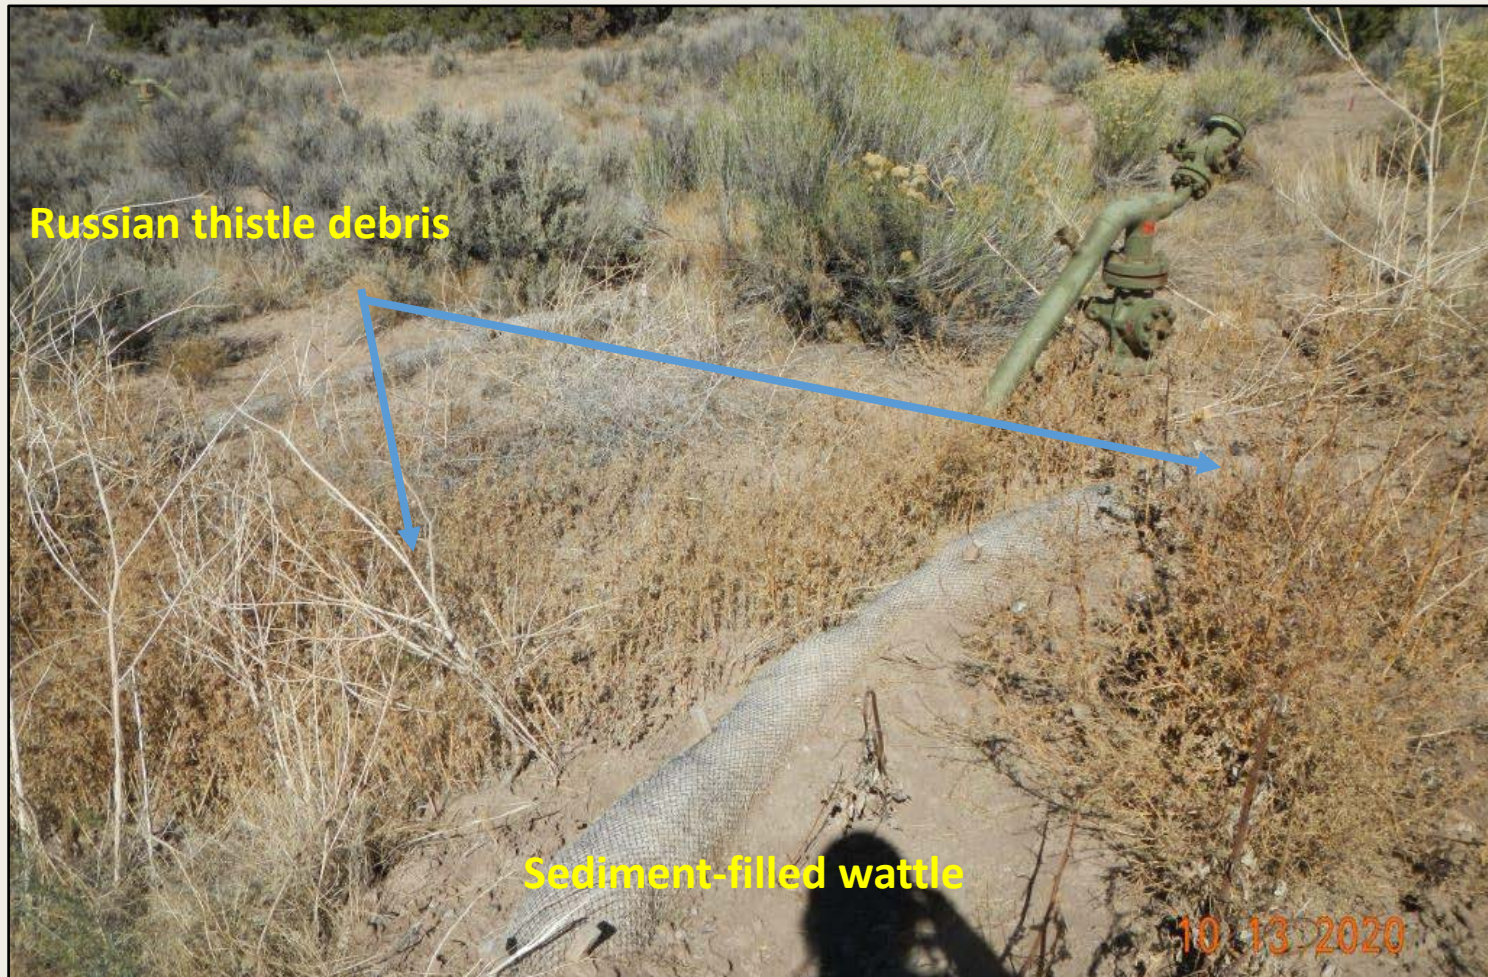
Photo 3. View of stormwater controls installed in the northern project area. The up-slope wattle is full of sediment and needs maintenance. Weed debris needs to be removed.
