Inspection Photos

Operator: BP America
API: 067-09482
Date: 10/13/2020

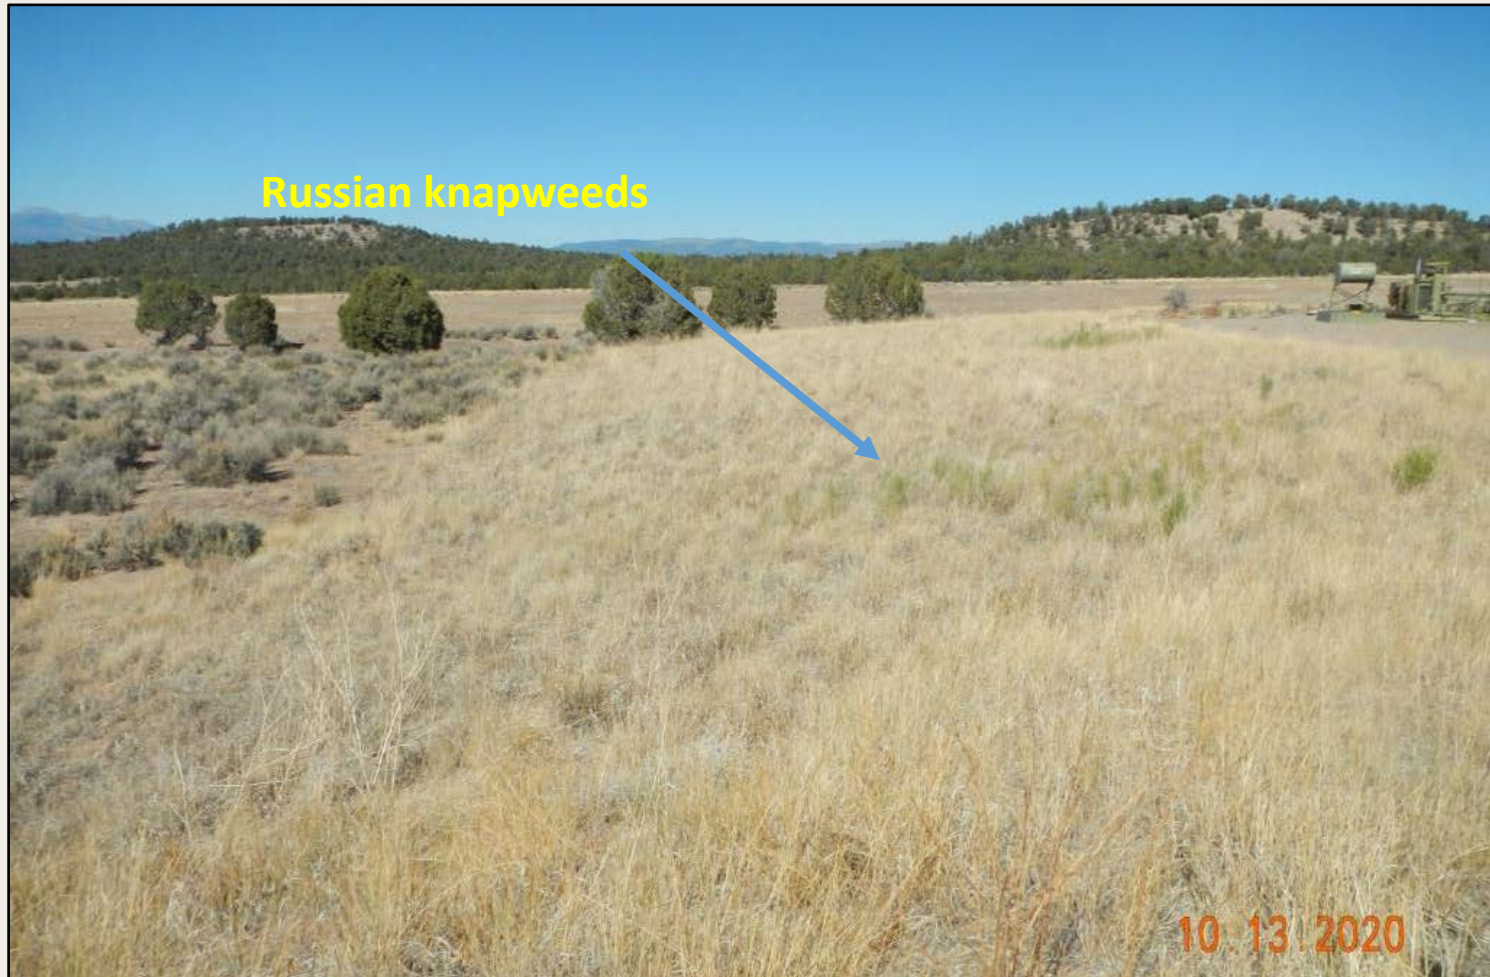
Photo 2. View of the western fill slope from the southwestern corner facing northward. Revegetation is progressing with crested wheatgrass, sand dropseed, and western wheatgrass. Russian knapweeds are scattered here.

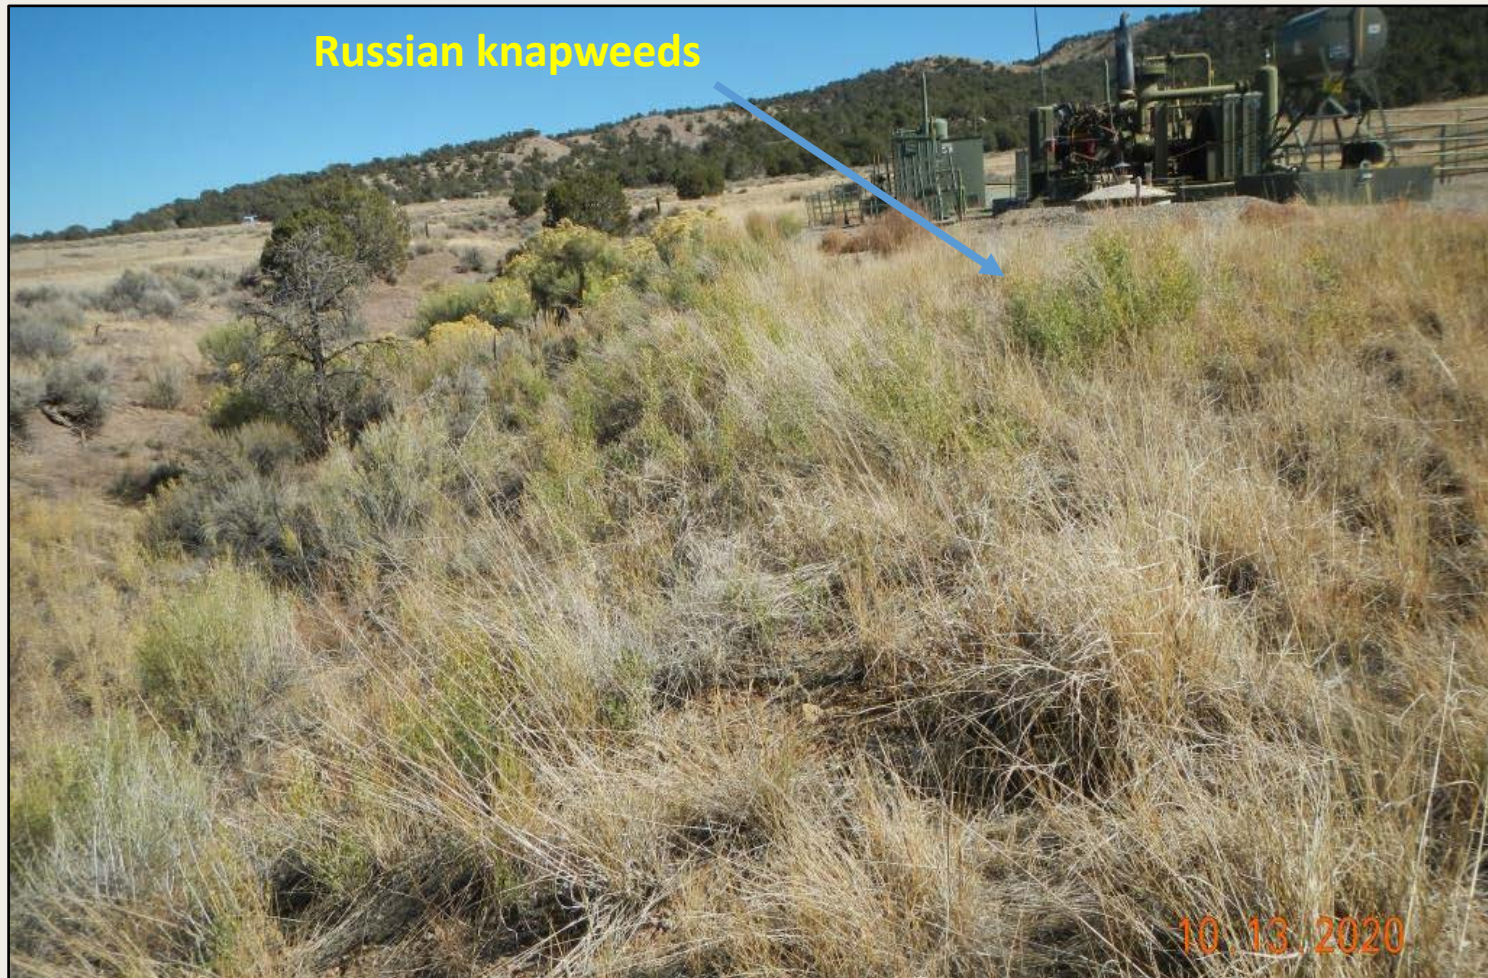
Photo 3. View of the northern fill slope from the northwestern corner facing eastward. Scattered Russian knapweeds also observed here.

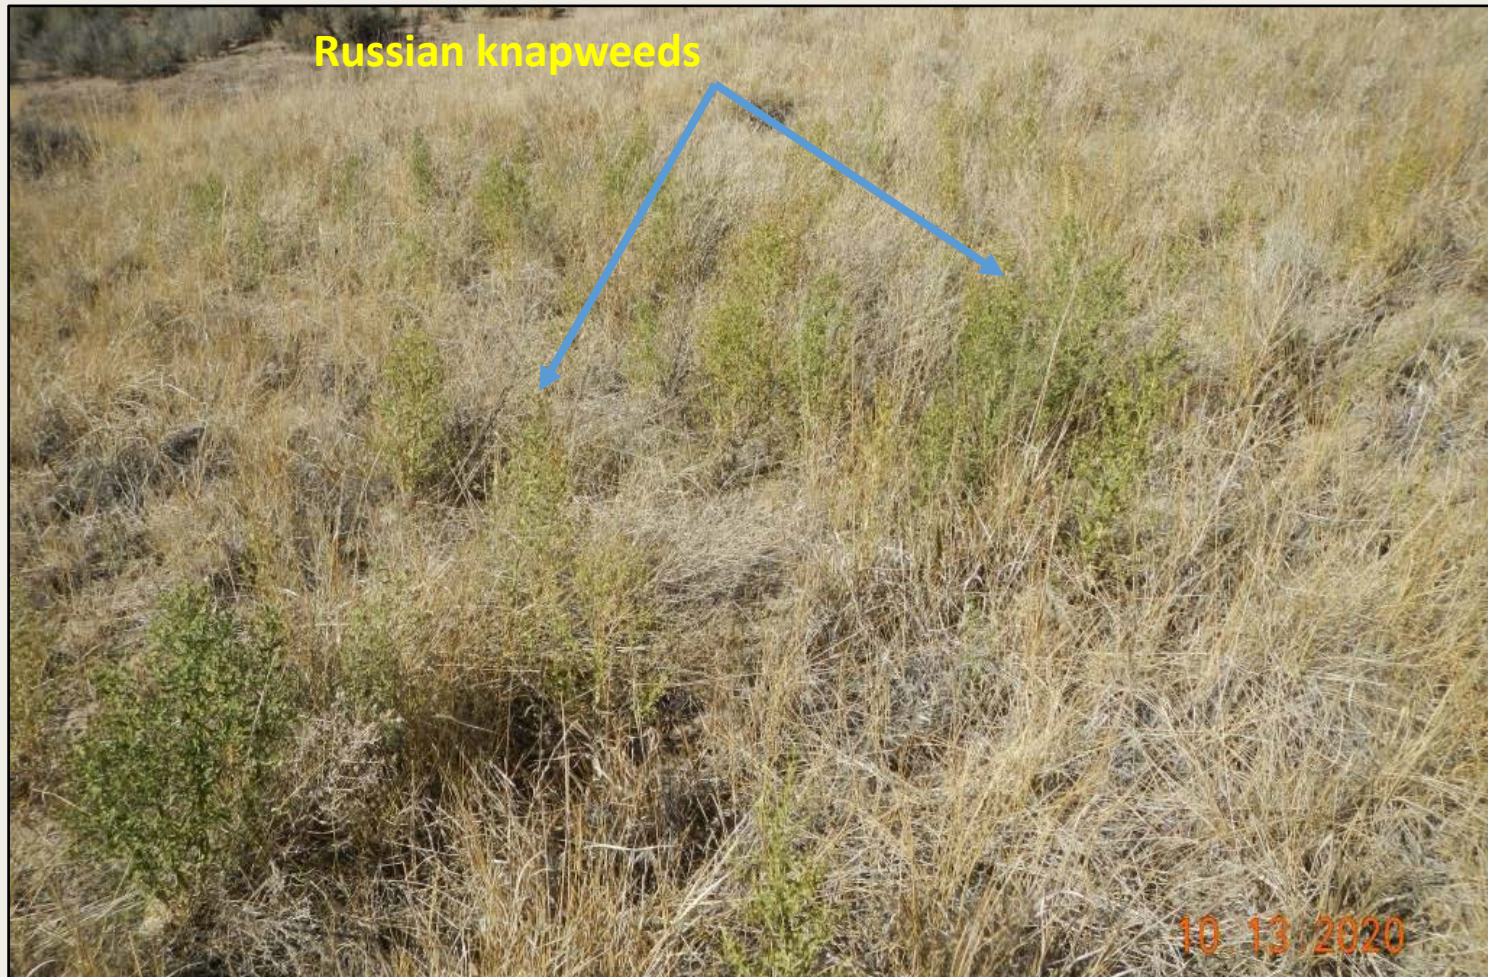
Photo 4. Closeup view of Russian knapweeds within the western project area. Approximately 500 individuals observed.

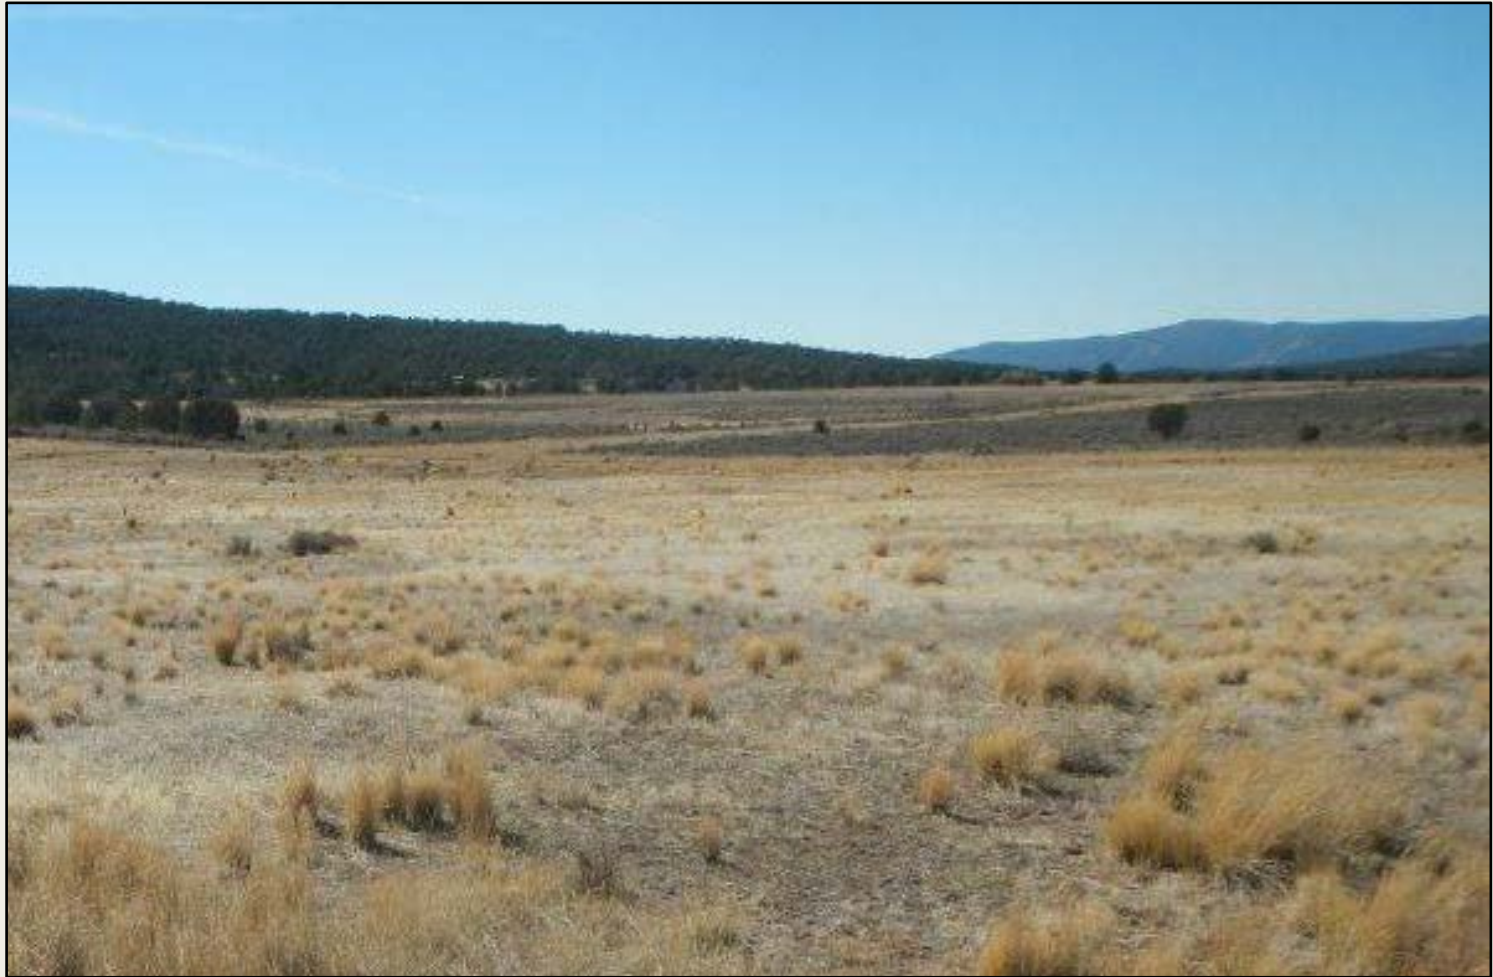
Photo 5. View of reference area vegetation comprised of dryland grass field with western wheatgrass and crested wheatgrass in a dormant vegetative condition at this time.
