Inspection Photos

10/12/2020

Operator: CAERUS PICEANCE LLC # 10456

Location ID: 334087

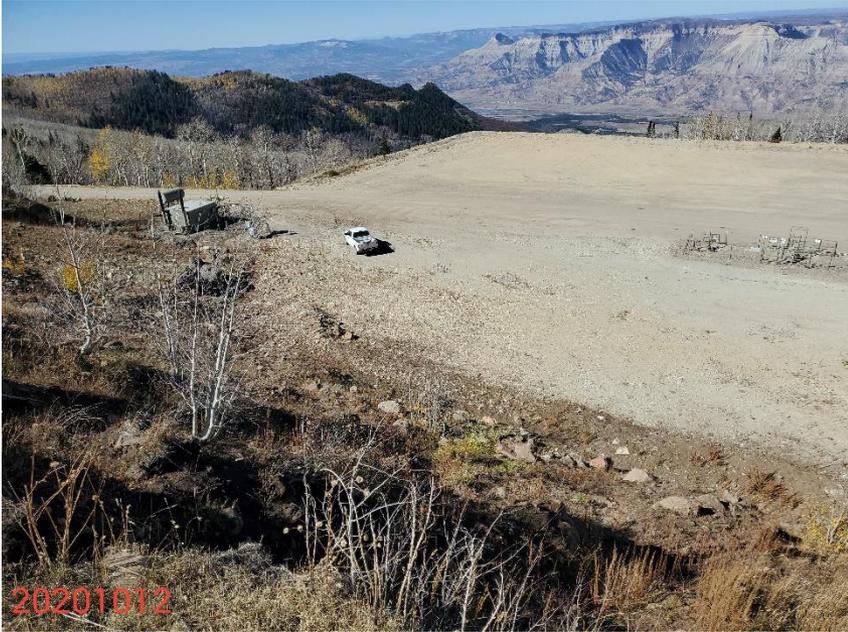
Photo 1: Photo taken from the east end of the Location, facing southwest. Photo shows overview of the Location. Photo shows interim reclamation pursuant to 1003.b has not been conducted on the Location.

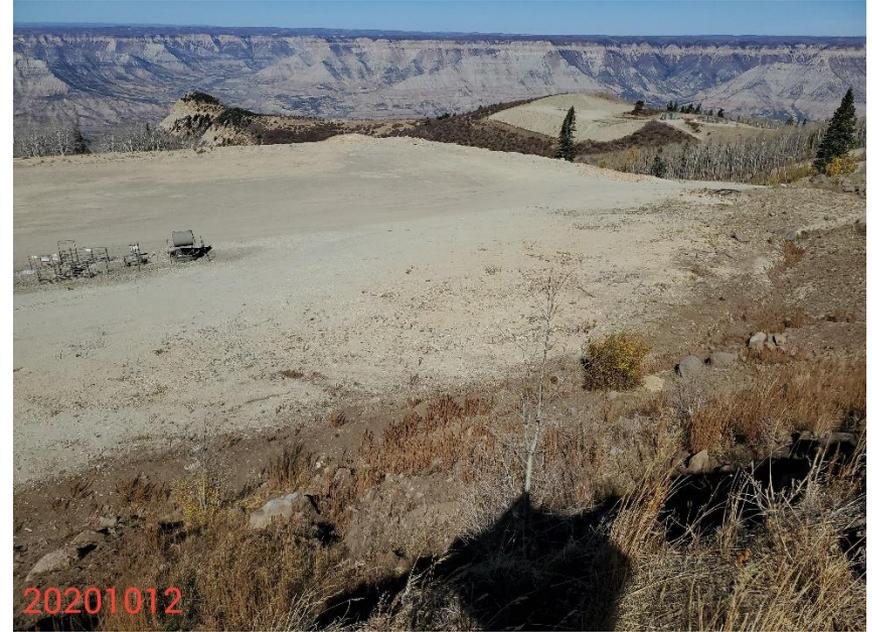
Photo 2: Photo taken from the east end of the Location, facing northwest. Photo shows overview of the Location. Photo shows interim reclamation pursuant to 1003.b has not been conducted on the Location.

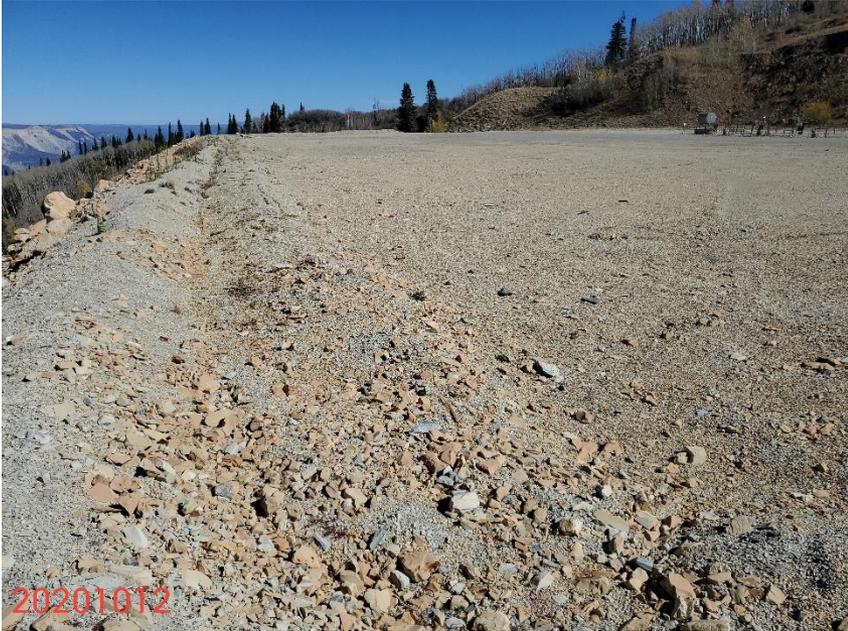
Photo 3: Photo taken from the southwest end of the Location, facing north. Photo shows overview of the Location. Photo shows interim reclamation pursuant to 1003.b has not been conducted on the Location.

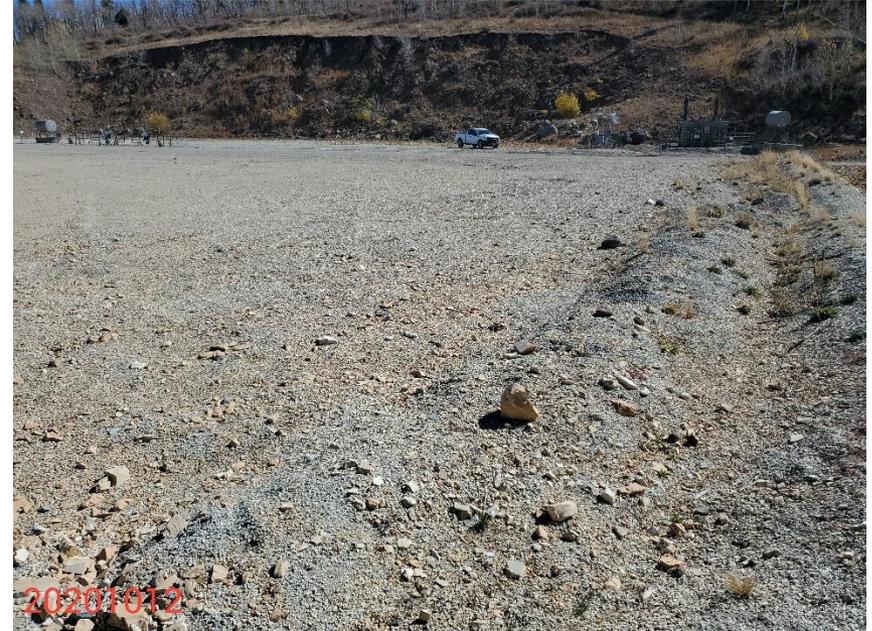
Photo 4: Photo taken from the southwest end of the Location, facing east. Photo shows overview of the Location. Photo shows interim reclamation pursuant to 1003.b has not been conducted on the Location.
