Final Reclamation Inspection

Operator: HRM RESOURCES II LLC - 10548

Location ID: 319846

Inspection Photos
Location Name: MARTIN #1
Location ID: 319846

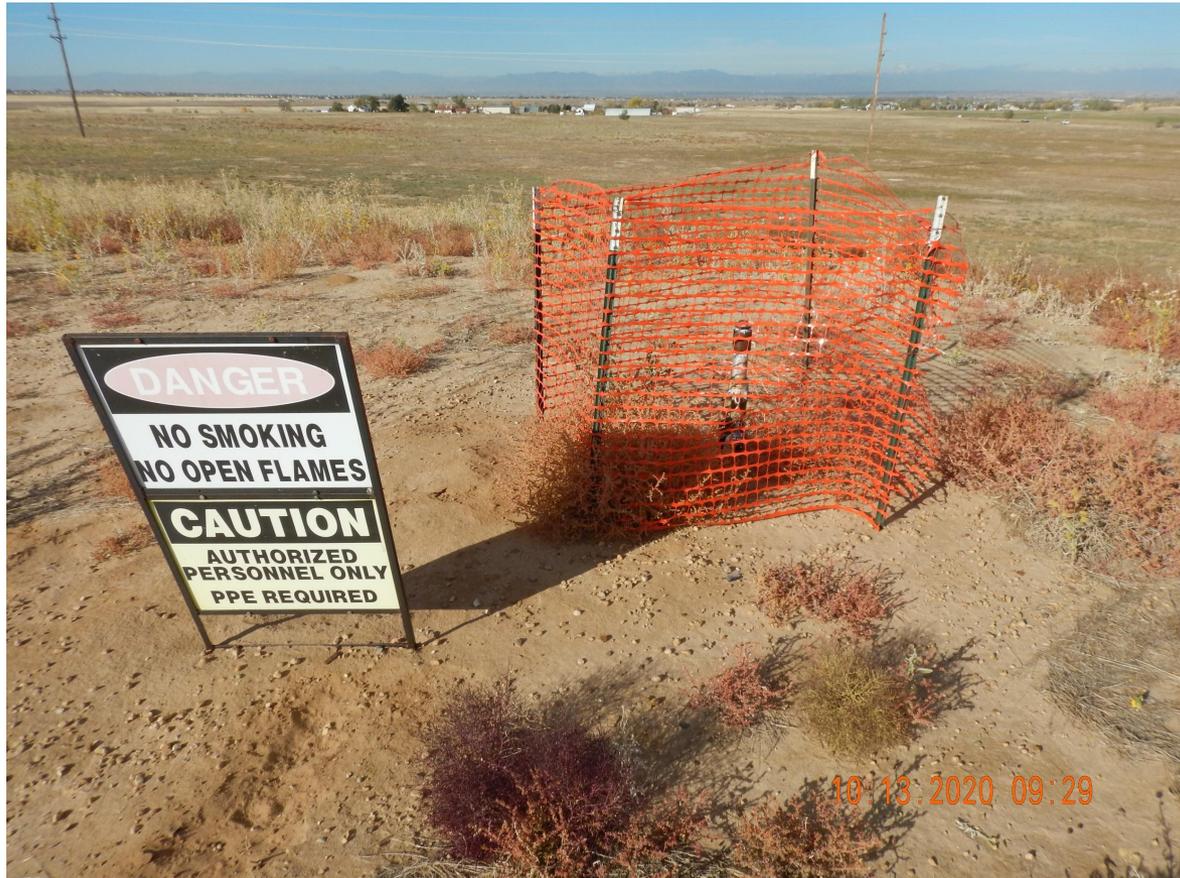
Photo 1. Photo taken from the western location, facing West. Photo illustrates the Operator has failed to remove all equipment (i.e, riser).

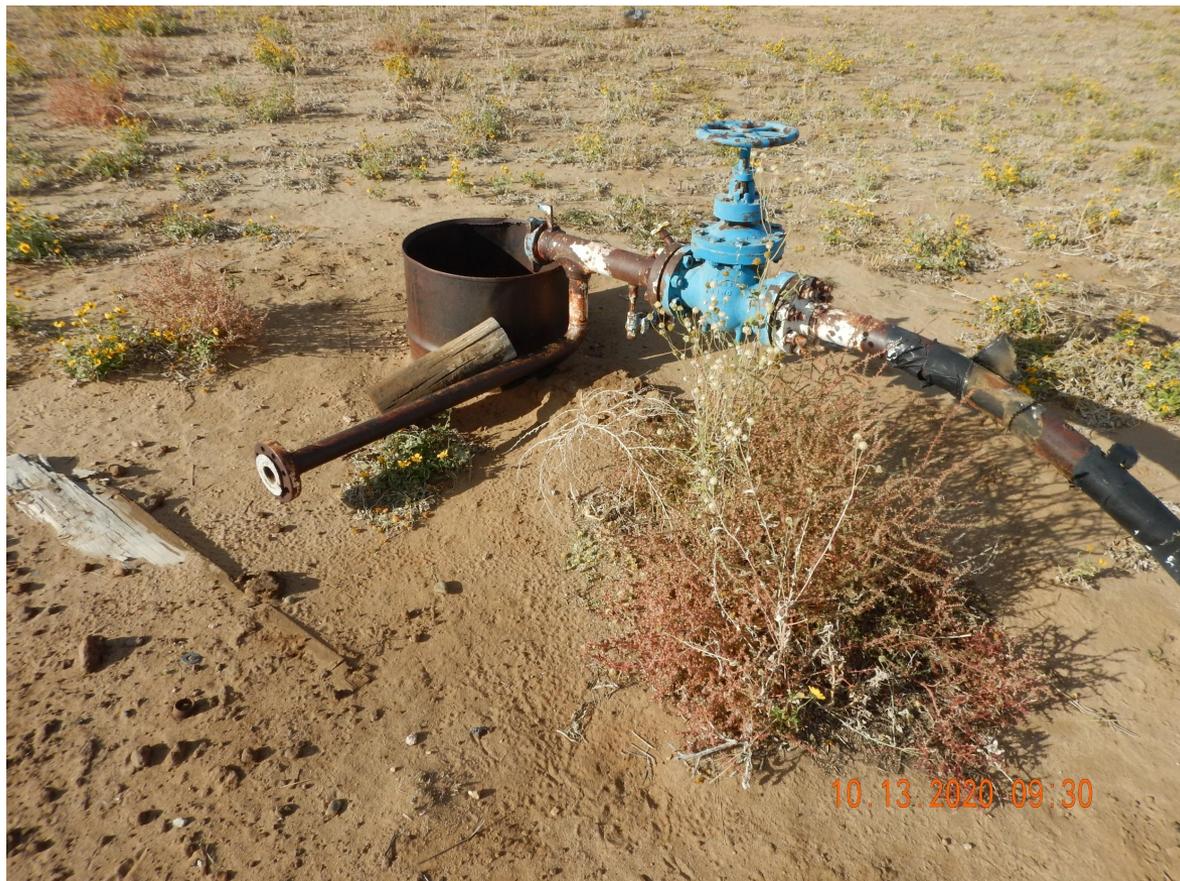
Photo 2. Photo taken from the eastern location, facing South. See comments under Photo 1.

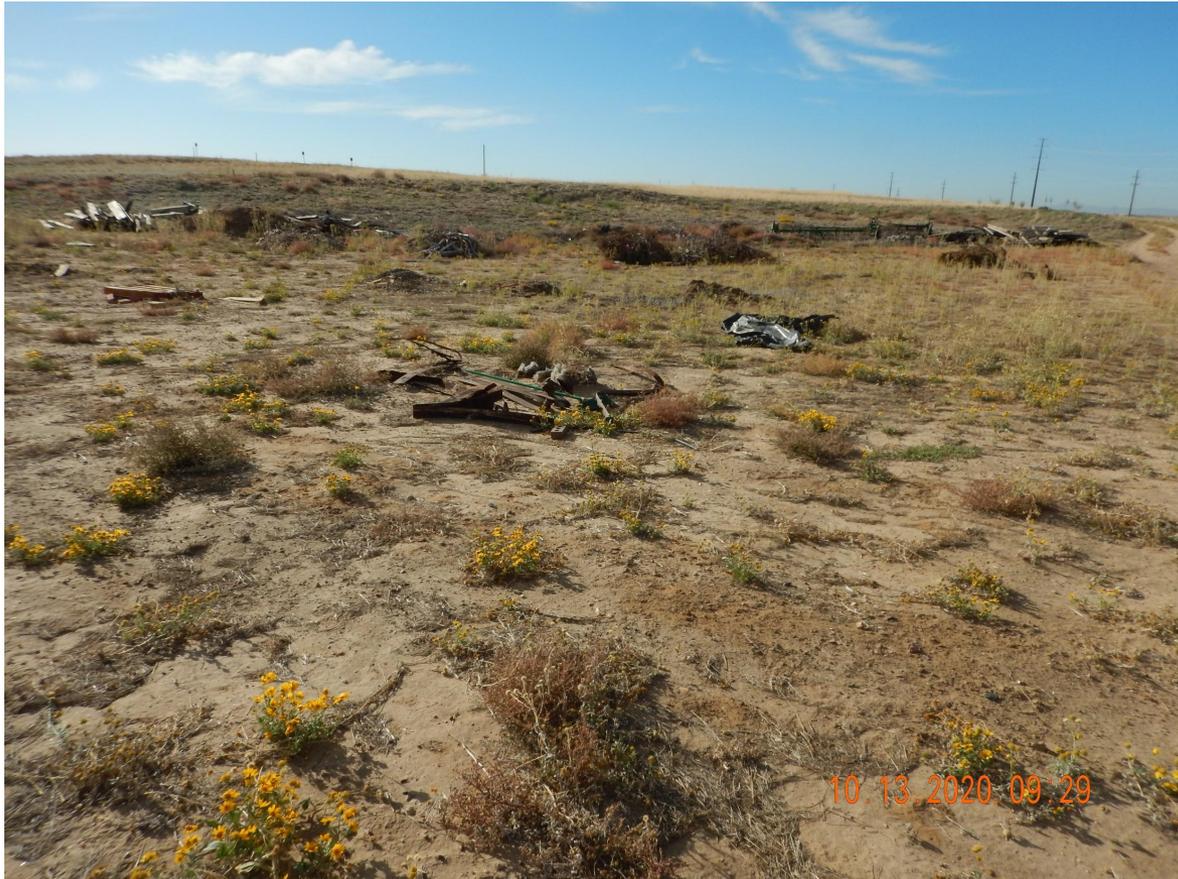
Photo 3. Photo taken from the northern location, facing South. Photo illustrates the location does not meet Rule 1004 standards. The location consists mostly of Curlycup gumweed.

Note: it appears the surface owner is storing equipment and trash.
