Final Reclamation and Stormwater Inspection

Operator: GREAT WESTERN OPERATING COMPANY LLC- #10110

Location ID: 319834

Inspection Photos
Location Name: BOX ELDER FARMS 32-35 #4 (1-66)
Location ID: 319834

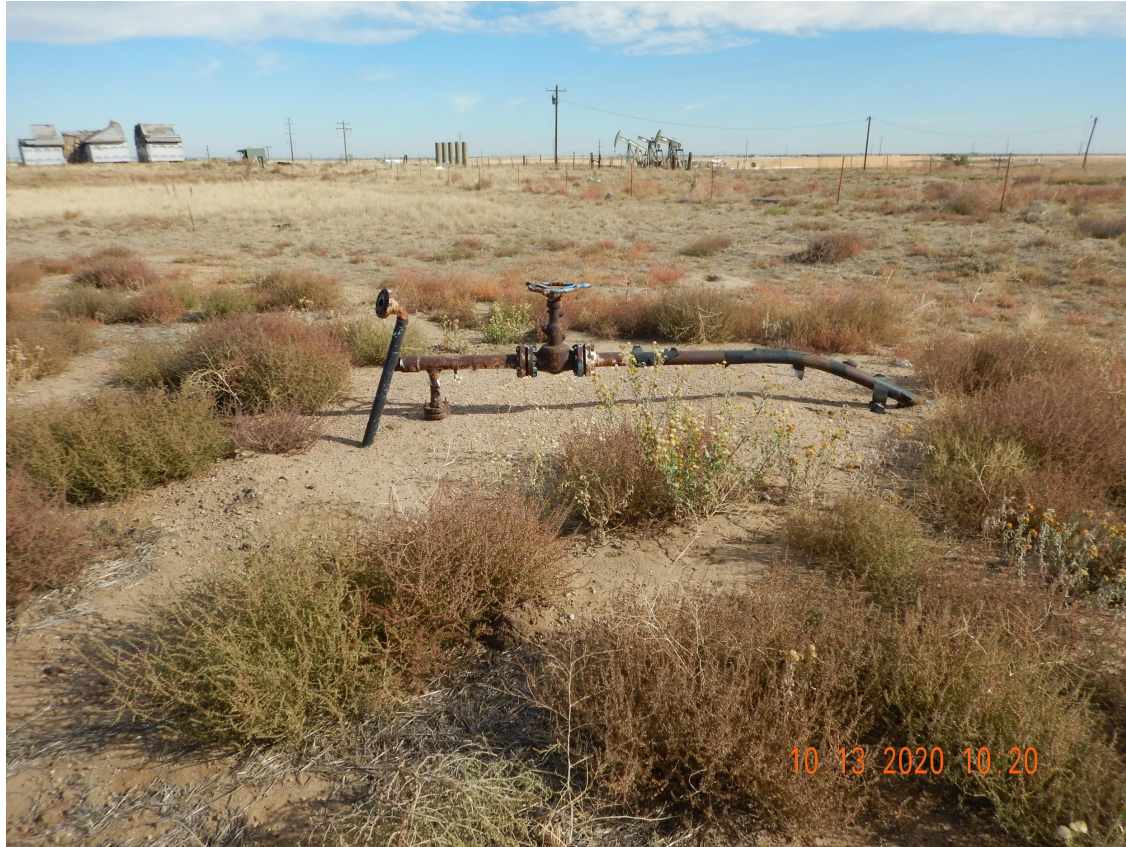
Photo 1. Photo taken from the associated offsite tank battery location, facing North. Photo illustrates the Operator has failed to remove all equipment. Also, Operator has failed to control weeds.

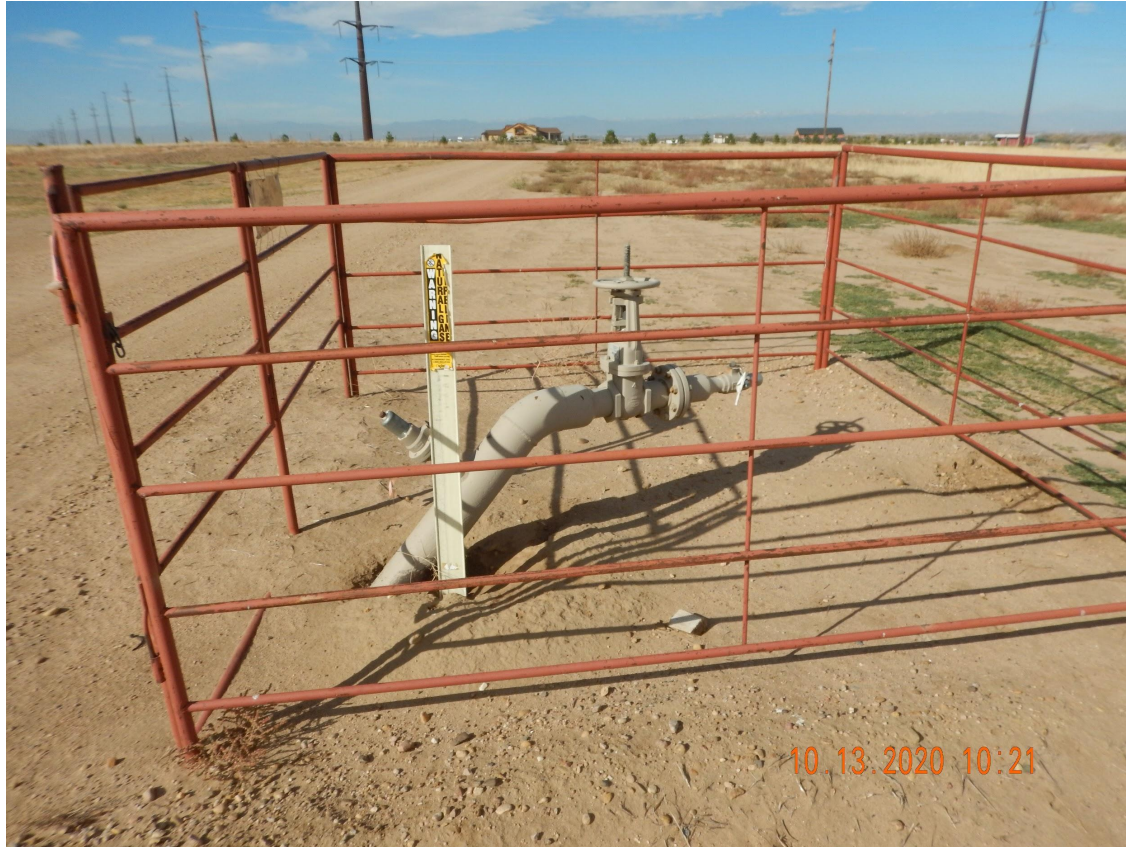
Photo 2. Photo taken from the associated offsite tank battery location, facing West. Photo illustrates the Operator has failed to remove all equipment.

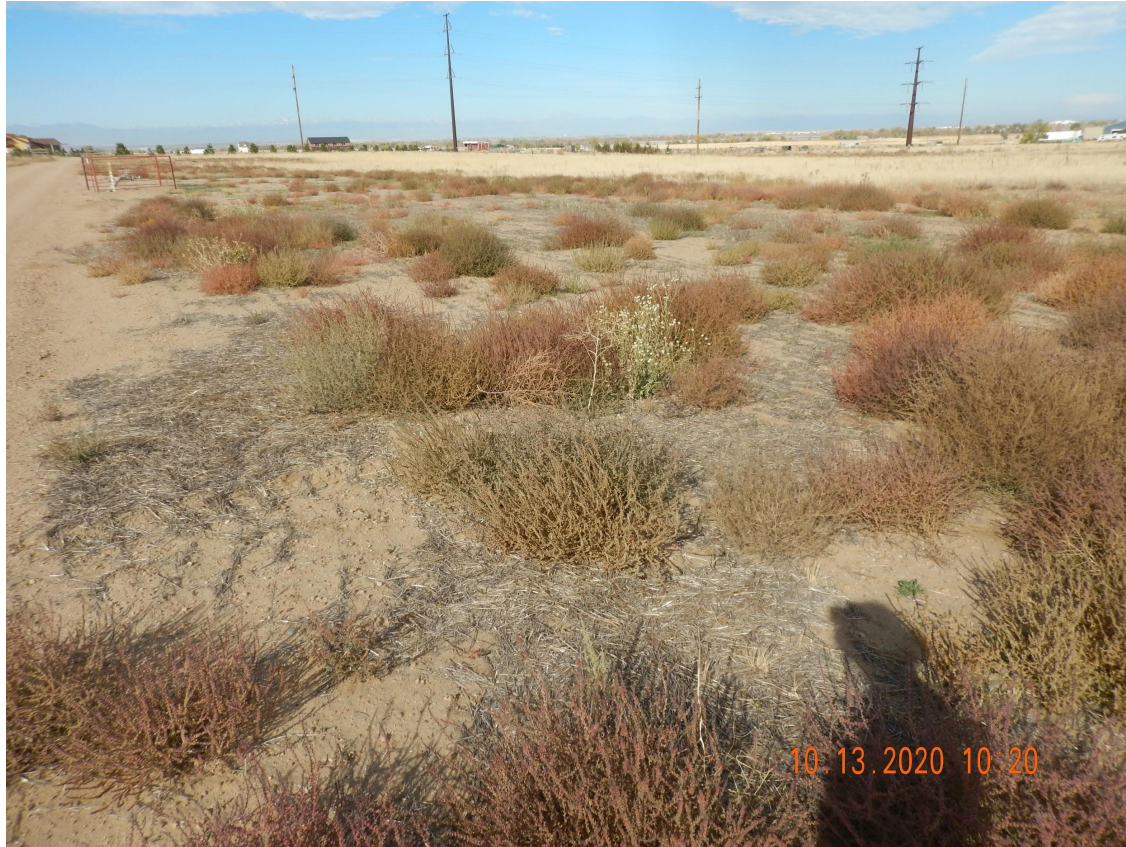
Photo 3. Photo taken from the associated offsite tank battery location, facing West. Photo illustrates the Operator has failed to control weeds.

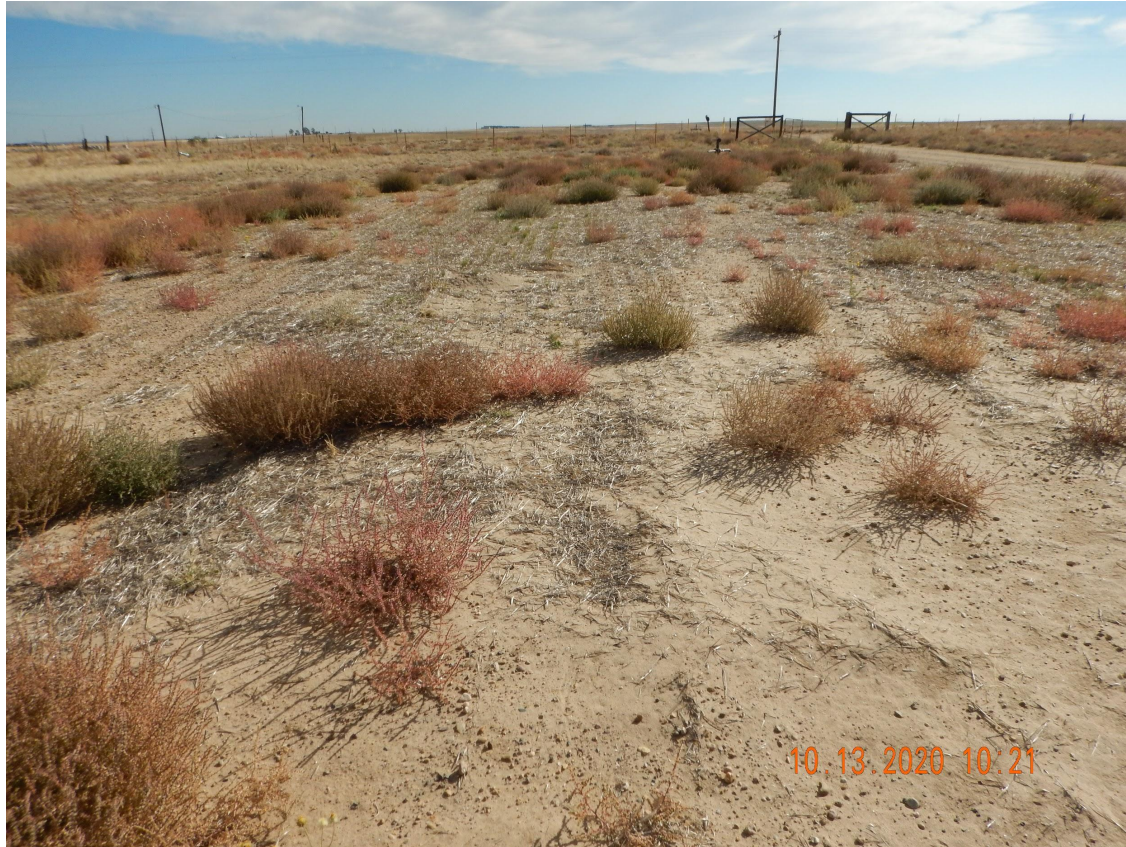
Photo 4. Photo taken from the associated offsite tank battery location, facing East. See comments under Photo 3.

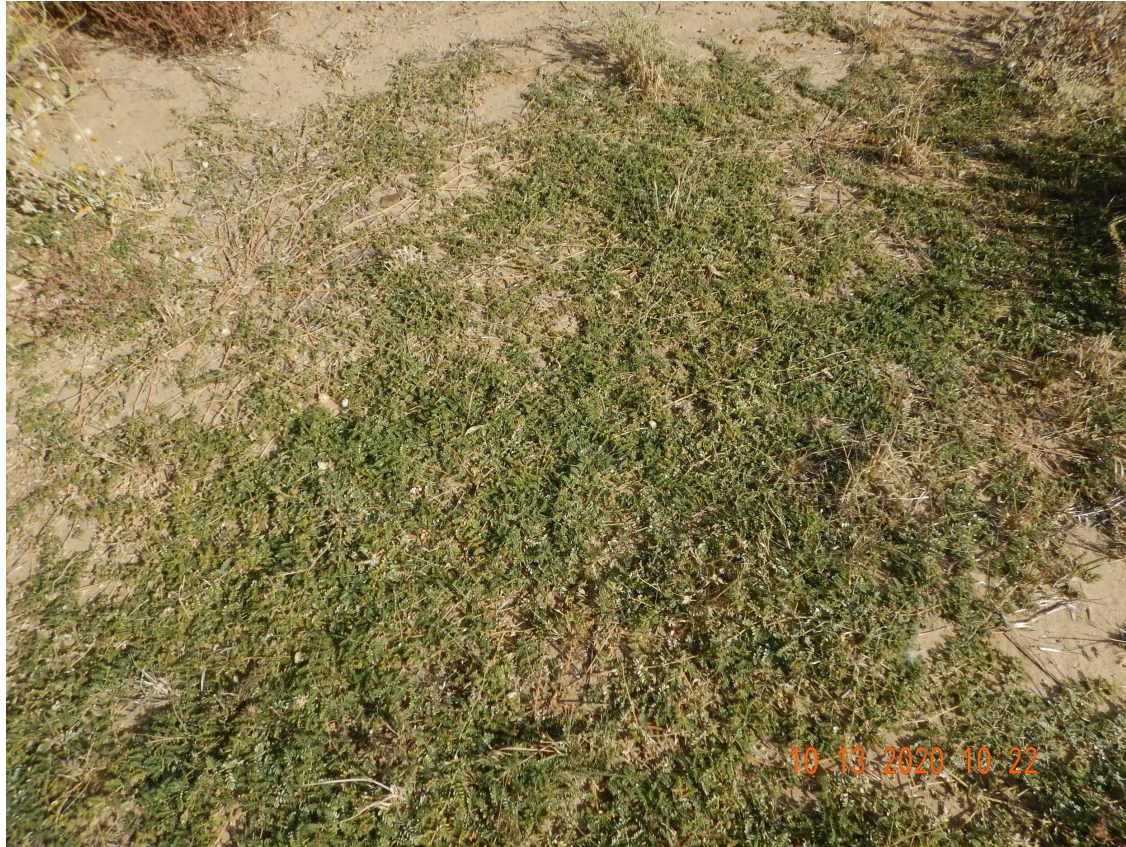
Photo 5. Photo taken from the associated offsite tank battery location. Photo illustrates Operator has failed to control weeds (i.e., puncture vine).

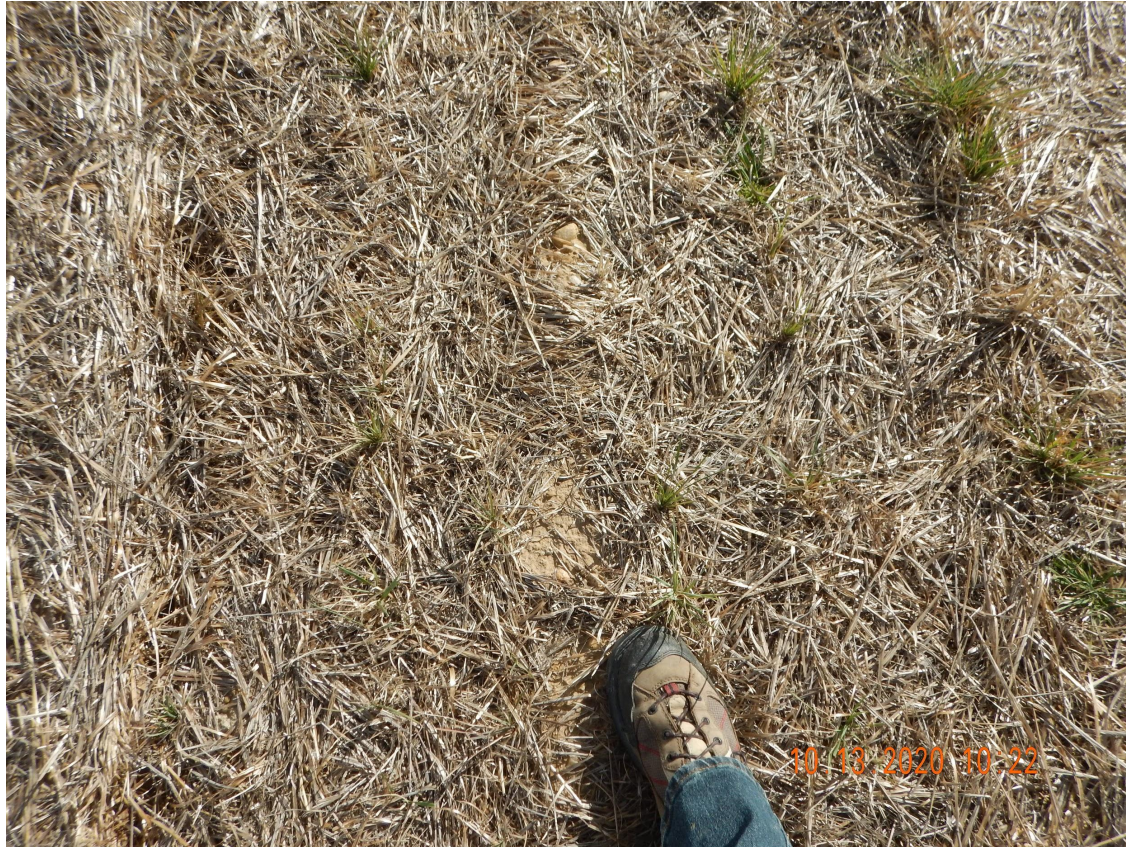
Photo 6. Photo taken from the associated offsite tank battery location. Photo illustrates germination of desirable grass species. Germination was not evident throughout the location and will likely require additional reclamation activities.

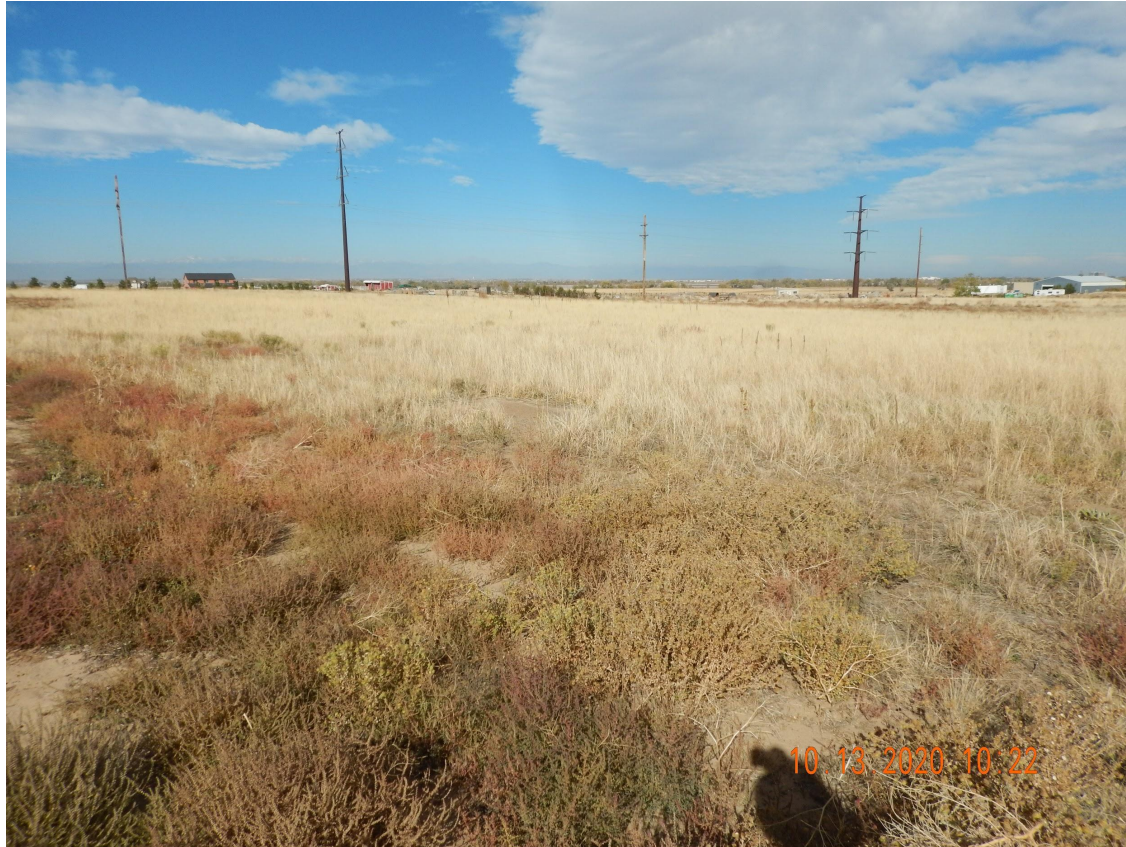
Photo 7. Reference photo taken from the associated offsite tank battery location, facing Northwest. Photo illustrates the adjacent reference areas consists mostly of Sand dropseed.

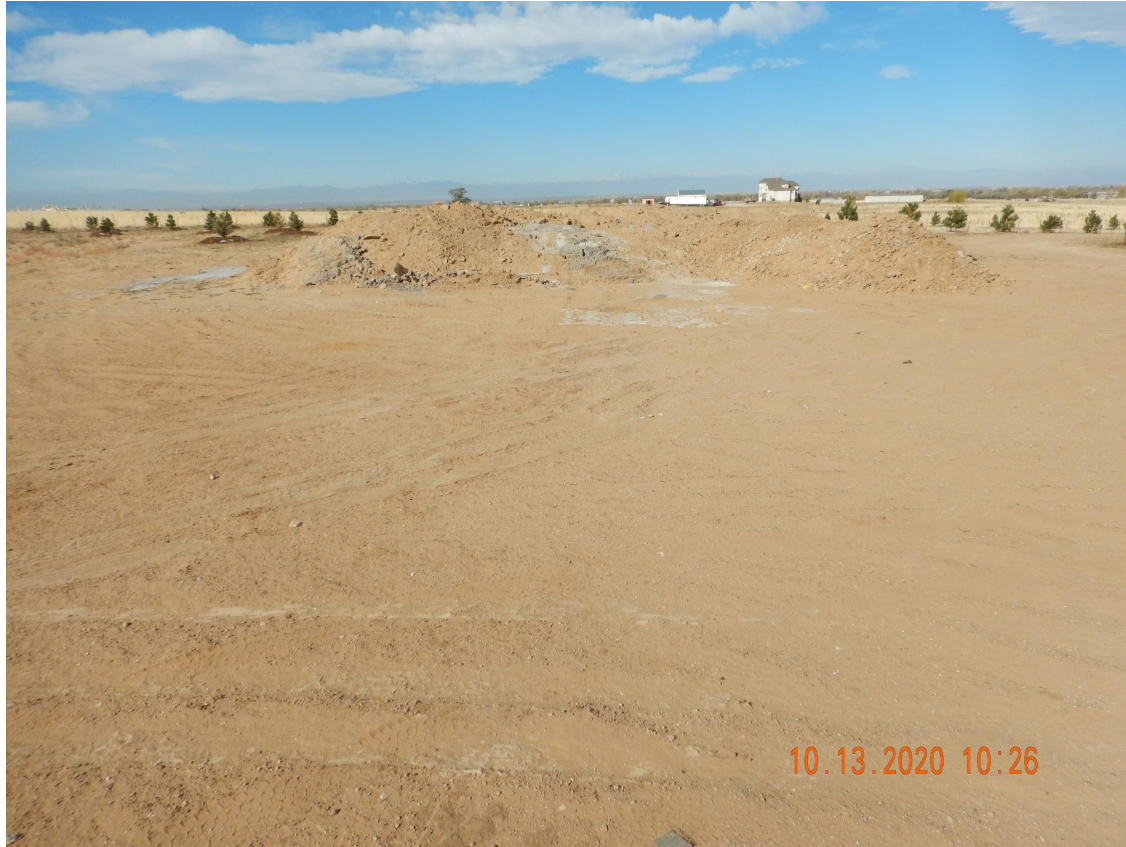
Photo 8. Photo taken from the well location, facing West. Photo illustrates all equipment has been removed from the well location. Well location is now part of a new housing development.

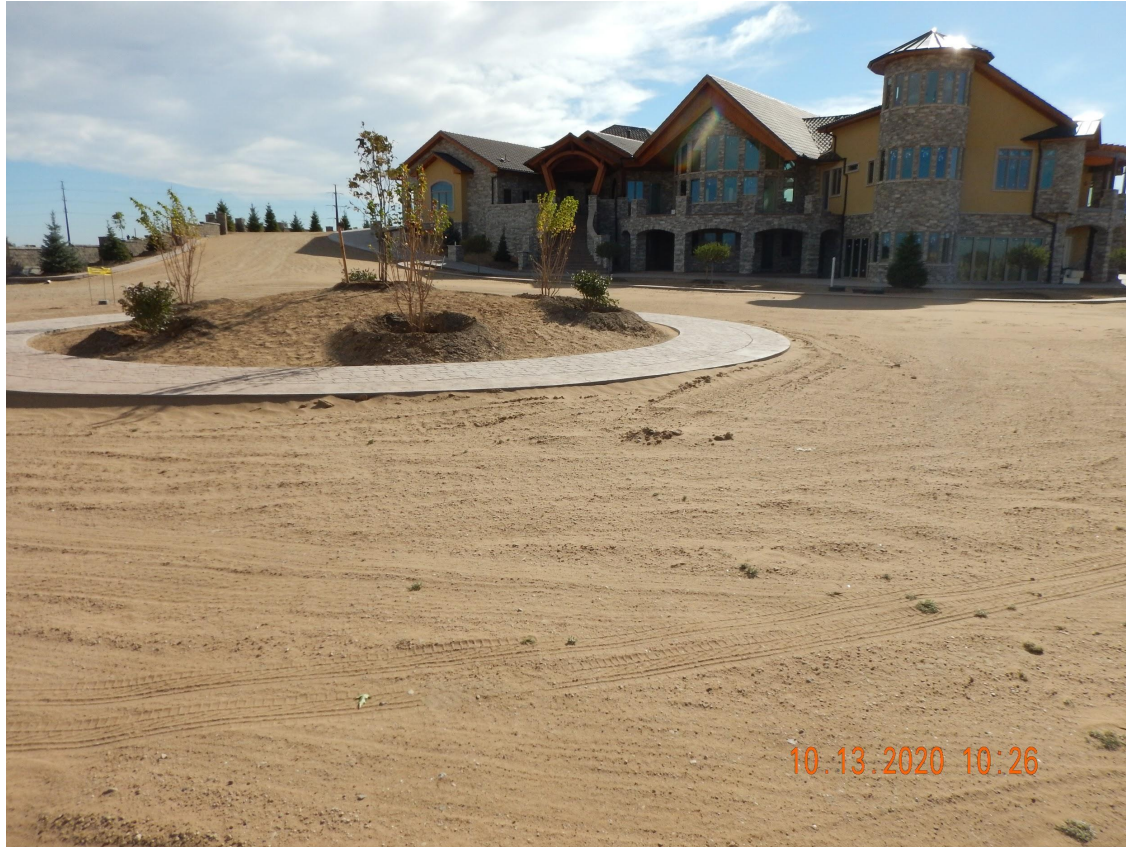
Photo 9. Photo taken from the well location, facing East. See comments under Photo 8.
