Construction and Stormwater Inspection

October 22, 2020

Operator: MALLARD EXPLORATION LLC- #10670

Inspection Photos
Location Name: Blue Teal /Pad
Location ID: 454414

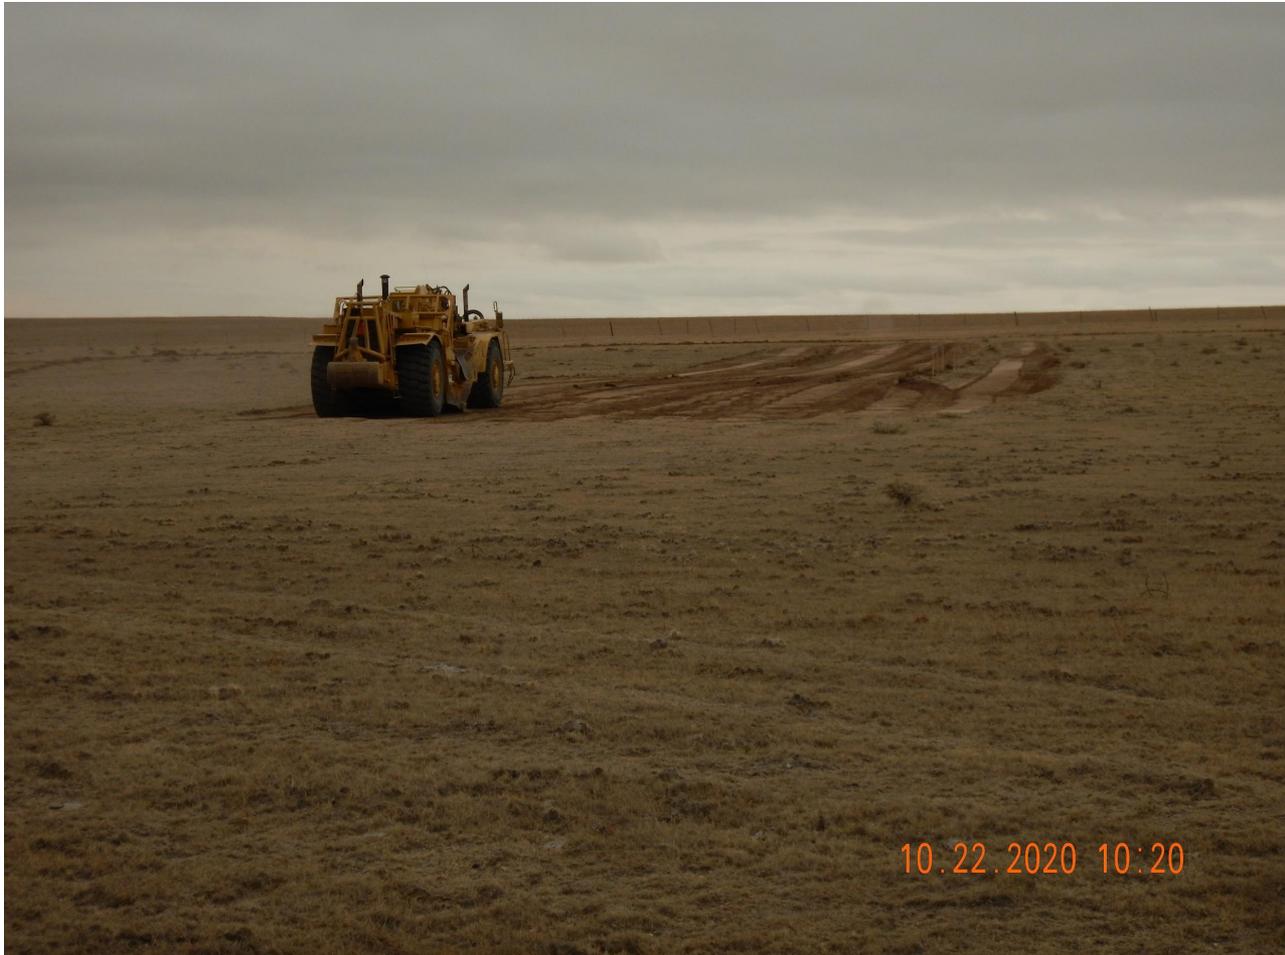
Photo 1. Photo taken from the eastern location, facing West. Photo illustrates the Operator is in process of salvaging topsoil. However, Operator has failed to install stormwater BMPs prior to starting topsoil salvage operations.

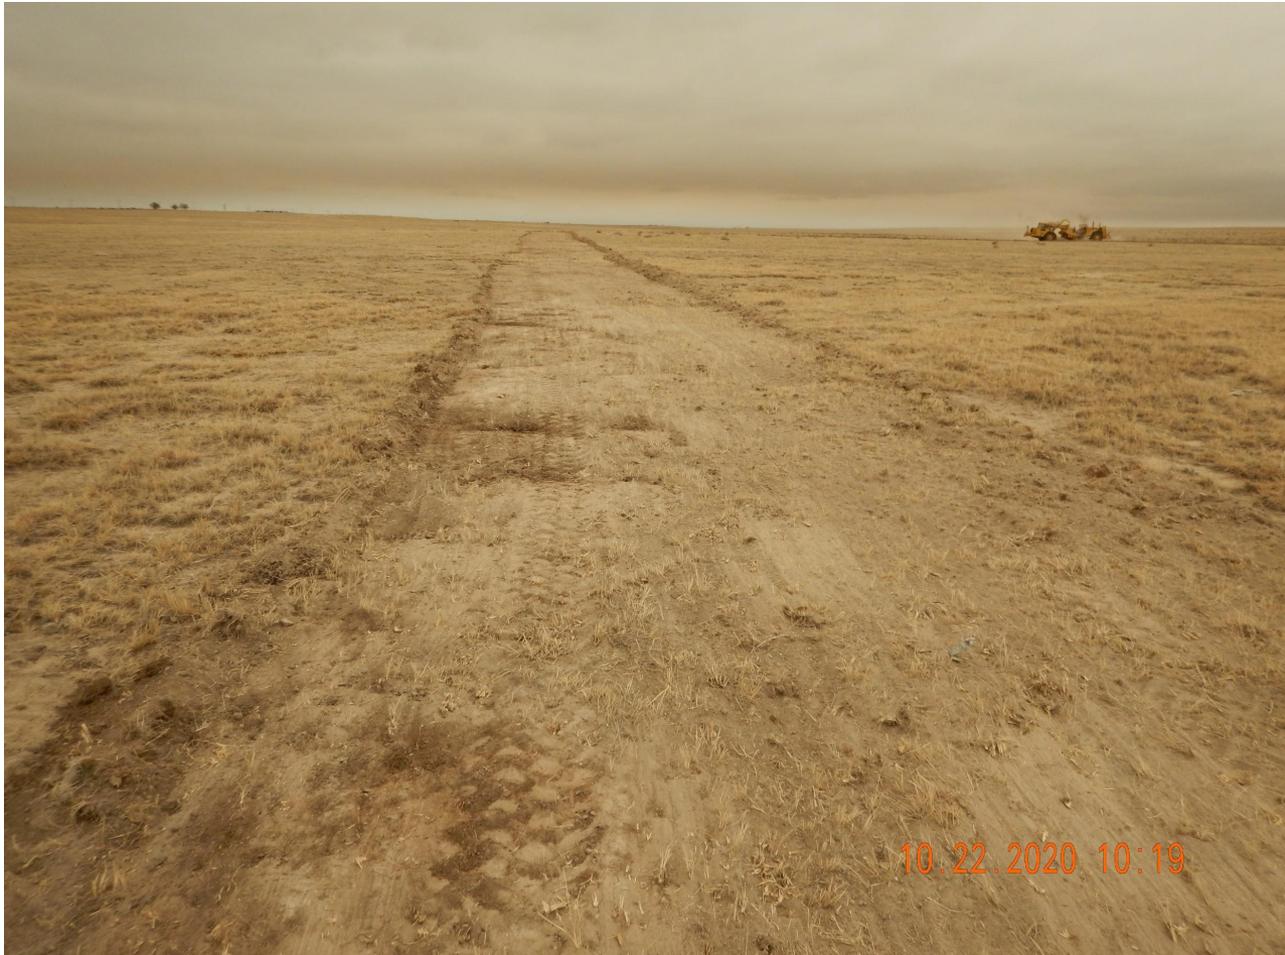
Photo 2. Photo taken from the eastern location, facing South. Photo illustrates the Operator has failed to install stormwater BMPs prior to starting topsoil salvage operations.

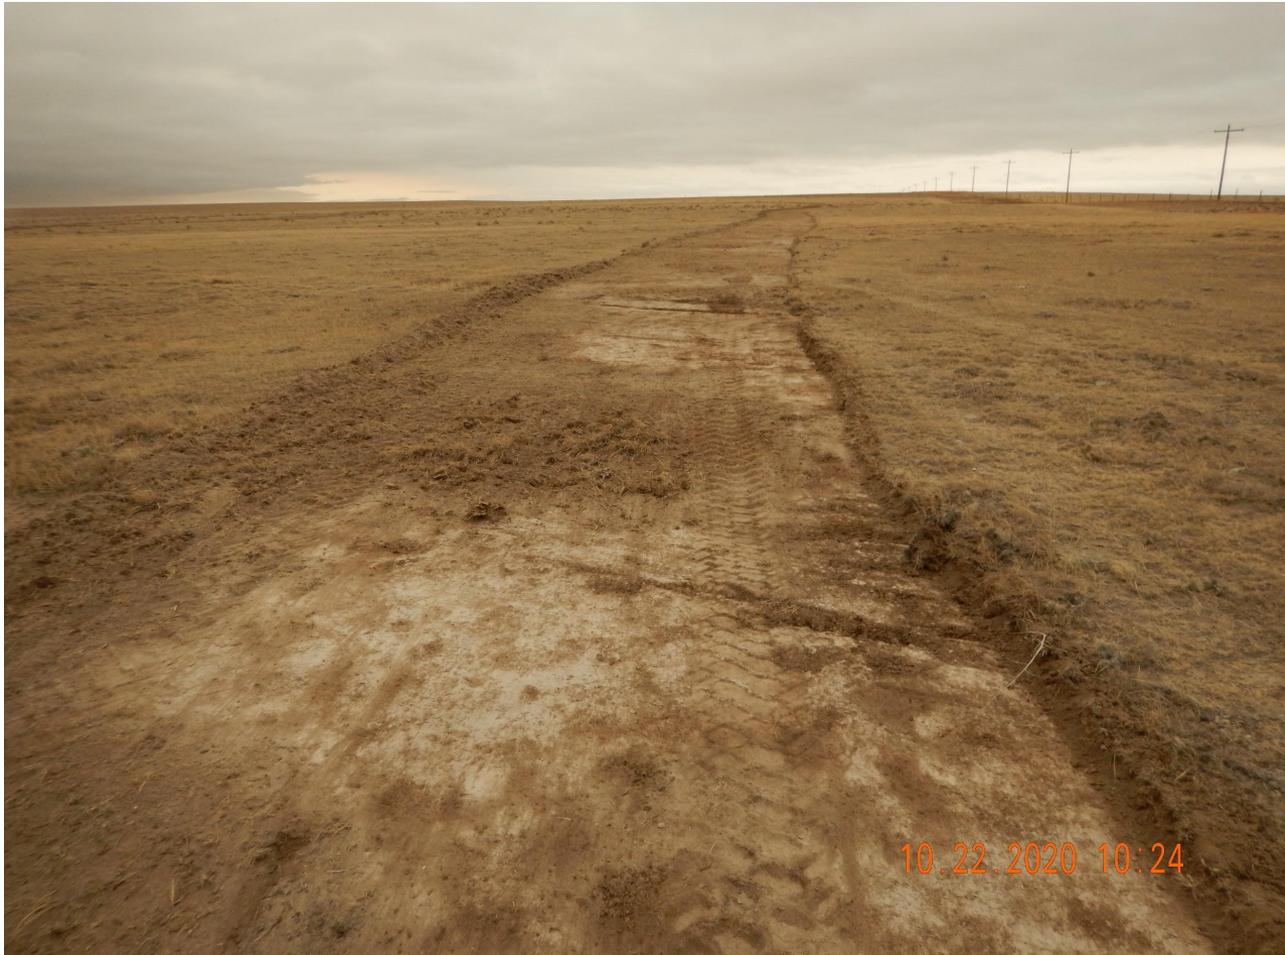
Photo 3. Photo taken from the northeastern location, facing West. Photo illustrates the Operator has failed to install stormwater BMPs prior to starting topsoil salvage operations.
