Final Reclamation Inspection Form

Site: ALOHA MULA 6 JETTED

Date: 10/1/2020

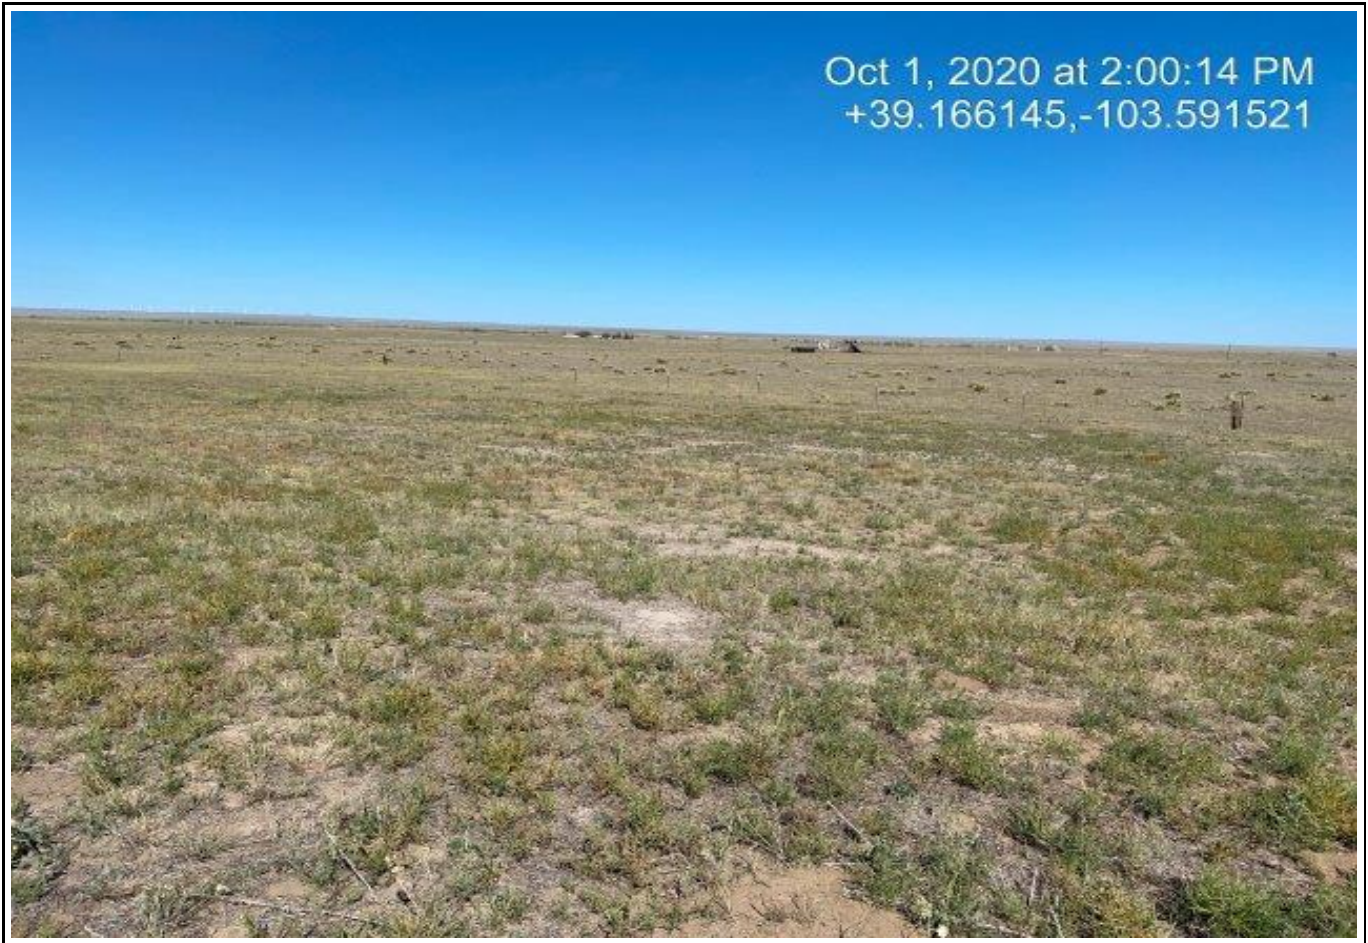
Photograph 5: Overview photograph.

Other Comments/Observations: Observed good grass growth onsite. There are a couple of bare spots still on site but those look to be getting smaller with future grass growth. Observed Adonis stickleaf, Cuman ragweed, prairie sunflower, field sagewort, soapweed yucca, wrinkly thistle, white sagebrush, curlycup gumweed growing onsite.
