Final Reclamation Inspection

Operator: PDC ENERGY INC - 69175

Location ID: 317901

Inspection Photos
Location Name: APOLLO #1
Location ID: 317901

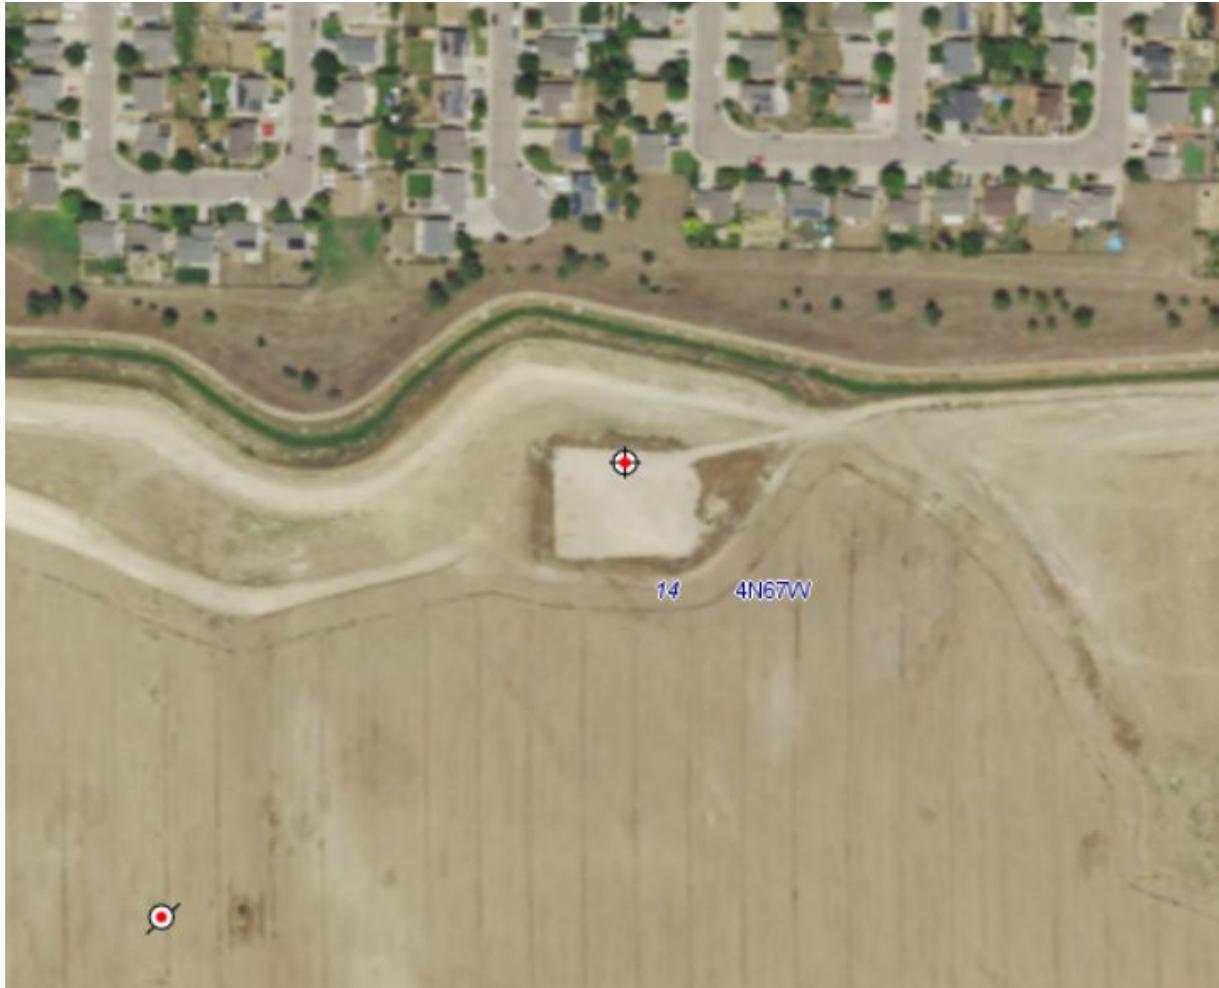
Photo 1. COGCC GISOnline 2019 aerial imagery illustrating the well and tank battery location which has not been reclaimed.

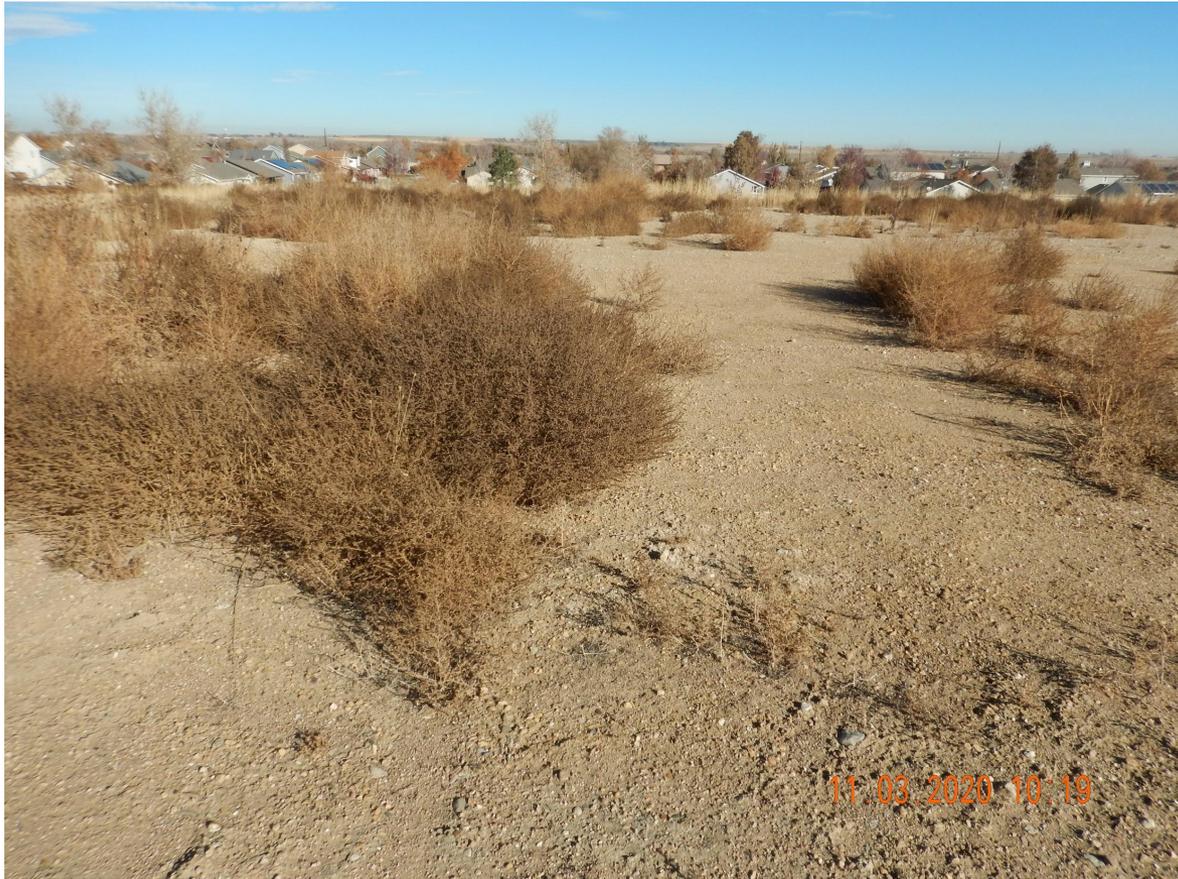
Photo 2. Photo taken from the western well and tank battery location, facing North. Photo illustrates the Operator has failed to perform final reclamation activities per Rule 1004. Also, unmanaged weeds (Russian thistle and Kochia) were observed throughout the locations.

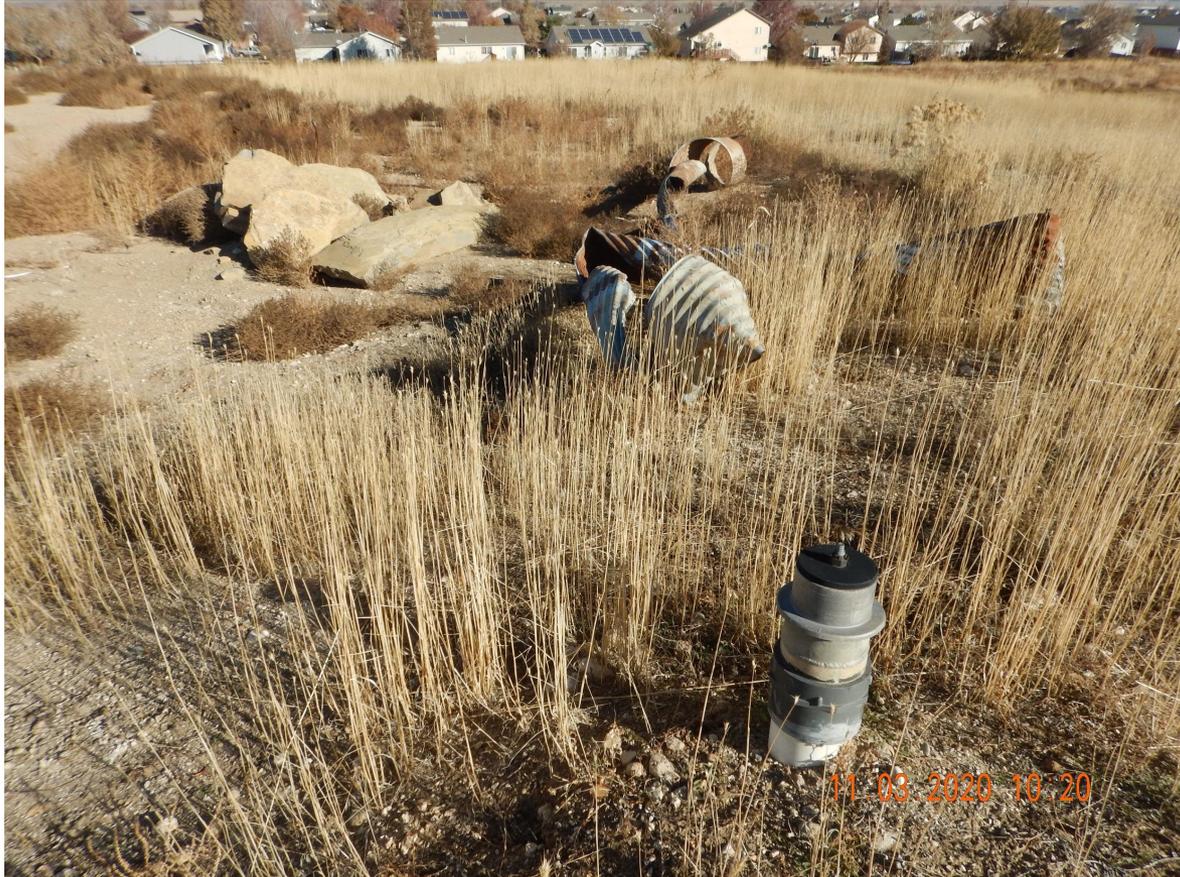
Photo 3. Photo taken from the eastern well and tank battery location, facing North. Photo illustrates the Operator has failed to perform final reclamation activities per Rule 1004 and remove debris.

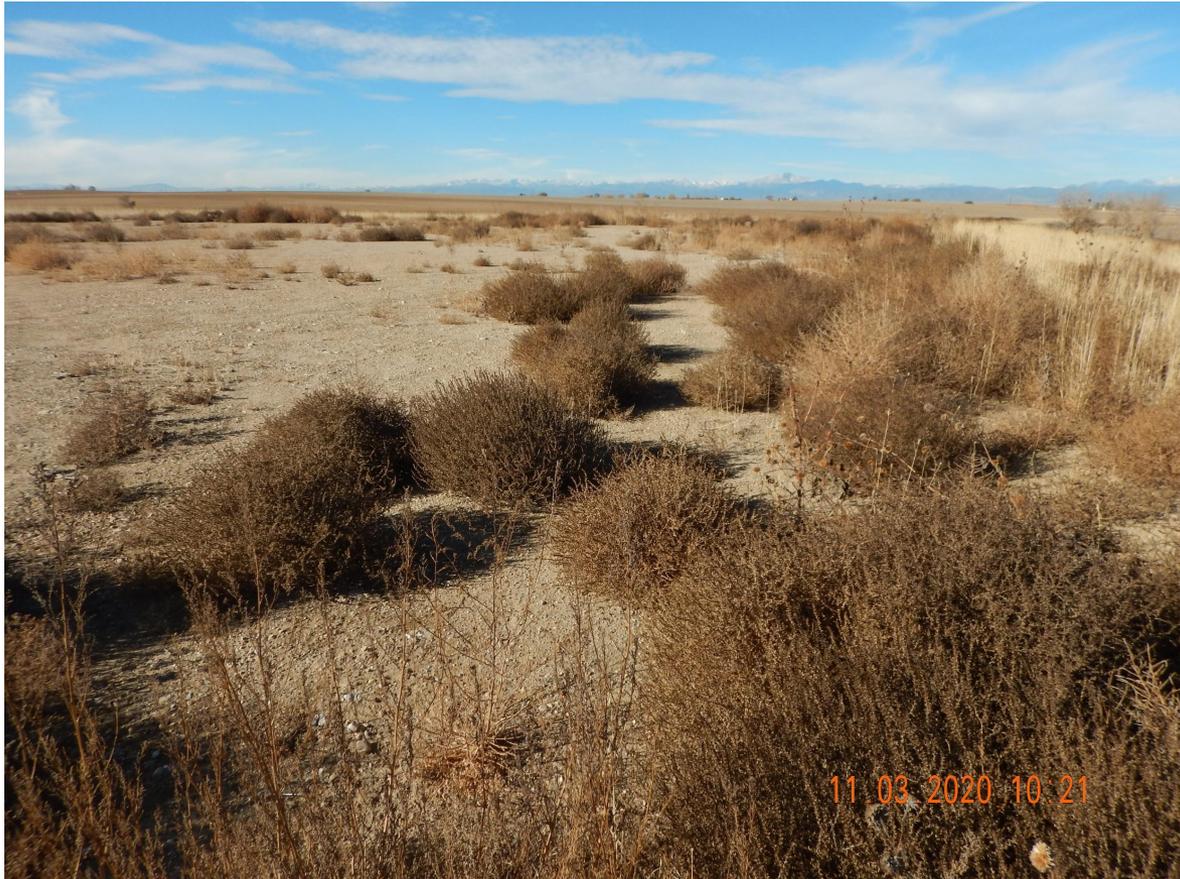
Photo 4. Photo taken from the northeastern well and tank battery location, facing West. See comments under Photo 1.

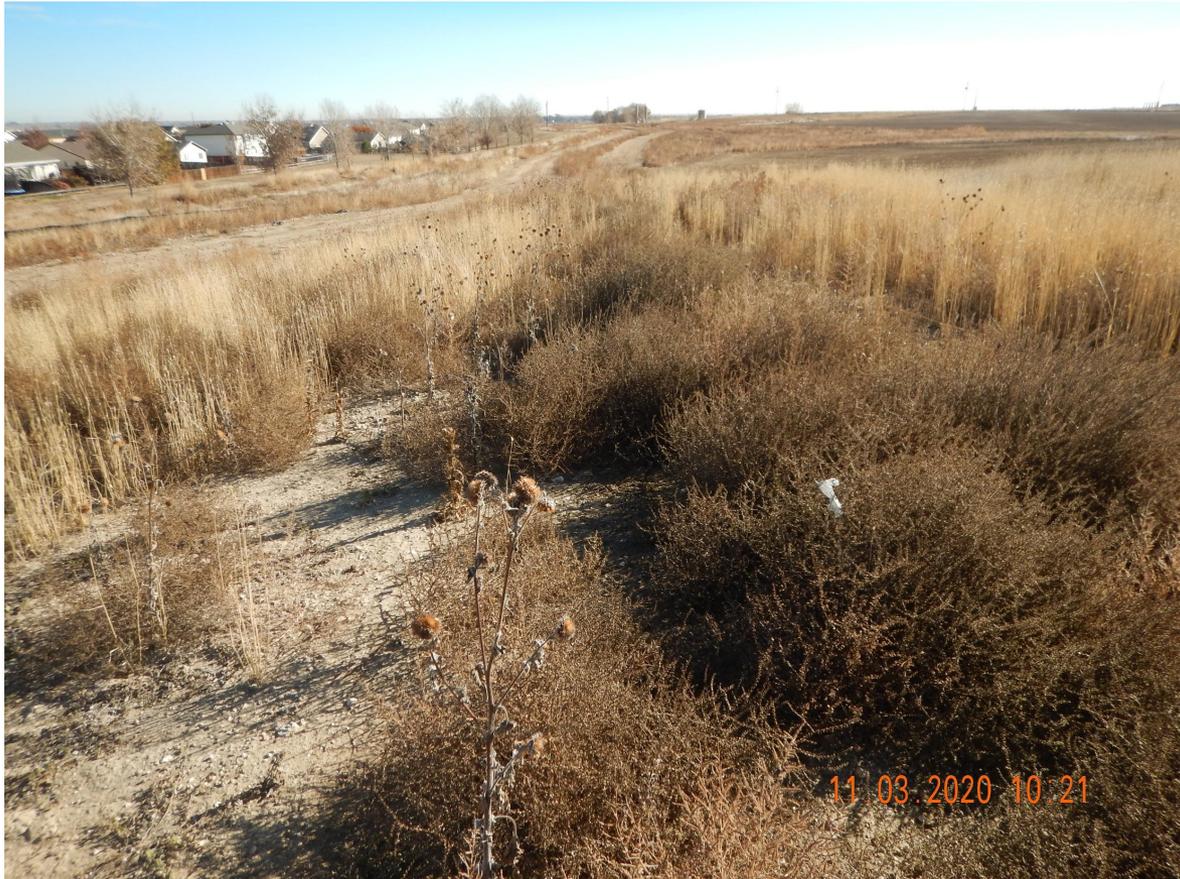
Photo 5. Photo taken from the northeastern well and tank battery location, facing East along the access road. See comments under Photo 1.
