Inspection Photos

11/02/2020

Operator: NONSUCH NATURAL GAS INC #
10163

Location ID: 453726
Garfield, CO

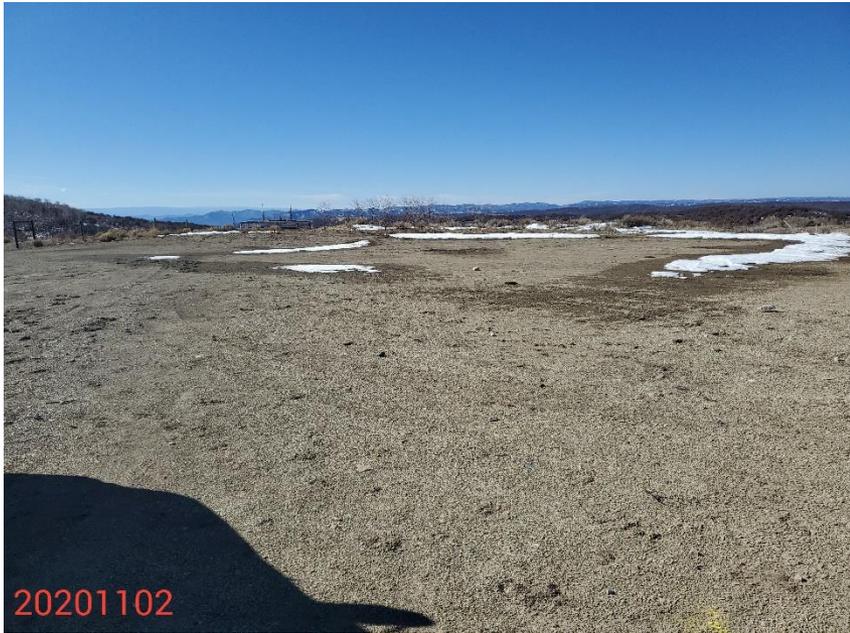
Photo 1: Photo taken from the east end of the Location, facing south. Photos 1-3 provide an overview of the production area from east, west to northwest.

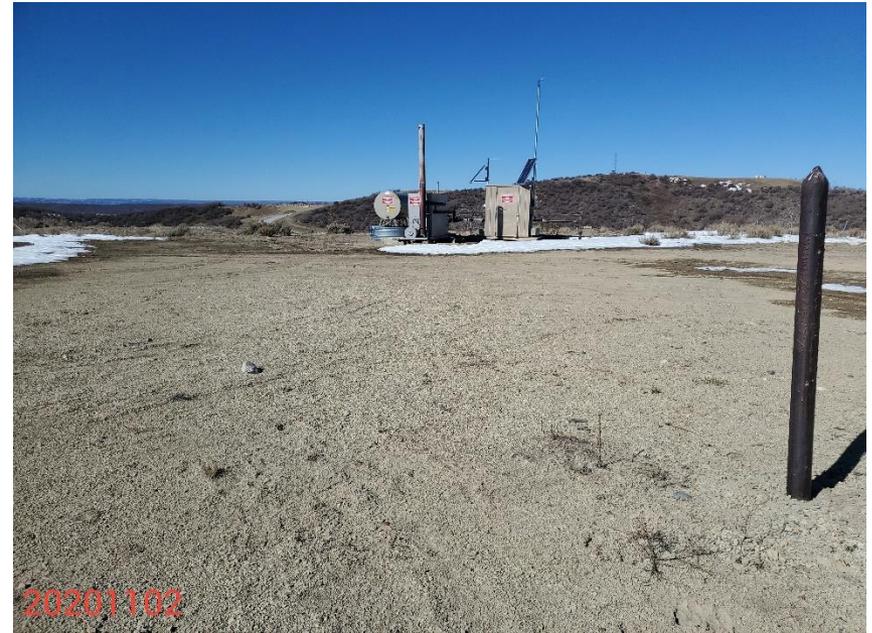
Photo 2: See comments under photo 1.

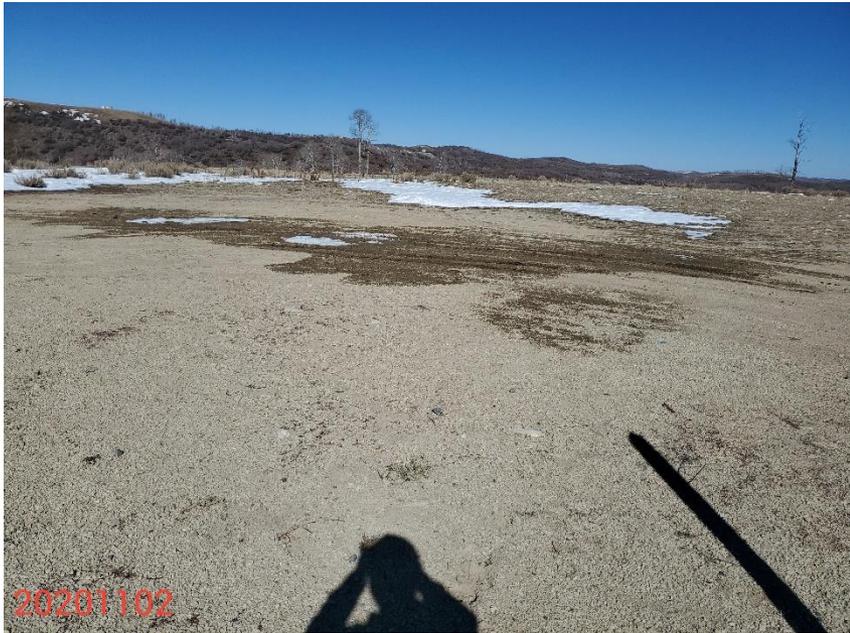
Photo 3: See comments under photo 1.

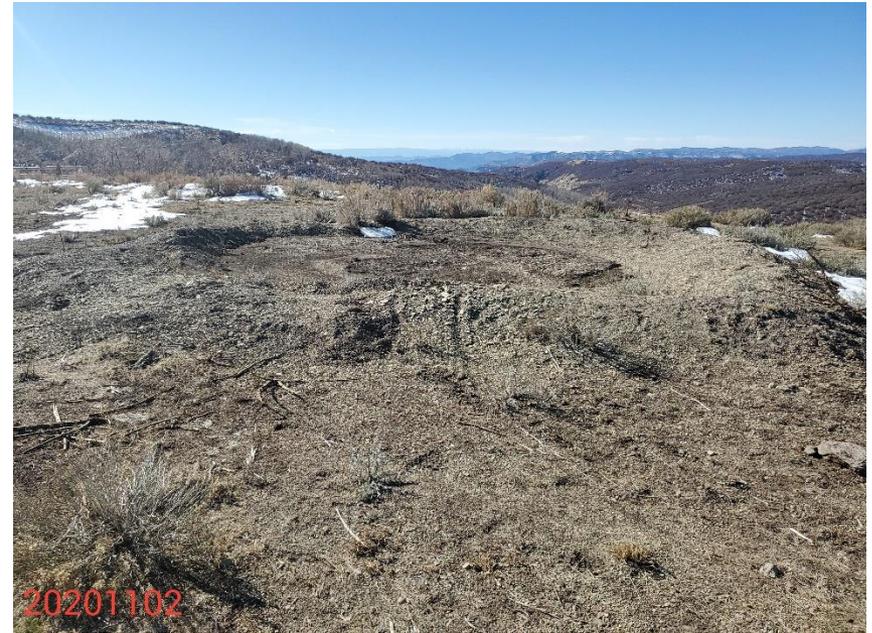
Photo 4: Photo shows 200 bbl condensate tank has been removed. Area does not appear needed for production and is now subject to 1003 interim reclamation

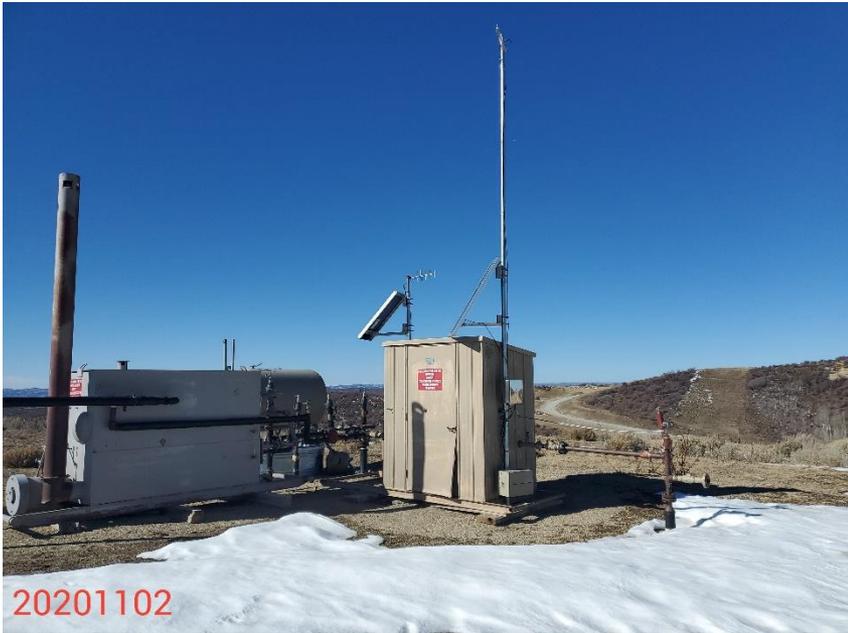
Photo 5: Photo shows meter shed on Location. COGCC Records show meter shed is active and associated with the CSOC 697-14 1 well, API #045-07948

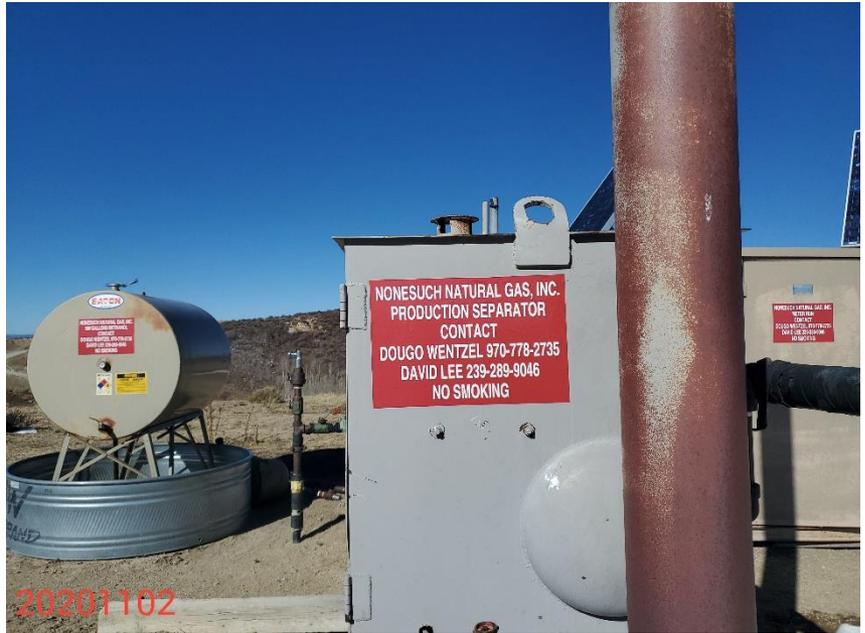
Photo 6: Photo shows separator equipment on Location. It is unclear to the COGCC at to what the equipment's current use is on the Location, and if equipment is considered active.

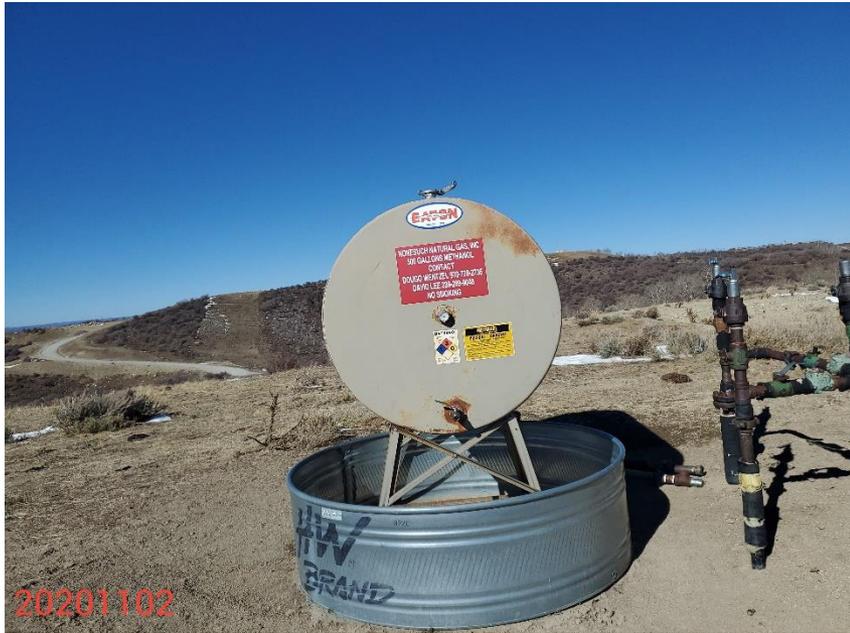
Photo 7: Photo shows methanol tank on the Location. It is unclear to the COGCC as to what the equipment's current use is on the Location, and if equipment is considered active.

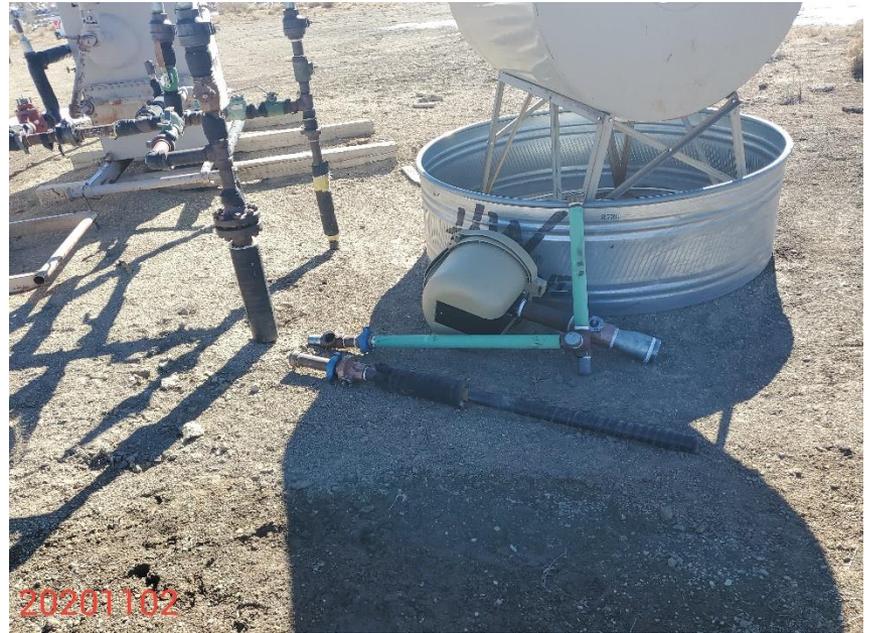
Photo 8: Photo shows unused pipe equipment stored behind the methanol tank.
