# Inspection Photos

Operator: BERRY PETROLEUM COMPANY LLC

Location ID: 335964

Garfield, CO

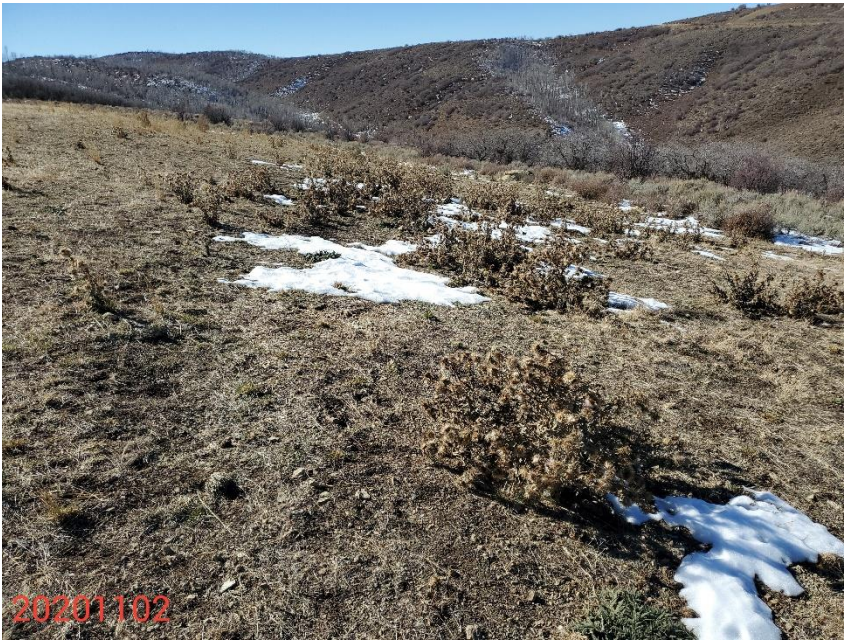
**Photo 1:** Photo taken from the western interim areas of the location, facing south. Photo shows noxious weeds remaining on the Location. Previous inspections observed seed dispersal in process. It was observed in this inspection that seed dispersal appears to have been allowed to be completed, as the majority of the weed's seed heads are now bare. Weeds have not been removed as indicated by the FIRR; Unable to find evidence that sufficient weed management activities to prevent establishment and spread of noxious weeds on and from the Location have been conducted.

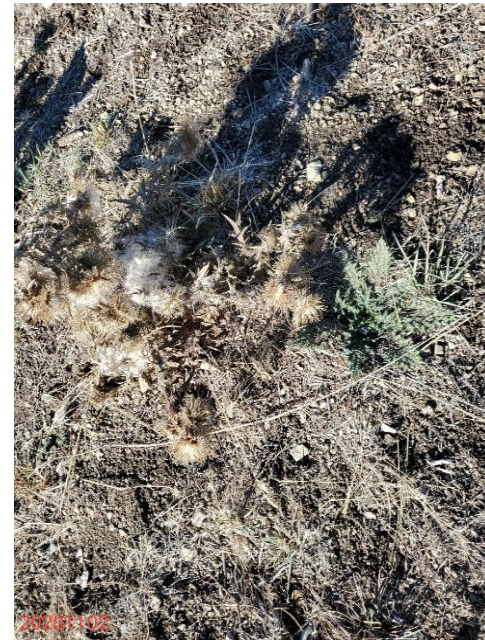
**Photo 2:** Photo shows weed with bare seed head. Weed seed can be observed at the base of the plant, as well as an additional rosette. See comments under photo 1.

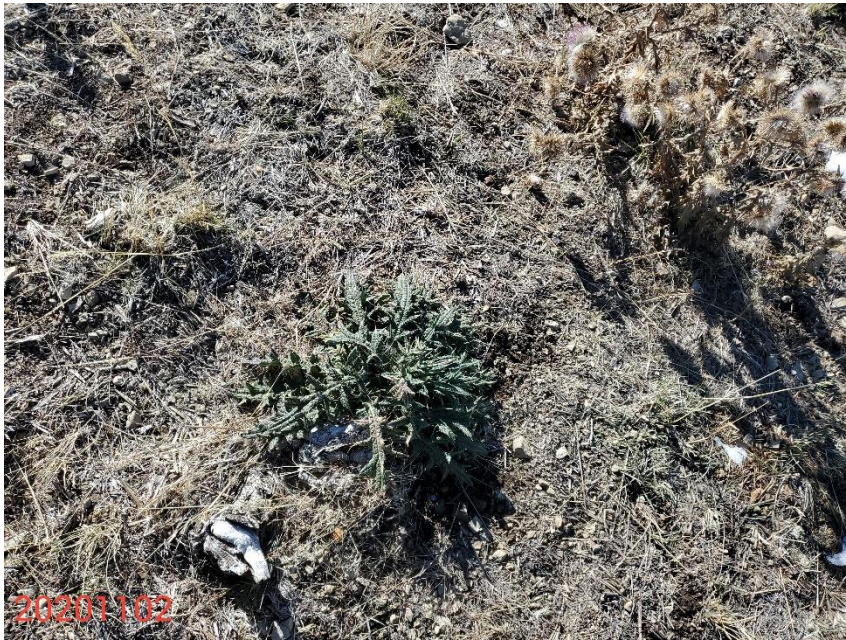
**Photo 3:** See comments under photo 1.

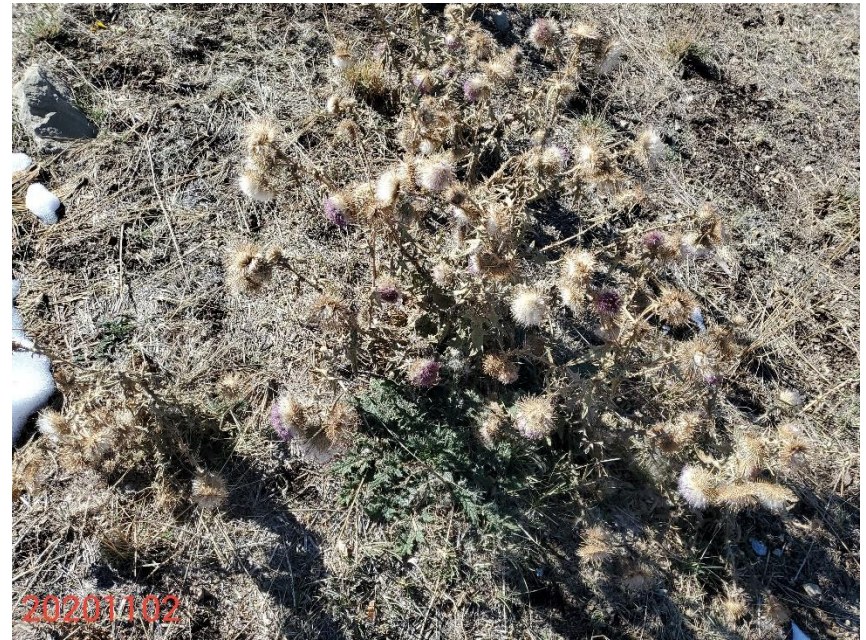
**Photo 4:** See comments under photo 1.
