# Inspection Photos

Operator: BP America  
API: 067-06657  
Date: 11/17/2020

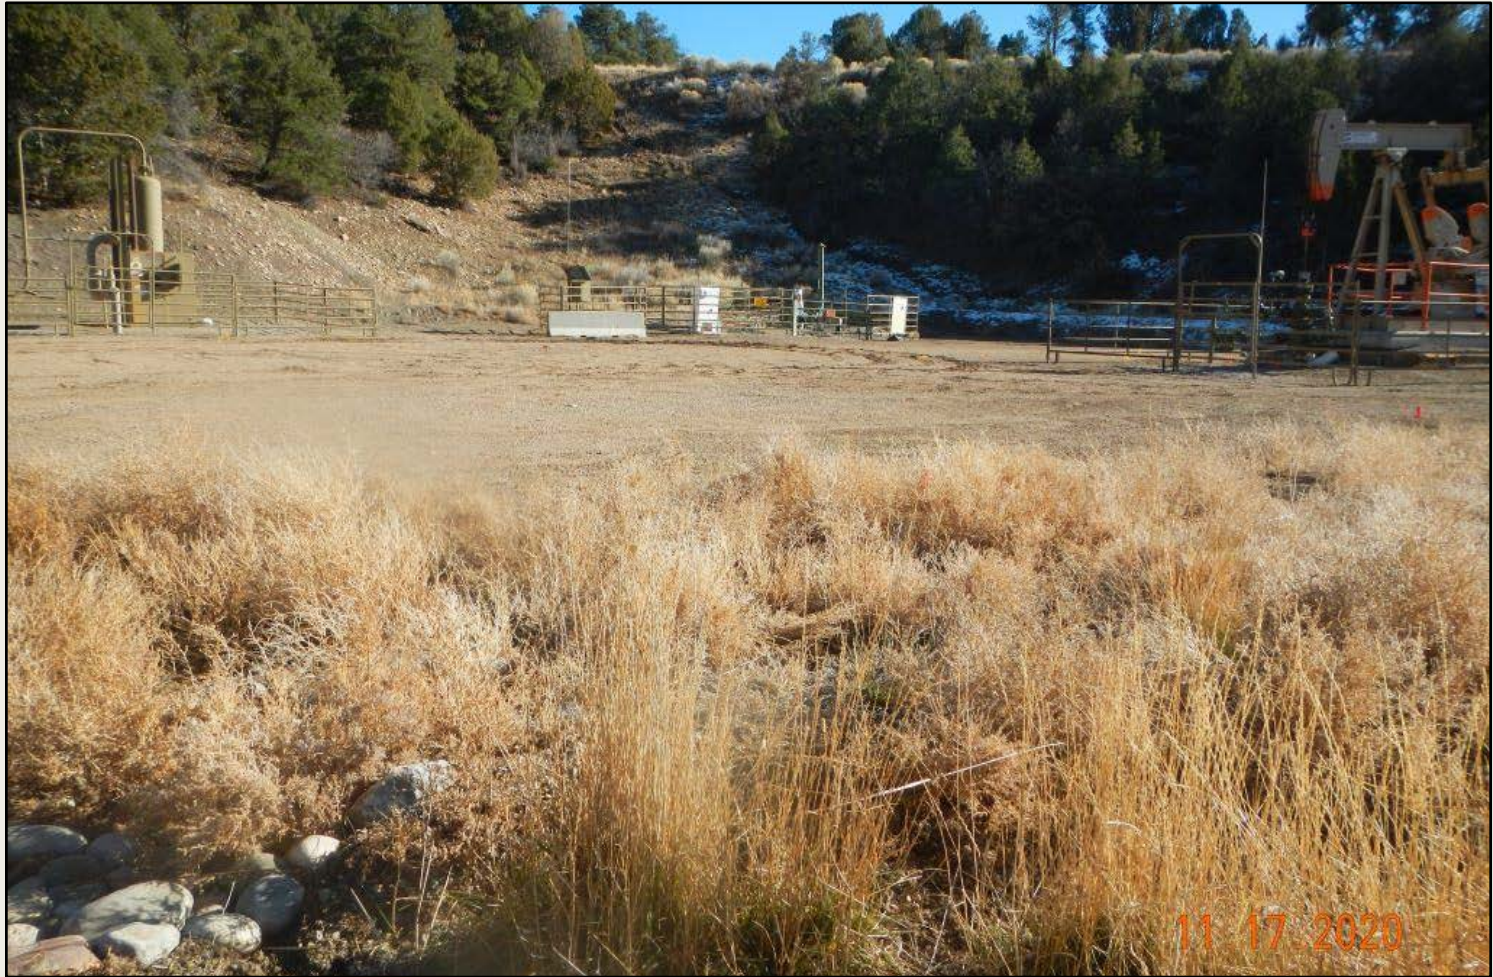
Photo 1. View of the project area from the northwestern corner facing center.

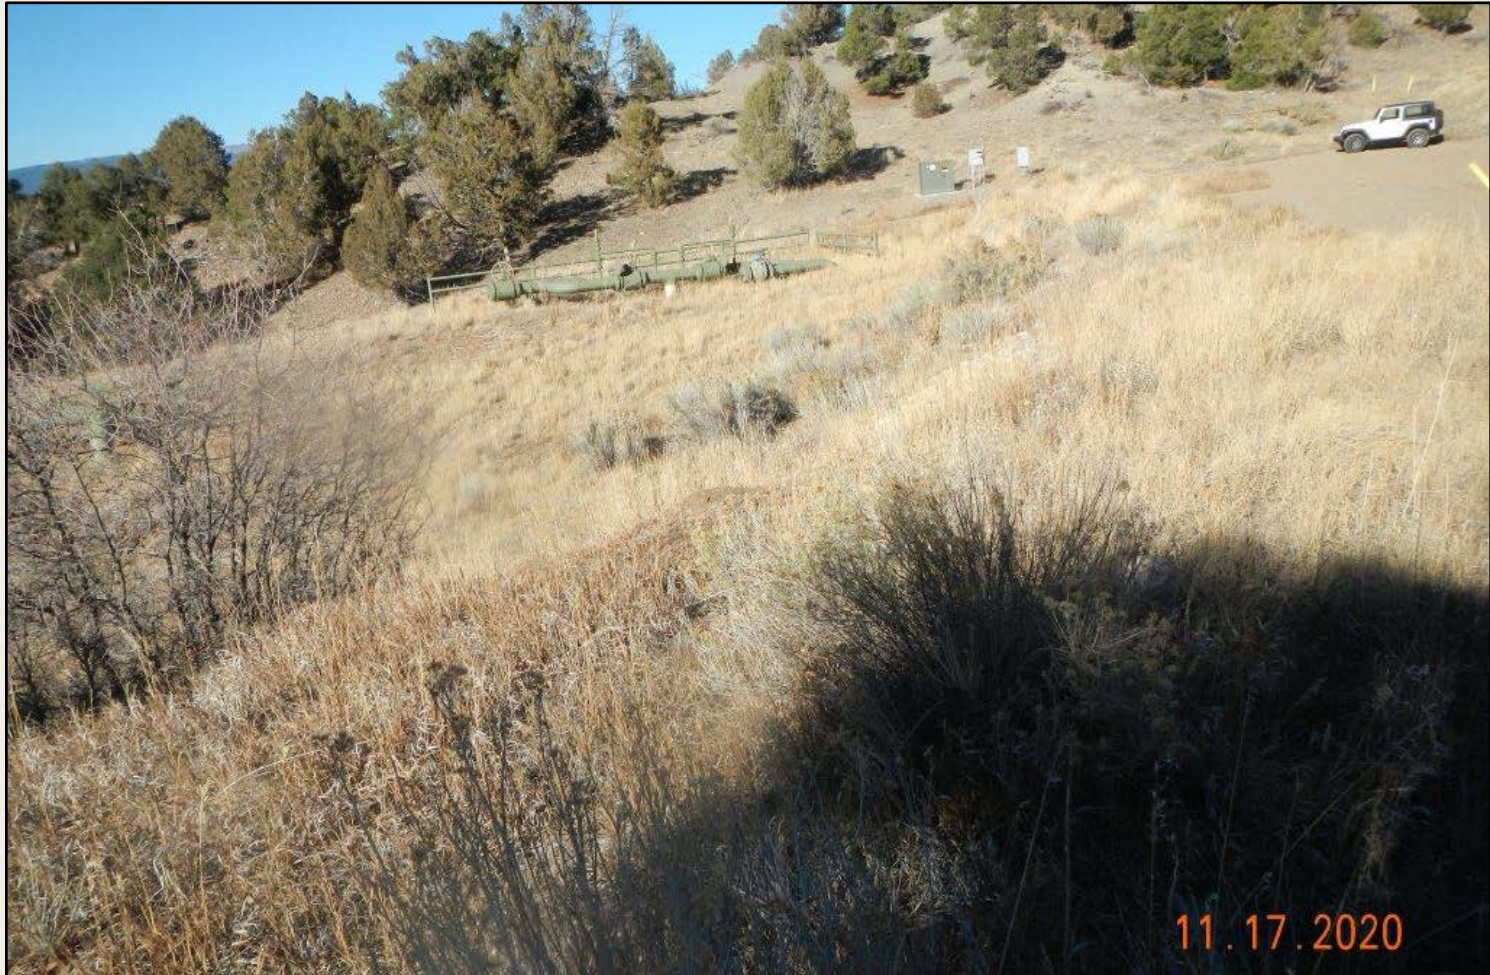
Photo 2. View of the western fill slope from the southwestern corner facing northward. Revegetation is progressing with grasses such as smooth brome, western wheatgrass, and thickspike wheatgrass.

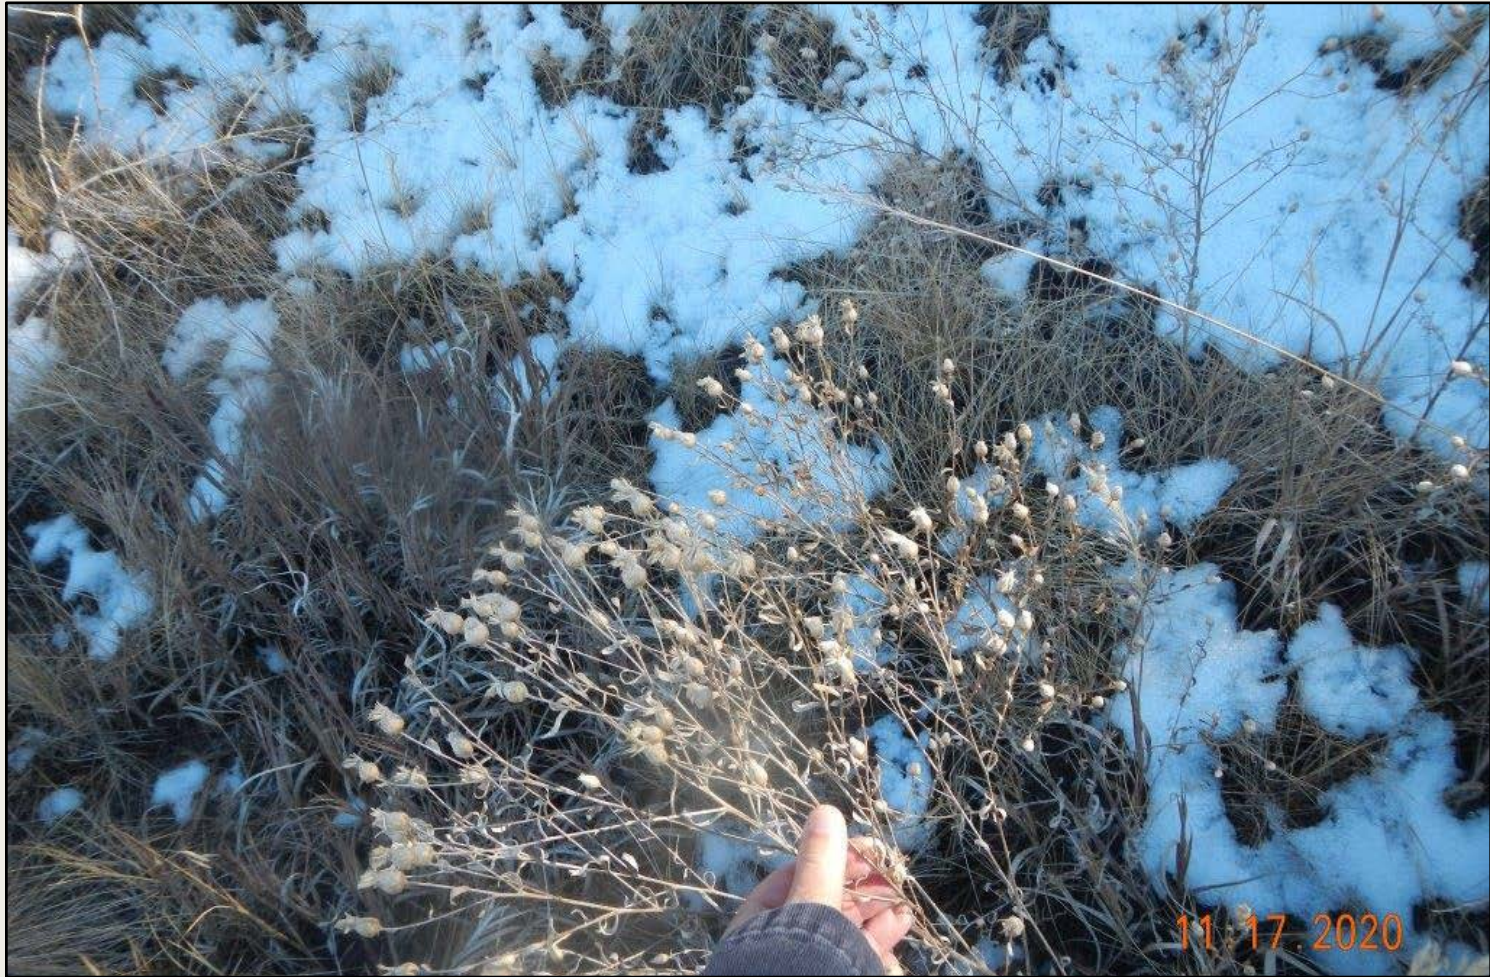
Photo 3. View of Russian knapweed within the southern project area. Approximately 200 individuals observed.

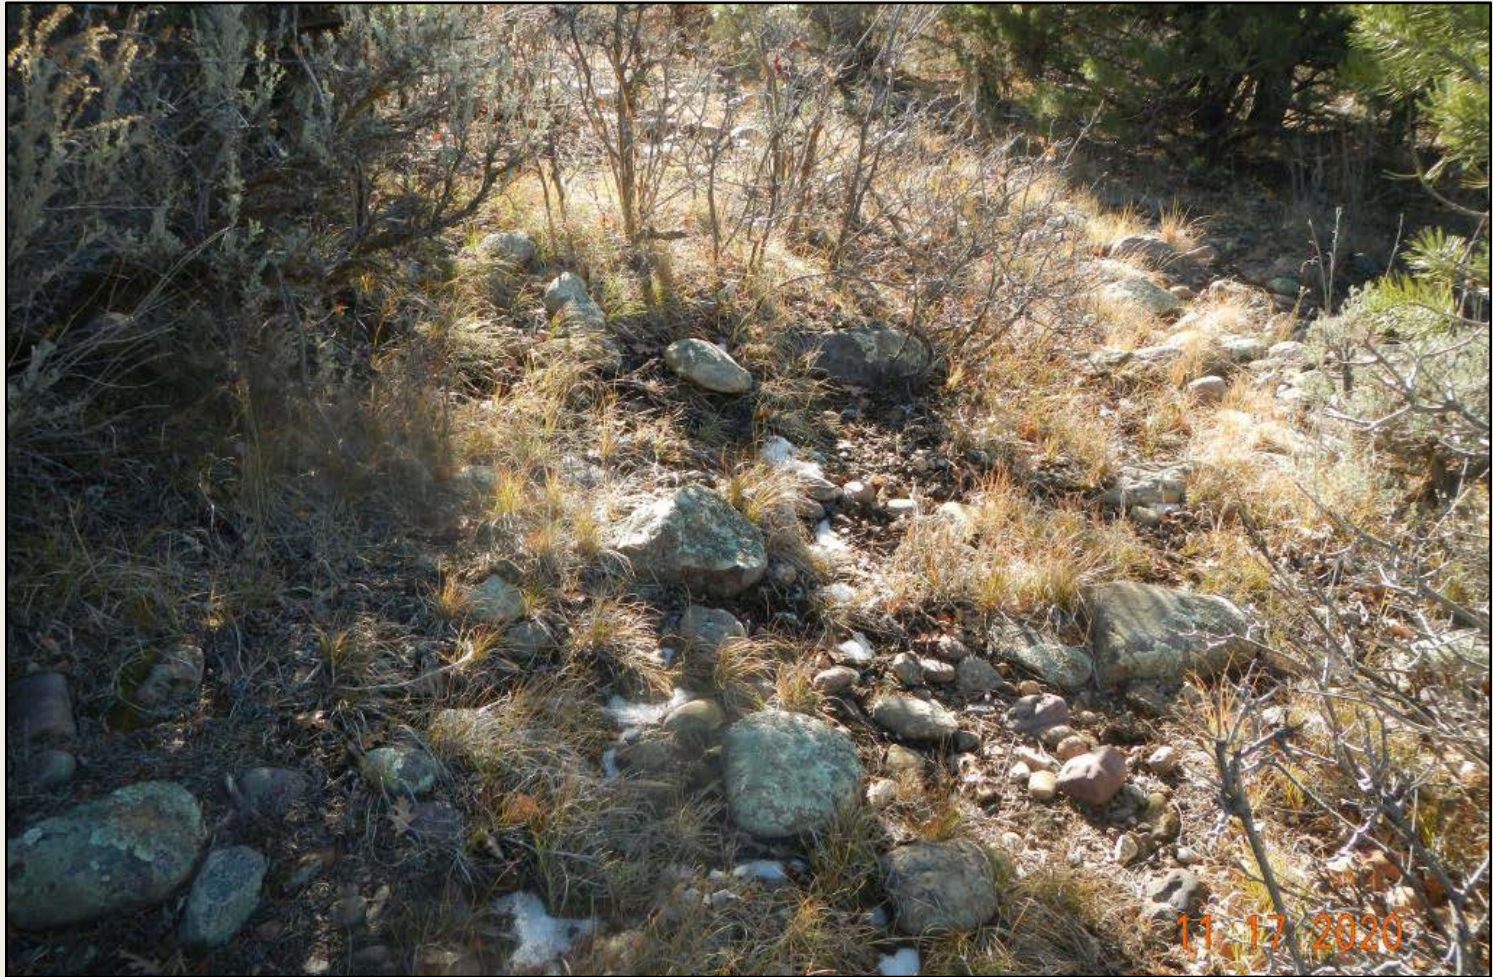
Photo 4. View of the reference area comprised of pinyon juniper woodland with gambel oak, sagebrush, western wheatgrass, and blue grama.
