Inspection Photos

11/19/2020

Operator: SG INTERESTS I LTD # 77330

Location ID: 422990

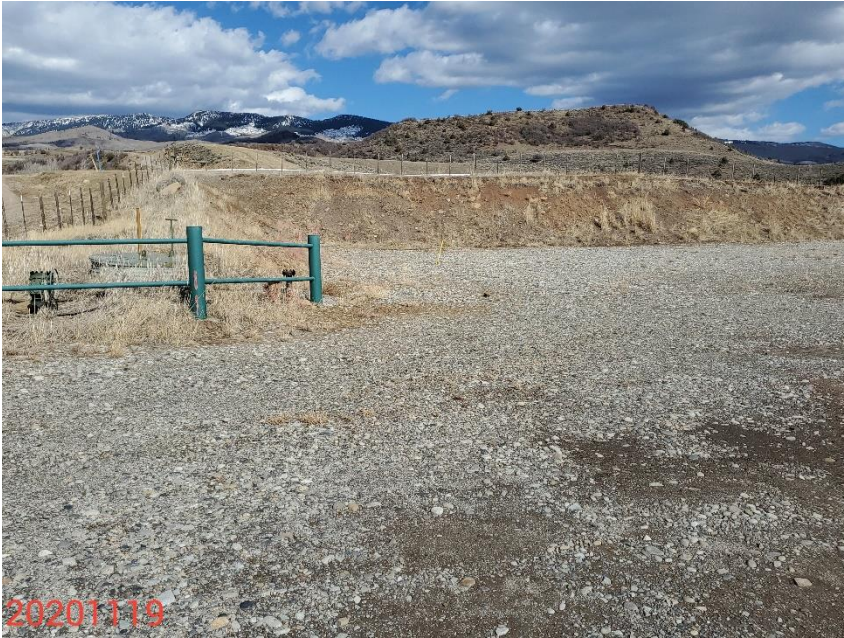
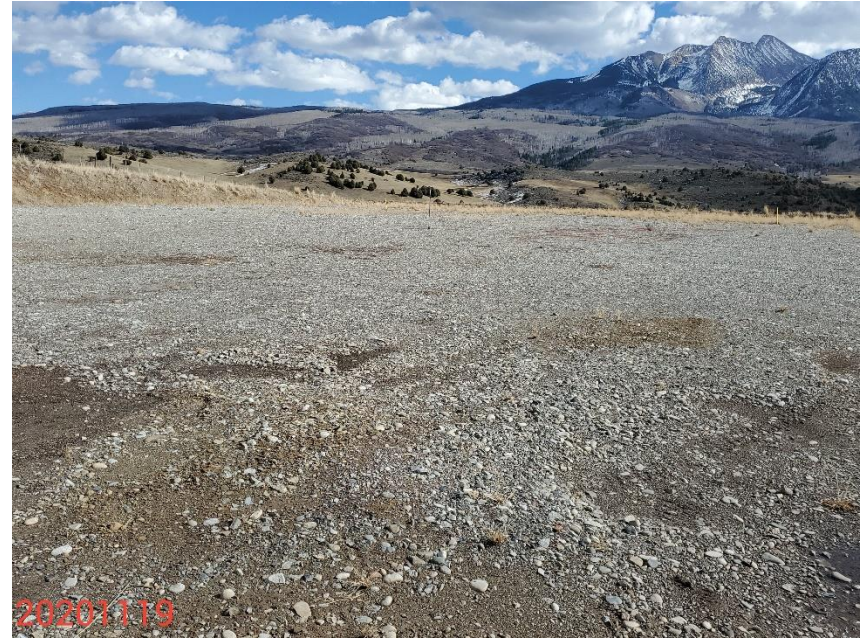
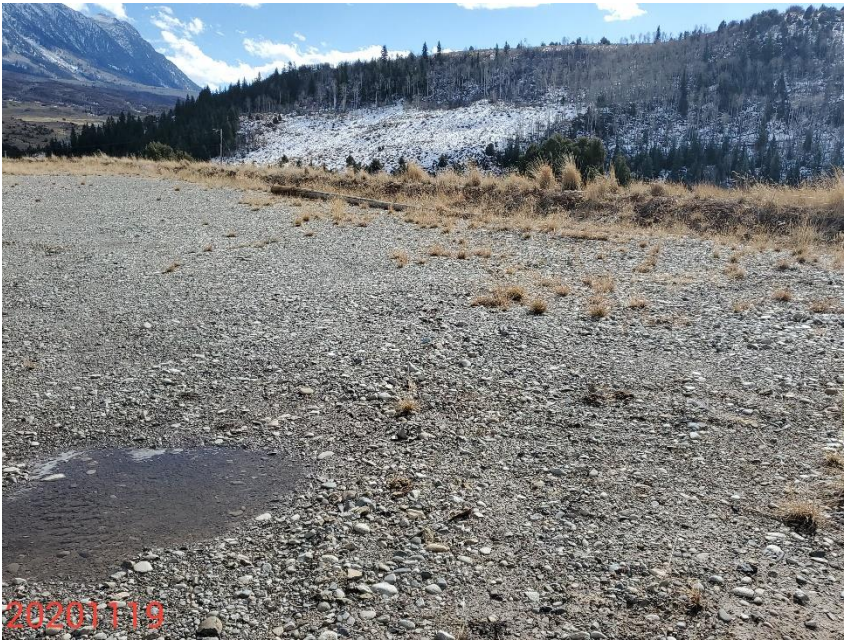
Photo 1: Photo taken from the northwest end of the Location, facing northeast. Photos 1-3 provide an overview of the Location from northeast, south to southwest.

Photo 2: See comments under photo 1.

Photo 3: See comments under photo 1.

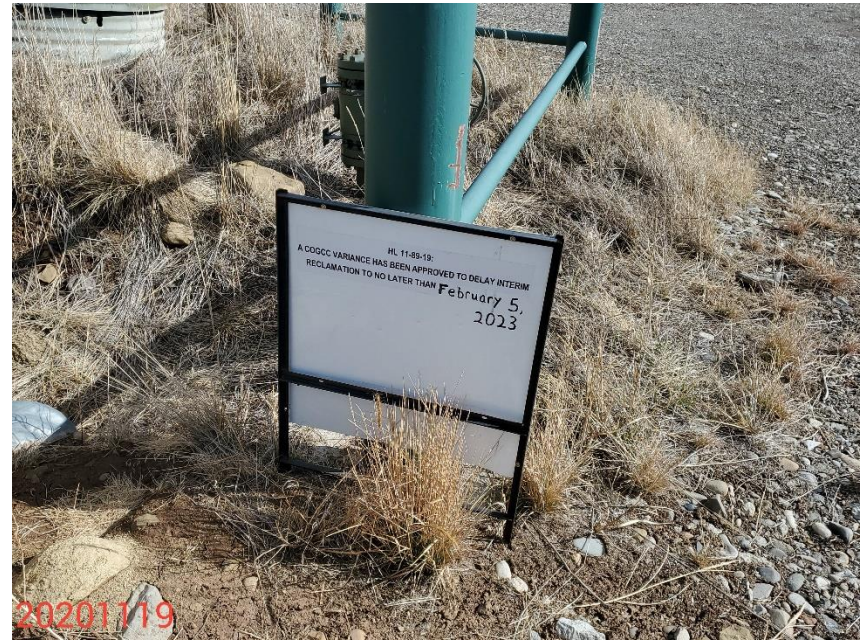
Photo 4: Photo taken from the location entrance. Photo shows signage has been installed per COAs from Form 4 #402247341

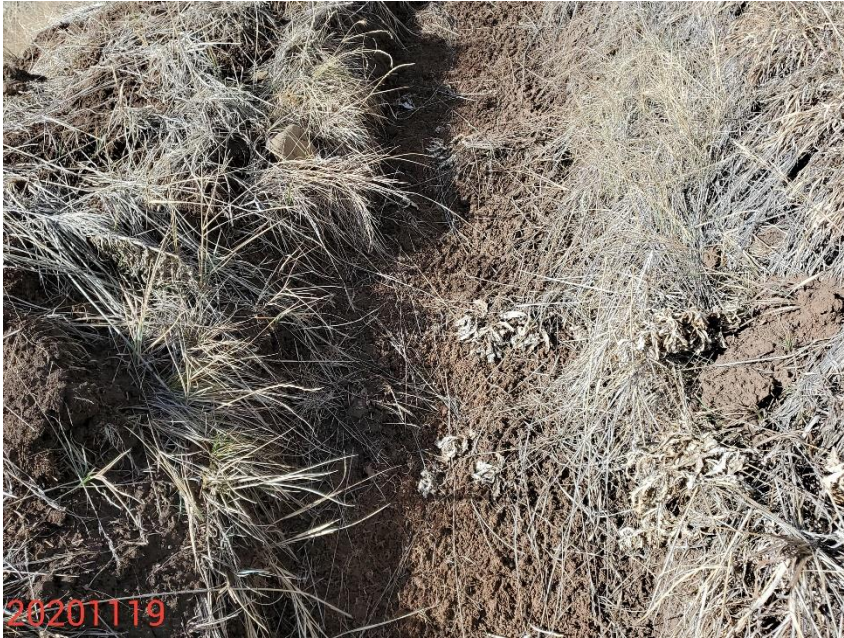
Photo 5: Photo taken from the ditch on the northeastern end of the Location. Previous inspections observed Canada thistle within ditch and required Operator to conduct weed management. Due to the onset of winter conditions and plant dormancy, it is unclear if sufficient weed management activities have been conducted. A followup inspection will need to be conducted during the 2021 growing season to determine compliance with Rule 1003.f

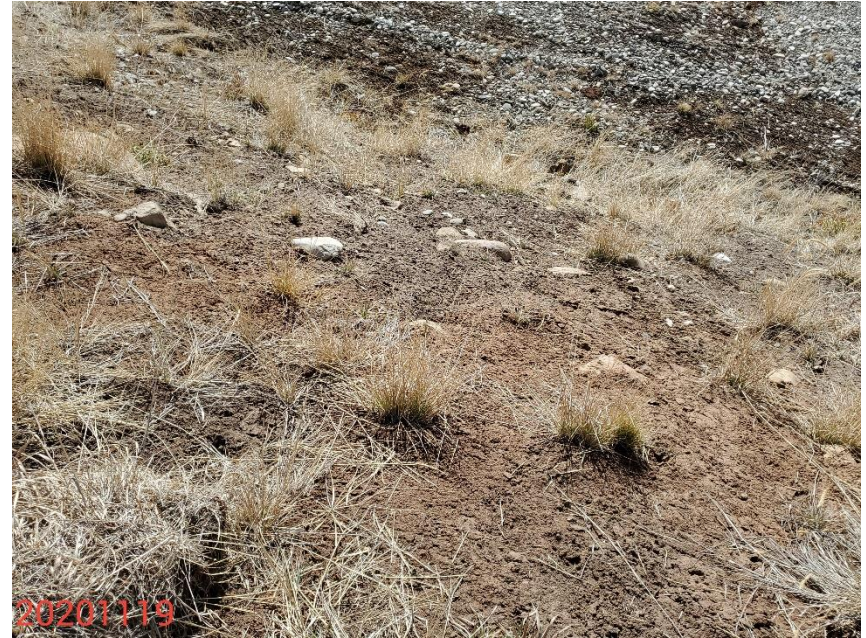
Photo 6: Photo taken from the cut slopes on the northeast end of the Location, facing southwest. Photo shows BMPs to protect and stabilize the slopes remaining missing or insufficient.

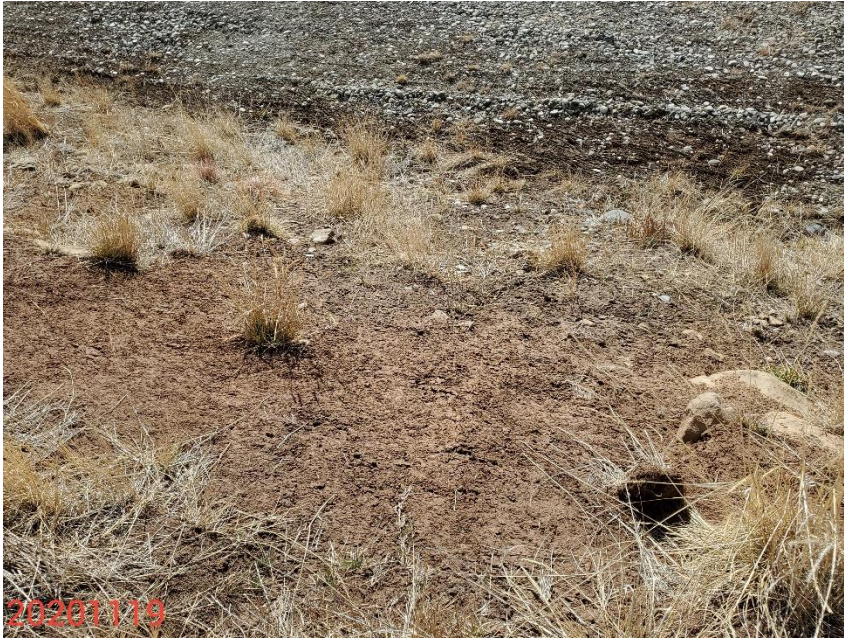
Photo 7: Photo taken from the cut slopes on the northeast end of the Location, facing southwest. Photo shows BMPs to protect and stabilize the slopes remaining missing or insufficient.

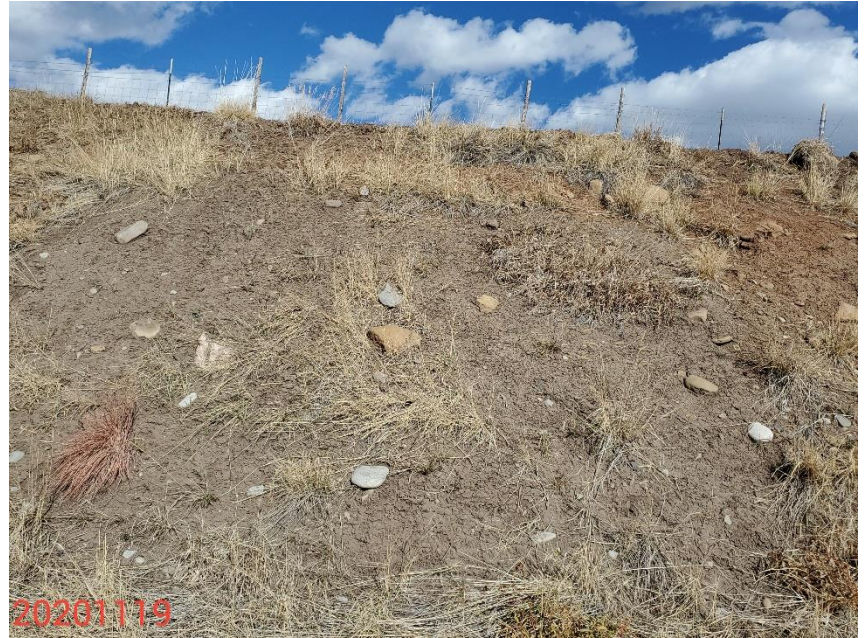
Photo 8: Photo taken from the cut slopes on the northeast end of the Location, facing northeast. Photo shows BMPs to protect and stabilize the slopes remaining missing or insufficient.

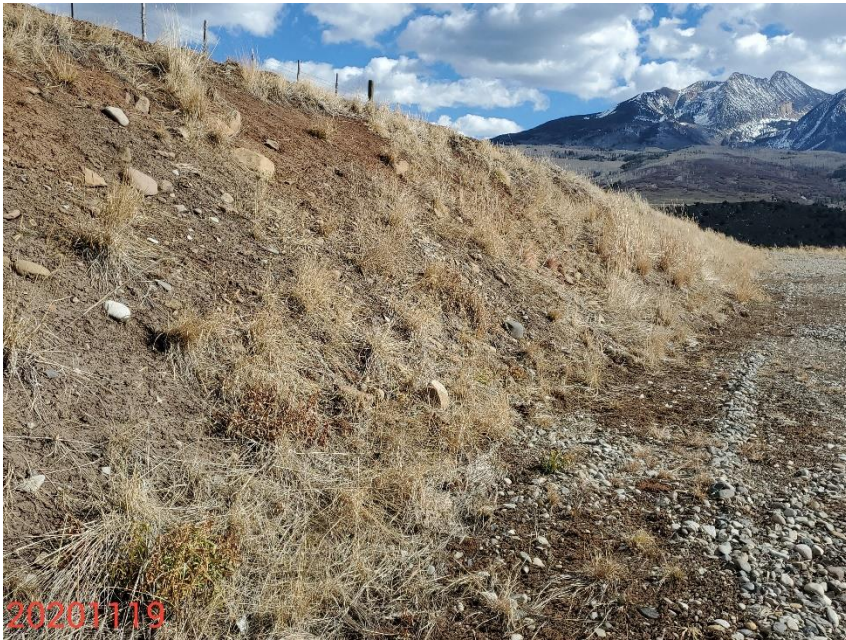
Photo 9: Photo taken from the cut slopes on the northeast end of the Location, facing east. Photo shows BMPs to protect and stabilize the slopes remaining missing or insufficient.

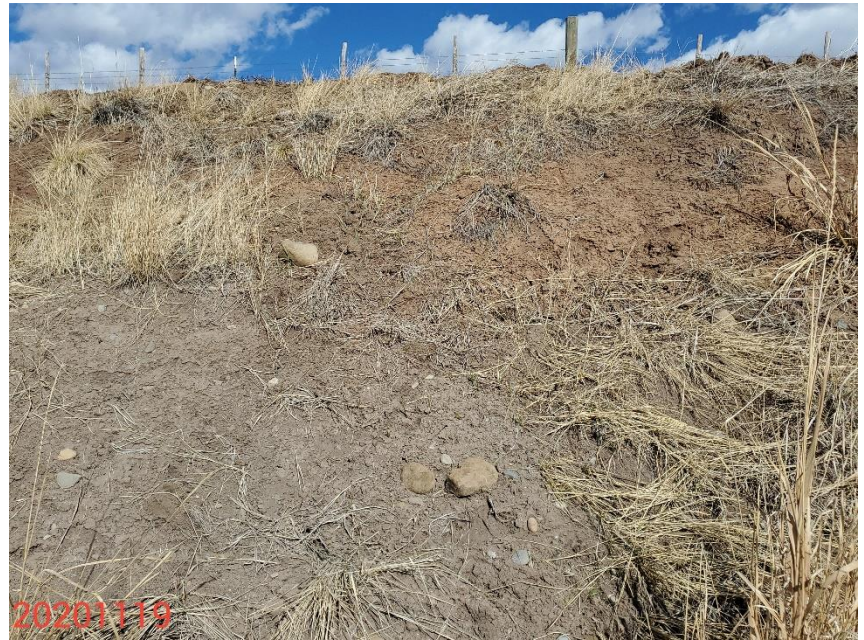
Photo 10: Photo taken from the cut slopes on the northeast end of the Location, facing northeast. Photo shows BMPs to protect and stabilize the slopes remaining missing or insufficient.

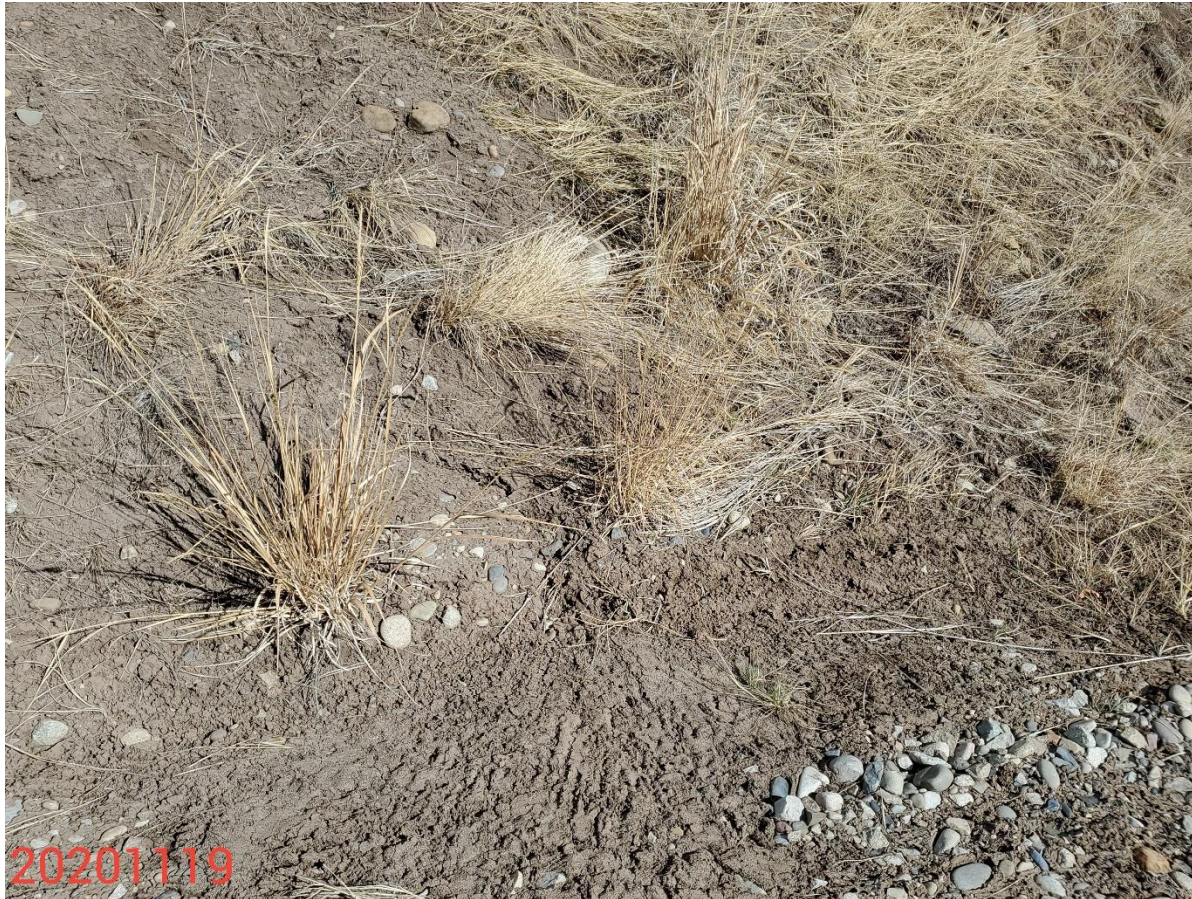
Photo 11: Photo taken from the cut slopes on the northeast end of the Location. Photo shows erosion is beginning to recur.
