Inspection Photos

Operator: SG INTERESTS I LTD # 77330

Location ID: 428197

Aaron Trujillo
NW Reclamation Specialist
COGCC

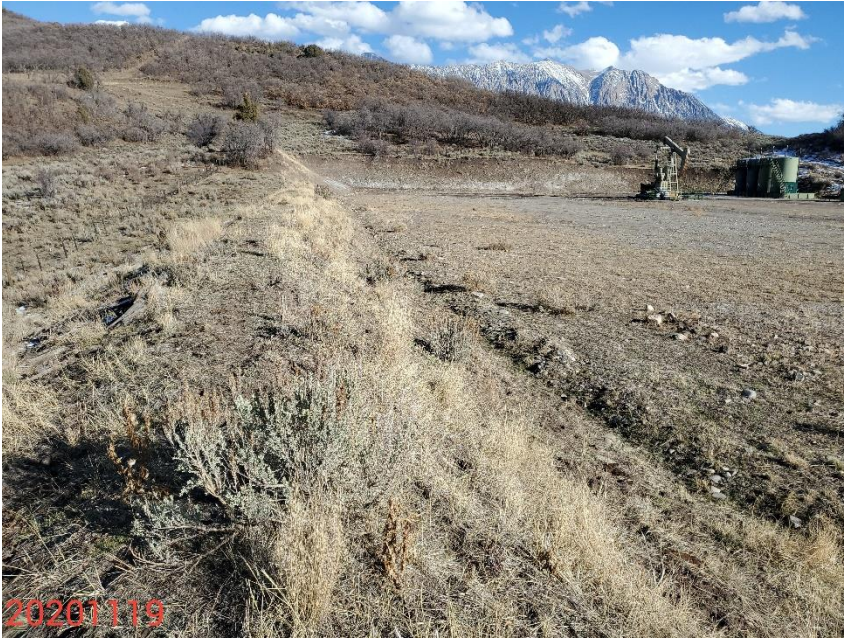
Photo 1: Photo taken from the northwest corner of the Location, facing east. Photos 1-2 provide an overview of the Location from east to southeast.

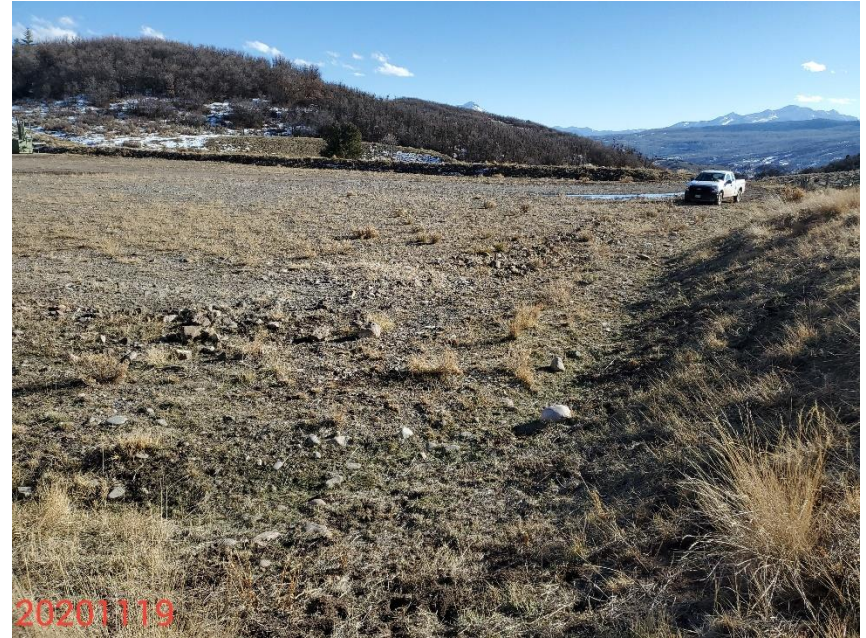
Photo 2: See comments under photo 1.

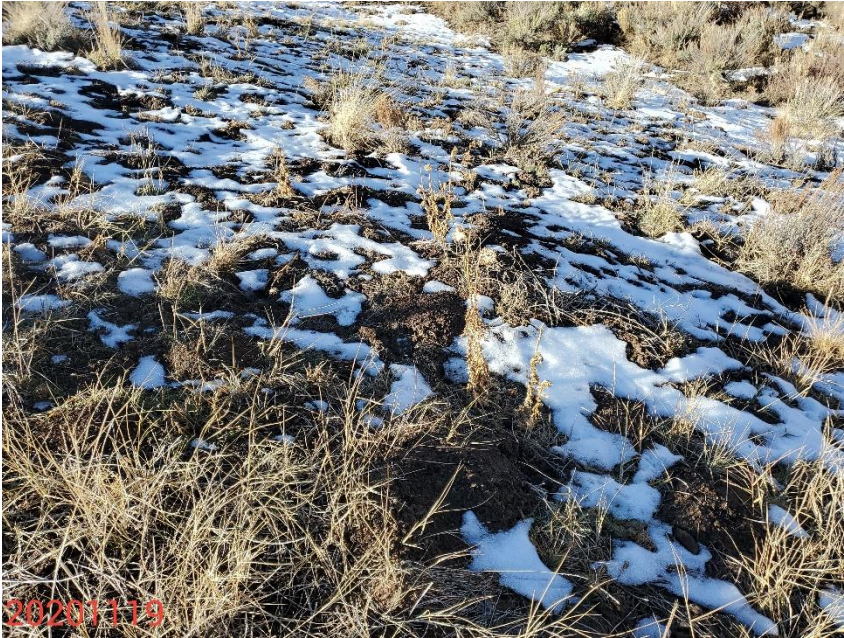
Photo 3: Photo taken from the fill slopes on the north end of the Location. Photo shows Musk thistle is evident on the Location. Due to the onset of winter conditions and plant dormancy, a followup inspection will need to be conducted in the 2021 growing season to determine compliance with Rule 1003.f.

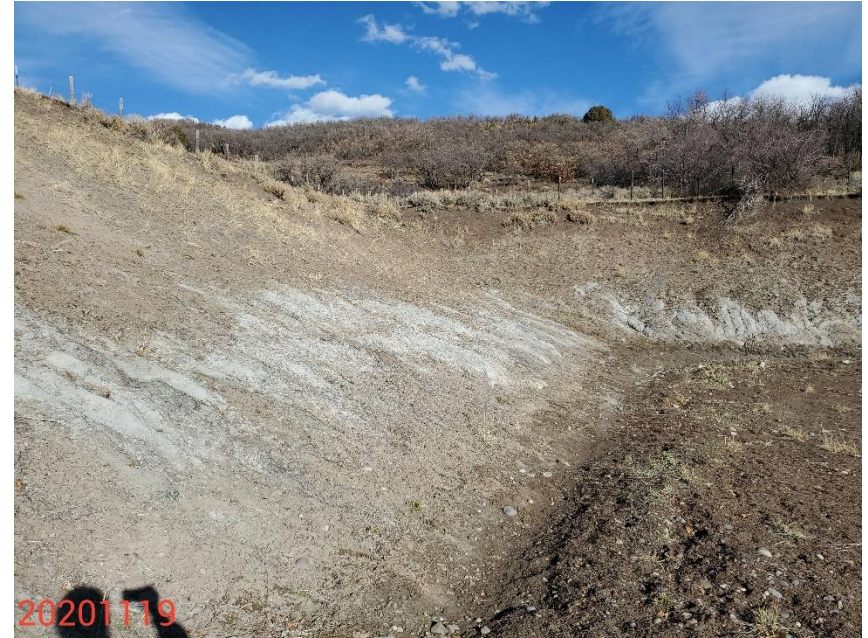
Photo 4: Photo taken from the northeast corner of the Location. Photo erosion degradation on the cut slopes of the Location. Photo shows that long-term erosion control BMPs do not appear to have been installed in conjunction with the erosion matting, appears insufficient and/or has not been maintained in a proper functioning condition.

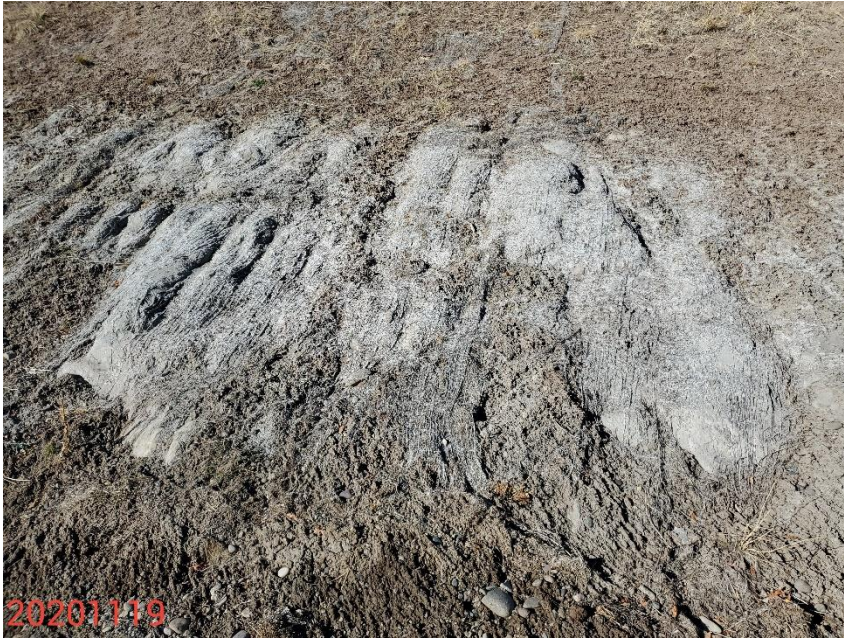
Photo 5: Photo taken from the northeast corner of the Location. Photo erosion degradation on the cut slopes of the Location. Photo shows that long-term erosion control BMPs do not appear to have been installed in conjunction with the erosion matting, appears insufficient and/or has not been maintained in a proper functioning condition.

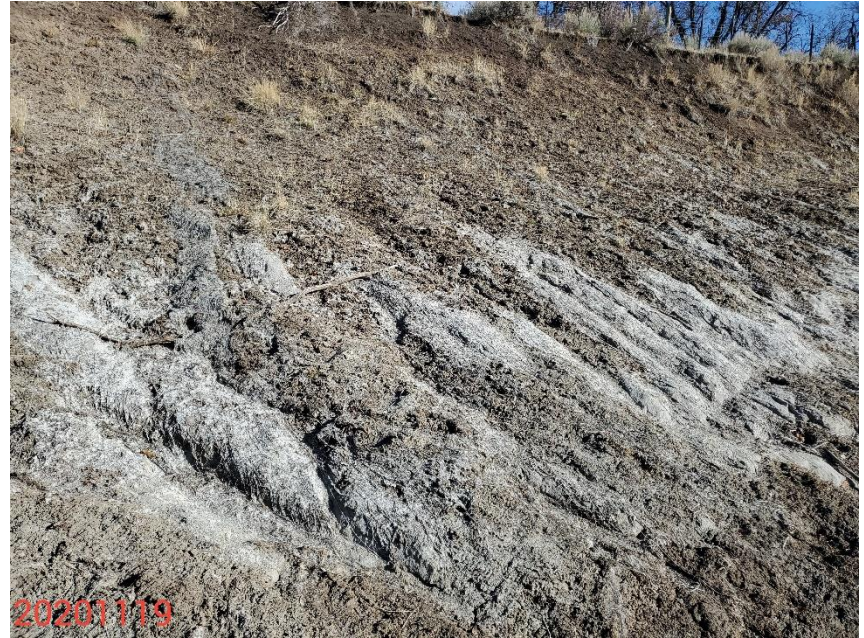
Photo 6: Photo taken from the northeast corner of the Location. Photo erosion degradation on the cut slopes of the Location. Photo shows that long-term erosion control BMPs do not appear to have been installed in conjunction with the erosion matting, appears insufficient and/or has not been maintained in a proper functioning condition.

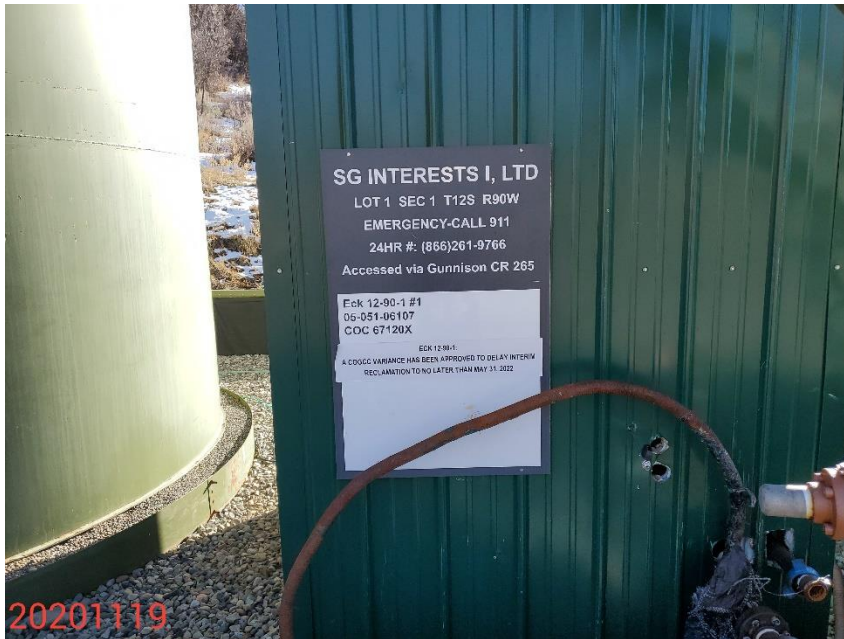
Photo 7: Photo shows sign located at the tank battery identifying that Location has a delayed IR variance until 5/31/2022

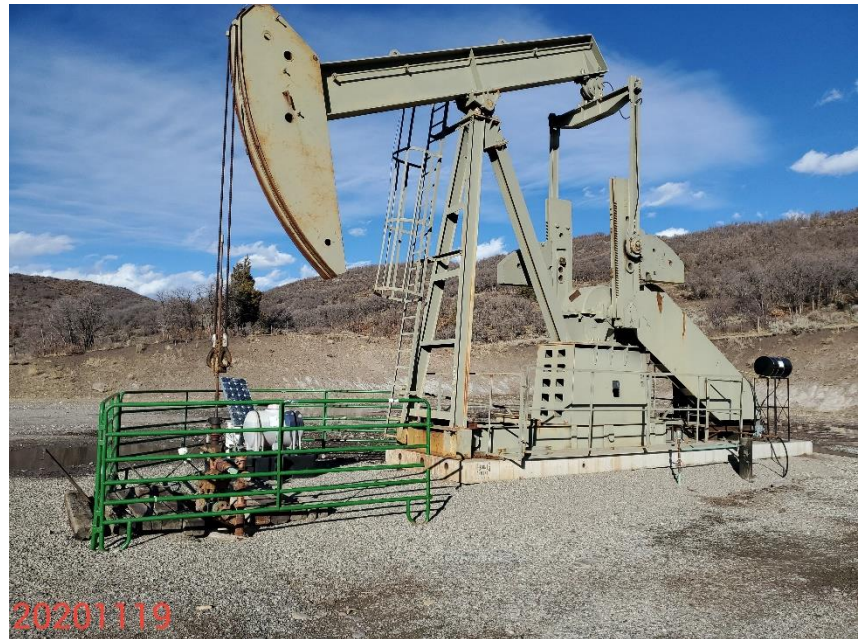
Photo 8: Photo shows the single drilled well on the Location.

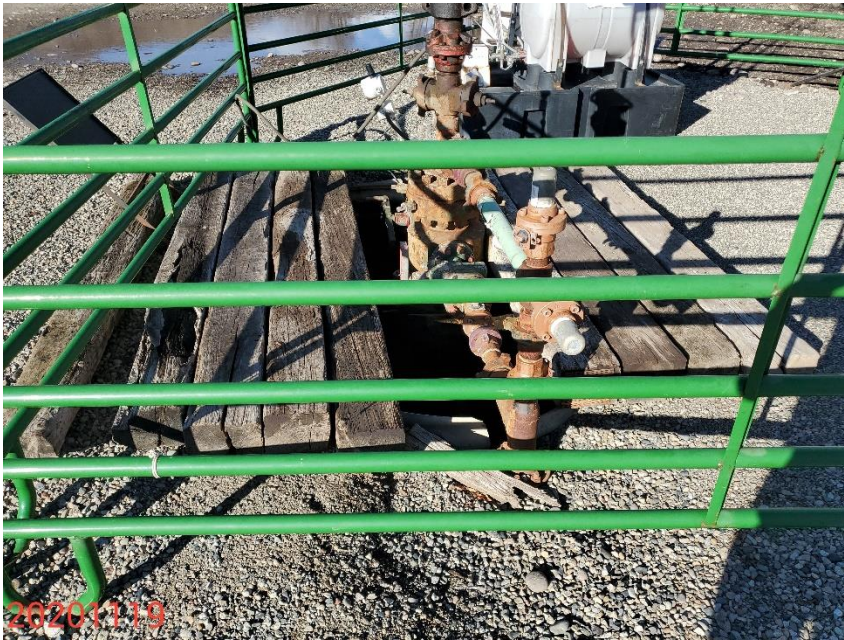
Photo 9: Photo taken from the PR well. Photo shows cellar at wellhead.

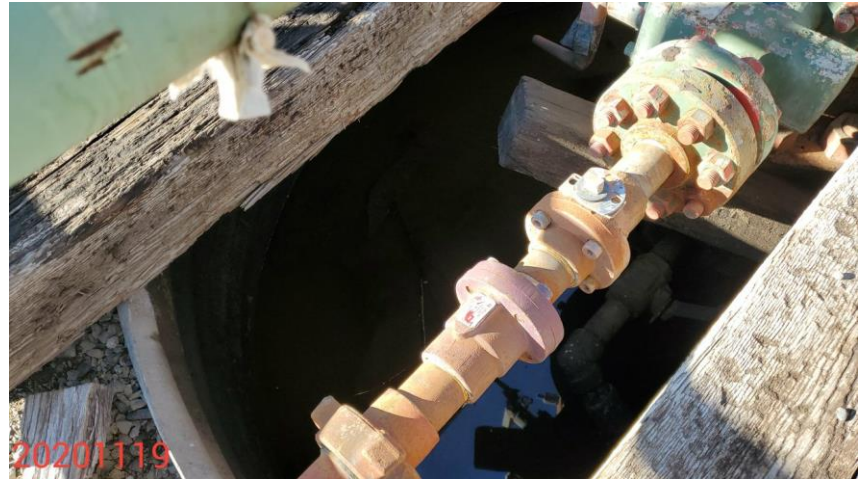
Photo 10: Continued from photo 9. Photo shows cellar has filled with fluids/chemicals, BMPs to prevent wildlife access to the cellar are insufficient.
