Inspection Photos

Operator: RIO MESA RESOURCES INC - 74740

Location ID: 315237

Rio Blanco County, CO

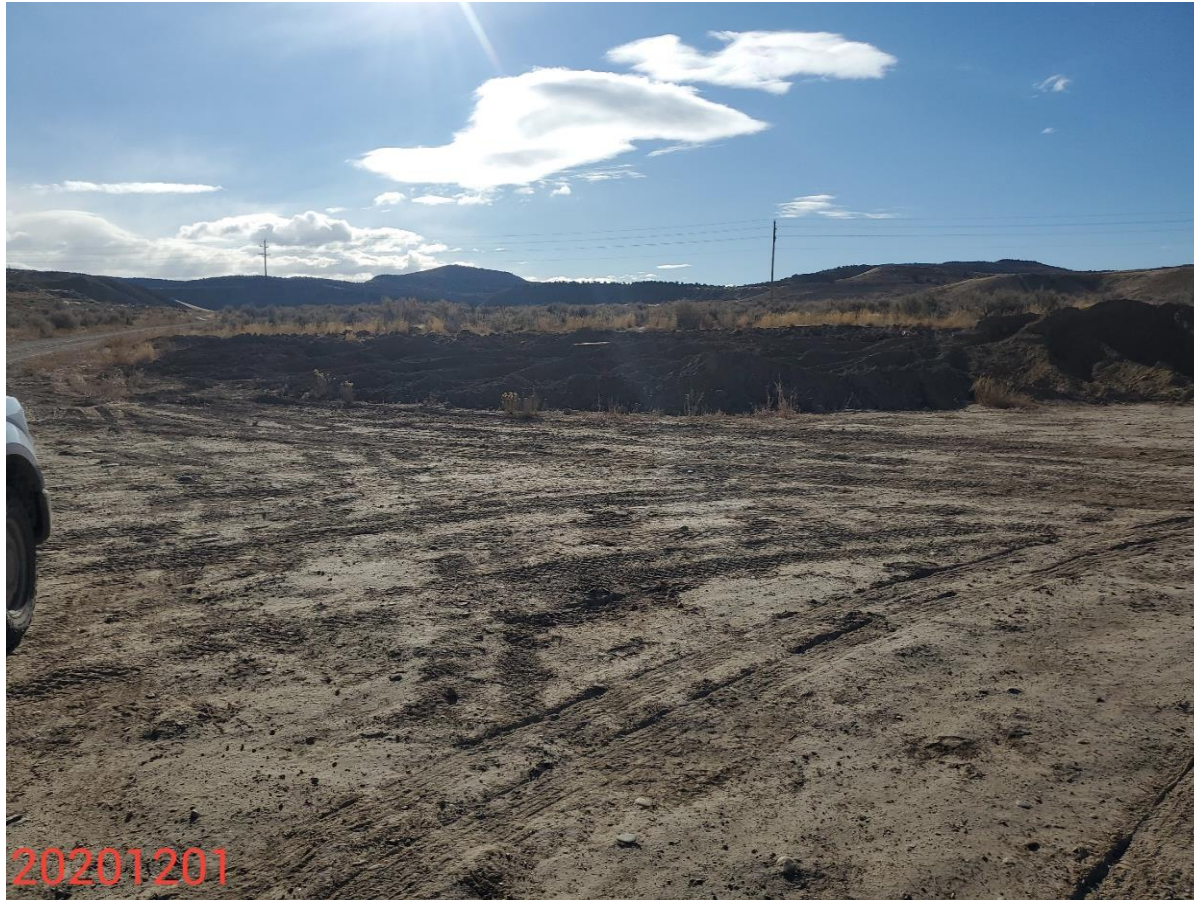
Photo 1: Photo taken from the east end of the Location, facing south. Photos 1-4 provide an overview of the Location from south, southwest, northwest to north. Photos also show remediation efforts appear to be ongoing at the form tank, heater treater and pit areas. Location remains out of compliance with Rules.

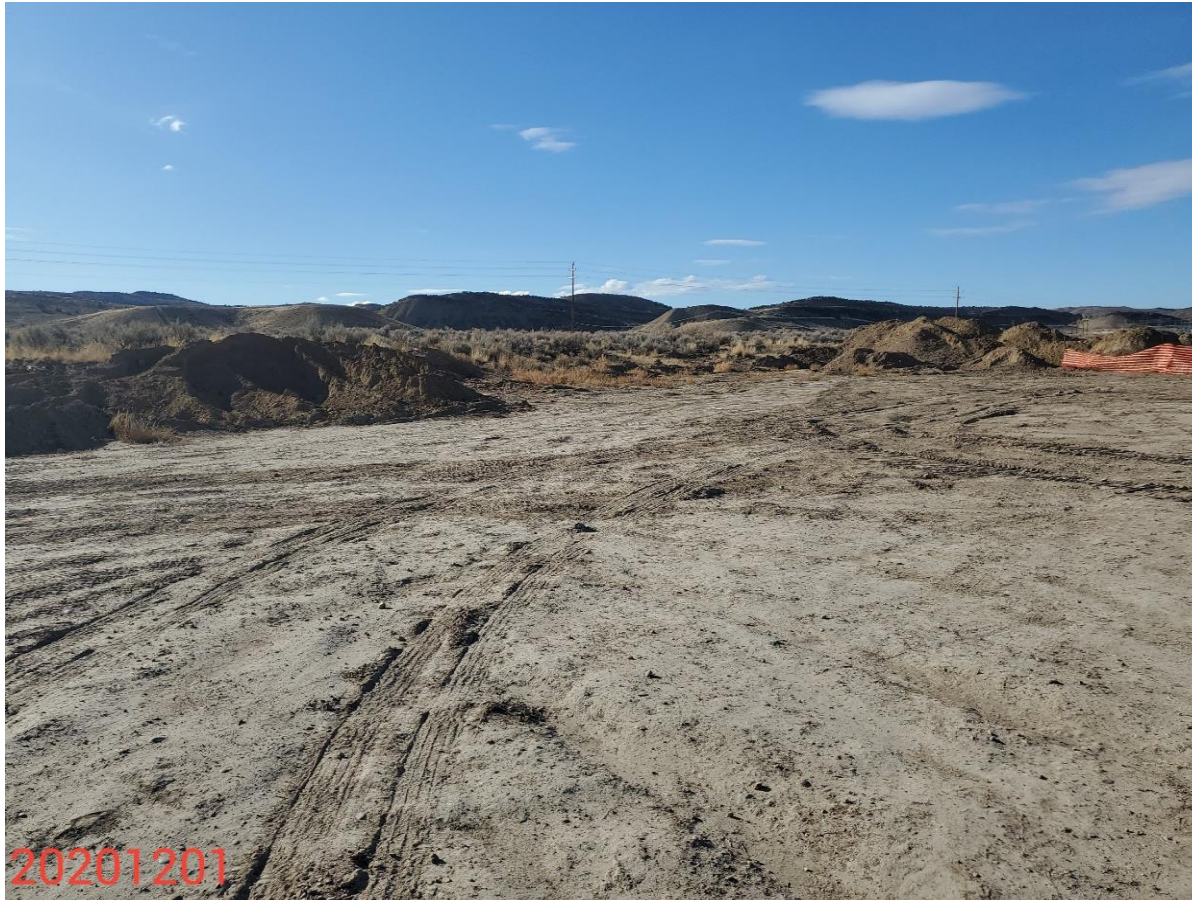
Photo 2: See comments under photo 1.

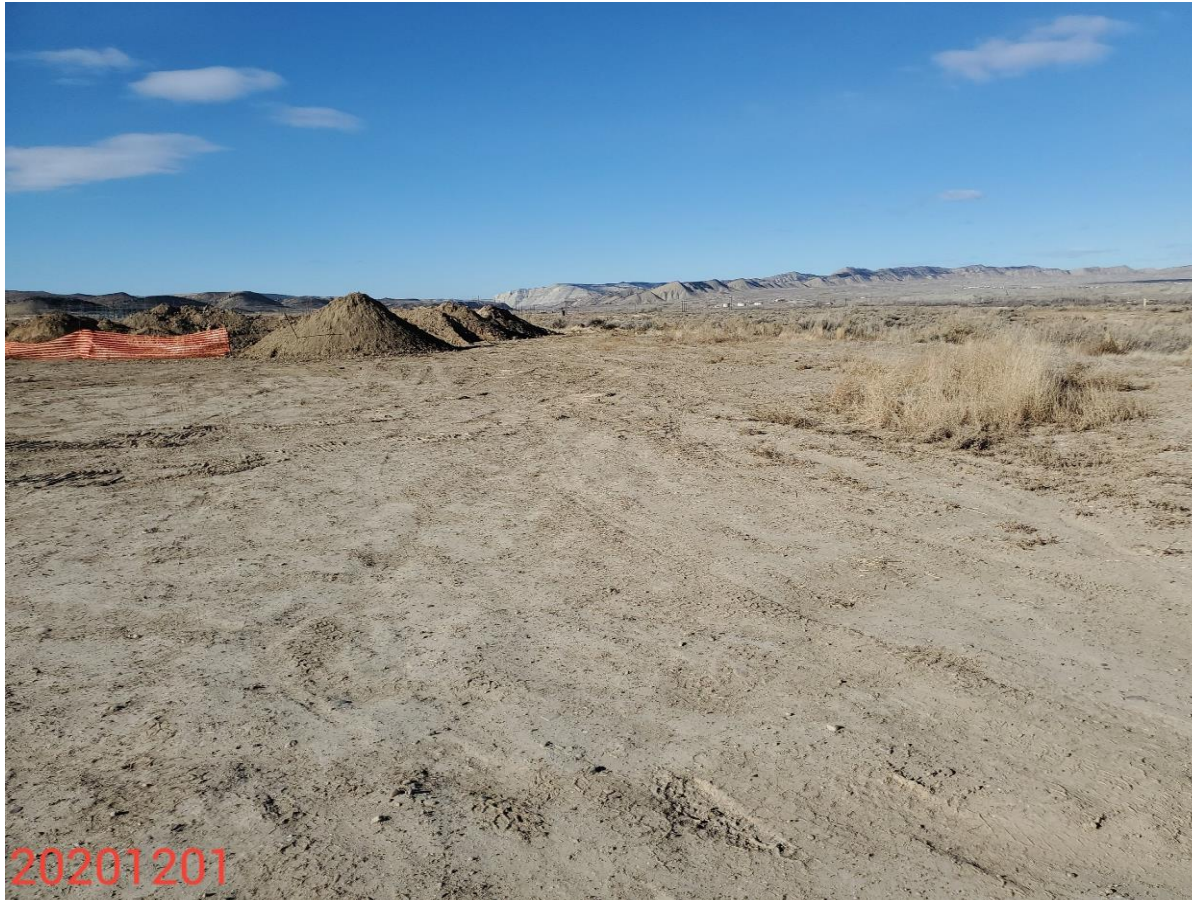
Photo 3: See comments under photo 1.

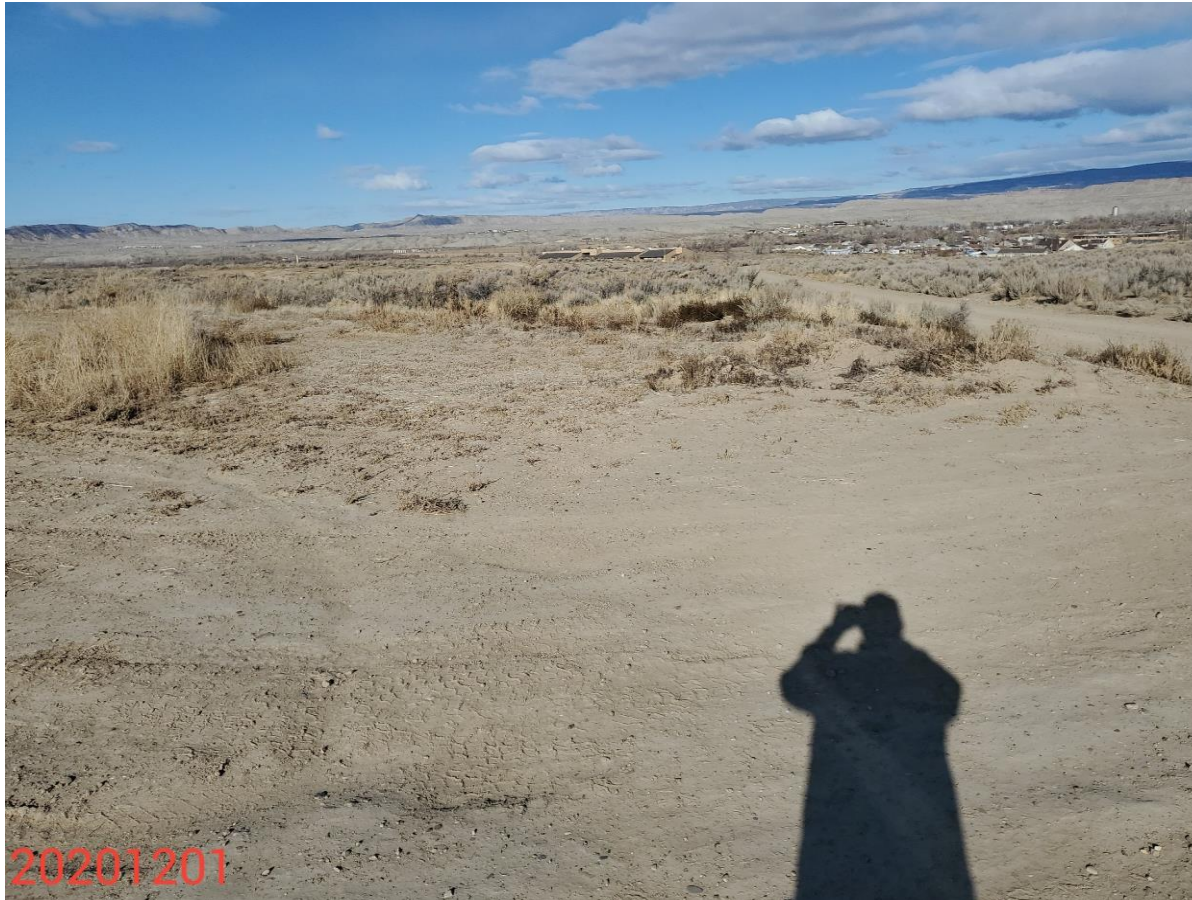
Photo 4: See comments under photo 1.

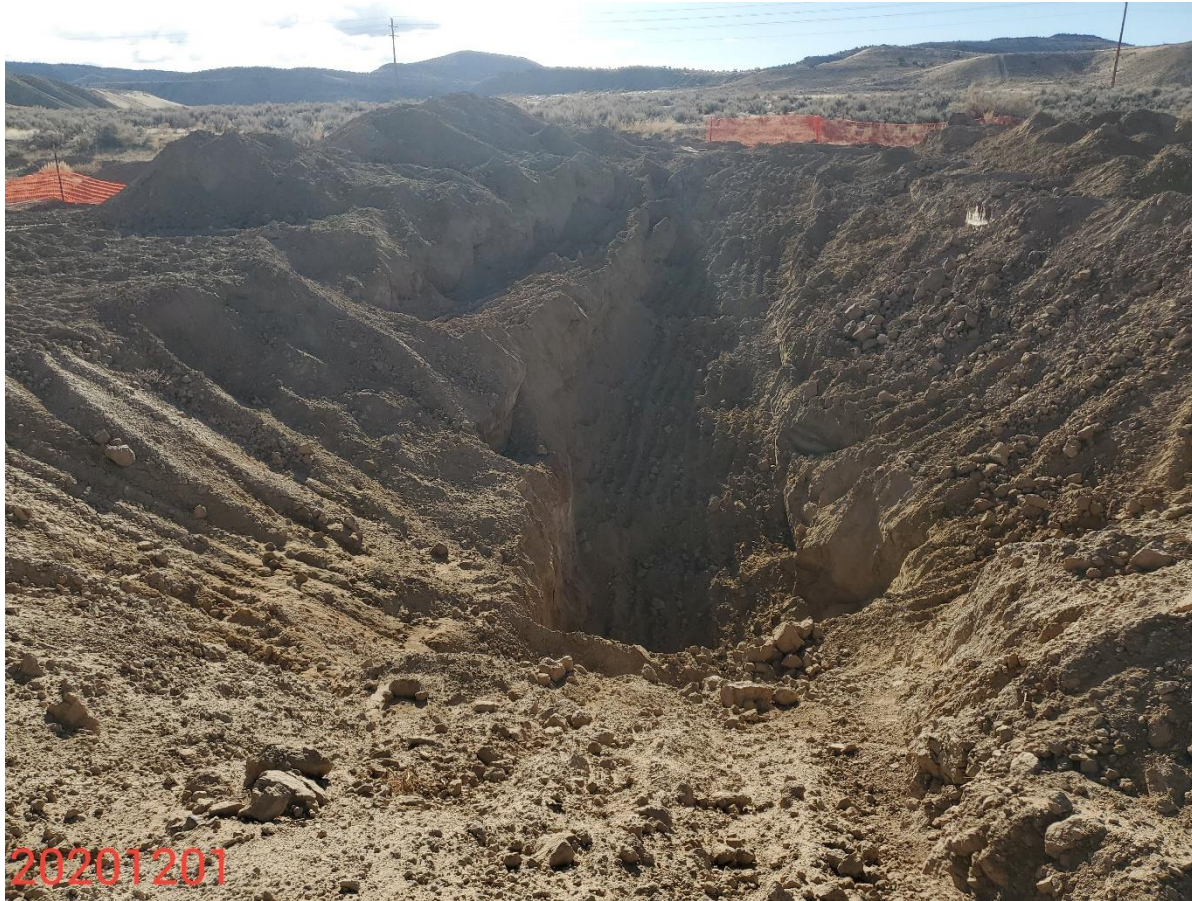
Photo 5: Photo taken from the pit on the west end of the Location. Remediation of pit in process. See project #15643 for additional details.

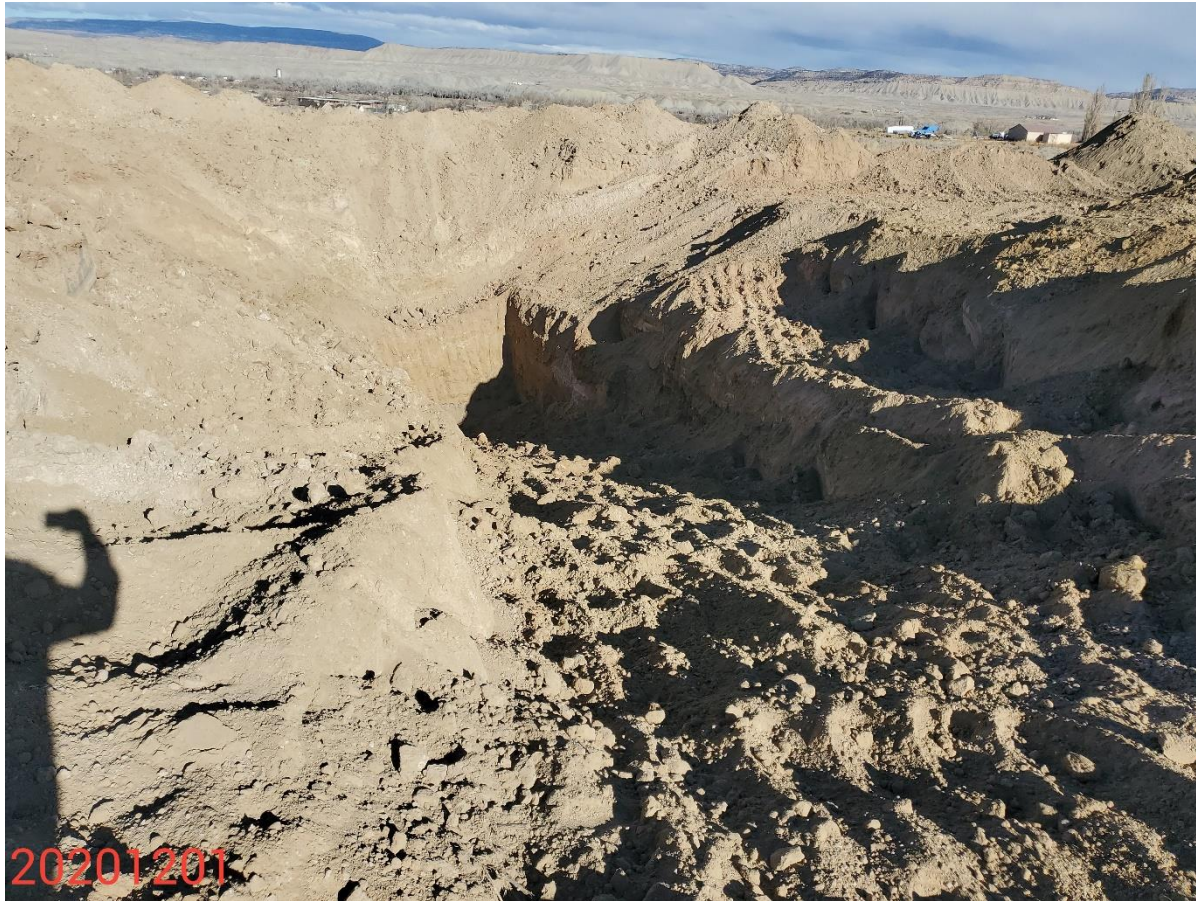
Photo 6: Photo taken from the pit on the west end of the Location. Remediation of pit in process. See project #15643 for additional details.

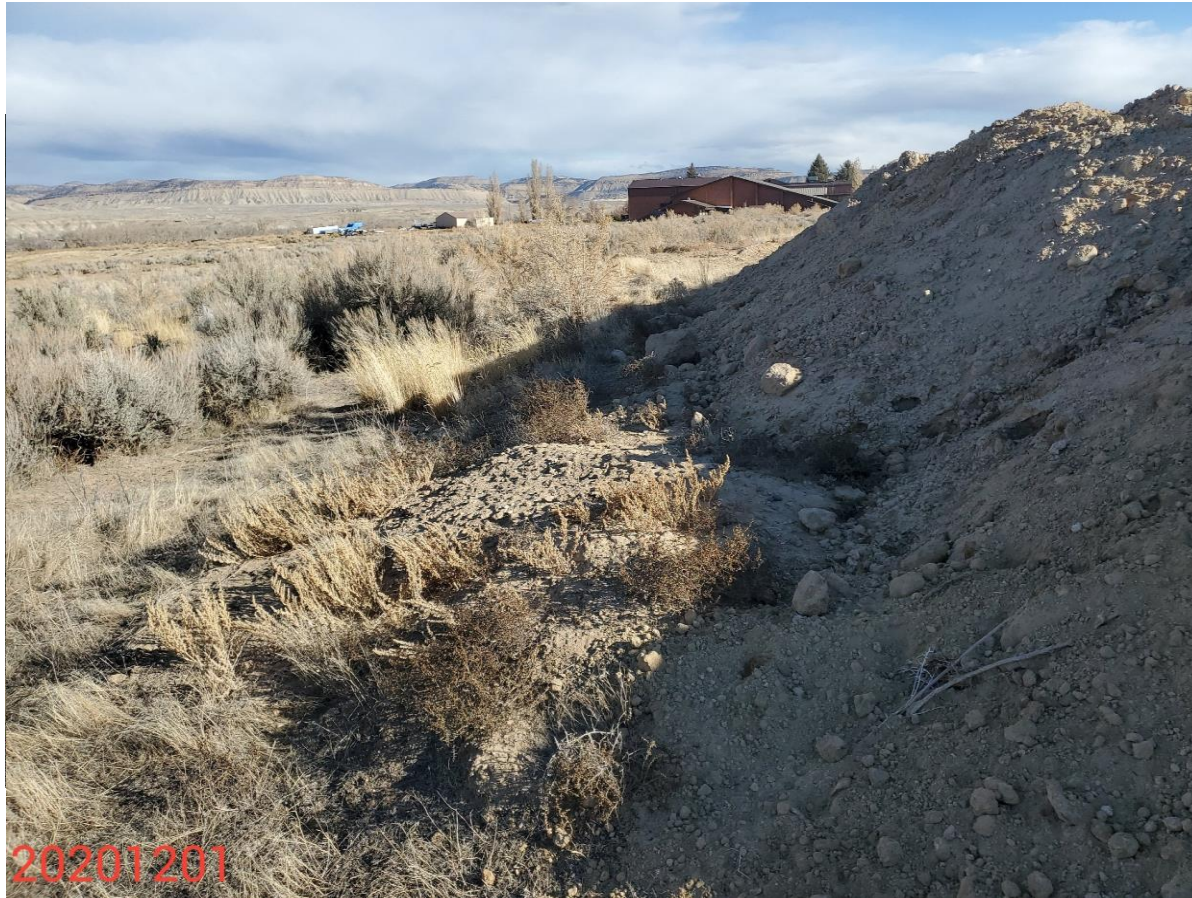
Photo 7: Photo taken from the northwest corner of the Location, facing east. Photo shows BMPs are missing to prevent off-site sediment transport of potentially impacted soils from the stockpiles.

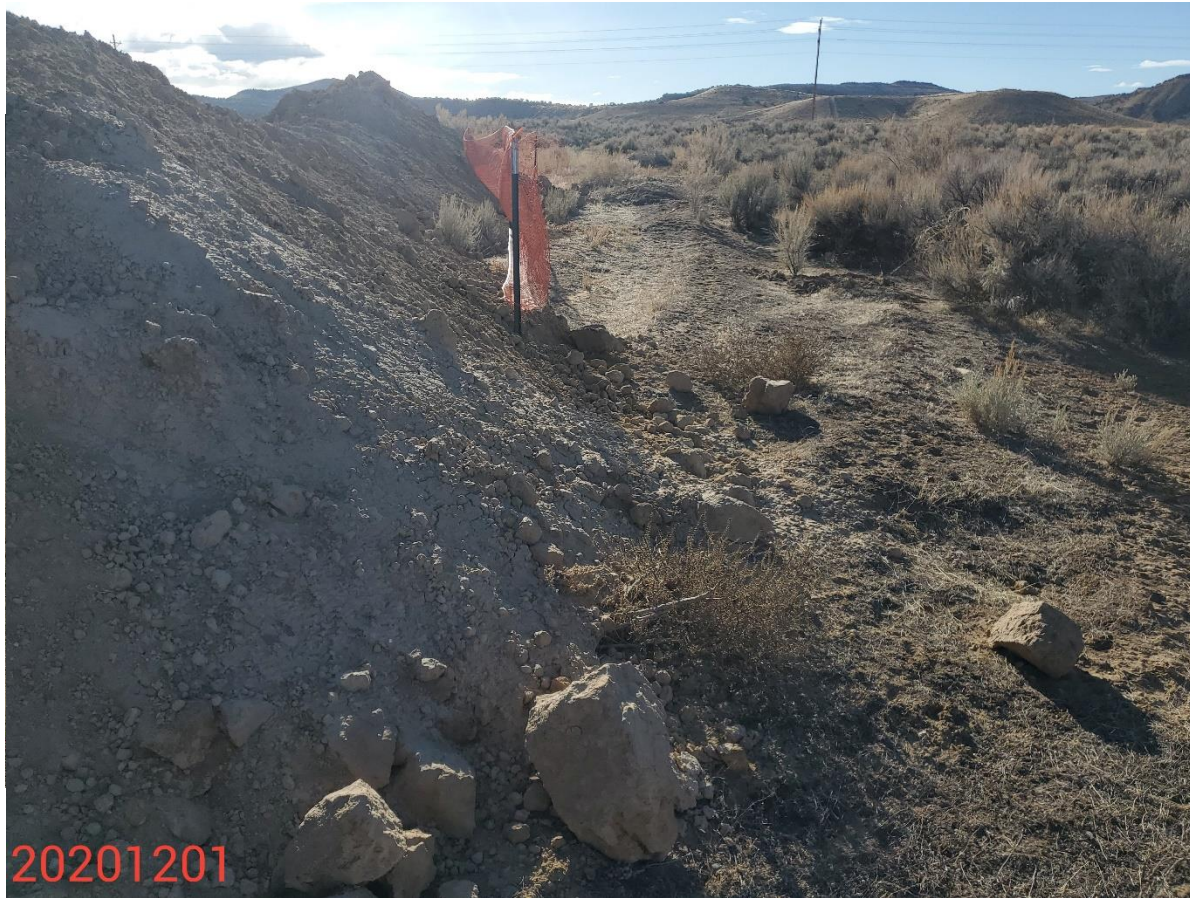
Photo 8: Photo taken from the northwest corner of the Location, facing south. Photo shows BMPs are missing to prevent off-site sediment transport of potentially impacted soils from the stockpiles.

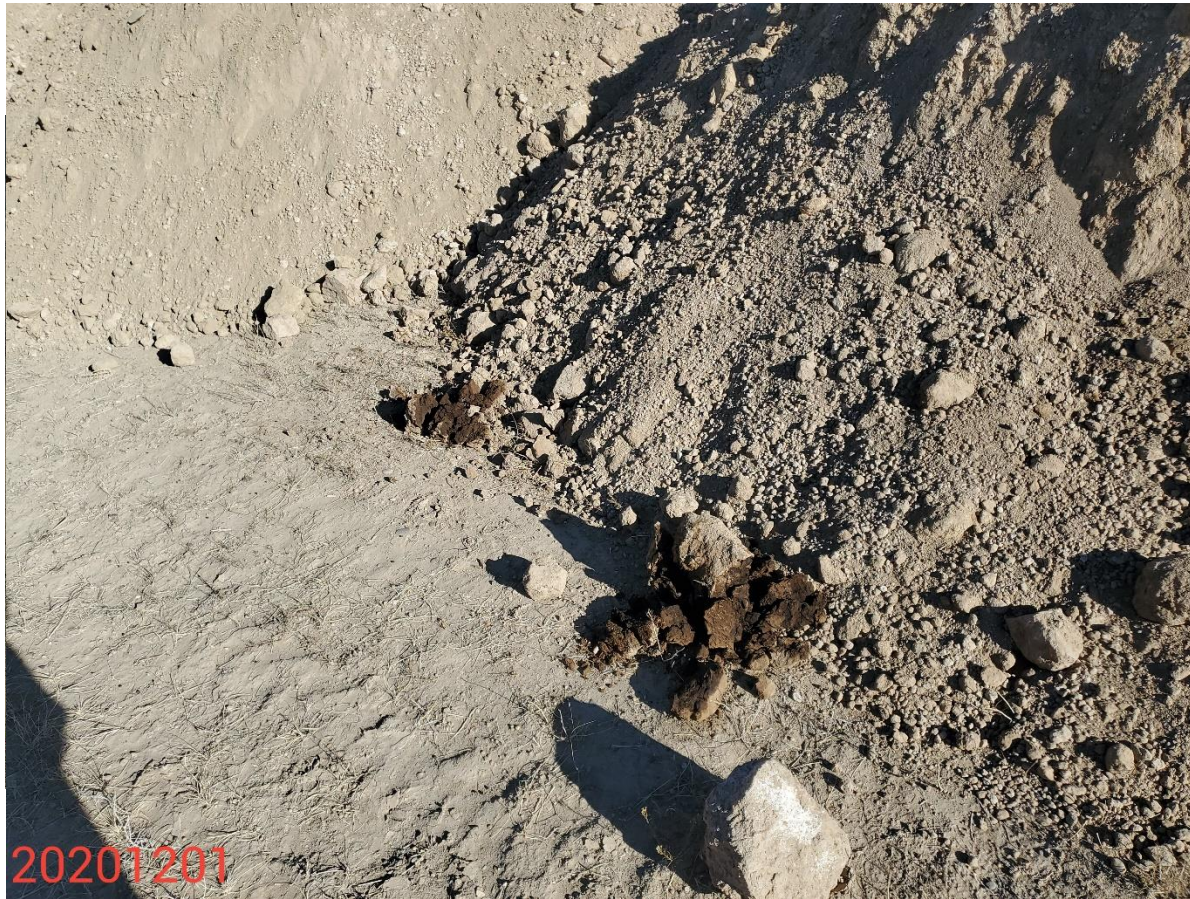
Photo 9: Photo taken from the west end of the Location. Photo shows oil stained soils observed at the soil stockpiles.
