# Inspection Photos

Operator: C & J FIELD SERVICES - 10027

Location ID: 314281

Rio Blanco County, CO

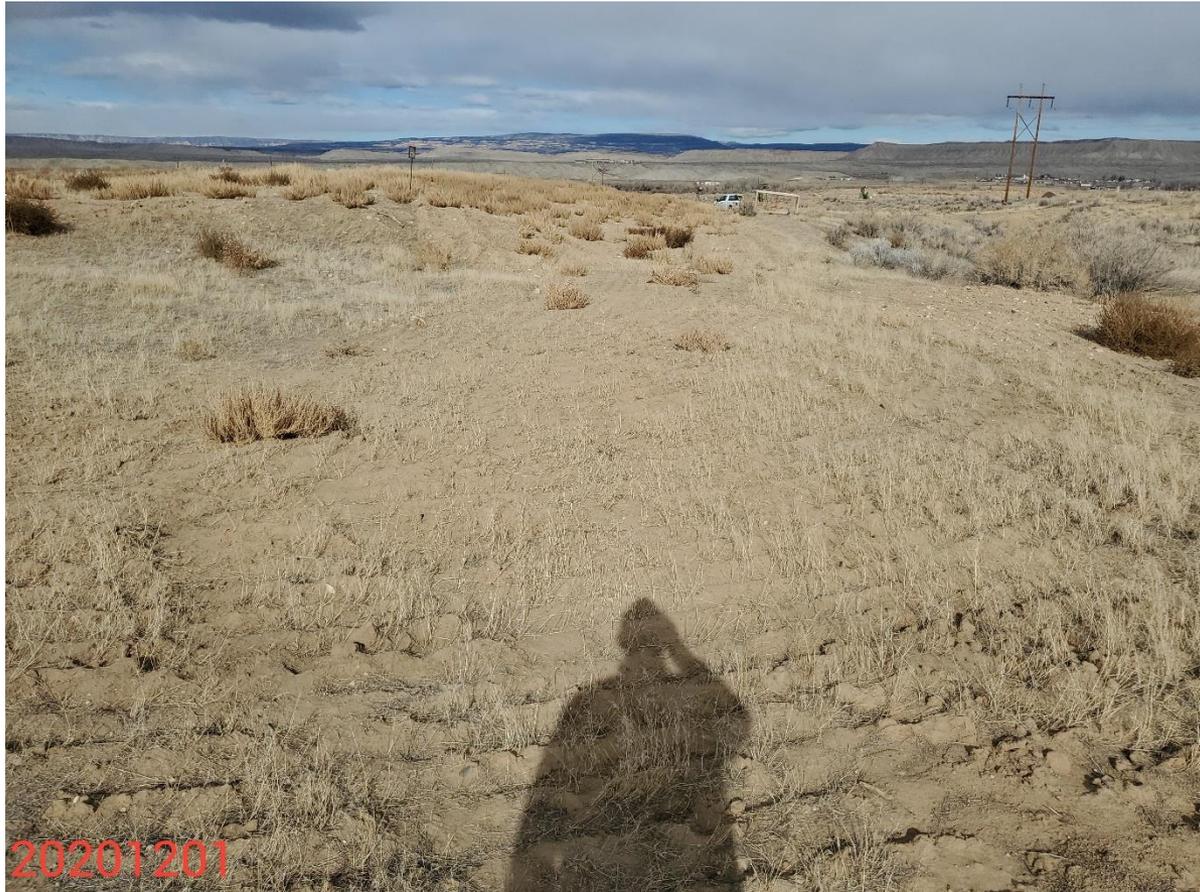
**Photo 1:** Photo taken from the south end of the Location, facing north. Photo provides an overview of the Location and reclamation area.

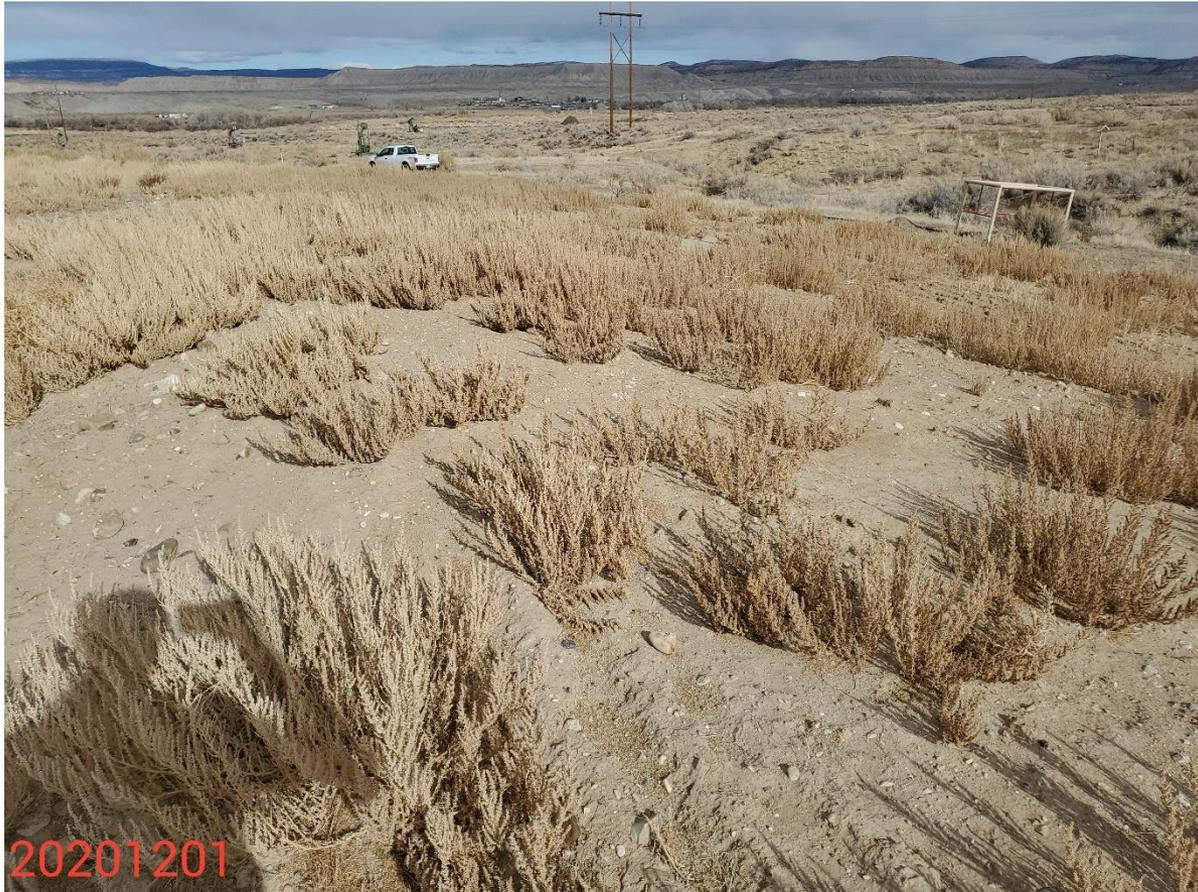
**Photo 2:** Photo taken from the west end of the Location, facing northeast. Photo provides an overview of the Location and reclamation area. Photo also shows weedy vegetative establishment on the reclamation area. Continue conducting weed management on the Location until final reclamation has passed.

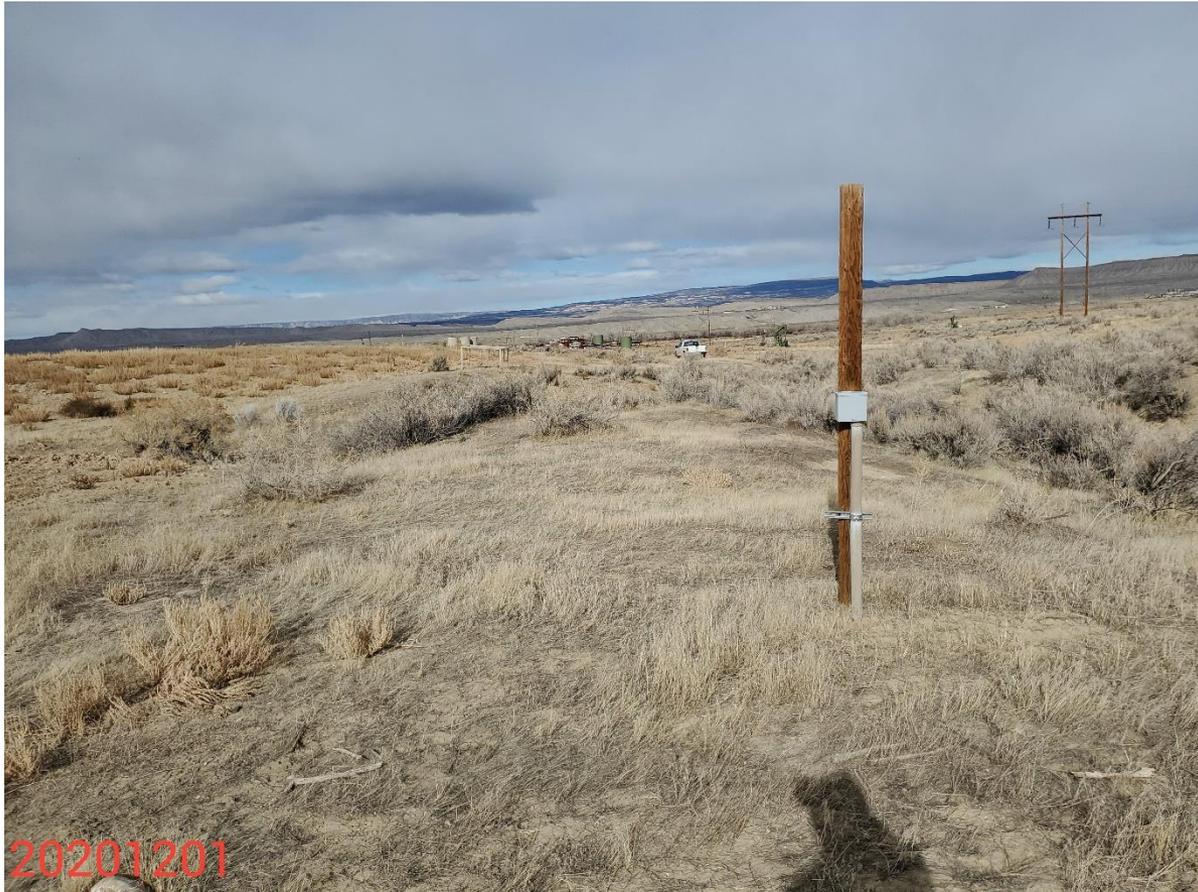
**Photo 3:** Photo taken from the southeast end of the Location. Photo shows electric equipment remains on the Location.

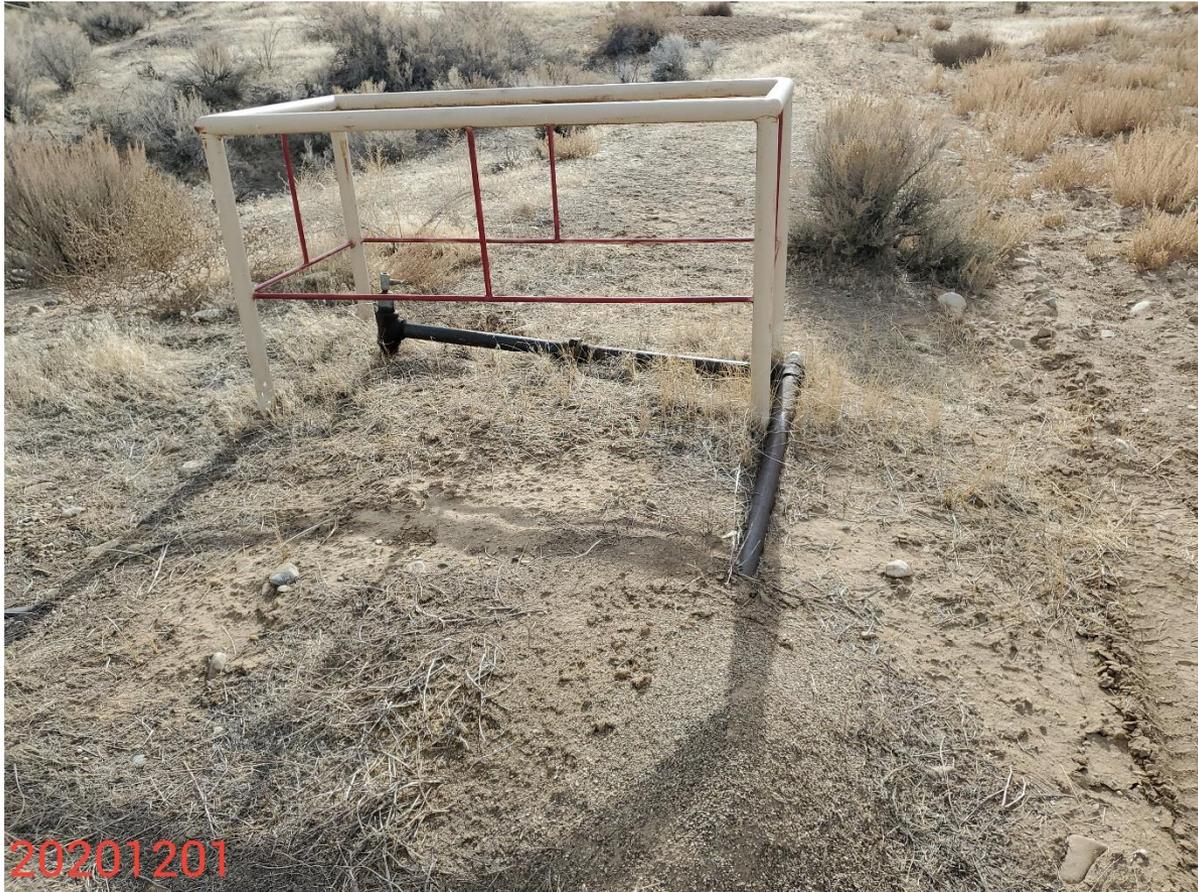
**Photo 4:** Photo taken from the access road, facing south. Photo shows flowline/riser equipment remaining.

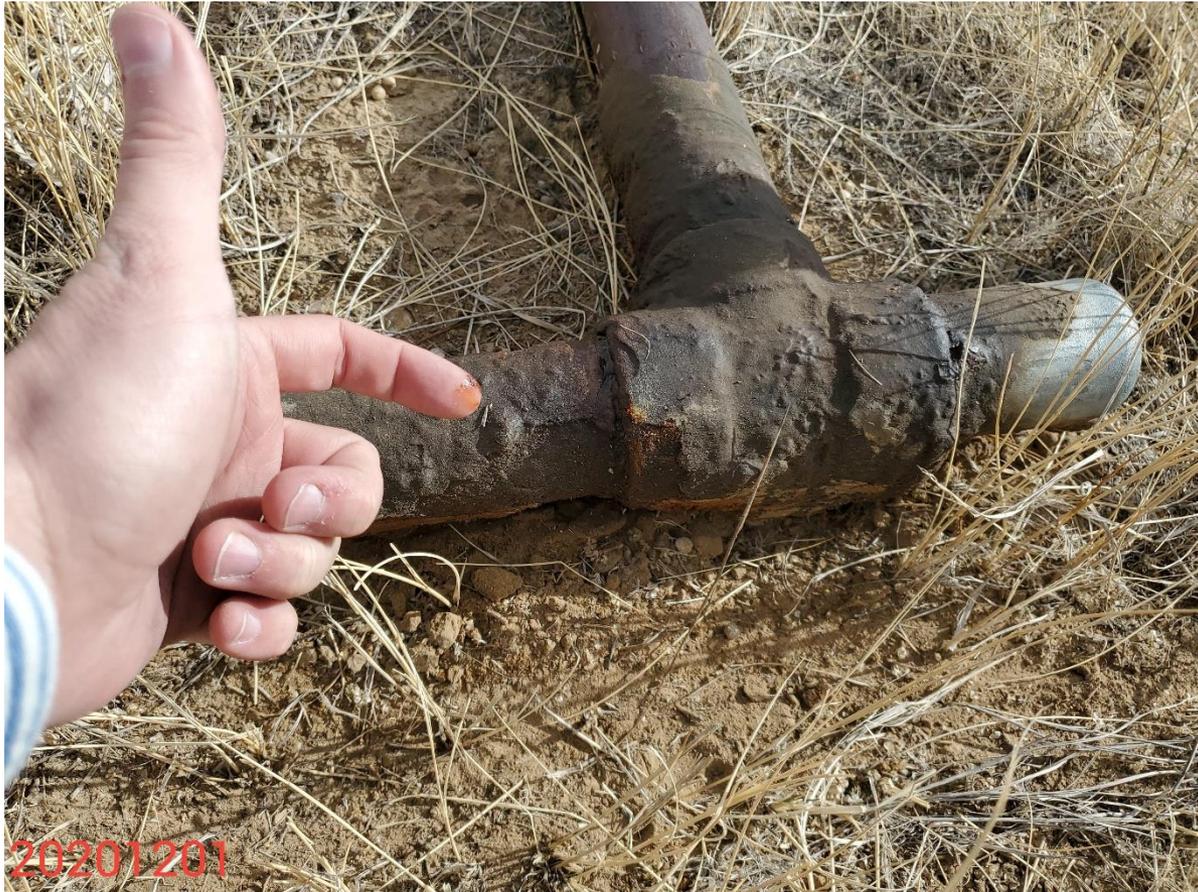
**Photo 5:** Continued from photo 4. Photo shows leaking from the flowline remains evident. Maintenance to prevent failures or leakage has not been conducted

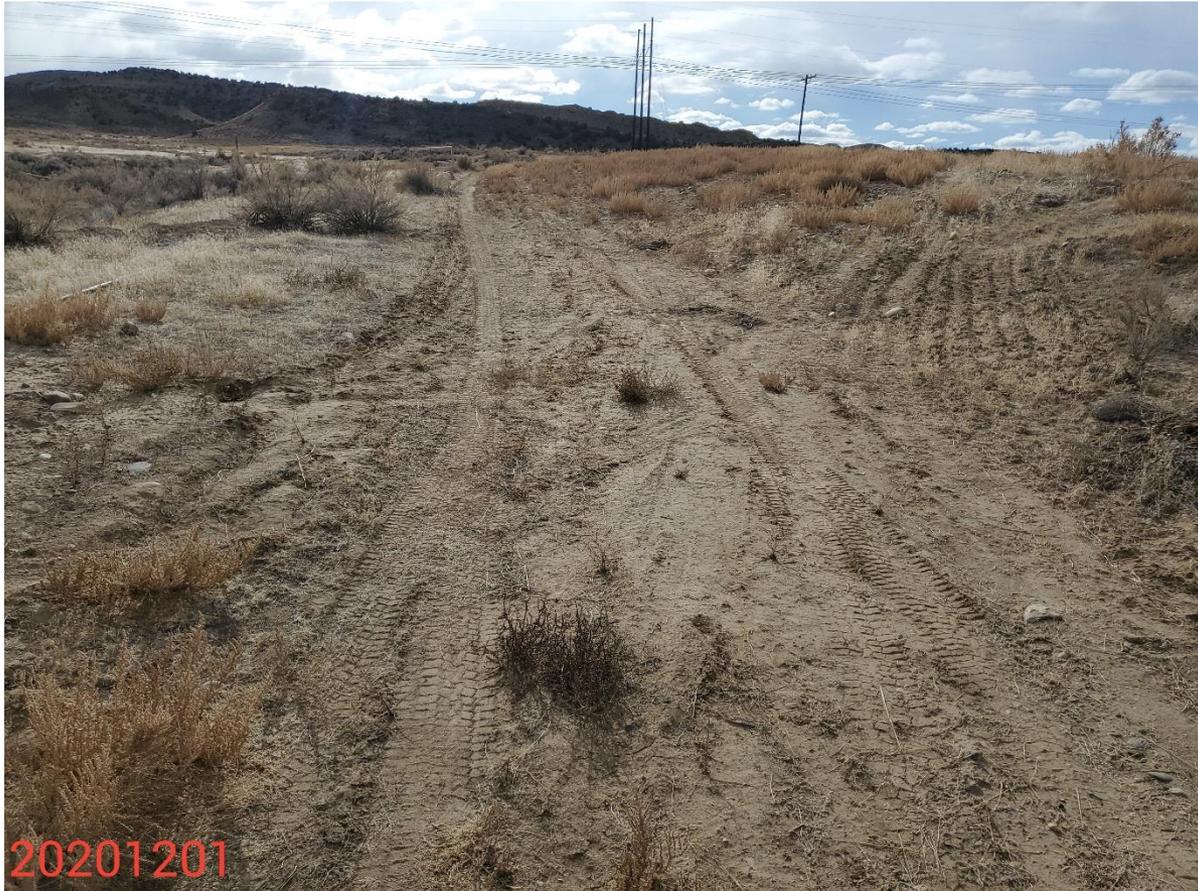
**Photo 6:** Photo taken from the access road north of the Location, facing south. Photo shows that a portion of the access road between the turn-off and the Location has not been reclaimed per corrective actions and rules. Vehicle travel over the reclamation area evident; Continued vehicle use is not conducive to reclamation.
